Phase One Planning

Preliminary Environmental Risk Assessment

Kirk House, 97-109 High Street, Yiewsley, West Drayton, UB7 7QH

Report Reference
AEL-4707-PP1-904773_V2

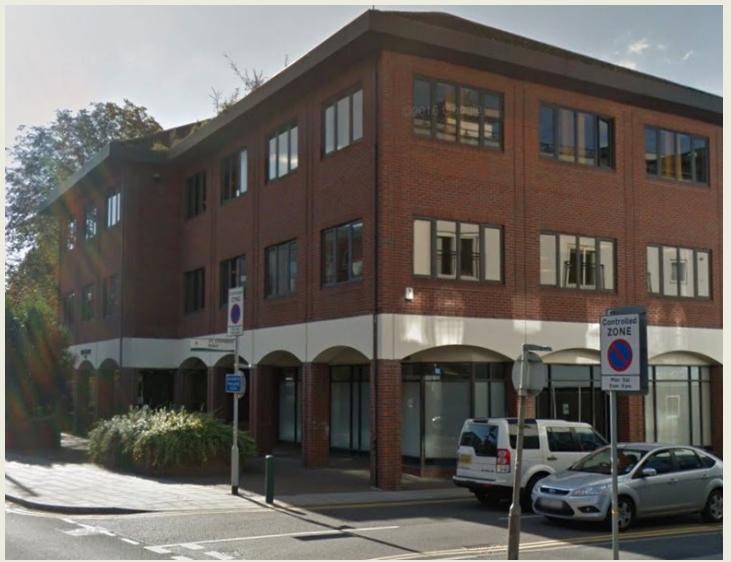
Site Description	
General description	<p>The Site comprises one building situated in the east of the Site with a car parking area in the west. The office extends to the west of the main building via a wing acting as a canopy partly forming an undercroft car parking area. A fire escape route is situated at the rear of this wing leading down to the car park. The car park is accessed from St Stephen's Road via a security barrier entrance in the north west and the main office entrance can be accessed from the main High Street through revolving doors in the south east. The car park is bound by brick walls in the south and north and a wooden panel fence in the west.</p> <p>The offices are split over three floors and the main building does not have a basement. The ground floor houses the main reception and waiting area, with a comms room behind and a lockable storage cupboard to the north; storing office furniture, supplies, a fridge and cleaning equipment. A boiler room and electricity switchboard room, accessed from the car park, and staff convenience facilities are positioned behind the main reception.</p> <p>The main office space is spread across the first and second floors; comprising, open offices, meeting rooms, training rooms, an IT store, a printing/comms room, a board room, a library, a first aid and prayer room, staff room and staff convenience facilitates.</p> <p>Some assumed storage cupboards, the electricity switchboard room and gas powered boiler room were locked and therefore not accessible during the Site inspection.</p> <p>Argyll have been provided with existing service plans for the Site, and the Site representative reported that each individual flat will be connected to its own mains gas, electricity and water supply.</p> <p>The Site is fitted with surveillance cameras, an alarm and security fob entrances with security lights in the car park.</p>

Buildings and infrastructure	<p>The building is of brick and concrete construction with a tiled roof.</p>

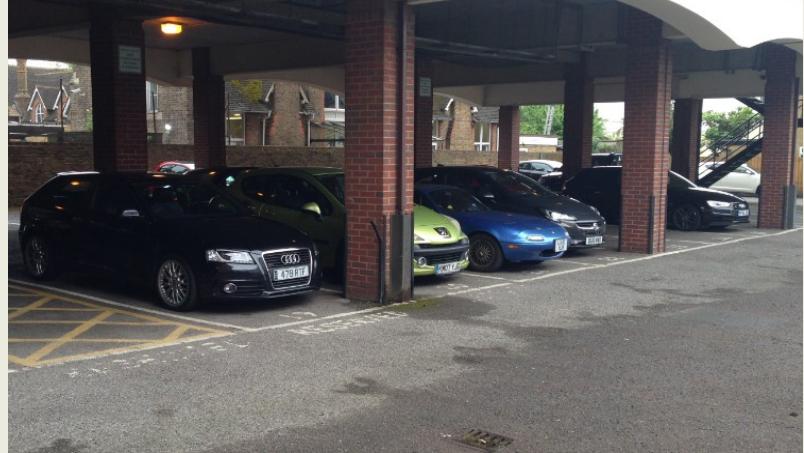
Site Description	
Site topography	The Site and the surrounding area appeared to be relatively flat, with a gentle slope noted in the car parking area towards the car park entrance in the north west.
Surface conditions	Good quality hard-standing is located across the car parking area and brick paving covers the eastern boundary of the Site in front of the main entrance.

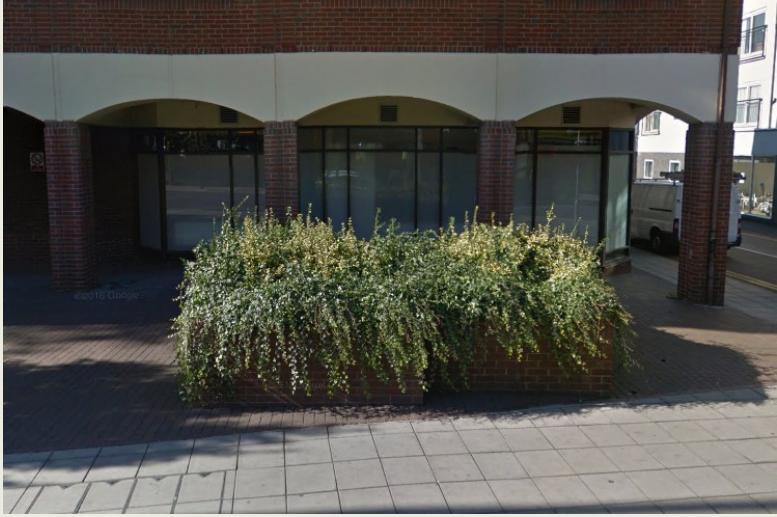
Vegetation	No areas of soft landscaping were identified at the Site. Enclosed planted raised brick beds are located in front of the main office entrance at the east of the Site.

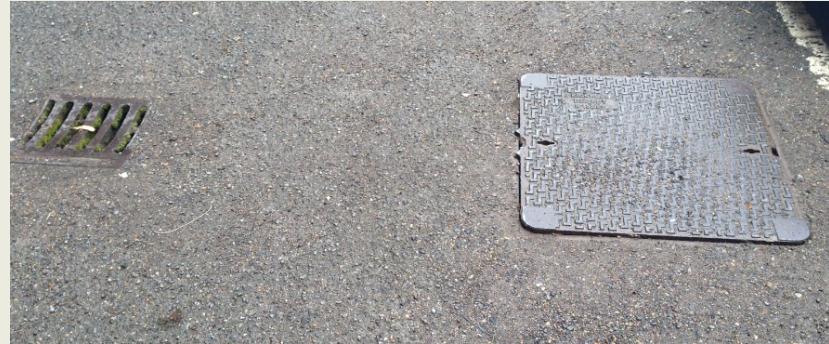
Several drains and inspection covers were noted within the car parking area and although the discharge point of these could not be confirmed, the Site representative reported that the Site is connected to the existing sewer network.

Argyll have been provided with the existing service plans for the Site, and the Site representative reported that the properties will be connected to the existing sewer network.

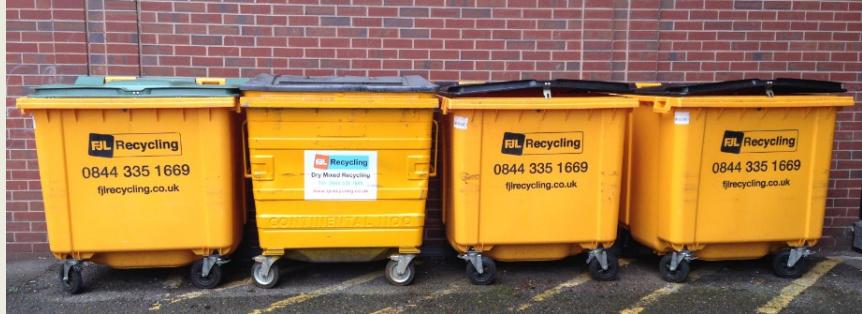
Source	Description
Former land uses off-site – heavy metals, solvents, lubricants, hydrocarbons, coolant, detergents, battery acid and antifreeze.	An engineering works, an unspecified works with an associated tank, a depot and an abattoir were noted in the surrounding area from historical mapping between 75m west and 95m north west. The areas occupied by these former land uses have been redeveloped and so visual inspection during the Site visit was not possible.
Non-Hazardous Waste	<p>General and recyclable waste is collated across the offices in separate bins. This waste is then stored within waste bins located in the car parking area adjacent to the north west of the main building on good quality hard-standing. This waste is collected 2/3 times a week by FJL Recycling.</p> <p>Waste battery and ink cartridges are also collated in designated areas within the office and collected by the local council as and when required.</p>

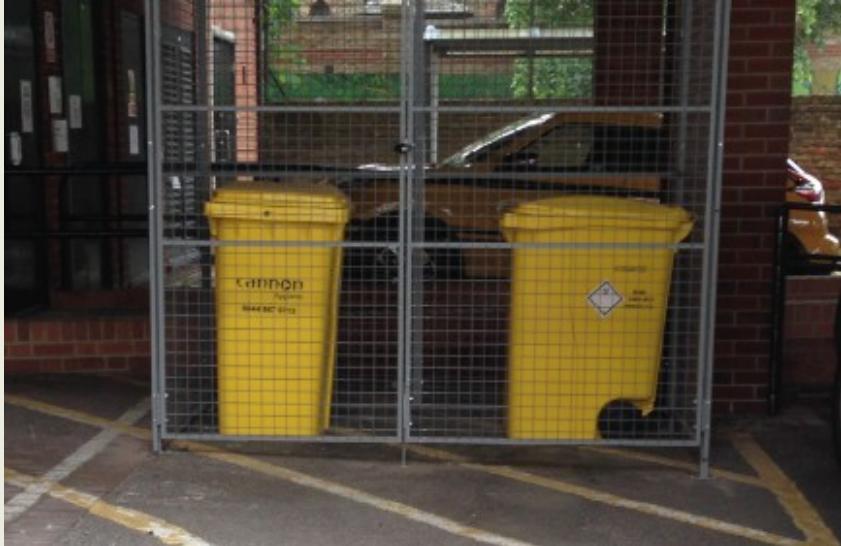
Storage of other hazardous chemicals	Minor quantities of cleaning chemicals and detergents are stored internally within a lockable cupboard located in the north east of the Site.
Hazardous waste	<p>Clinical waste collated by the district nurses during their rounds (conducted off-site) is disposed of within two lockable wheelie bins located in a locked cage in the car parking area to the west of the main building on good quality hard-standing. This is collected by Cannon Hygiene on at least a weekly basis.</p> <p>Waste electrical equipment is taken away and disposed of off-site by the IT department, who service the equipment used with the offices.</p>

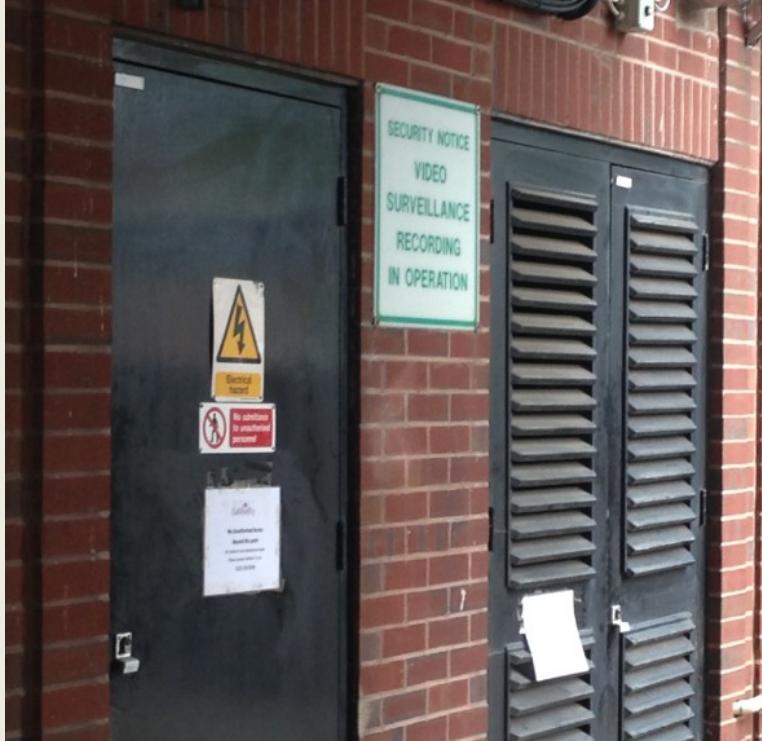
<p>Polychlorinated Biphenyls (PCBs) from transformer units/other PCB containing equipment</p>	<p>An internal switchboard is located on the ground floor in the south west of the main building within a locked room, which is accessible from the car park. As the building was constructed prior to the ban of PCBs in 1986 (EU directive 96/59/EC), it is possible that the internal equipment contains PCBs. The age of this equipment could not be confirmed by the Site representative.</p>

Any risk posed to site users and ground workers from the potential presence of PCBs, however, is reduced given that they have a low mobility and therefore any contamination is likely to be localised. The equipment is assumed to be stored within a cupboard with a hard-standing floor, preventing the migration of potential contaminants into sub surface soils. Appropriate Personal Protection Equipment (PPE) is anticipated to be worn during redevelopment.

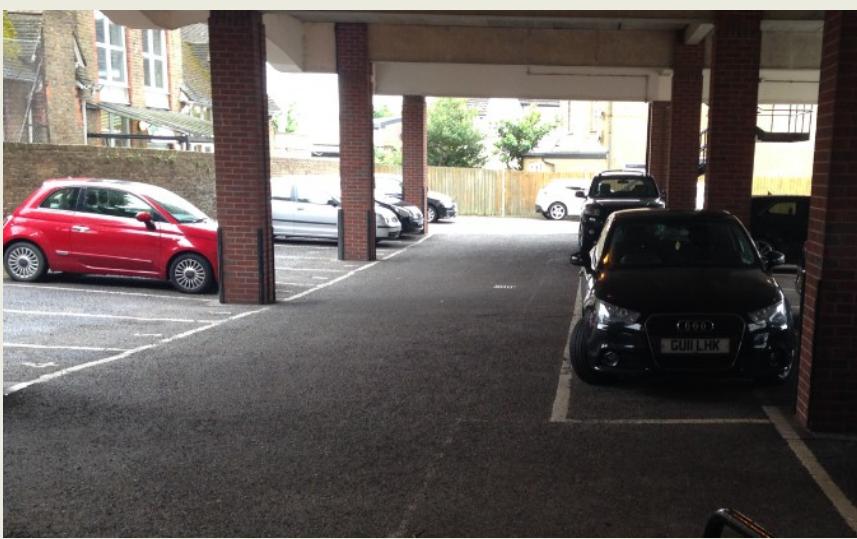
<p>Made Ground</p>	<p>The car parking area on Site is covered in concrete hard-standing, which may be underlain by a thin layer of hardcore and rubble, acting as a base for the pouring of the tarmac.</p>

It is plausible that made ground could underlie the Site. However, the building on Site is not of sufficient scale to have required significant ground works to be undertaken. As such, it is considered unlikely that there will be made ground beneath the Site to an extent that could cause concern with regard to gassing issues, content of asbestos or other contaminants such as heavy metals or VOCs. Furthermore the nature of the proposal

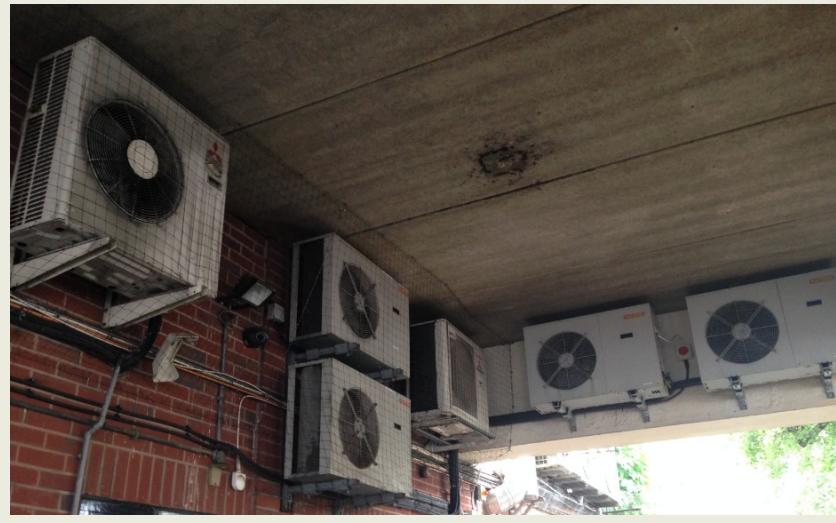
Emissions to Air and Ozone Depleting Substances (ODSs)

The office building is cooled/heated via 12 air conditioning/heating units. These are connected to an air handling unit situated in the loft of the main building. The maintenance of these units is contracted out to CBRE, who are responsible for their inspection and on-going maintenance. It was reported that the units are inspected on a 6 monthly basis. The age of these units nor the refrigeration agent used could not be confirmed, and therefore this fluid may be an ozone depleting substance (ODS). The Site representative reported that these would be removed prior to the proposed conversion of the property.
