Appendix D Exploratory hole location plan, exploratory hole logs and photographs

Exploratory hole logs

Project: Meadow High School

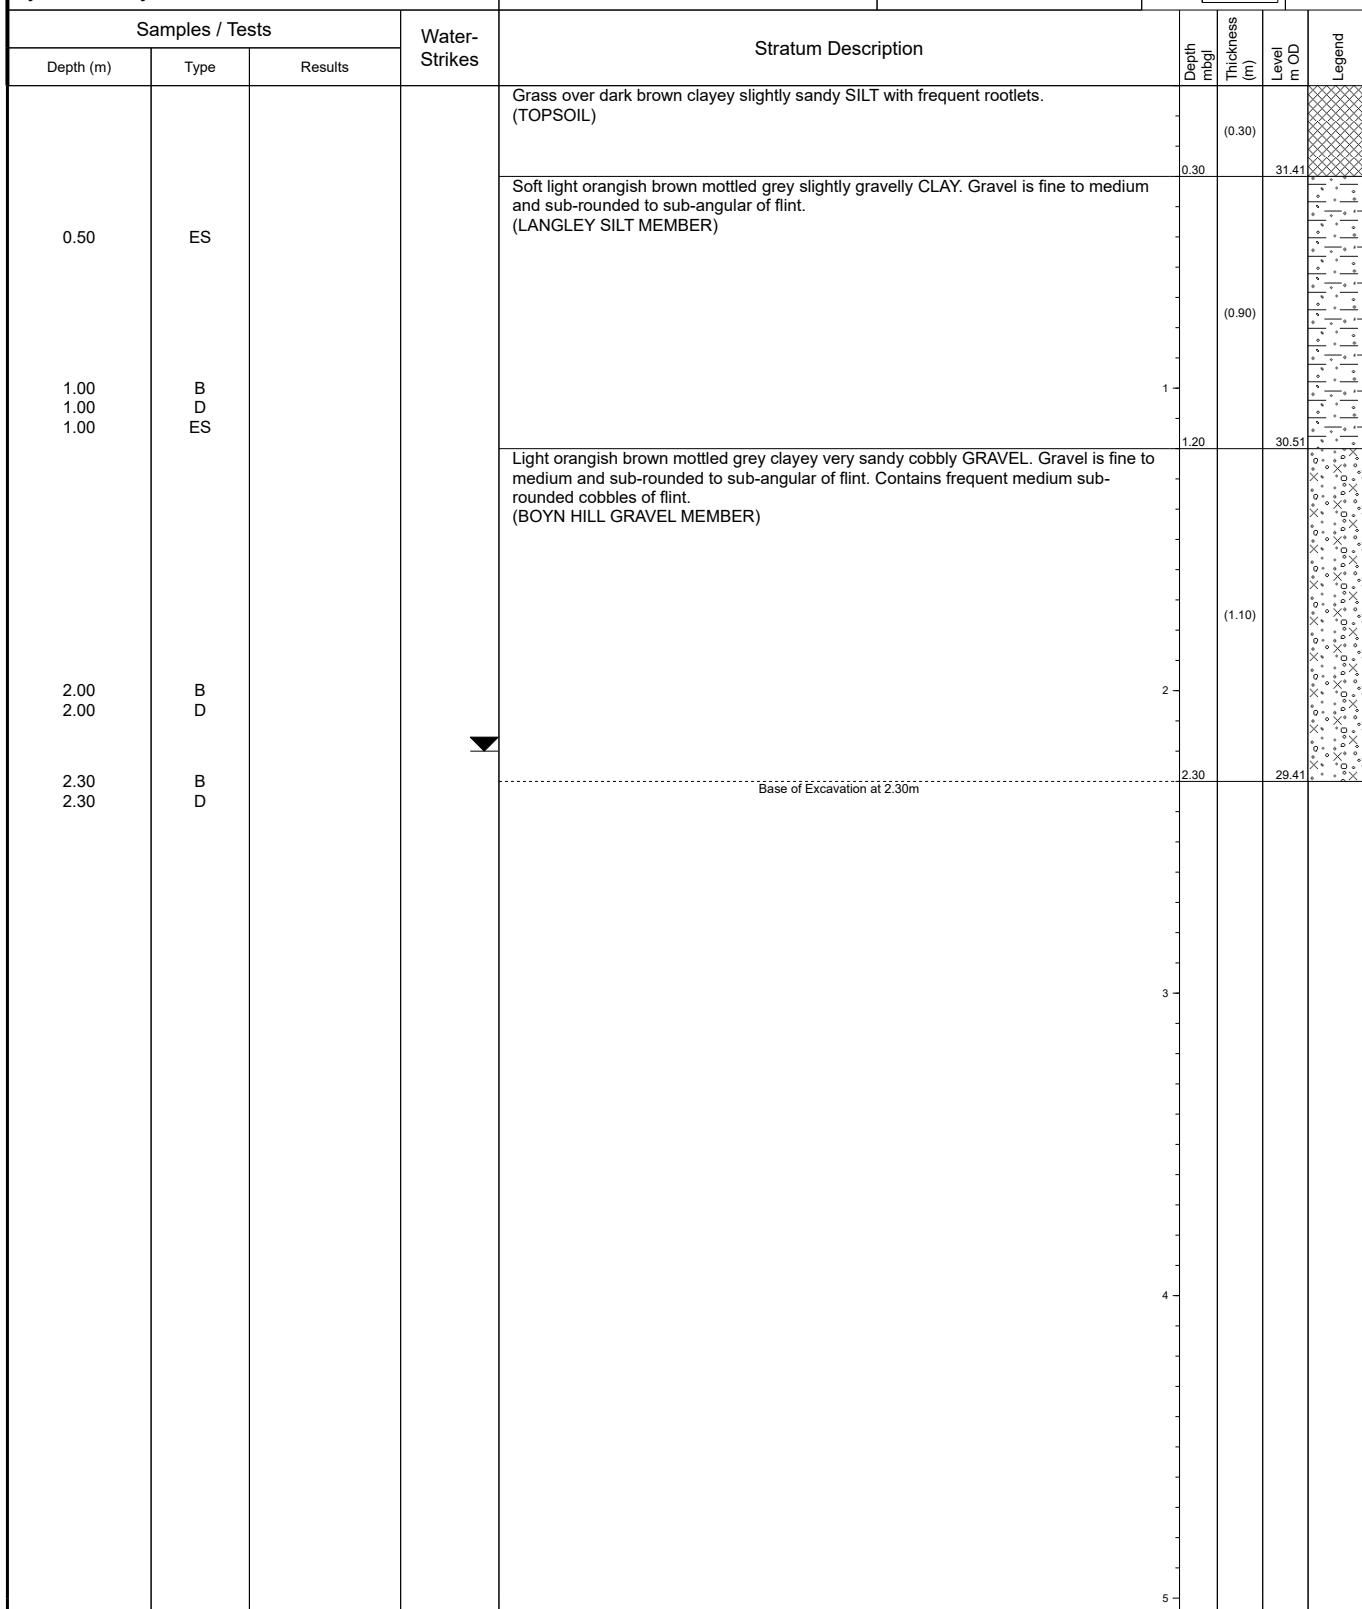
SA01

1. Terminated at 2.30m bgl and backfilled with gravel to 1.30m bgl and arises to 0.0m bgl.
2. Water ingress at 2.20m bgl.
3. Slight collapse from 2.0m bgl.

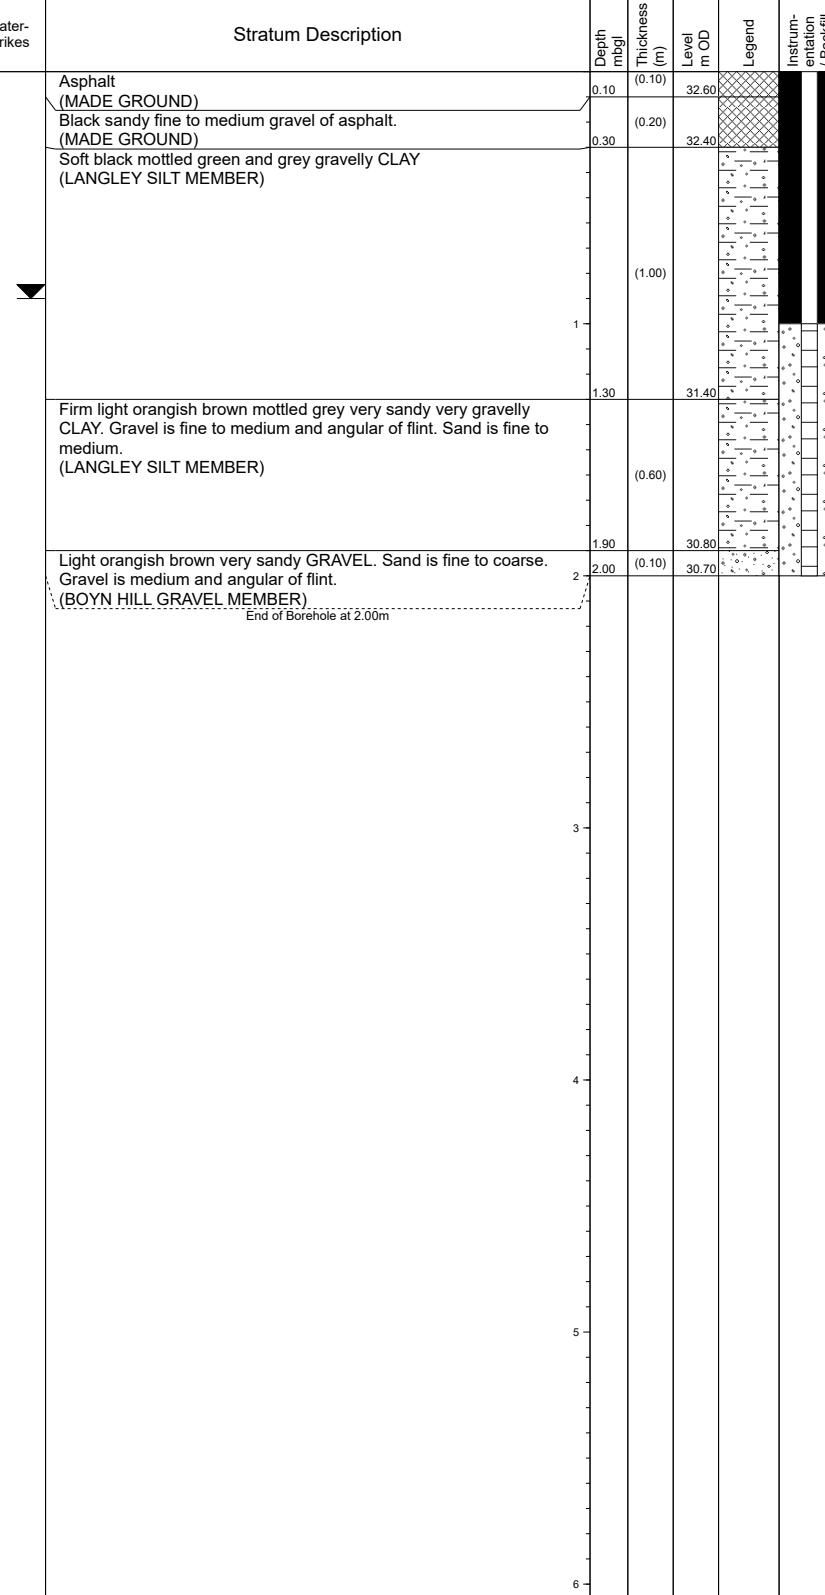
Asphalt (MADE GROUND)
Black sandy fine to medium gravel of asphalt. (MADE GROUND)
Soft black mottled green and grey gravelly CLAY (ANGLEY SILT MEMBER)
Firm light orangish brown mottled grey very sandy very gravelly CLAY. Gravel is fine to medium and angular of flint. Sand is fine to medium. (ANGLEY SILT MEMBER)
Light orangish brown very sandy GRAVEL. Sand is fine to coarse. Gravel is medium and angular of flint. (BOYN HILL GRAVEL MEMBER)
End of Borehole at 2.00m

1. Handpitted to 1.20m bgl. 2. Terminated at 2.0m bgl due to refusal within gravels. 3. Installed with plain pipe from 0.0 to 1.0m bgl and backfilled with bentonite and arisings. 4. Installed with slotted pipe from 1.0 to 2.0m bgl and backfilled with gravel.

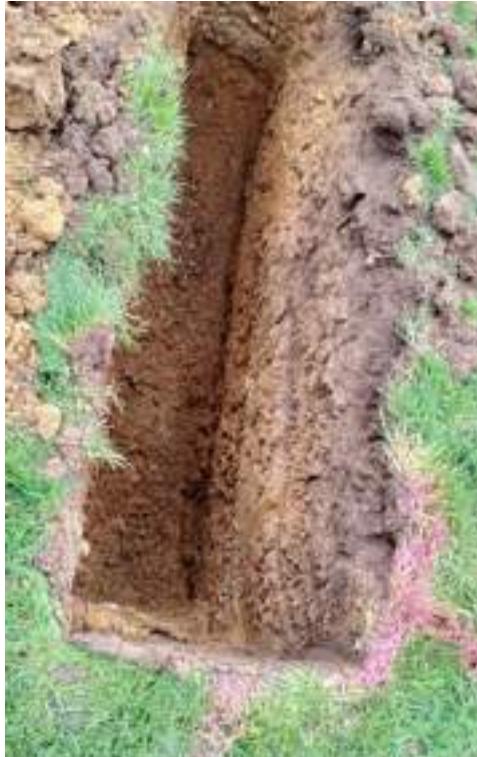
Site Investigation Photograph 1

Date: 11/04/2023	
Direction Photograph Taken: n/a.	
Description: SA02 excavation showing Langley Silt over Boyn Hill Gravel member.

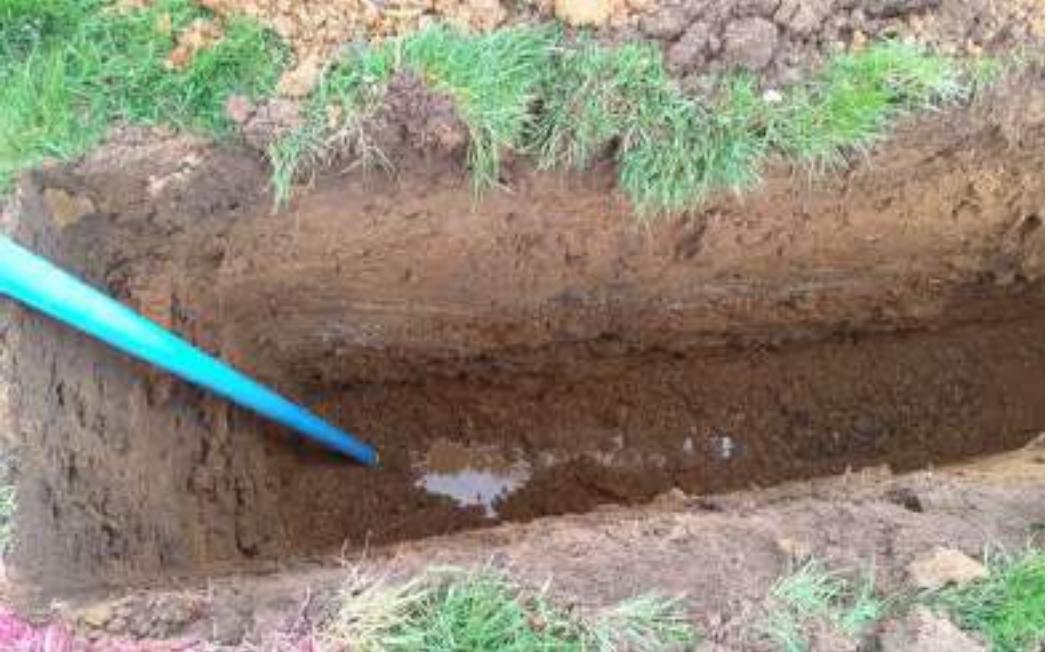
Site Investigation Photograph 2

Date: 11/04/2023	
Direction Photograph Taken: n/a.	
Description: SA02 showing water ingress at 2.20m bgl.

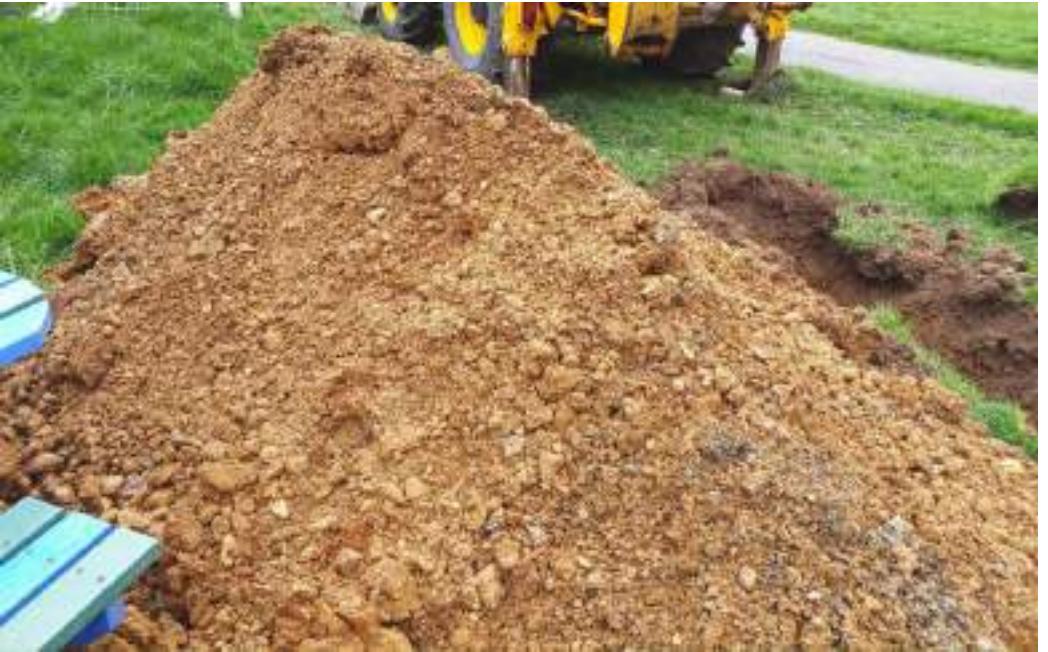
Site Investigation Photograph 3

Date: 11/04/2023	
Direction Photograph Taken: n/a.	
Description: SA02 showing Boyn Hill Gravel Member.

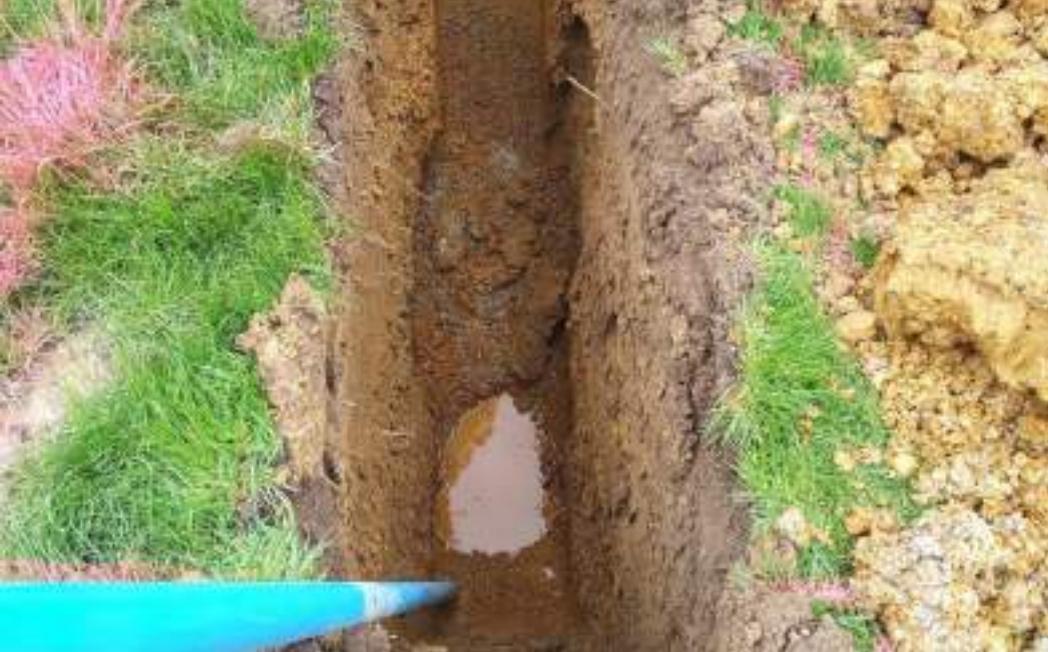
Site Investigation Photograph 4

Date: 11/04/2023	
Direction Photograph Taken: n/a.	
Description: SA01 showing water ingress at 2.20m bgl.

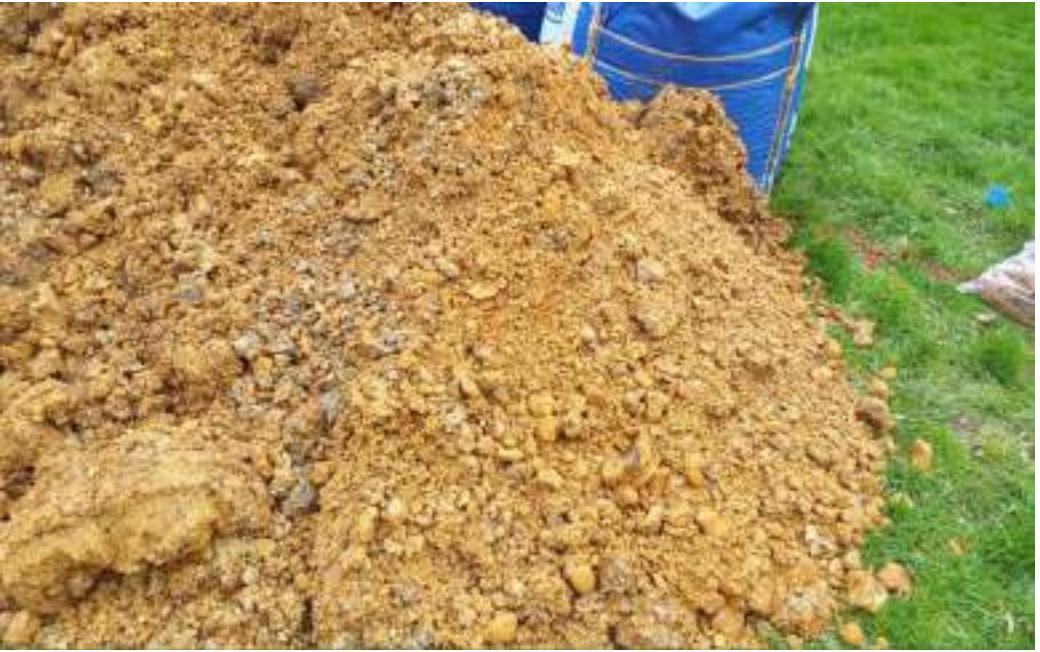
Site Investigation Photograph 5

Date: 11/04/2023	
Direction Photograph Taken: n/a.	
Description: SA01 spoil showing Boyn Hill Gravel Member.

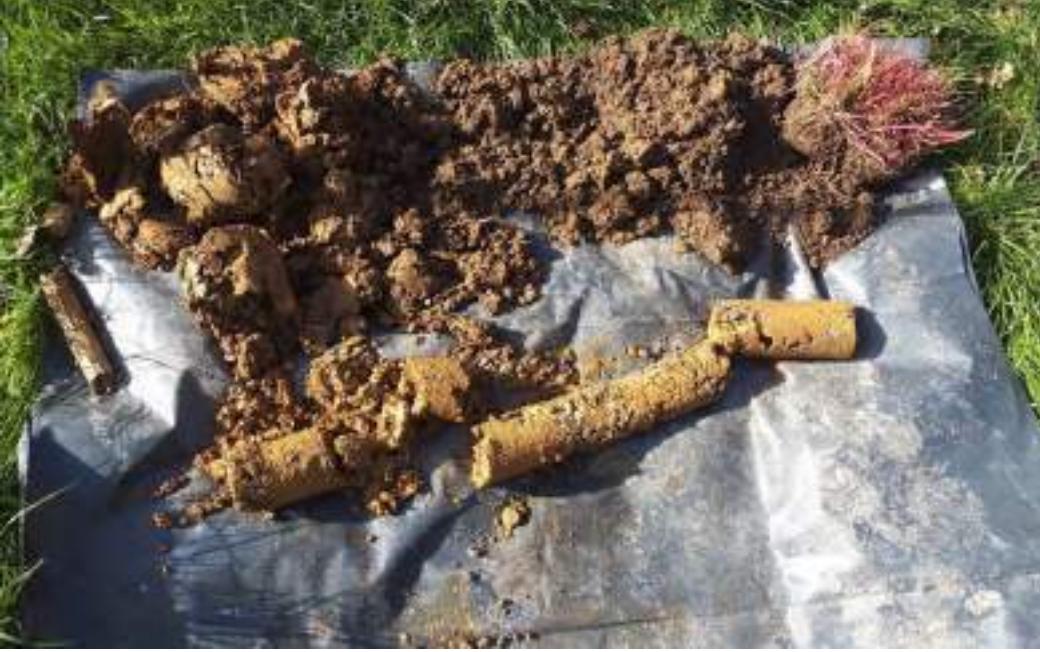
Site Investigation Photograph 6

Date: 12/04/2023	
Direction Photograph Taken: n/a.	
Description: WS02 showing Made Ground over Langley Silt and Boyn Hill Gravel.

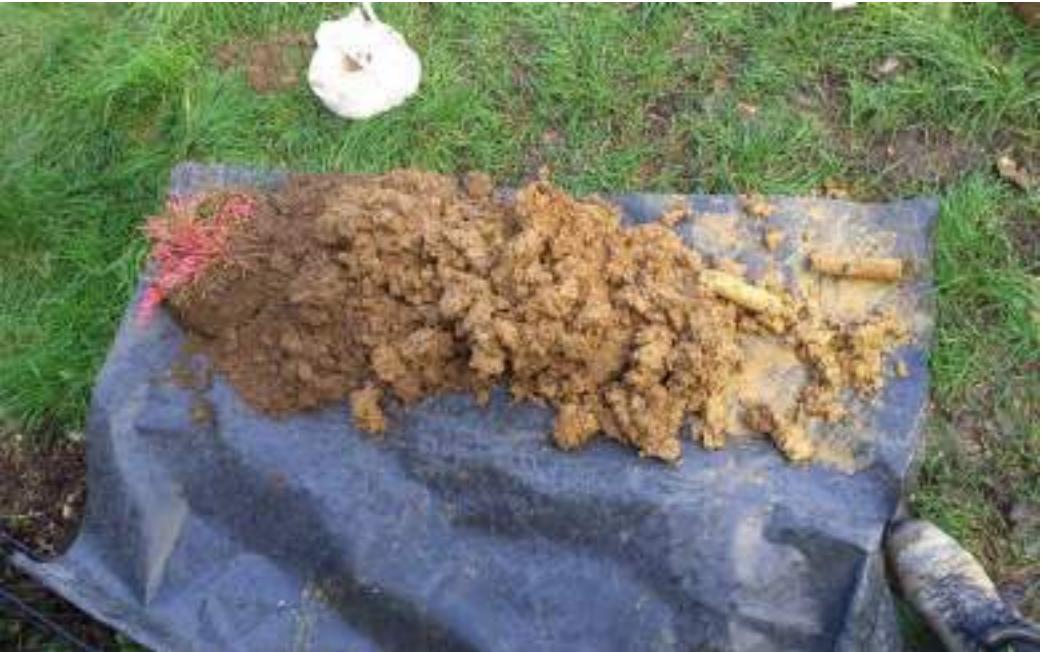
Site Investigation Photograph 7	
Date: 12/04/2023	
Direction Photograph Taken: n/a.	
Description: WS01 handpit spoil showing Made Ground over Langley Silt.

A photograph showing a pile of brown, crumbly soil or spoil resting on a dark blue tarp. The tarp is laid out on a grassy area. In the background, a white bag is visible on the grass.

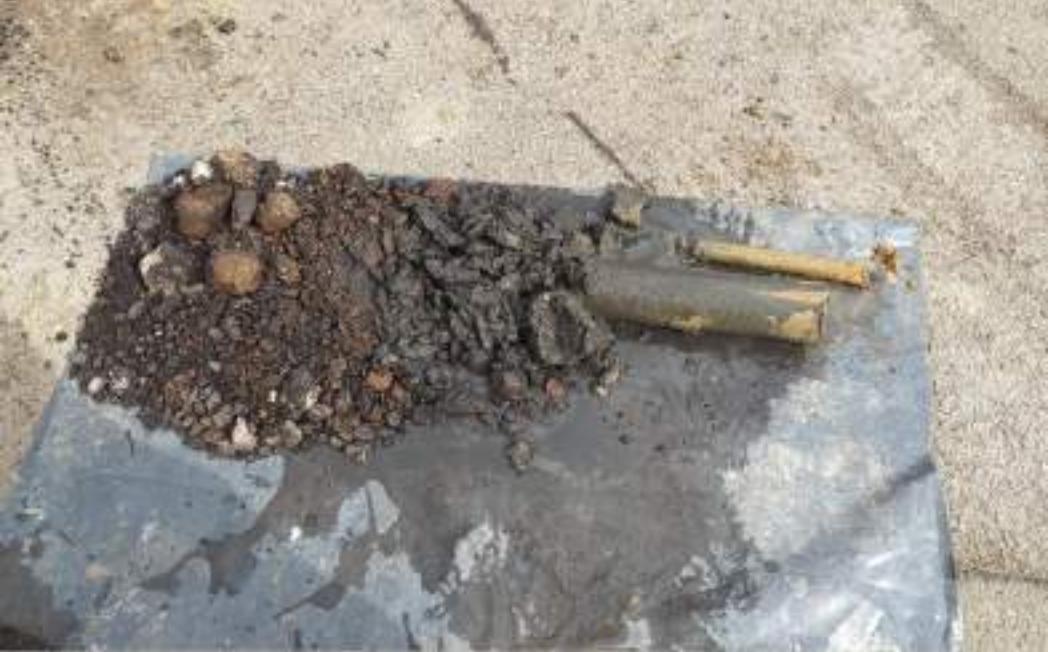
Site Investigation Photograph 8	
Date: 12/04/2023	
Direction Photograph Taken: n/a.	
Description: WS03 showing Made Ground over Langley Silt with black staining.

A photograph showing a pile of dark, granular material, likely made ground, resting on a dark blue tarp. The material has some black staining. A few yellowish, cylindrical objects are visible within the pile. The tarp is laid out on a concrete or paved surface.

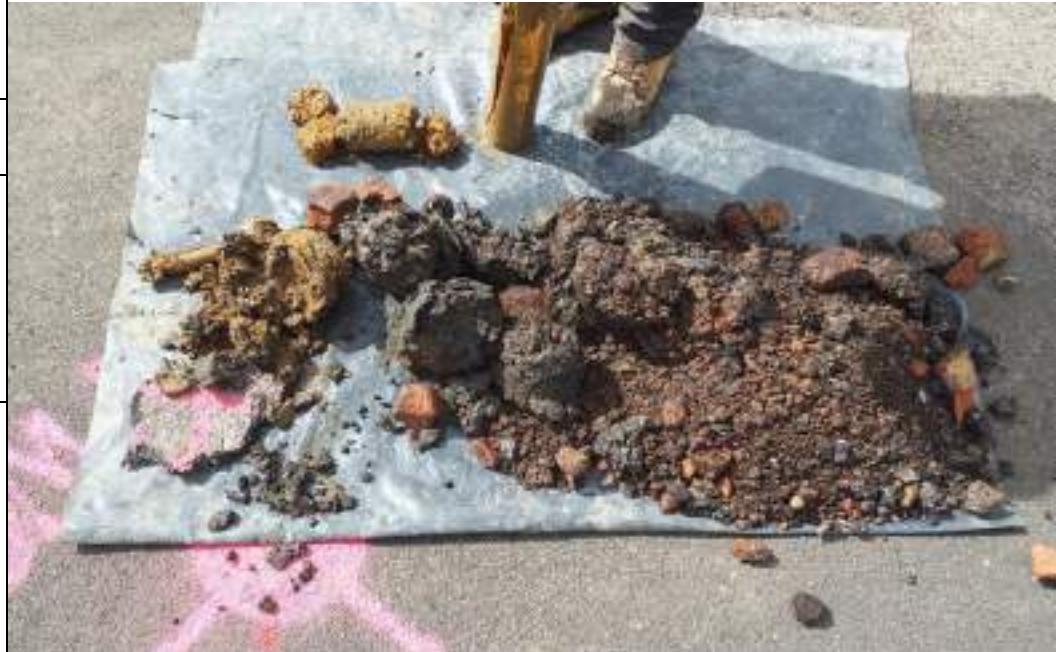
Site Investigation Photograph 9

Date: 12/04/2023	
Direction Photograph Taken: n/a.	
Description: WS04 showing Made Ground with black staining and brick cobbles.

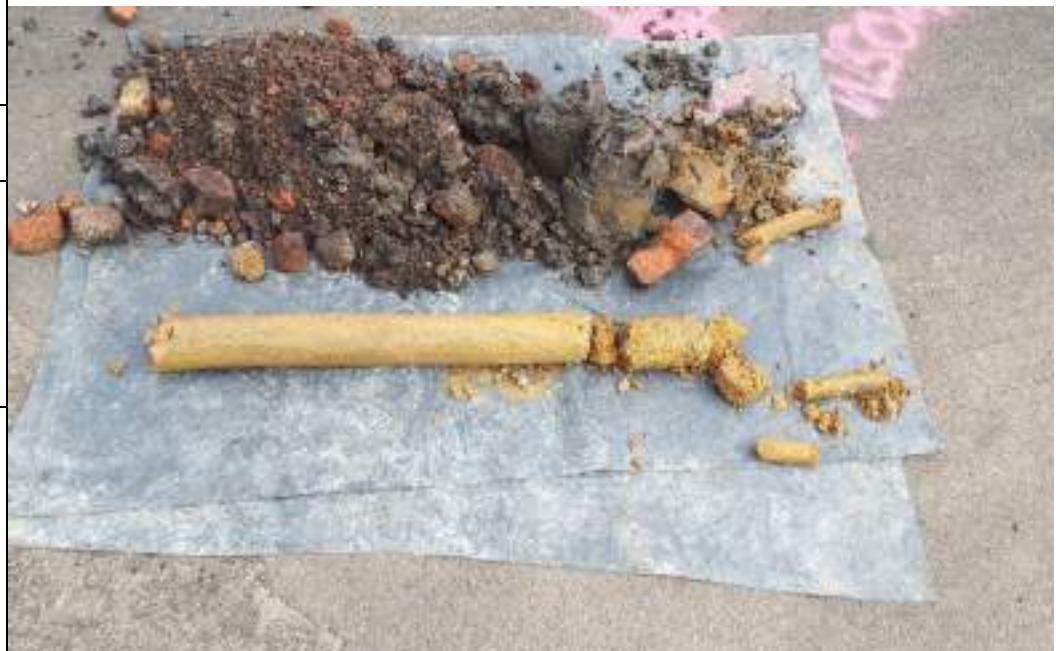
Site Investigation Photograph 10

Date: 12/04/2023	
Direction Photograph Taken: n/a.	
Description: WS04 showing Made Ground over Langley Silt.
