## Preliminary Ecological Appraisal & Roost Assessment

87 Copse Wood Way, Northwood HA62TX

This report is prepared to inform a planning application with London Borough of Hillingdon. Full demolition to build a new dwelling

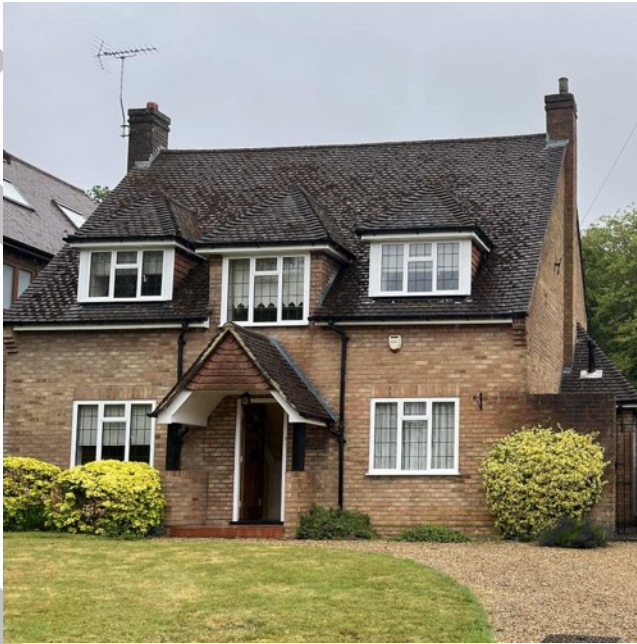
B1 is a residential dwelling, featuring a gabled roof with dormer windows to the north and south. The northern elevation features hanging tiles which are in good condition, with no gaps beneath. The roof features roosting features, including lifted tiles and gaps under lead flashing, particularly on the eastern extension and southern elevation, while the timber soffits on the northeastern elevation also present gaps. Internally, the loft void, lined with bitumen felt, features timber rafters and fiberglass insulation; although no clear external access points were noted, a rip in the felt lining could offer entry or roosting space. Approximately 50 bat droppings, suspected to be from brown long-eared bats, were found within the void, which have been sent for DNA testing. The building has been assessed to have high habitat value, and is a confirmed roost.

Building B1, southern elevation

Three bat emergence/re-entry surveys are required on B1 during the active bat season (May – September) to characterise the roost/s present in or on the building. These survey visits should be completed during the optimal survey period mid-May to August inclusive. The survey visits should be at least three weeks apart. Sub-optimal: early May and September. Would require greater justification of timing e.g., weather conditions, known local bat activity. One of the surveys could be a dawn re-entry survey, or all three can be at dusk if supported by night vision aids (NVA).

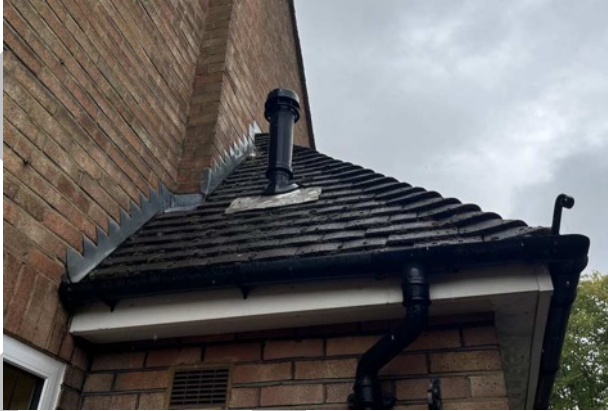
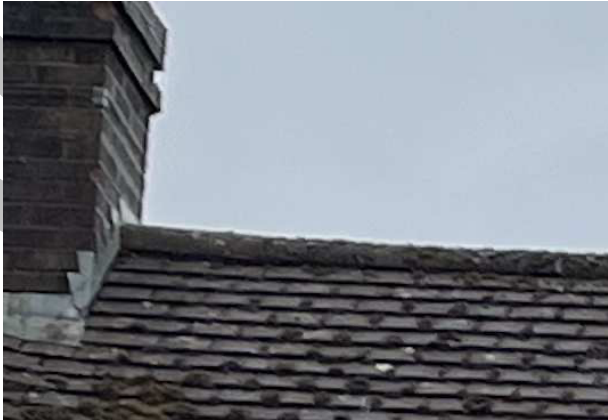
| Roof | Tiles | <p><b>Condition/description</b></p> <p>The roof was in fair condition, though featured one missing rooftile on the lower, single-storey extension to the east, adjacent to the garage. An area of missing tiles was also noted under the ridgeline on the southern elevation. Areas of lifted lead flashing were seen to be present on the dormer window on the northeastern elevation.</p> <p><b>Suitability/access/evidence of bats</b></p> <p>Lifted tiles offer good roosting opportunity for roosting bats, and where multiple lifted tiles are present, the there is a greater opportunity for larger roosts to be formed.</p> <p>Gaps under lead flashing can support low or individual numbers of crevice dwelling species of bats.</p> | <p>B1 roof, slipped tile, eastern outcrop</p> <p>B1 roof, missing tiles under ridgeline</p> |

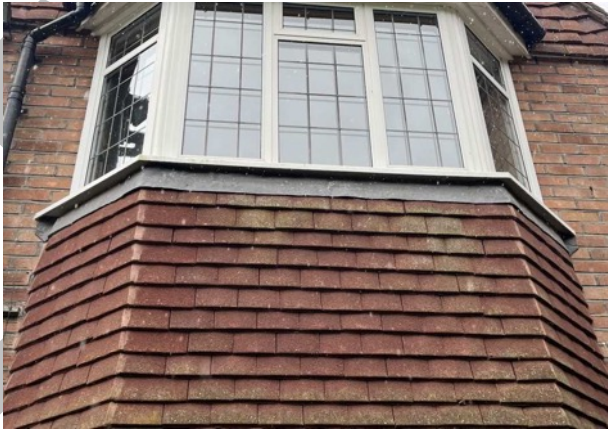
| | | | <p><i>B1 roof, lifted lead flashing</i></p> |

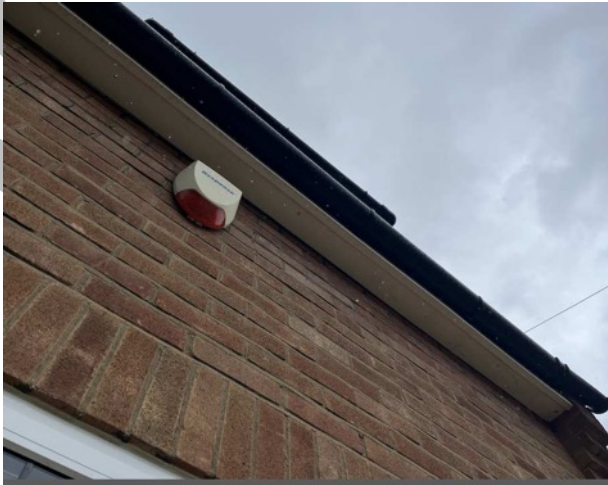
| Eaves | Timber board | <p><b>Condition/description</b><br/>Gaps were seen to be present where the wooden soffits join the walls of the dwelling on the northeastern elevation.</p> <p><b>Suitability/access/evidence of bats</b><br/>Soffit boxes have the capacity to host larger populations of crevice dwelling species of bats.</p> | <p><i>B1 eaves</i></p> |

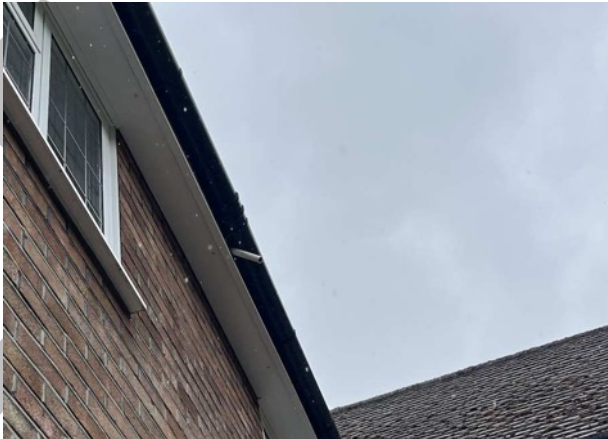
| | | | <p><i>B1 eaves, northeastern elevation</i></p> |

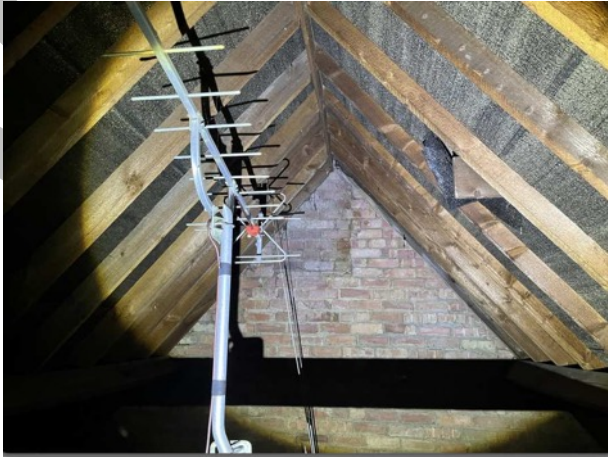
| Internal void 1 | Timber rafters.<br>Fiberglass insulation | <p><b>Condition/description</b></p> <p>Internally, the bitumen felt lining was in good condition, featuring one rip in the material. On either side, the brick gable ends of the building to the northwest and southeast were in good condition. No clear access points were noted within the void, and no light ingress noted. All wooden beams were in good condition with no cracks or splitting within the wood that would provide suitable shelter for bats.</p> <p>Dimensions (approx): Approximately 10m in length.</p> <p><b>Suitability/access/evidence of bats</b></p> <p>Though no clear access points into the loft void were detected, rips in the bitumen felt lining of the roof could offer access into the void from</p> | <p><i>B1 internal void 1, facing southeast</i></p> |

| | | <p>beneath roof tiles, or offer up space for crevice dwelling species to roost.</p> <p>Approximately 50 bat droppings were found largely concentrated beneath the ridge beam in the centre of the void. Owing to shape and size, along with surrounding woodland habitats, the droppings are suspected to be of singular species: brown long-eared bat. The droppings have been sent for DNA testing.</p> | |

As the building contains a confirmed roost, a bat licence will be required to demolish the building as it would involve the destruction of roosts. This is applied for with the help of a class 2 licensed bat ecologist after planning permission is granted, but before commencement of works.

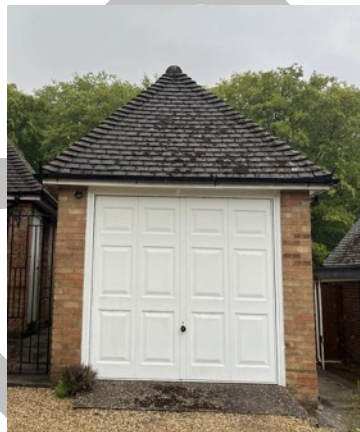
B2 is a detached garage to the southeast of B1. The walls are brick, and are in good condition, with no areas of missing mortar or cracks which provide suitability for bats. The building features windows to the north and east, allowing large amounts of light to fill the building. No access points were detected into the building internally or externally. B2 has been assessed to have negligible suitability for roosting bats.

*Building B2, southern elevation*

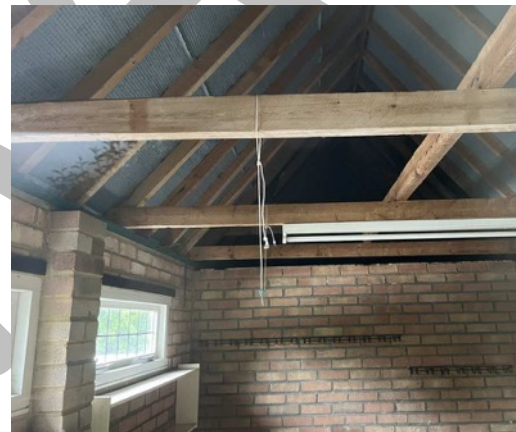
*Building B2, interior, facing south*

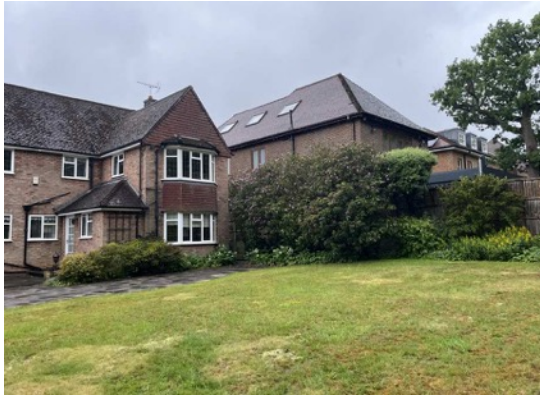
Rhododendron (*Rhododendron ponticum*) was identified on the site which is listed as an invasive, non-native species under Schedule 9 of the Wildlife and Countryside Act 1981.

*Vegetated garden, northern parcel, facing west, featuring rhododendron shrubs*

Rhododendron present adjacent to B1 (*immediately west*) will be sensitively removed prior to the commencement of works to prevent the spread of a non-native, invasive species listed on Schedule 9 of the WCA (*see Appendix 1a*). The Rhododendron will be removed using hand tools only. The most effective method of removal is through hand pulling, which results in minimal soil disturbance. Hand-pulling young shrubs will typically result in the full removal of the shrub and associated root network, which will prevent the re-establishment. Mature shrubs are likely to have a deeper and more established root network unlikely to be removed in full by hand pulling alone. Where there are mature shrubs, removal should be aided using hand tools to expose the root network in full so the entire shrub and associated roots can be removed. Development works will not commence until Rhododendron has been successfully removed from the site.

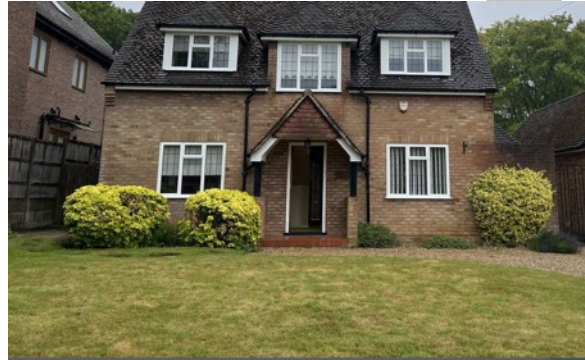
*Vegetated garden, southern parcel, facing northeast*

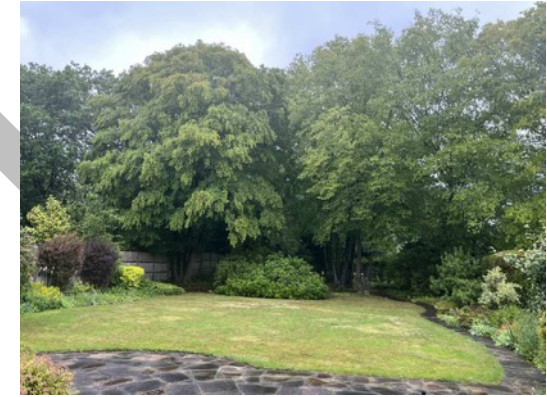
*Vegetated garden, northern parcel facing northeast*

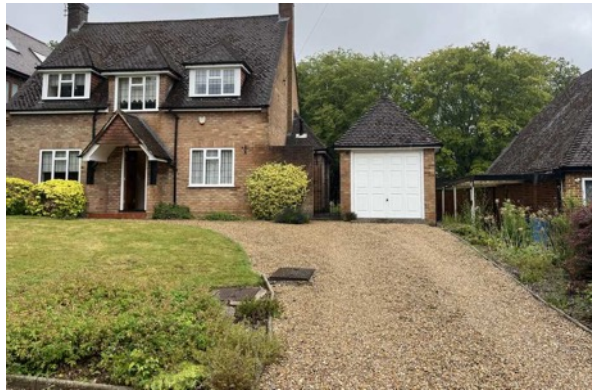
There is a parcel of artificial unsealed unvegetated surface to the south of the site, leading from the road to the house, comprising a gravel driveway.

*Artificial unvegetated, unsealed surface*

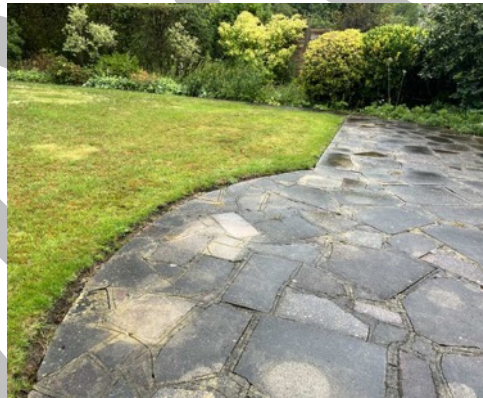
There is an area of hardstanding, in the form of paving stones surrounding the house and leading away from the house to the north, with a strip extending to the rear amongst the scattered trees.

*Developed land; sealed surface, northern garden surrounding B1 and B2*

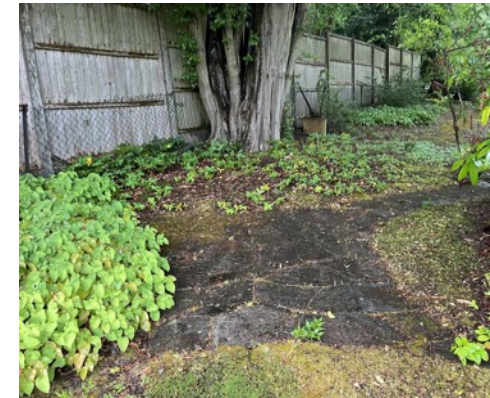
*Developed land; sealed surface, northern garden between scattered trees*

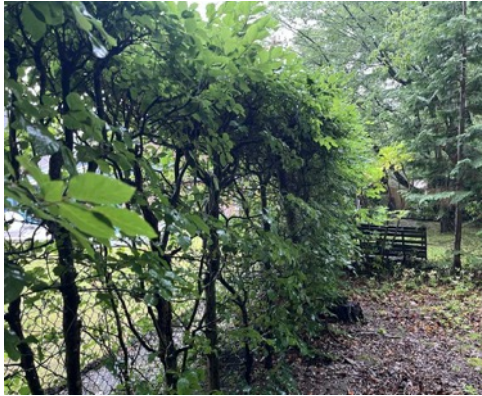
The site is enclosed by native hedgerow along sections of the northwestern site boundary. The hedgerow is actively maintained at 1.5m(h) and 0.5m (w). The hedgerow appears densely vegetated at canopy level, though the understorey is relatively open and sparsely vegetated.

*Native hedgerow, northeastern site boundary*

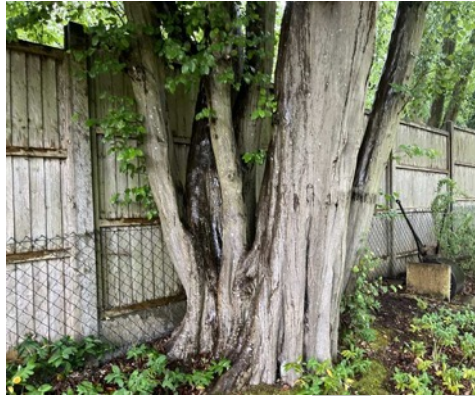
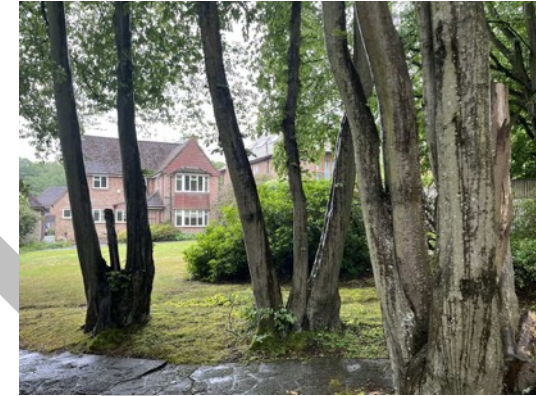
There are five scattered trees present on the site, all forming a single group. This group comprises three large hornbeam (*Betulaceae*) and two medium hornbeam, with over 50% of the trees considered mature. These trees are native to the UK, contributing to the woodland structure. No potential roosting features were identified. No evidence for bats was found.

*Scattered trees; hornbeam*

Retained trees should be protected in line with the measures outlined in the British Standard "Trees in Relation to Design, Demolition and Construction to Construction - Recommendations" (BS 5837) (2012).
