Sweet Express

Planning and Refurbishment at Uxbridge Tube Station High Street, Uxbridge UB8 1JZ

PAR-SE-001
Revision 1

Report Prepared For: Transport for London

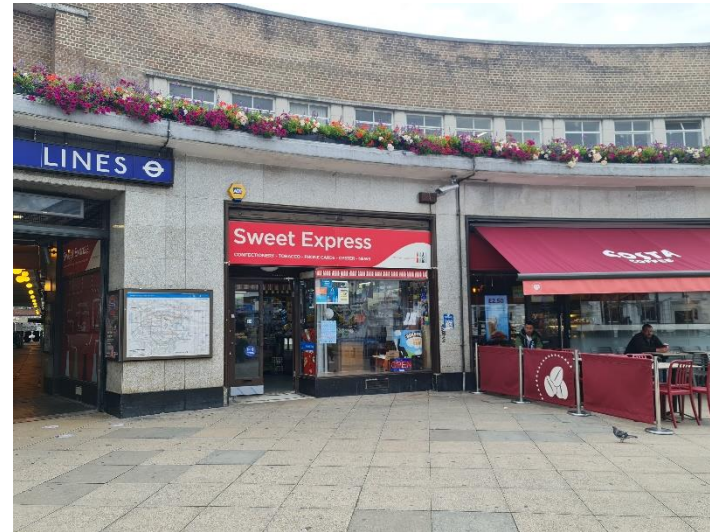
Figure 7 – Exiting front elevation from High Street

The window facing the front elevation is currently vacant of any goods and services. The glazing is broken in a few places and is a hazard that could harm the members of public. The wooden frame is loose fitting and does not provide adequate prevention of heatloss.

The existing building envelope is to be retained in its entirety, with the exception of upgrading the large glazing units on the front and side elevations to meet current building regulations.

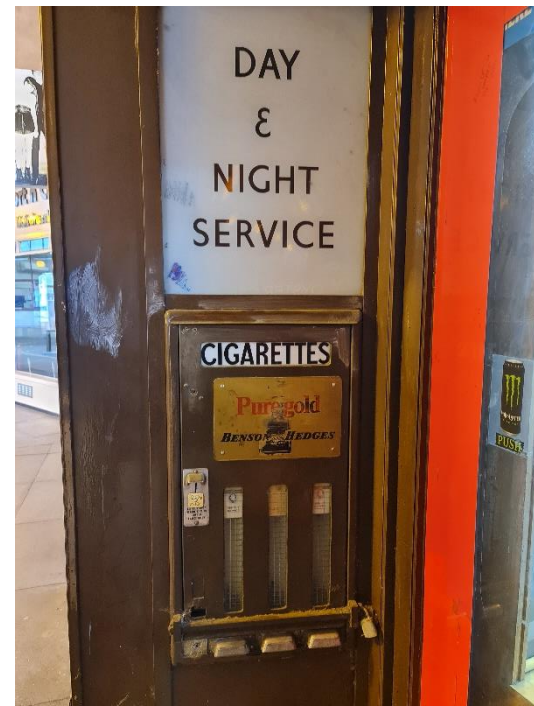
Figure 8 – Cigarette dispenser at front entrance/exit

These Cigarette machine in a poor state of repair and it seems no one in the recent history has attempted to restore these to working conditions or at the bare minimum clean these items that a key feature of Uxbridge Station. The intention of the client is to fully restore the Cigarette machines to their original condition. The machines will not be used for the original purpose, the idea is to use the restored machines to act as a focal points for the retail unit and heritage of whole Uxbridge Station complex. The objective of restoring the cigarette machines to retain and enhance the heritage asset which remain in Uxbridge Station. The restoration of the machines will seek to add discrete LED lighting behind the opaque lettering emphasising the cigarette machines as an integral part of the building.

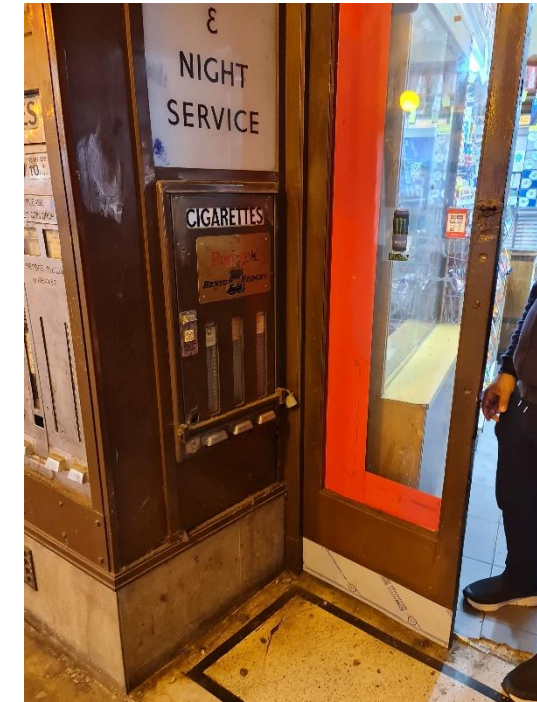
Figure 9 – Listed Cigarette machine at side entrance

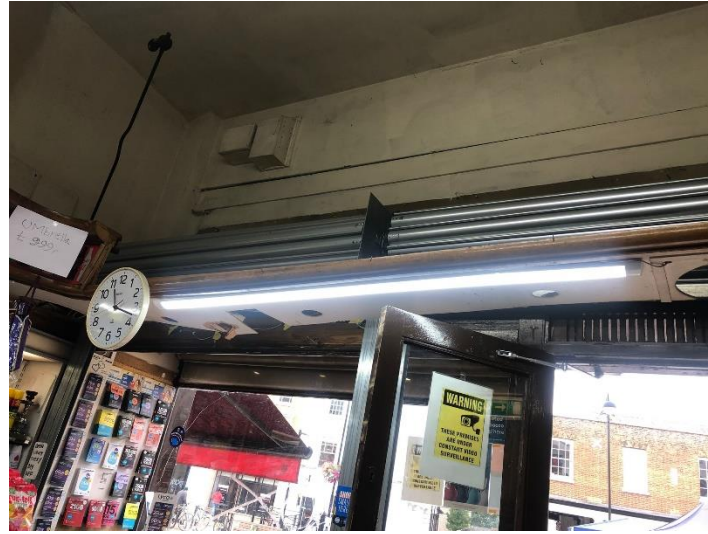
Figure 11 – Interior roller shutter in the shop

The architectural layout and interior fittings of the retail unit are dated and the majority of which are constructed from timber. There is a roller shutter on the interior of the shop but it does not provide protection from ‘break ins’ of the display window via the High Street. There are four listed Cigarette dispensing machine in the façade of the retail unit. The following table provides an overview of their locations:

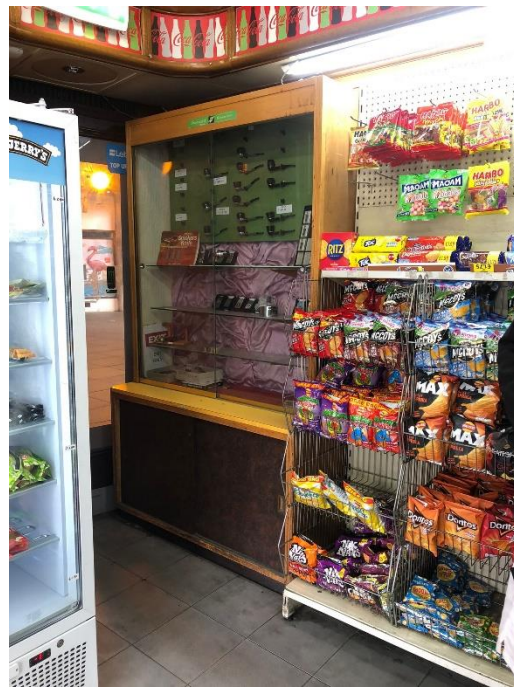
Figure 12 – Cigarette display cabinet

This space has the primary customer focused area, the goods are displayed in a variety of method. Some drinks are display a a selection of oddly sized refrigerated glass fronted fridges. There is one ice cream freezer with a sliding glass front plus a deep freezer for the Ben and Jerry’s ice cream tubs. All the remaining products are displays on a strange mixture of metal and wooden shelving at the serving counter and along the party wall with Costa Coffee. A wooden display cabinet which houses Tabacco paraphernalia which is of a vintage era. This cabinet will be kept in situ and the items within the cabinet will remain unchanged.

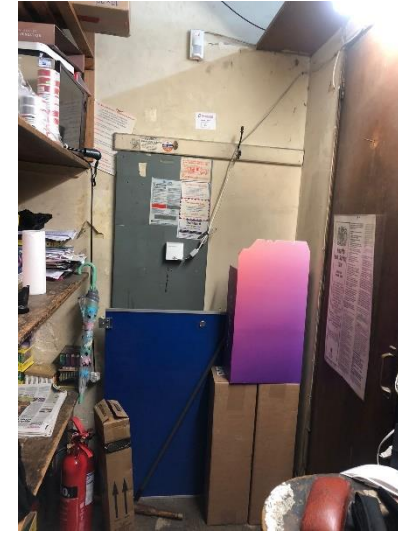
Figure 13 – Electrical services in store area 2

The store room is primarily used as a Back of House function and to some extent as a store for some select goods. There one electrical distribution boards on the party wall with Costa Coffee. This store room also at some point in in the past provided access to rear of the Cigarette machines on the Uxbridge Station side, for the sole purpose of refilling and maintenance.

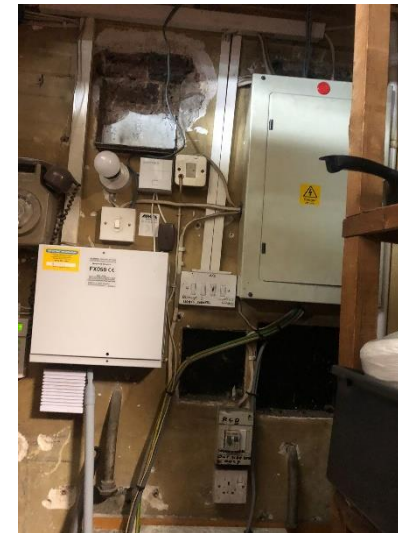
Figure 14 – Electrical Services in store area 1

Contain the main incoming electrical services and electric meter including the old telephone line. It also used for the storage of the produce for sale. This area does not provide adequate storage due to the unusual shape of the room. For this reason the tenant requires this internal space to be reconfigured.

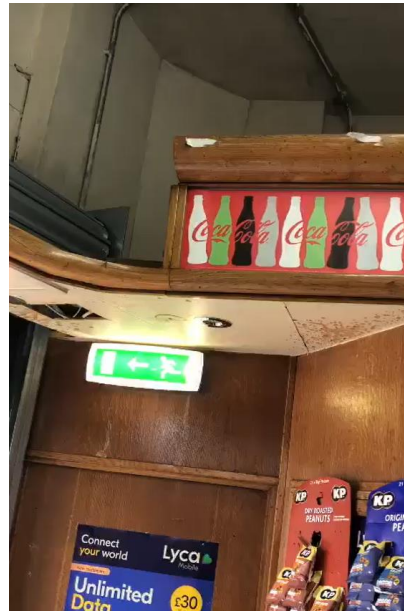
Figure 15 – Damaged timber coving detail to be removed

Given the condition of the existing interior fitout installation and the extent of the upgrade works required. It is proposed that the entire installation of the interior fitout / architectural design within the refurbished areas are replaced as part of this project. Services that are fit for purpose will be retained where possible.

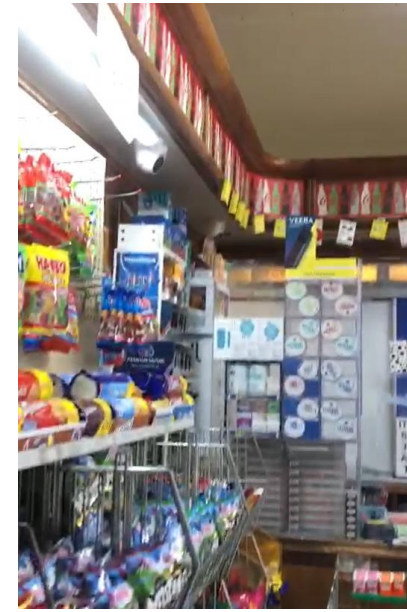
Figure 17 – Serving counter with timber coving above

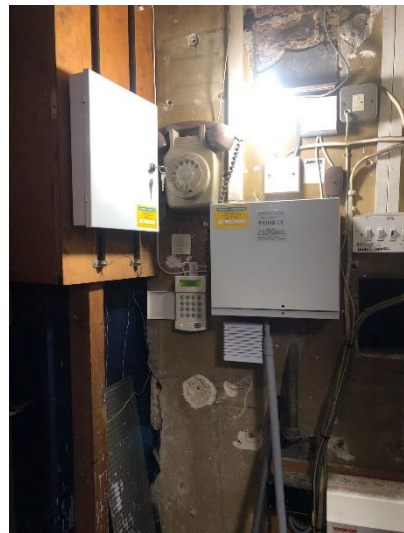
Figure 16 – Electrical services in store area 1

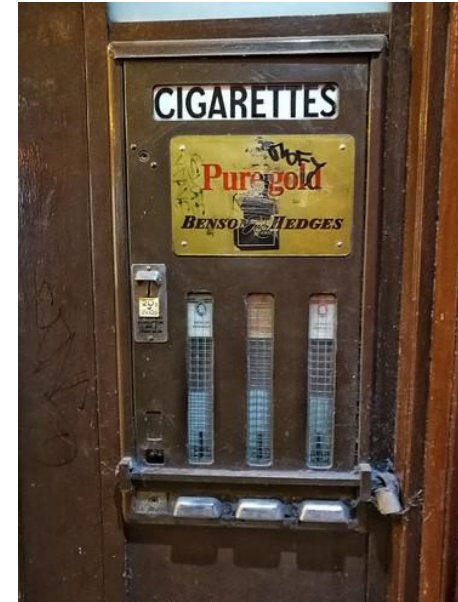
Figure 18 – Listed Cigarette machine at the main entrance

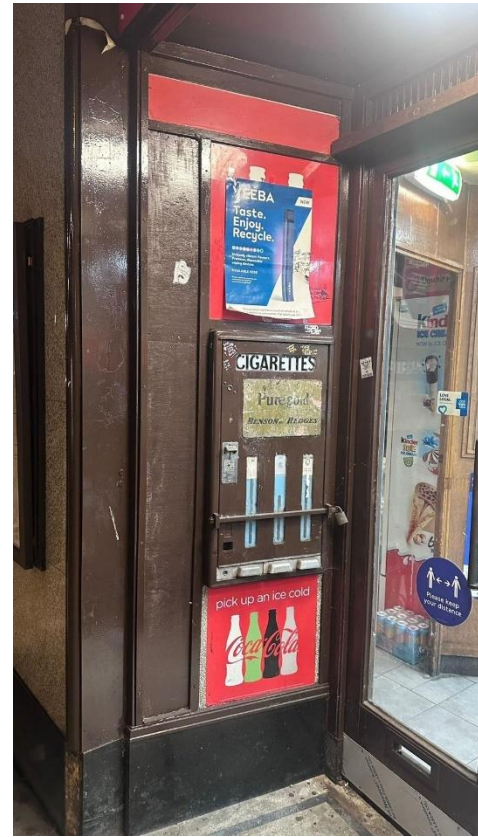
Figure 19 – Cigarette machine at the main entrance
