Storm Water Drainage Technical Note
for 147 Aylsham Drive, Ickenham
on behalf of

Savoys Developments Limited,
4 Station Parade,
Ruislip,
HA4 7DL

This drainage technical note has been prepared on the instruction of Savoys Development Ltd in support of the planning application for the construction of a two storey, 1-bed attached dwelling and two storey rear extension involving parking and amenity space at 174 Aylsham Drive Ickenham UB10 8UF. The existing site is irregularly shaped and occupies an approximate area of 0.032ha.

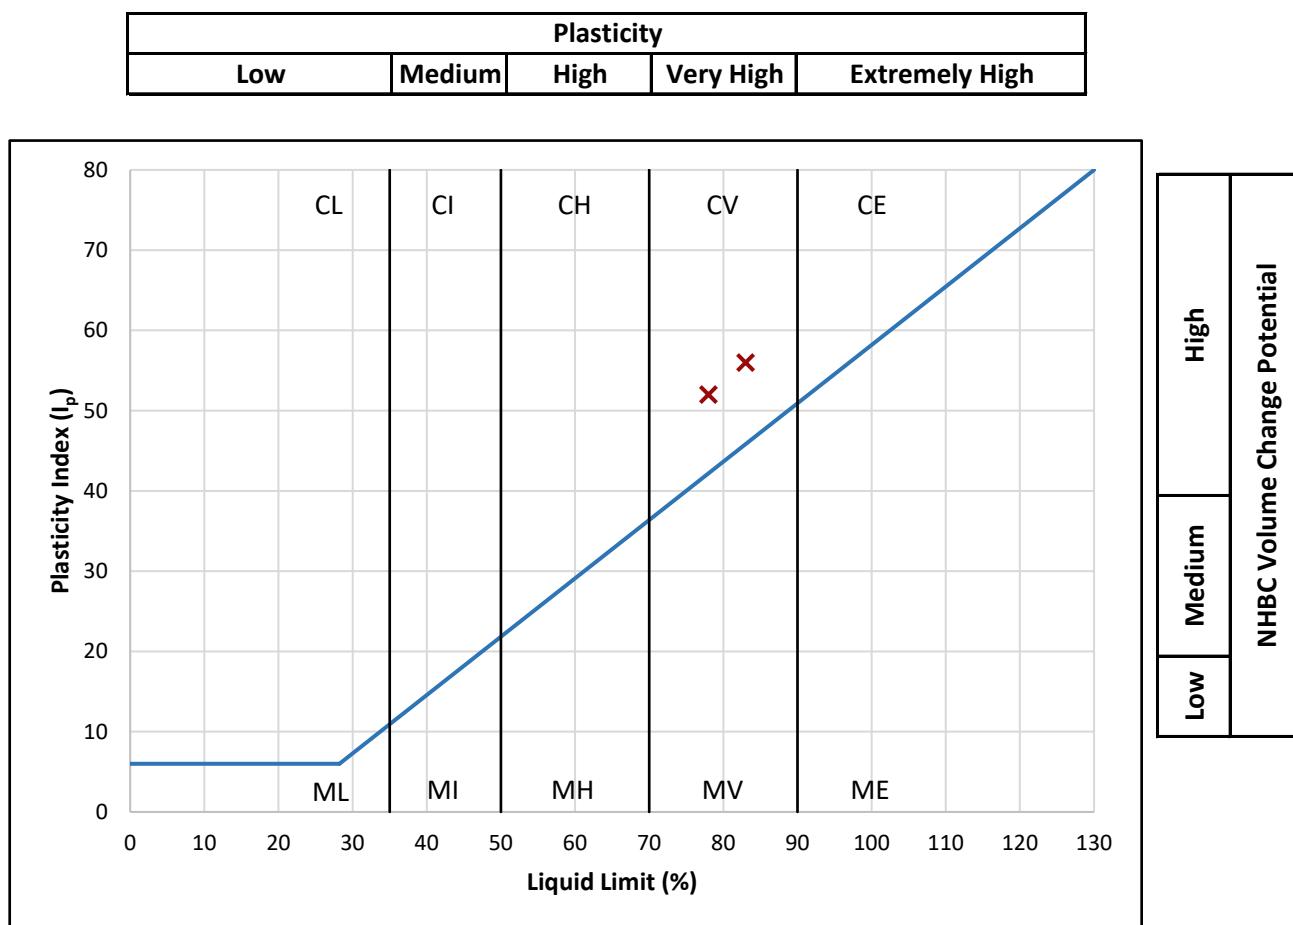
**PLOT OF PLASTICITY INDEX AGAINST LIQUID LIMIT USING
CASAGRANDE CLASSIFICATION CHART**

Borehole /Pit No.	Depth (m)	Type	Ref.	Water Content (%)	Liquid Limit (%)	Plastic Limit (%)	Plasti-city Index (%)	Liquid-ity Index	Sample Preparation				Description	Class
									Method	Ret'd 0.425mm (%)	Corr'd W/C <0.425mm	Curing Time (hrs)		
TP2	1.00	B	1	35.0	83	27	56	0.14	From Natural	0 (A)		71	Firm yellowish brown CLAY with occasional bluish grey mottling, and recently active and decayed roots.	CV
TP2	1.50	B	2	29.3	78	26	52	0.06	From Natural	0 (A)		71	Stiff yellowish brown CLAY with occasional bluish grey mottling, recently active and decayed roots, and selenite crystals.	CV

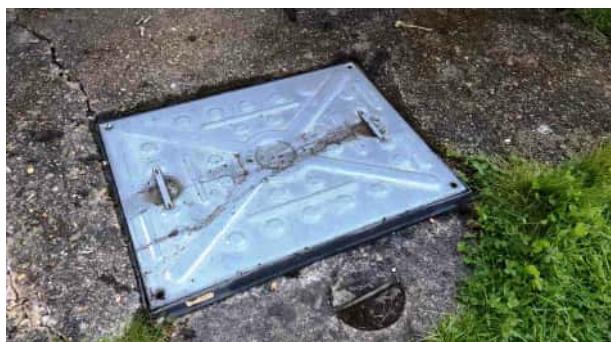
S1 - Manhole cover and frame is loose.

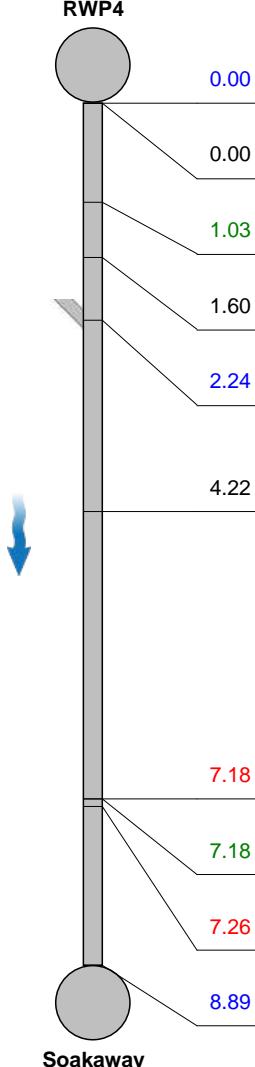
Pipework is of both vitrified clay and PVC material. The drainage is generally in good condition. However there is a hole within the pipework leading to the soakaway within the rear garden.

Scale: 1:78	Position [m]	Code	Observation	MPEG	Photo	Grade
Depth: 0.00 m						
RWP4						
	0.00	BR	Start node type, major connection without manhole, reference number: RWP4	00:00:02		
	0.00	WL	Water level, 5% % of the vertical dimension	00:00:04		
	1.03	LL	Line deviates left	00:00:14	20210517-112820-sn-ap0000.jpg	
	1.60	REM	General remark: Survey through main run	00:00:21	20210517-112820-sn-ap0001.jpg	
	2.24	JN	Junction, at 03 o'clock, diameter: 100 mm	00:00:46	20210517-112820-sn-ap0002.jpg	
	4.22	GP	General photograph taken at this point	00:00:57	20210517-112820-sn-ap0003.jpg

Construction Features					Miscellaneous Features						
Structural Defects					Service & Operational Observations						
STR No.	Def.	STR Peak	STR Mean	STR Total	STR Grade	SER No.	Def.	SER Peak	SER Mean	SER Total	SER Grade
2		80.0	11.2	100.0	4.0	1		2.0	0.2	2.0	3.0

2. **RWP4 - Soakaway:** excavate trench to expose defective pipework. Remove defective section. Install new PVC pipe section and make good connection to existing pipework. Backfill trench and reinstate ground to match existing.

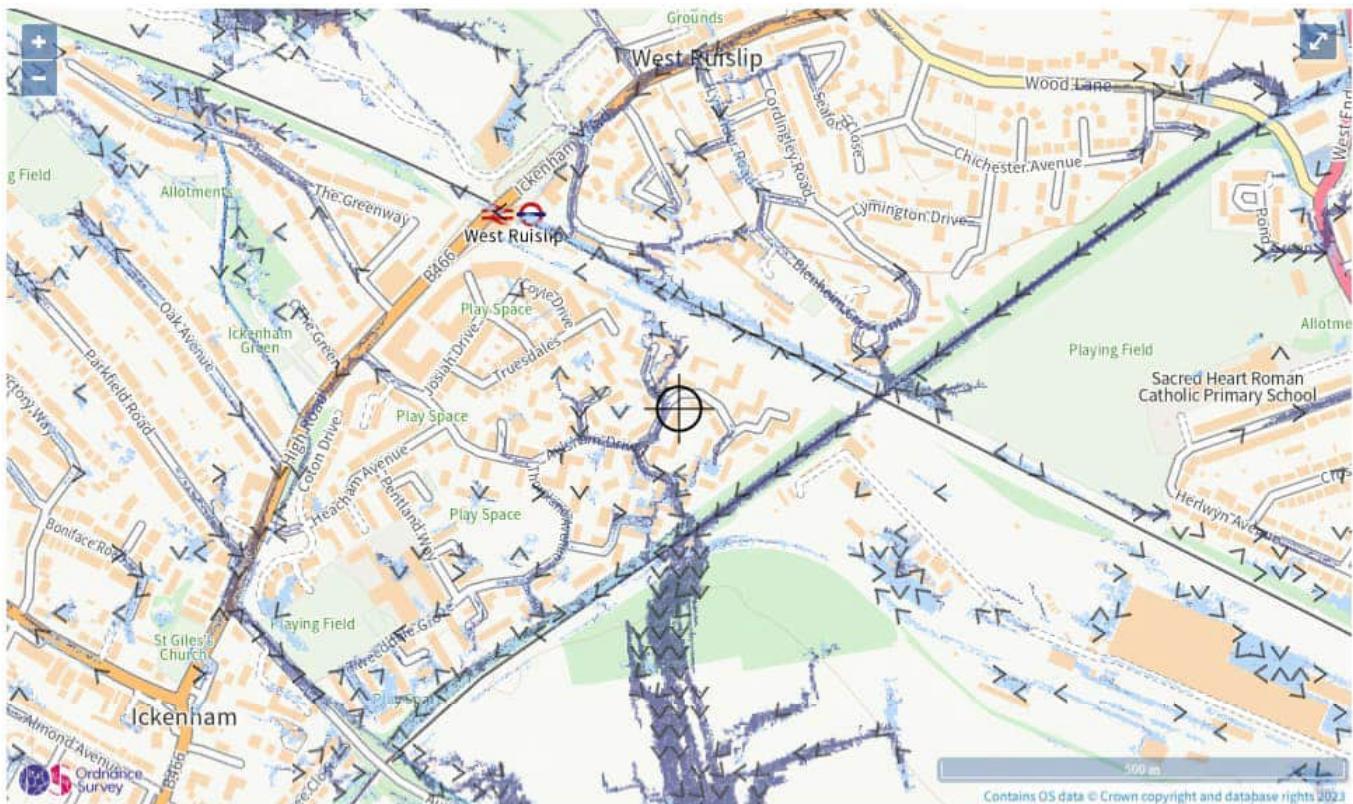
Surface water flood risk: water velocity in a low risk scenario

Flood velocity (metres/second)

● Over 0.25 m/s ● Less than 0.25 m/s ↗ Direction of water flow ⓧ Location you selected

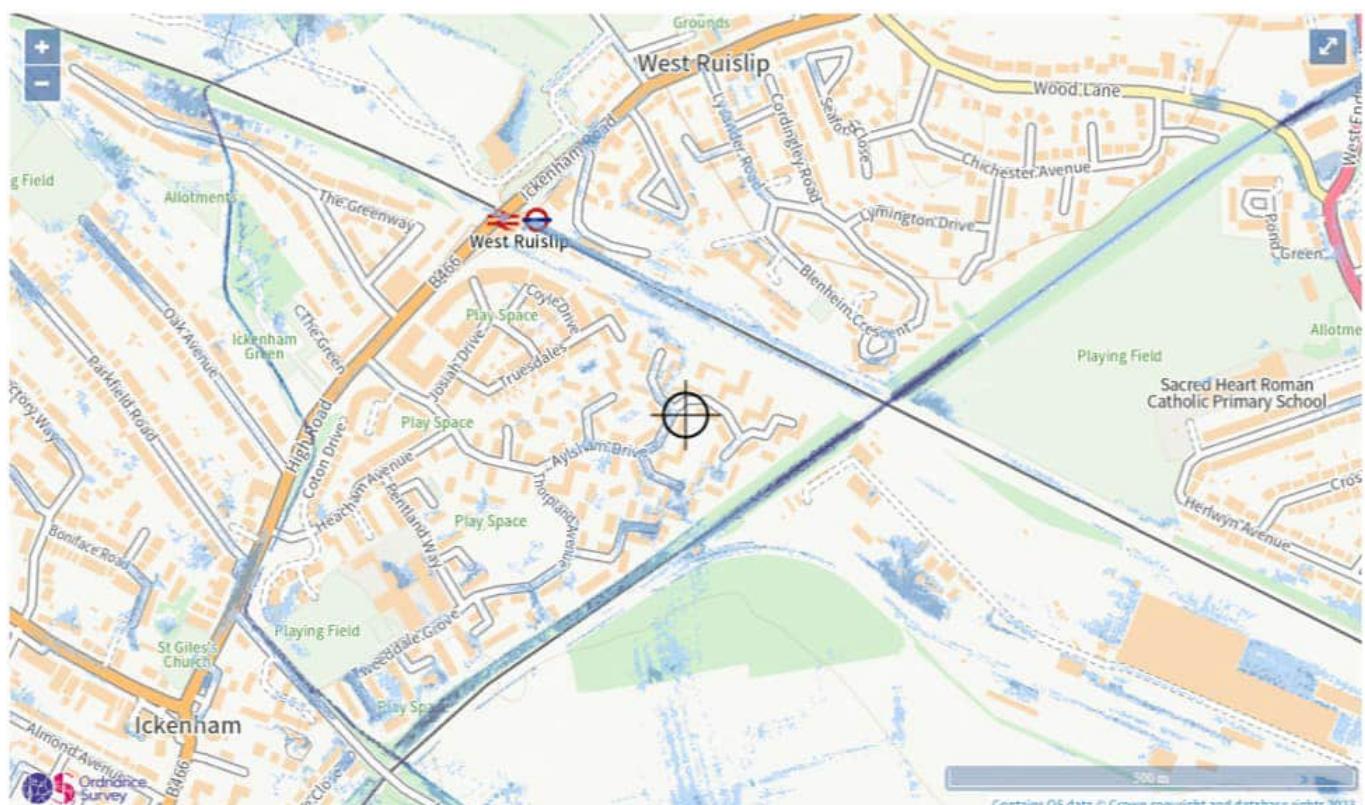
Surface water flood risk: water depth in a low risk scenario

Flood depth (millimetres)

● Over 900mm ● 300 to 900mm ● Below 300mm ⓧ Location you selected

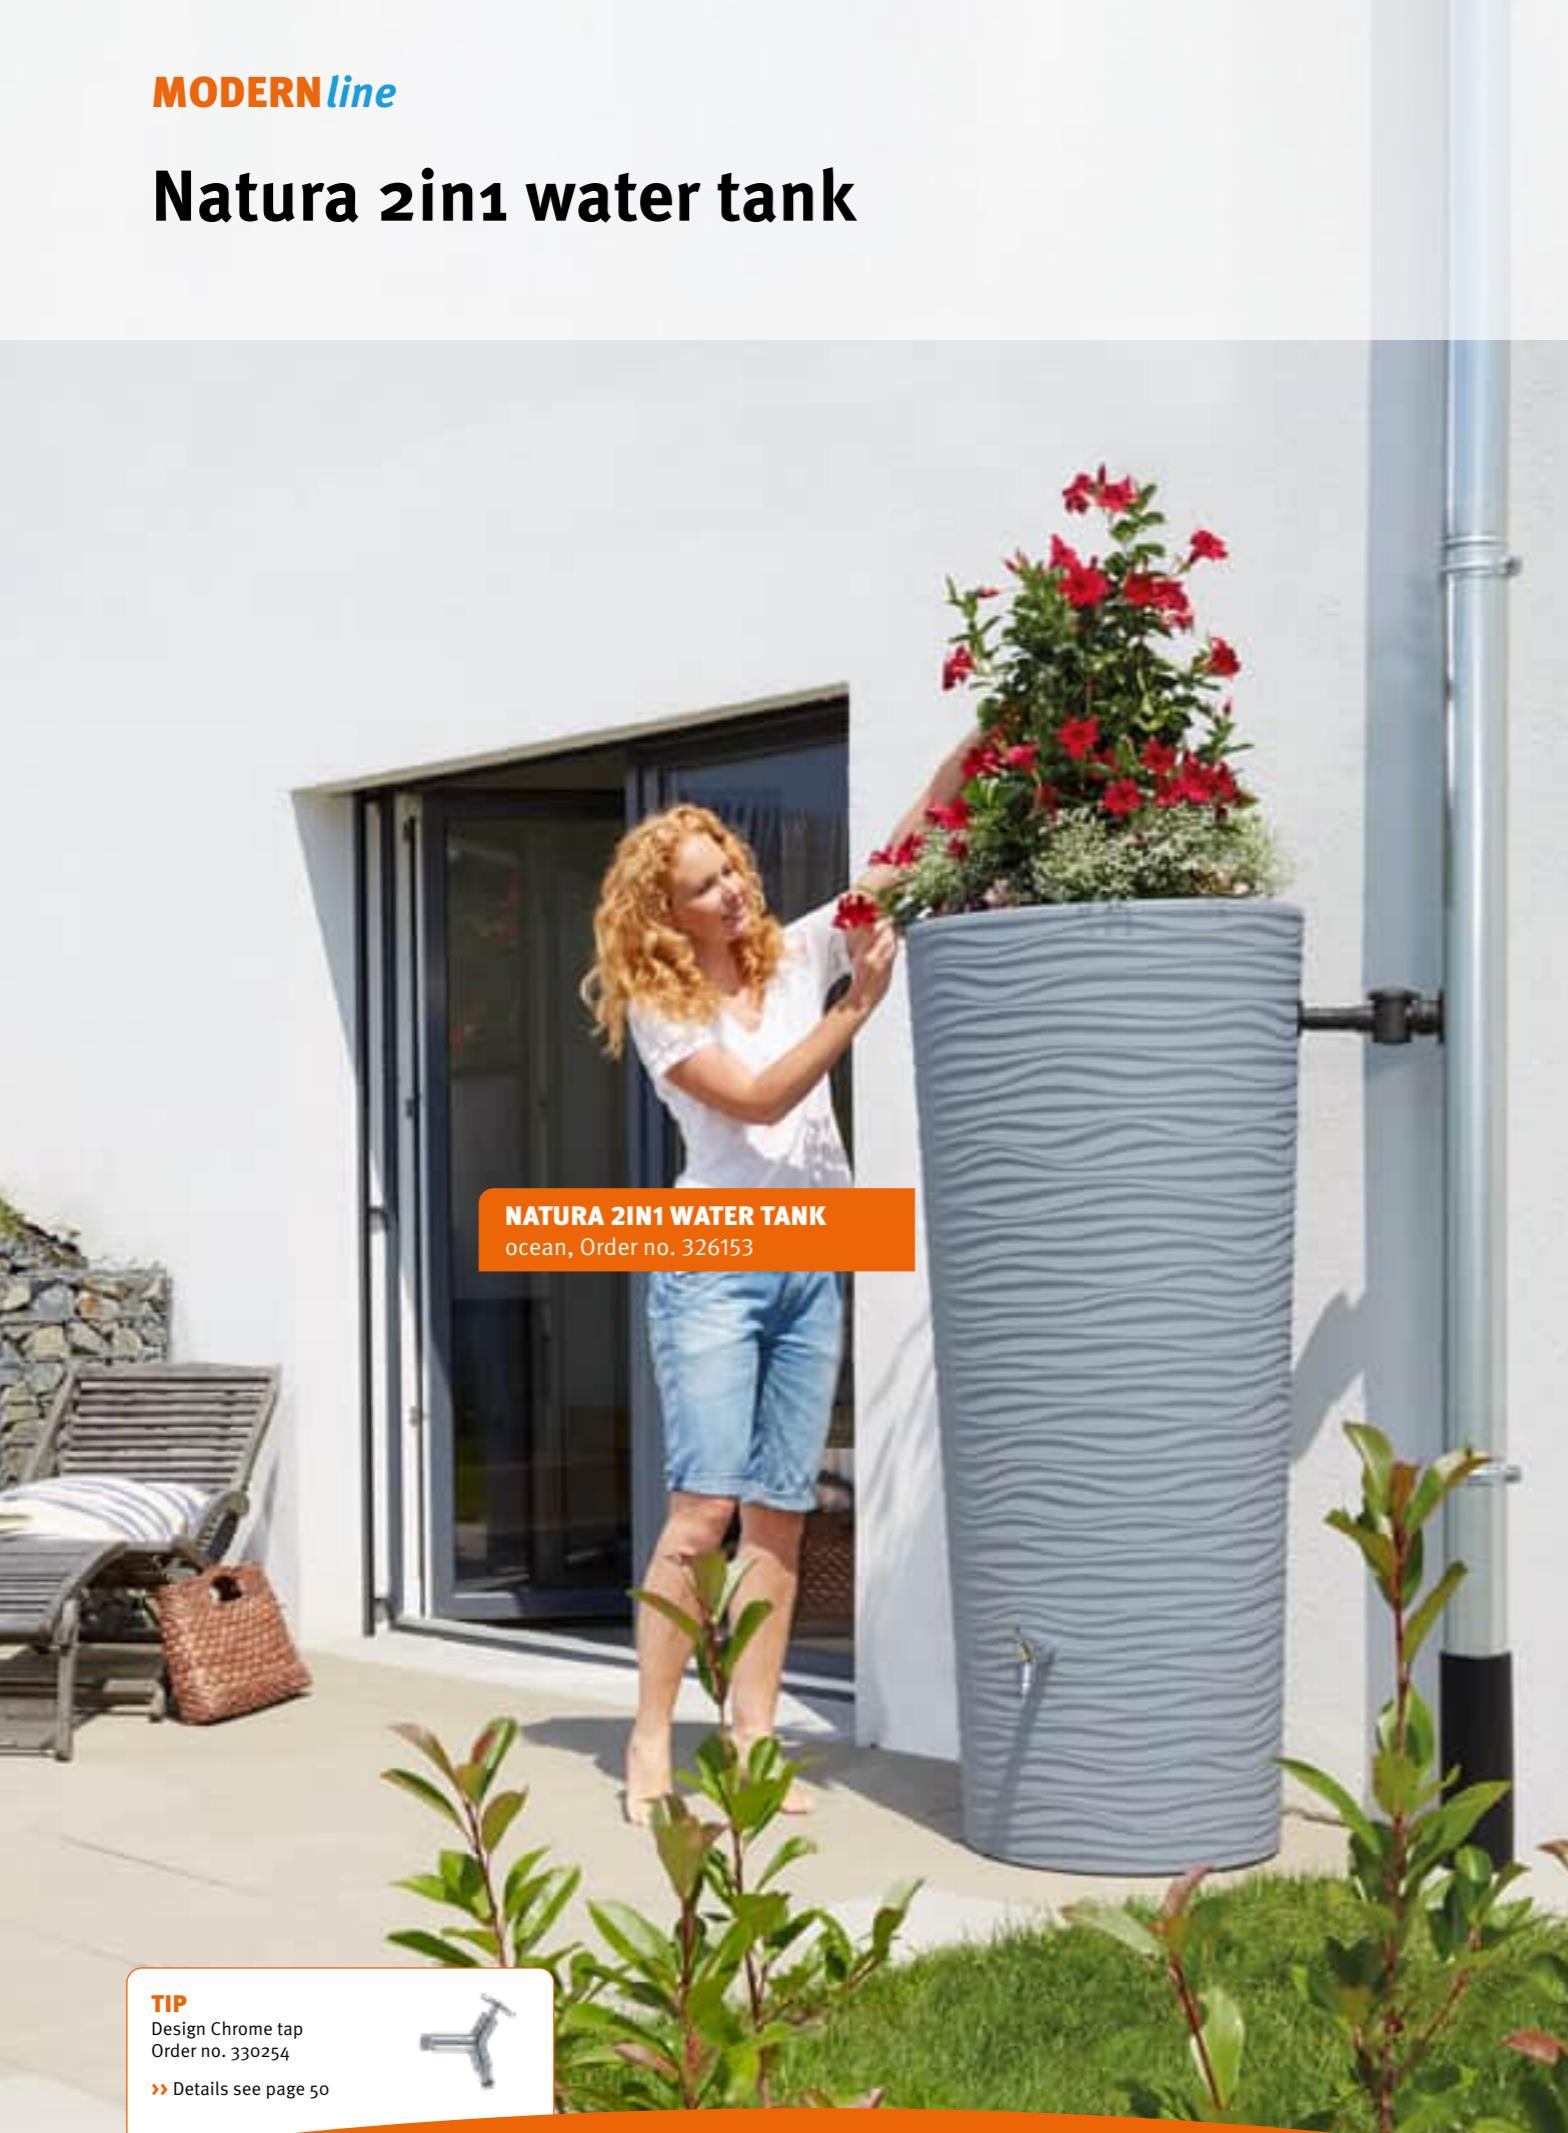
Natura 2in1 water tank
350 l (92.5 US gal.)

Height 150 cm (4' 11")
ø above 62 cm (24.5")
ø below 50 cm (20")
Weight 15 kg (33 lbs)

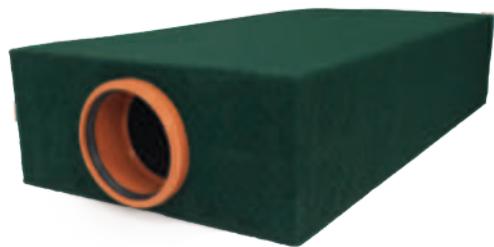
Permavoid Rainwater Diffuser Unit - Configuration Options

Run-off from building roofs is collected into downpipes and flows into a back inlet gully incorporating an internal filter or catchpit inspection chambers. The back inlet gully or chamber discharges the filtered stormwater into the permeable sub-base via Permavoid Rainwater Diffuser Unit encapsulated in a 2mm mesh fabric. The run-off will then diffuse out of the Permavoid Rainwater Diffuser Unit and into the modified granular sub-base layer. The Permavoid unit is a 150mm deep modular interlocking plastic unit storage system designed for use as a combined drainage component and sub-base replacement system, ideal for shallow infiltration/attenuation.

Width				
		354mm	708mm	1062mm	1416mm	2124mm
Length	708mm	✓	✓	✓	✓	✓
	1062mm	✗	✓	✓*	✓	✓
	1416mm	✓	✓	✓	✓	✓
	2124mm	✓	✓	✓	✓	✓
