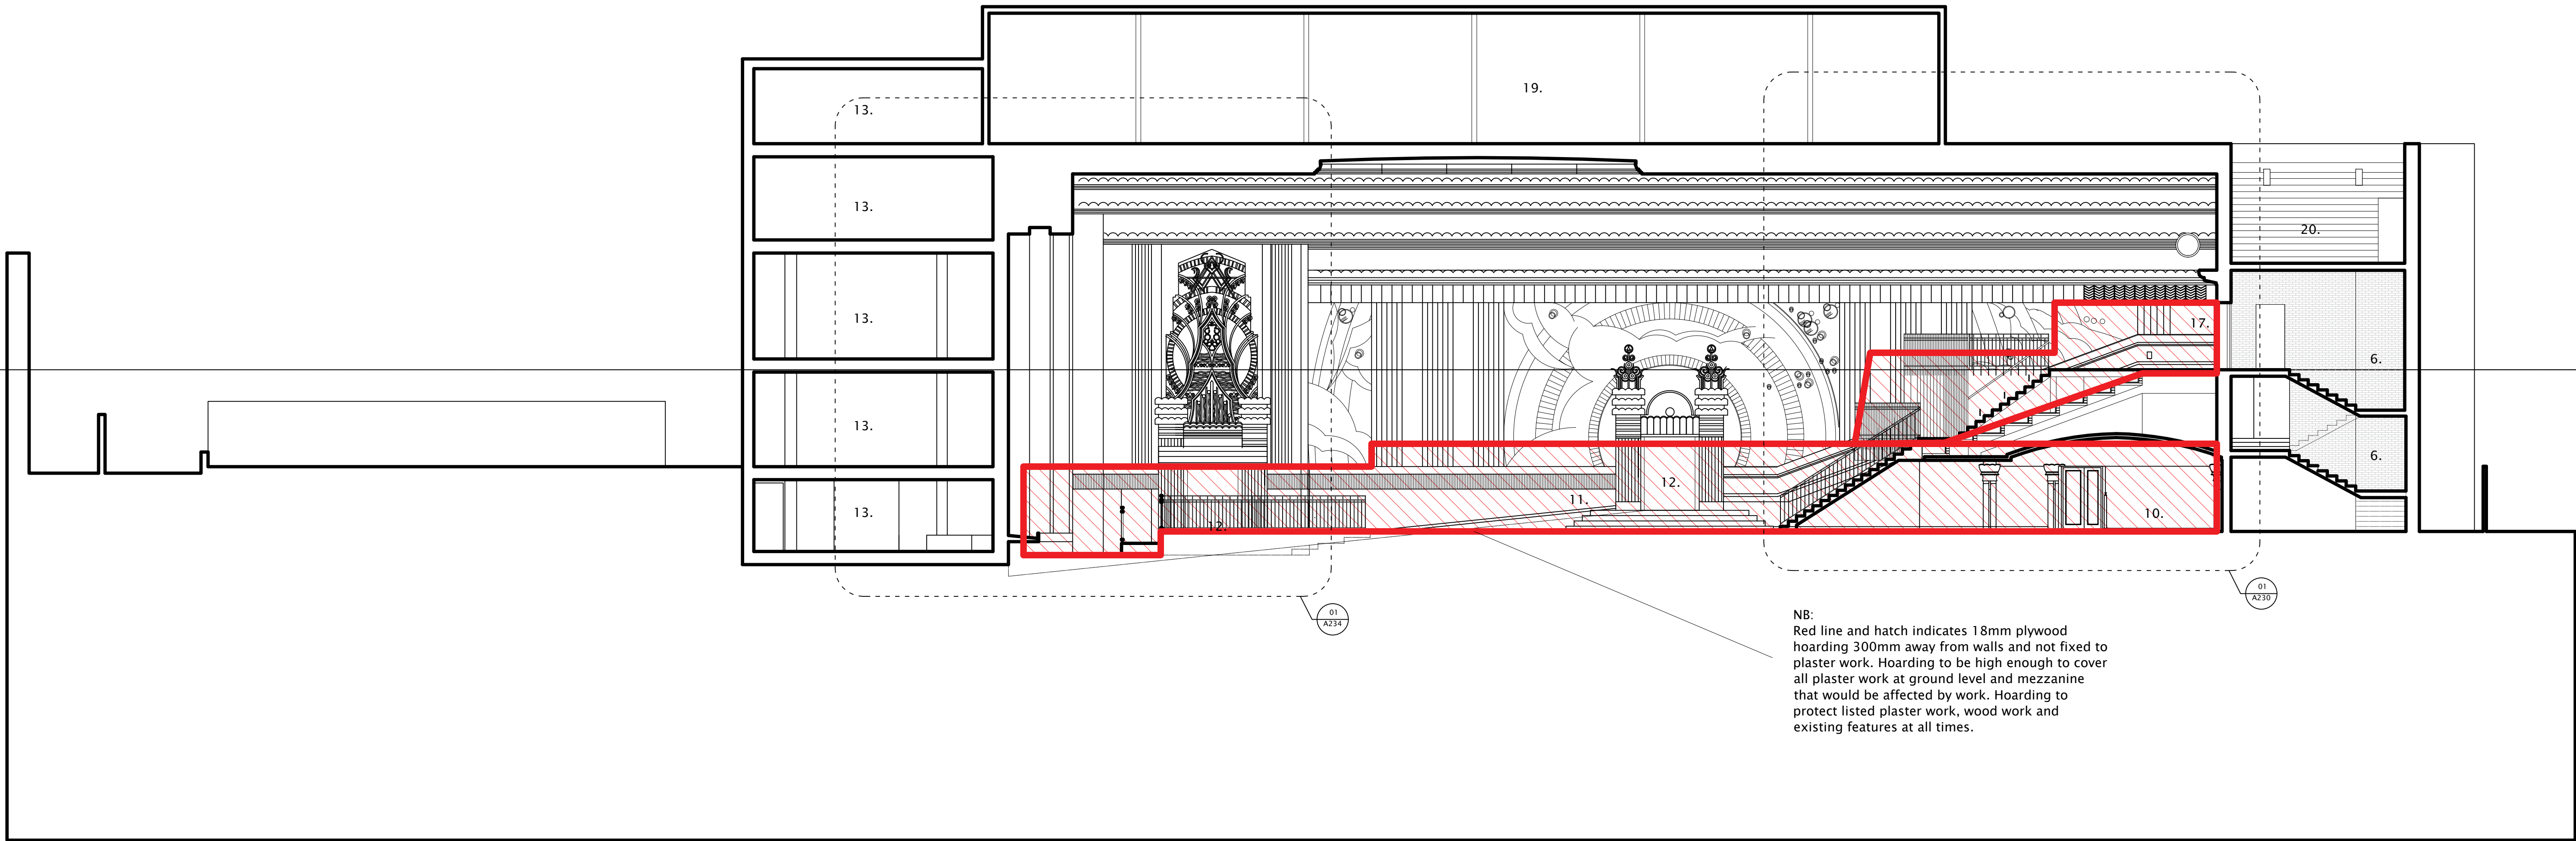
- Legend:
- 1. Entrance lobby.
 - 2. Coats.
 - 3. Pay booth.
 - 4. Snooker club entrance.
 - 5. Plant room.
 - 6. Stairs.
 - 7. Sub station.
 - 8. Beer cellar.
 - 9. Retained bar area post demolition.
 - 10. Bar area post demolition.
 - 11. Cinema/night club floor post demolition.
 - 12. Original exits.
 - 13. Gym spaces.
 - 14. Old plant room.
 - 15. WC and BOH.
 - 16. Music rooms.
 - 17. Part demolished mezzanine.
 - 18. Snooker halls.
 - 19. Roof void and access to cinema ceiling.
 - 20. Roof terrace.

NB:
Red line and hatch indicates 18mm plywood
hoarding 300mm away from walls and not fixed to
plaster work. Hoarding to be high enough to cover
all plaster work at ground level and mezzanine
that would be affected by work. Hoarding to
protect listed plaster work, wood work and
existing features at all times.
