**3 VIVEASH CLOSE  
HAYES, MIDDLESEX UB3 4RY**

**PHASE 1 PRELIMINARY RISK ASSESSMENT  
FOR  
*GENERAL FOOD TRADING CO LTD***

**Our Ref:** HLEI46277/001R

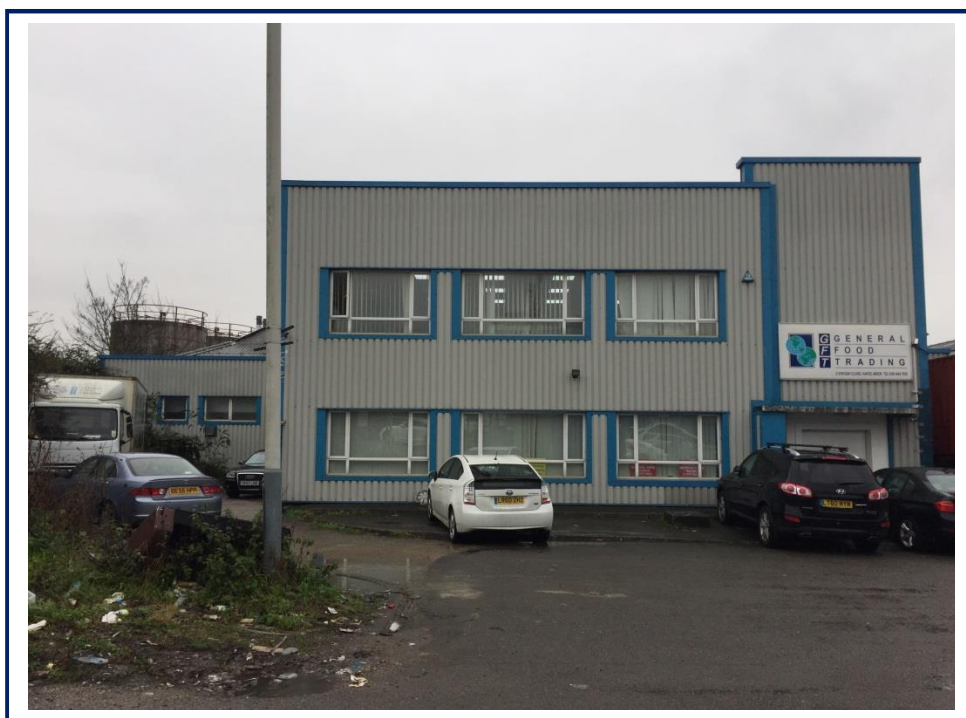
*General view of the site. For further photos see Appendix B.*

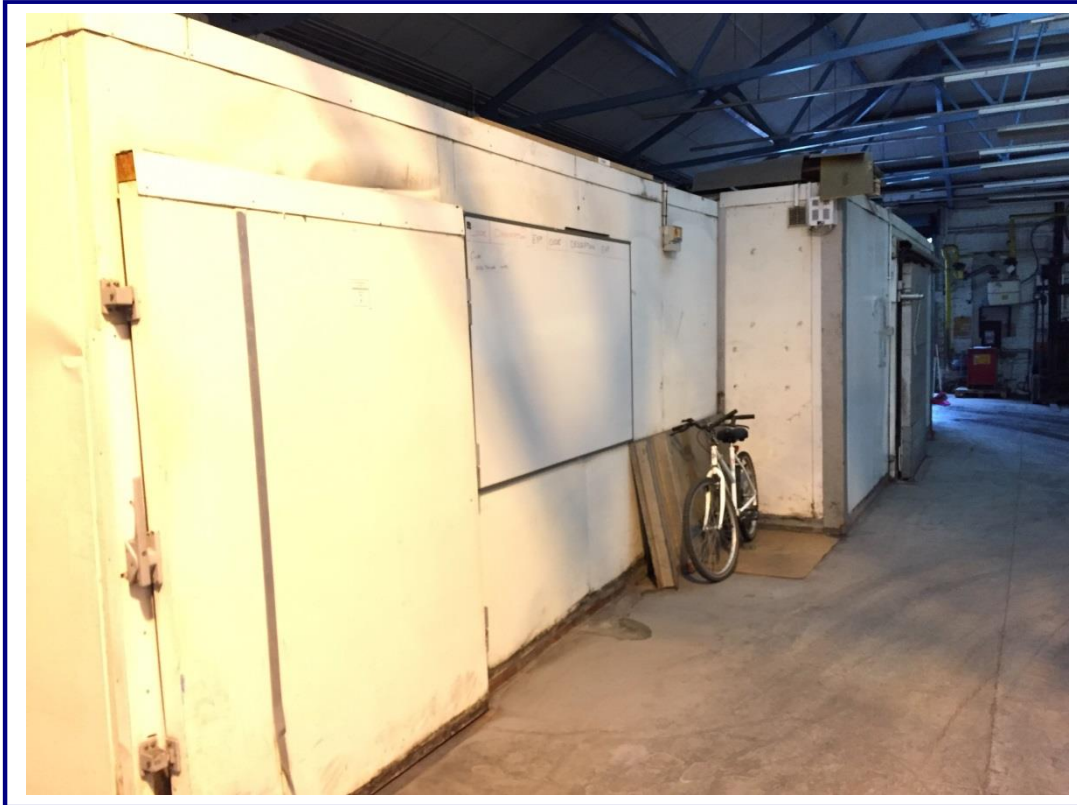
Photo 1: Two refrigerated units located in the west of the building.

| Section | Description |
|---|---|
| <i>Activity Operations:</i> | <p>At the time of the visit the site was occupied by <i>General Food Trading Ltd</i>, a food and drinks storage and distribution company.</p> <p>Items were stored on pallets on rows of metal racking. Two refrigerated units were located in the west of the building (see Appendix B, Photo 1).</p> <p>Two forklifts were used to transport goods around the warehouse. These were battery powered, with the charging unit located in the west of the warehouse (see Appendix B, Photo 2).</p> |

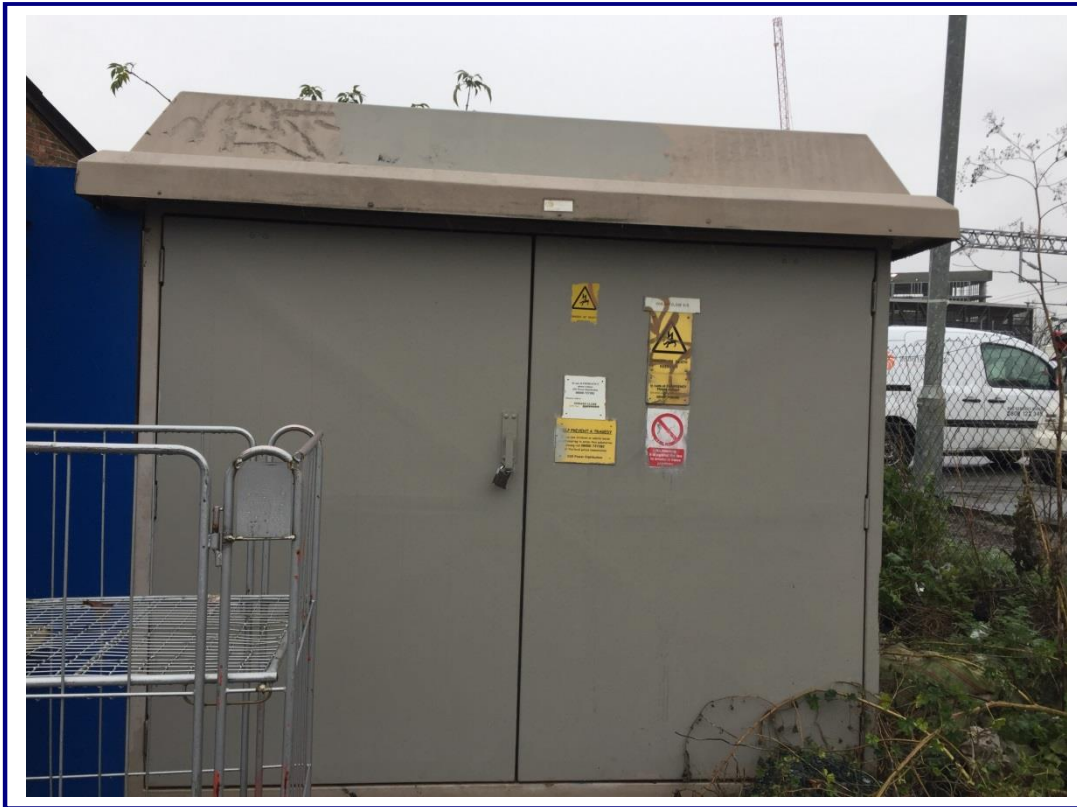
Photo 3: Electricity sub-station located to the west of the site.

| Section | Description |
|---|---|
| <i>Electricity Sub-stations / Transformers:</i> | <p>No electricity sub-stations/transformers were observed on site at the time of the walkover.</p> <p>One electricity sub-station was located approximately 5m to the west of the site. Signage indicated that this was owned and operated by <i>SSE Power Distribution</i> (see Appendix B, Photo 3).</p> |
