# PROLOGIS PARK: WEST LONDON

REMEDIATION VALIDATION REPORT

Project No: 70012920

Date: December 2016

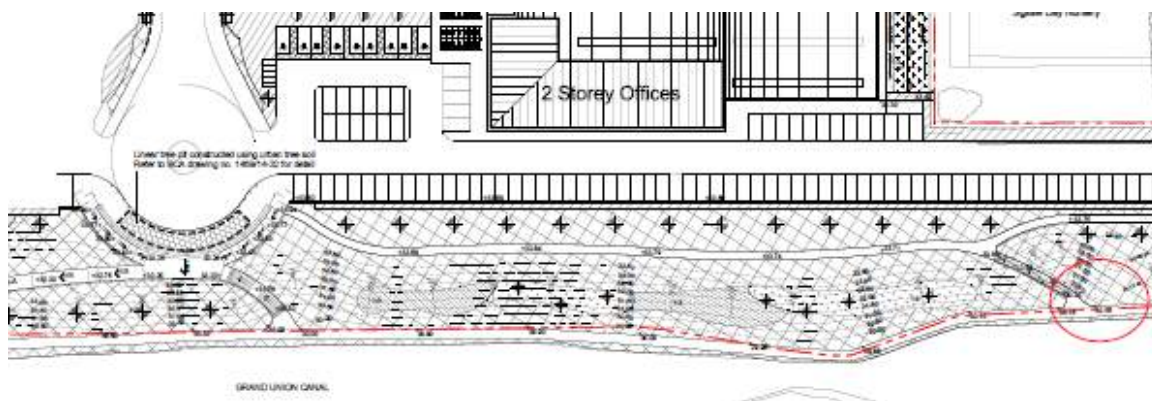
Fragments of asbestos sheeting were identified during the landscaping works in one location along the canal in the west of the site and the location is illustrated in the below image.

Visible asbestos sheets were identified by on-site personnel and the methodology for encountering unidentified contamination outlines in the RMS was followed. The visible fragments of Asbestos sheeting were removed and the capillary break layer and orange geotextile was placed at the base and the 300 mm of site won topsoil placed on top. This material was validated as suitable to form part of the upper layer in areas of soft landscaping.

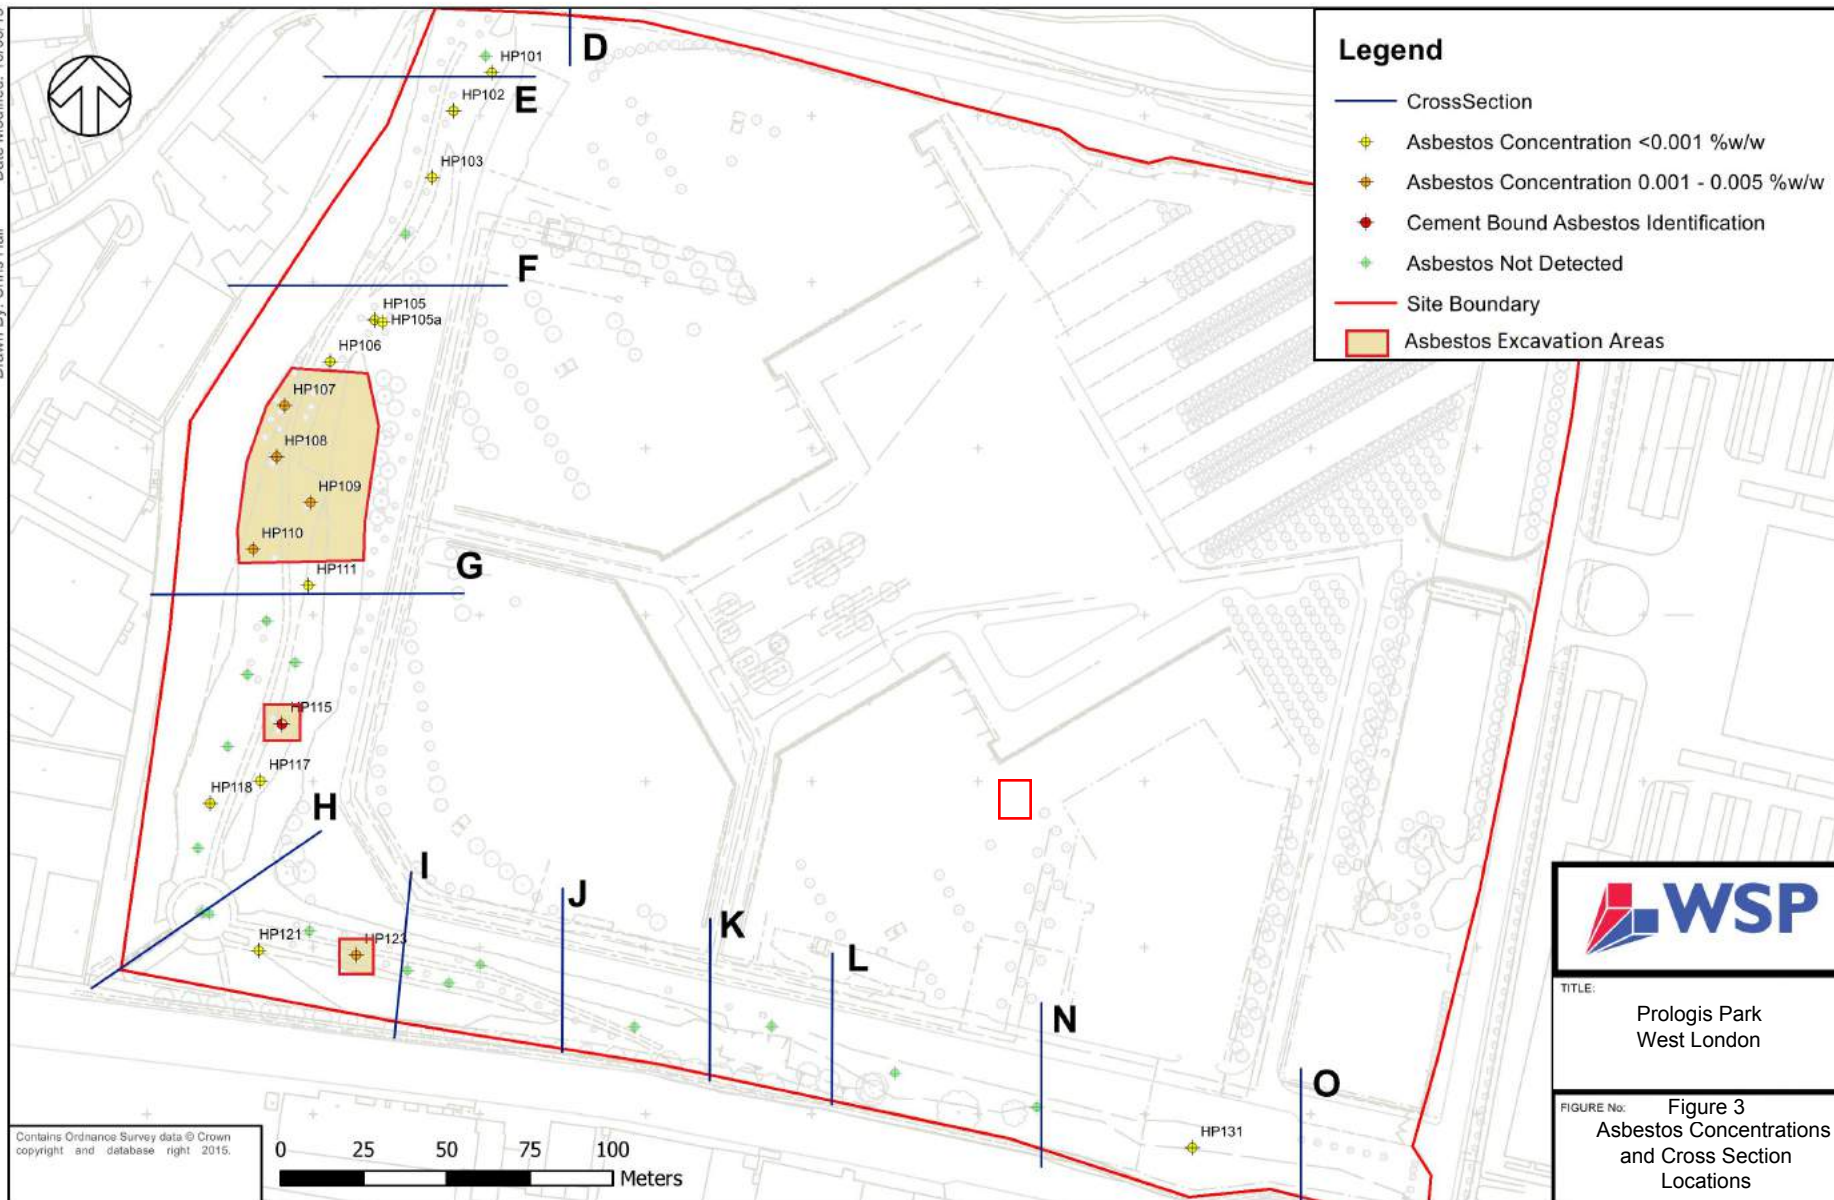
An area of 10 m x 10 m and 0.6 m in depth was excavated surrounding the known area of asbestos contamination and the area of work was secured to ensure no unauthorised access. All operatives working within the controlled zone were required to wear suitable PPE / RPE. The contaminated material from the excavations was transported and tipped within the fill area of Unit 2 and placed and compacted in accordance with the specification for the main works (illustrated in drawings included in **Appendix C**). This area was confirmed to be under a building footprint and not within an area that would be excavated as part of the drainage or foundation works. Further information is provided in the Jager Associates RAMS and is attached as **Appendix D**. The location of the hotspots and the associated contamination is outlined in the **Table 6.1** below and **Figure 3**.

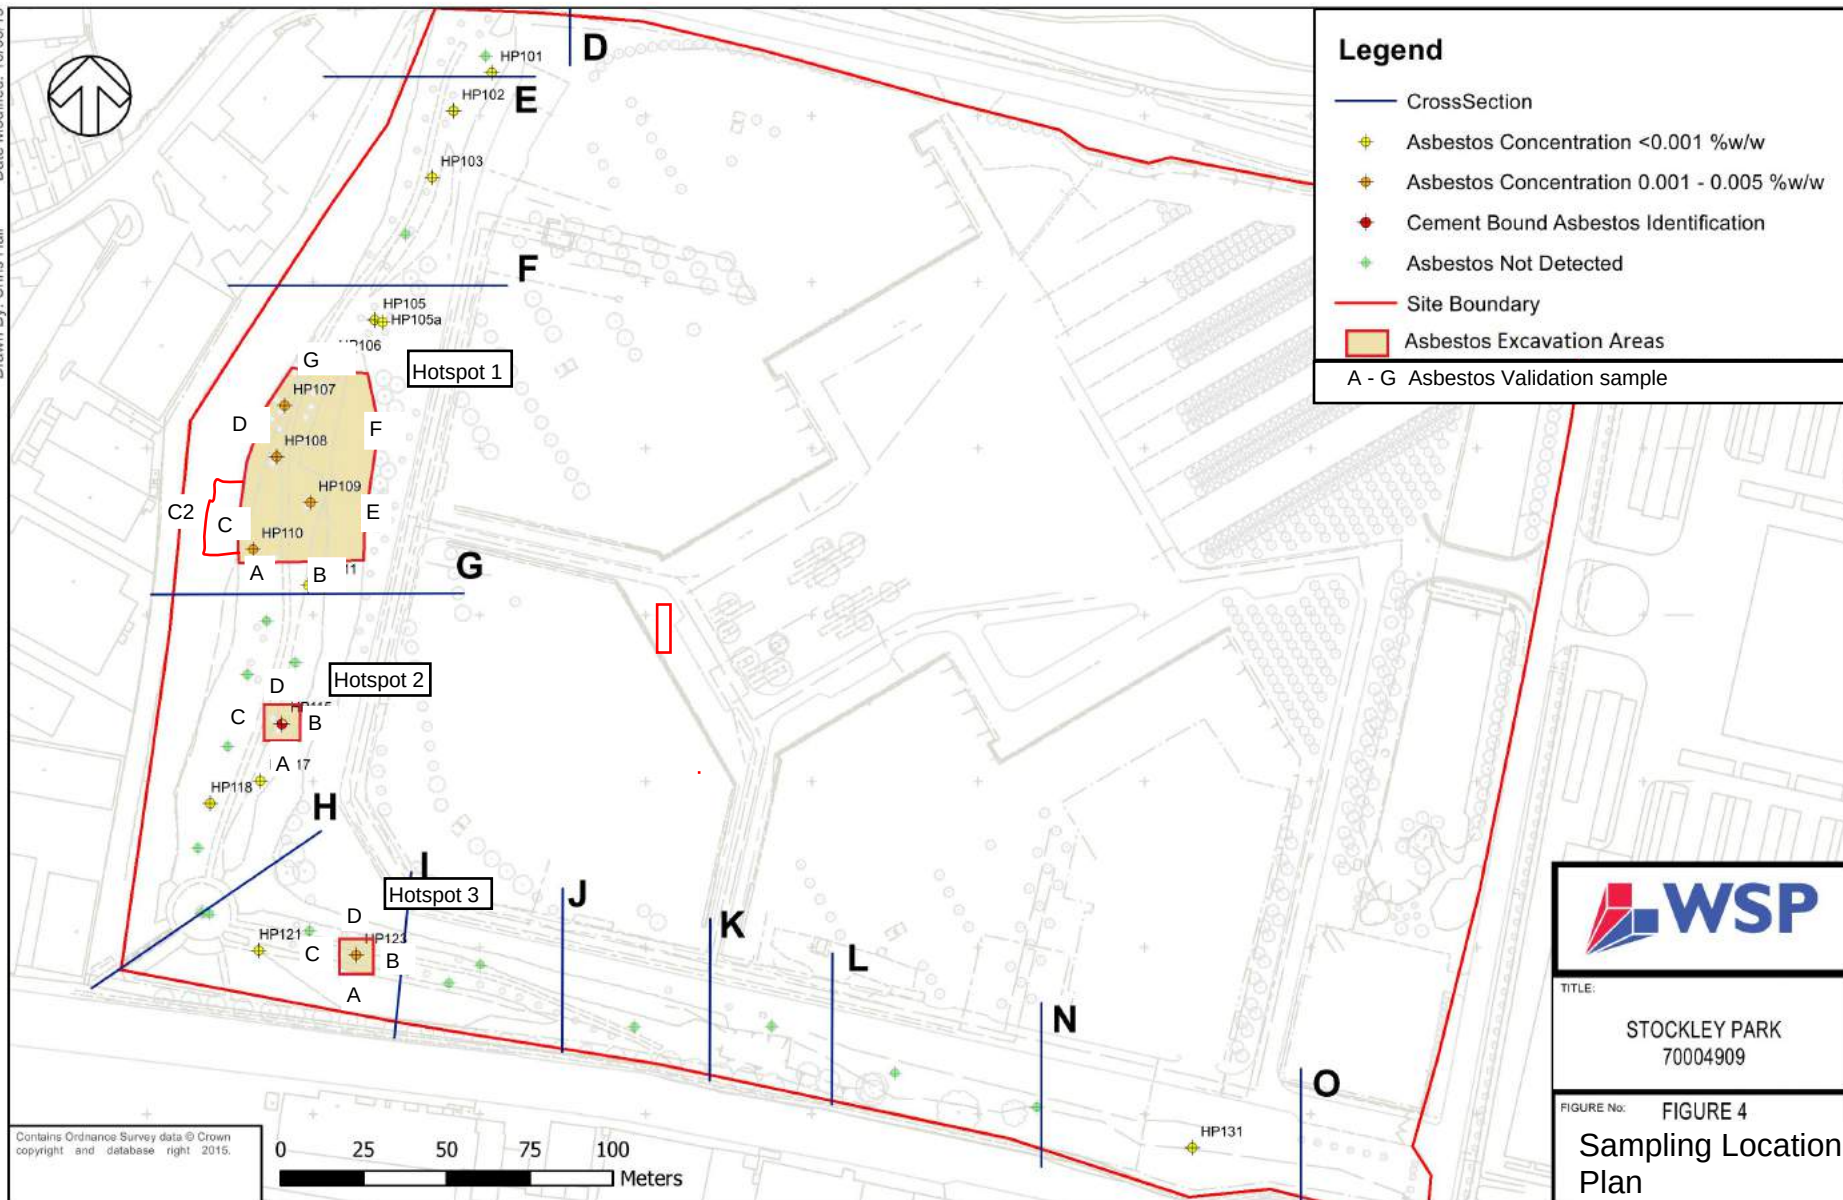
Sample C taken from Hotspot 1 initially failed as asbestos was identified in the sample at concentrations above the LOD at 0.004%. As detailed in the RMS additional materials were removed along the face of the sidewall to a horizontal depth of 0.5 m. Following further excavation, the location was subsequently re-sampled (Area 1, sample C2) and asbestos was identified to be <0.001% and suitable to remain insitu. The sample locations are illustrated in **Figure 4**.

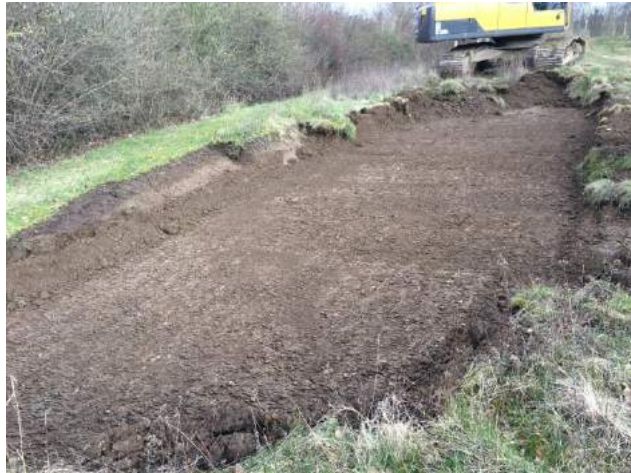
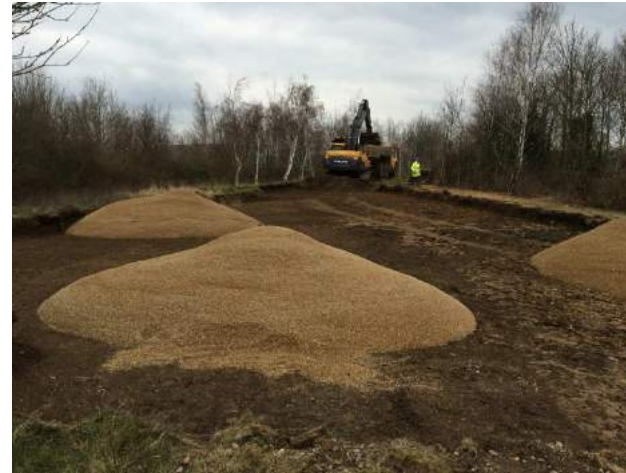
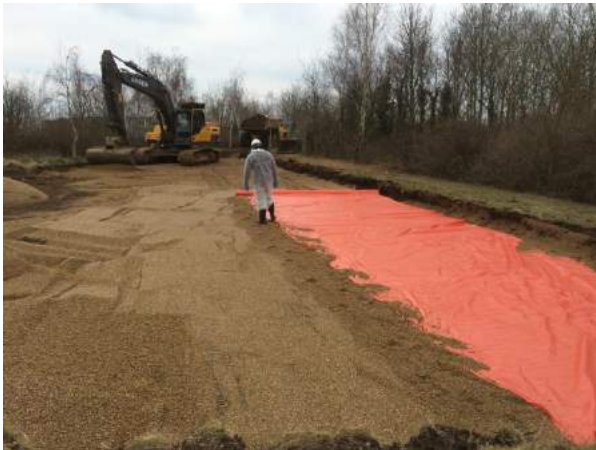
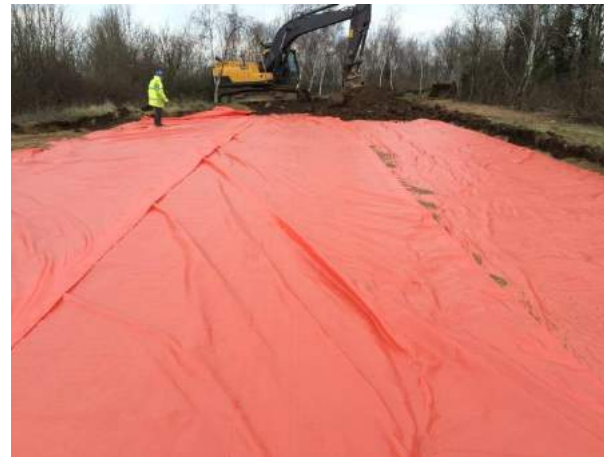
Photo 1: Hotspot 1 Excavation

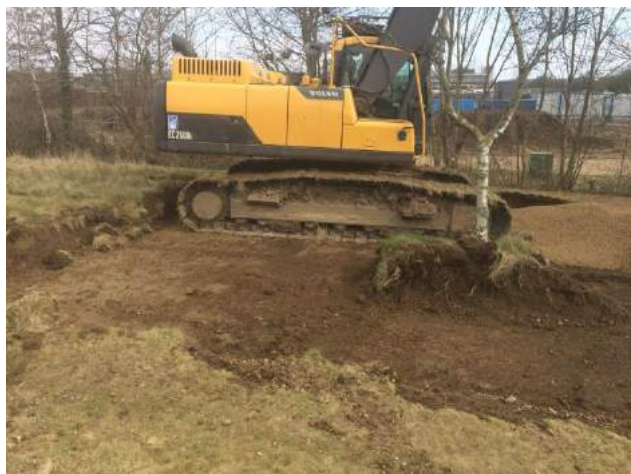
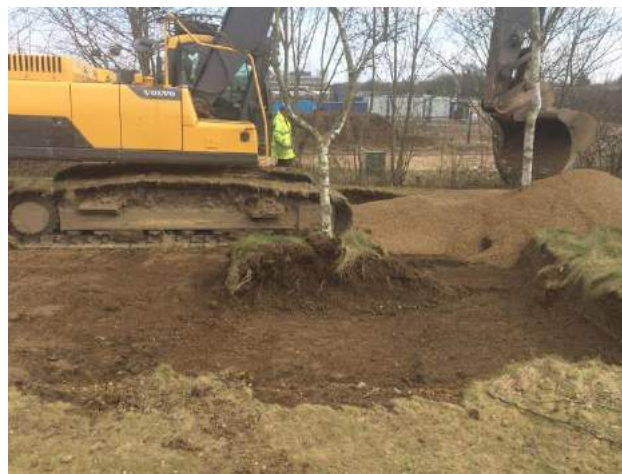
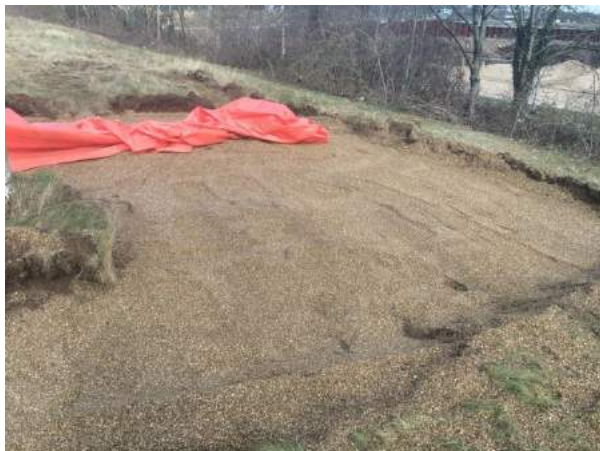
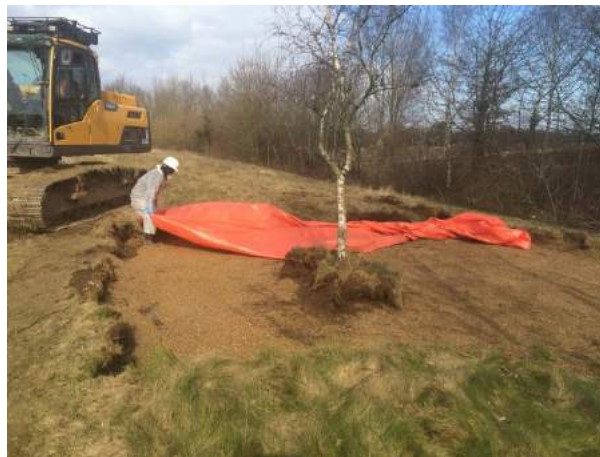
Photo 1: Hotspot 2 (HP115)  
Excavation

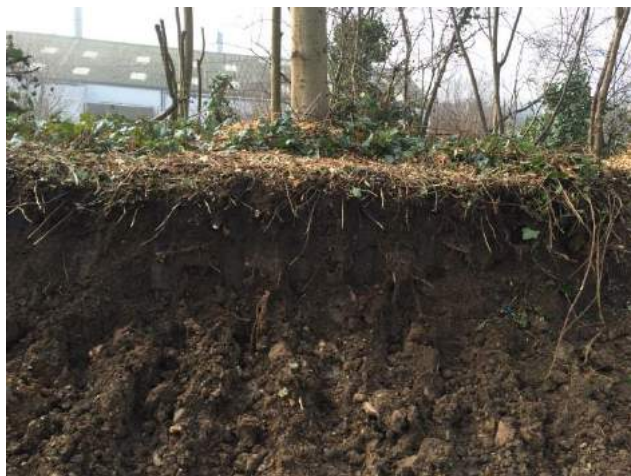
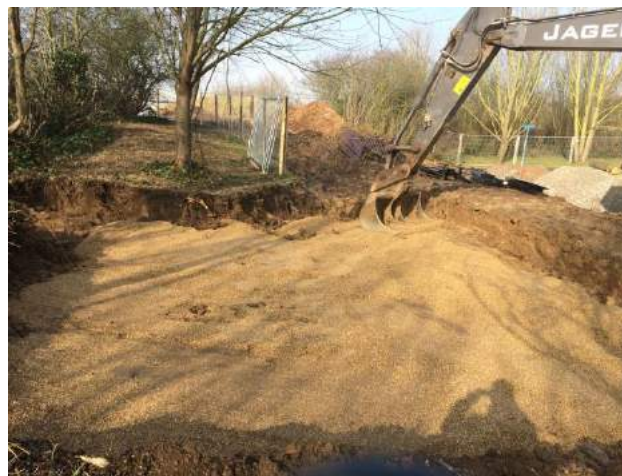
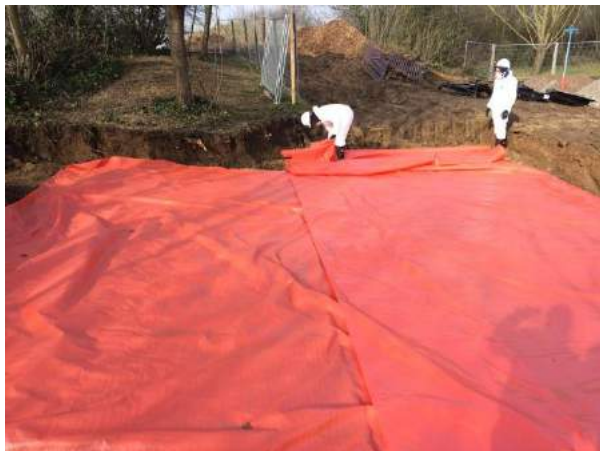
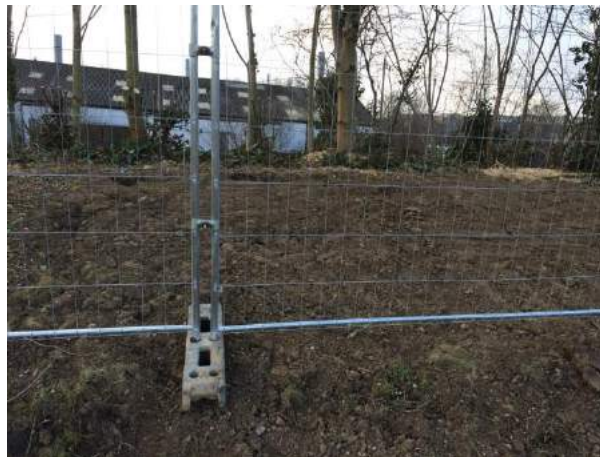
Photo 1: Hotspot 3 (HP123)  
Excavation

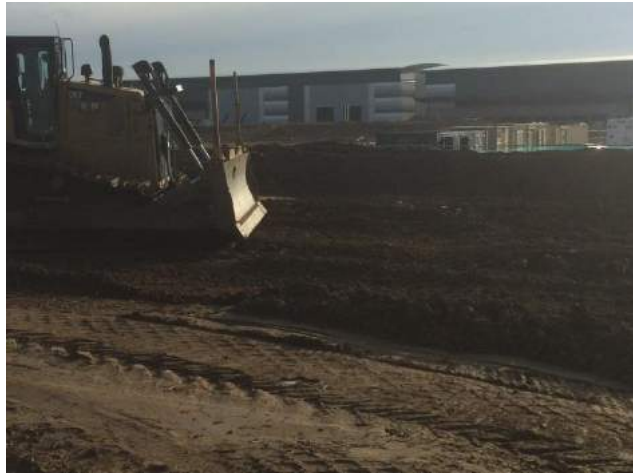
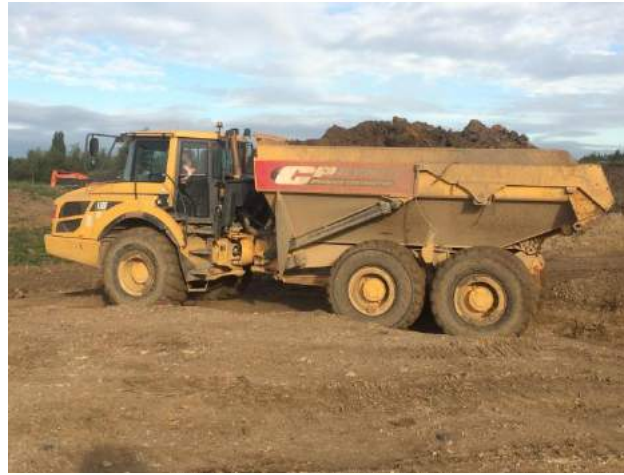
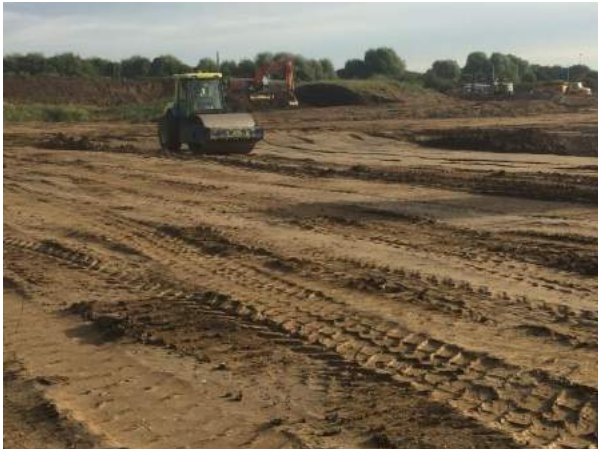
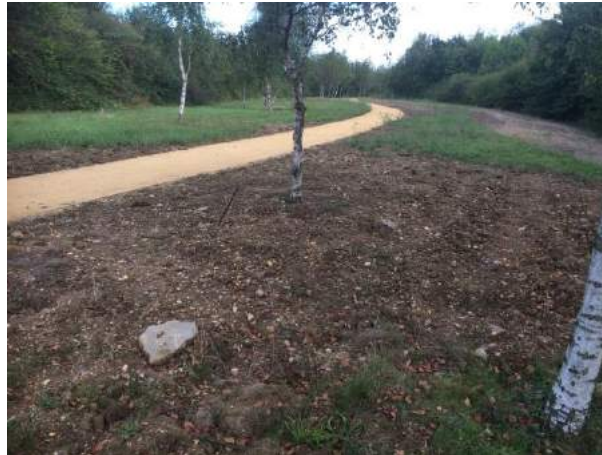
Photo 1 - 4: Earthworks watching Brief

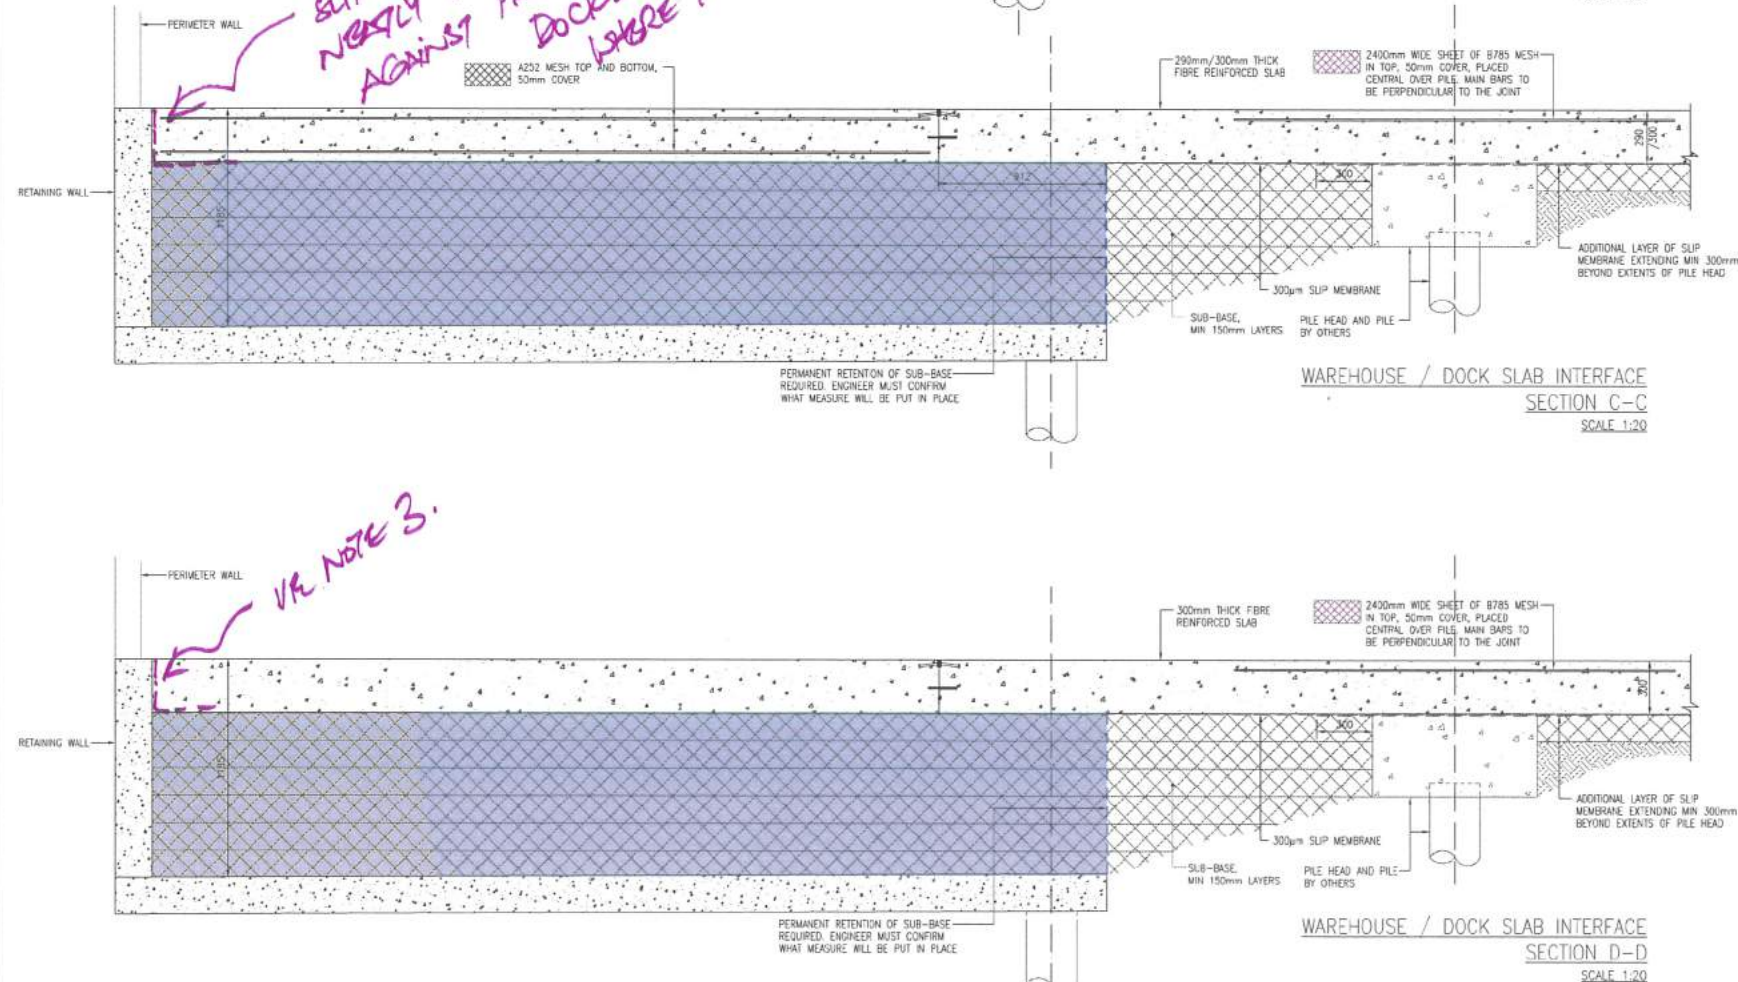
WAREHOUSE / DOCK SLAB INTERFACE  
SECTION D-D  
SCALE 1:20

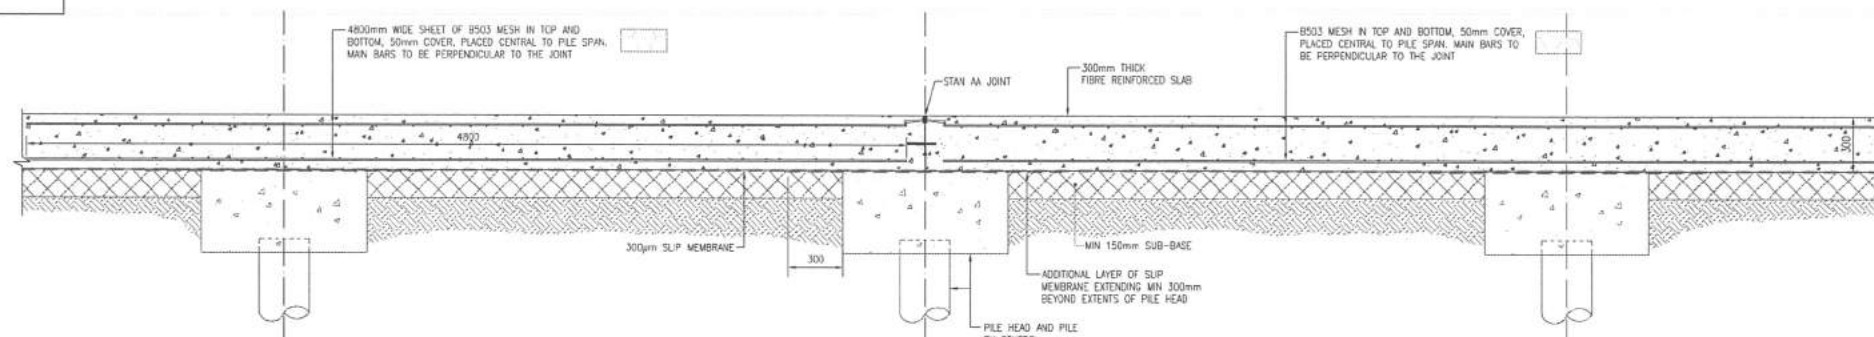
UNIT 2 - ADDITIONAL REINFORCEMENT  
SECTION E-E  
SCALE 1:20

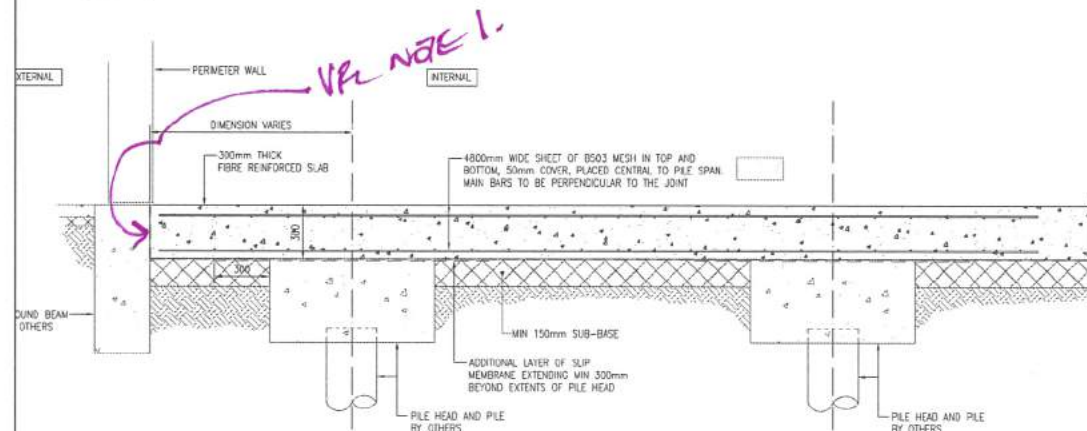
UNIT 2 - ADDITIONAL REINFORCEMENT  
SECTION F-F

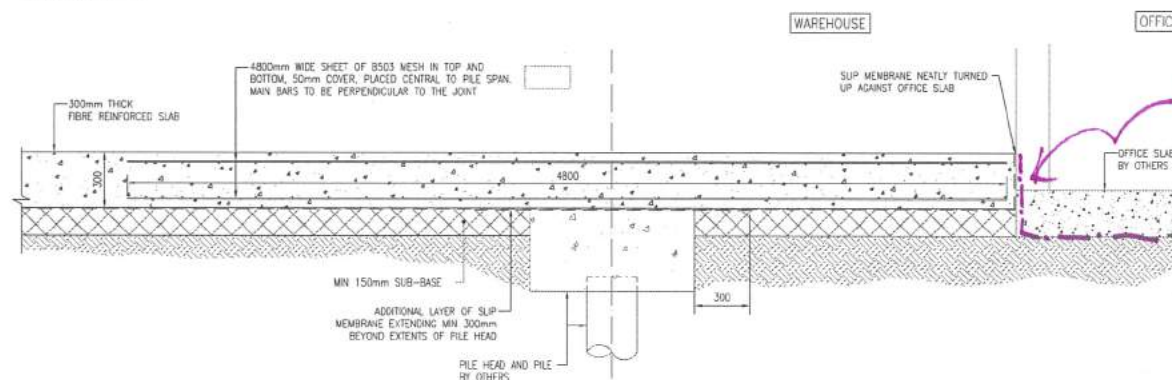
UNIT 2 - ADDITIONAL REINFORCEMENT  
SECTION G-G  
SCALE 1:20

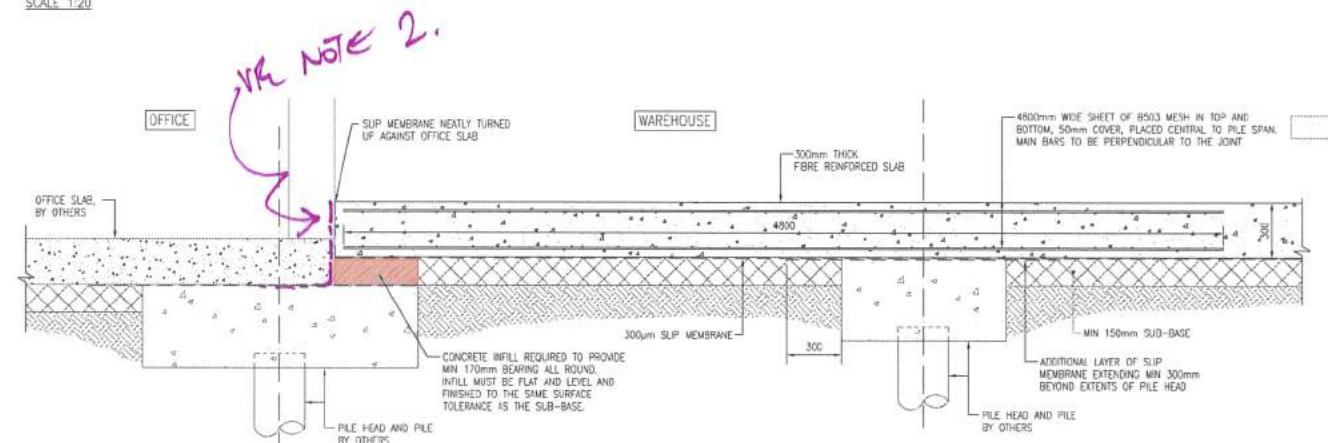
UNIT 2 - ADDITIONAL REINFORCEMENT  
SECTION H-H  
SCALE 1:20

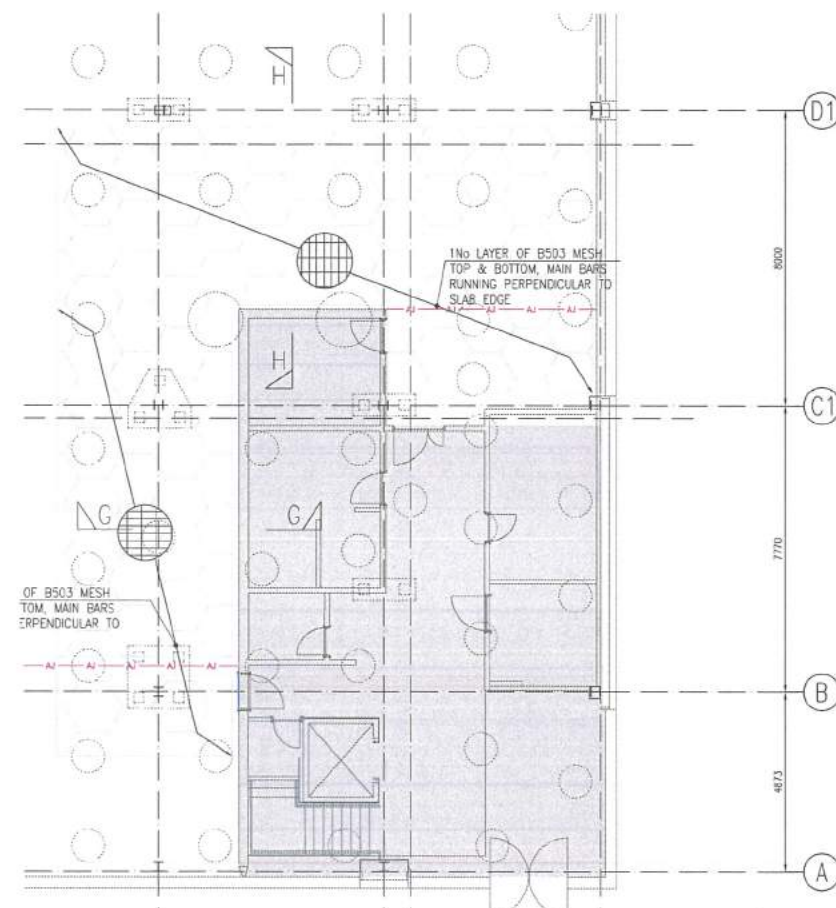
UNIT 2 - ADDITIONAL REINFORCEMENT  
PLAN A  
SCALE 1:100

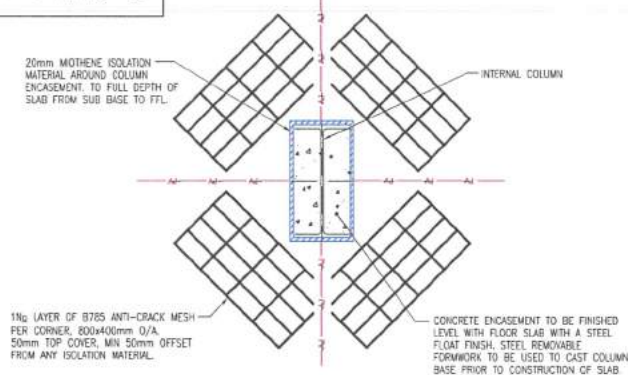
INTERNAL COLUMN ISOLATION WITH CENTRALLY LOCATED JOINTS  
TYPICAL PLAN  
SCALE 1:20

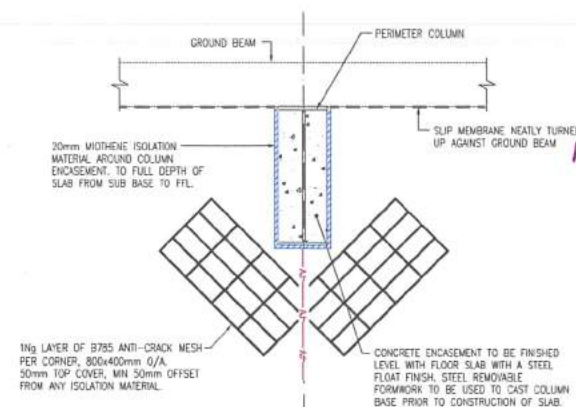
PERIMETER COLUMN ISOLATION WITH CENTRALLY LOCATED JOINT  
TYPICAL PLAN  
SCALE 1:20

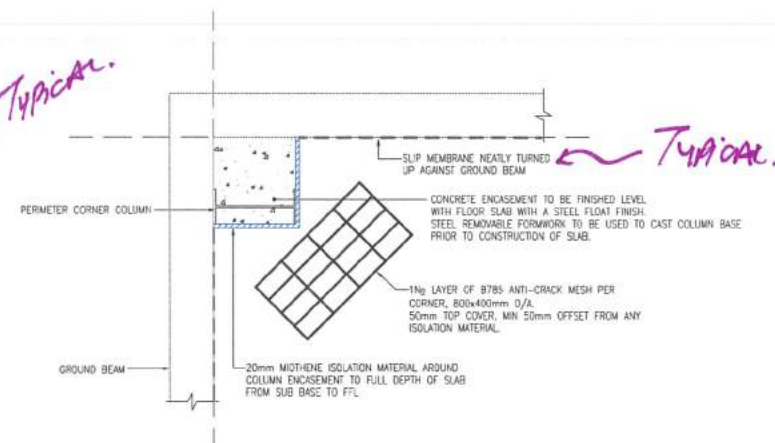
PERIMETER CORNER COLUMN ISOLATION  
TYPICAL PLAN  
SCALE 1:20

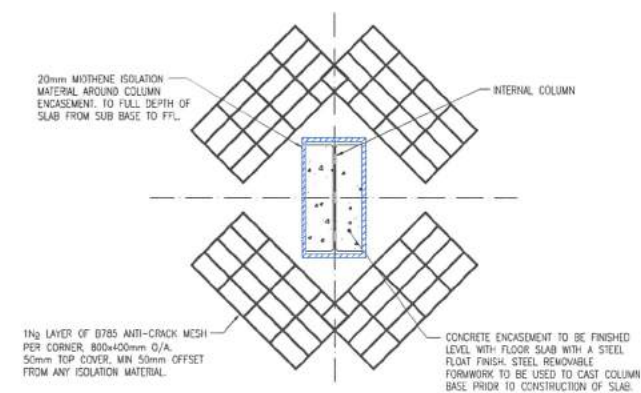
INTERNAL COLUMN ISOLATION  
TYPICAL PLAN  
SCALE 1:20

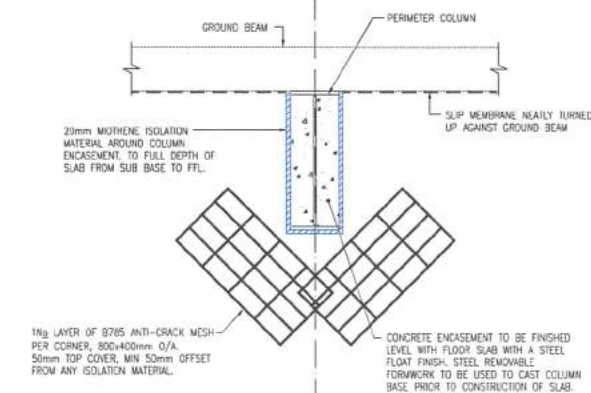
PERIMETER COLUMN ISOLATION  
TYPICAL PLAN  
SCALE: 1/20

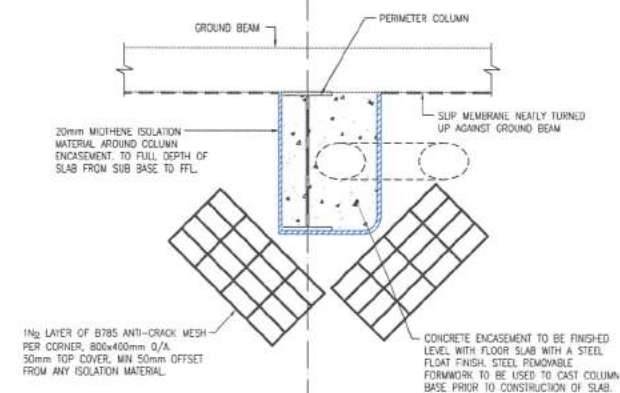
PERIMETER COLUMN BRACING ISOLATION  
TYPICAL PLAN  
SCALE 1:20

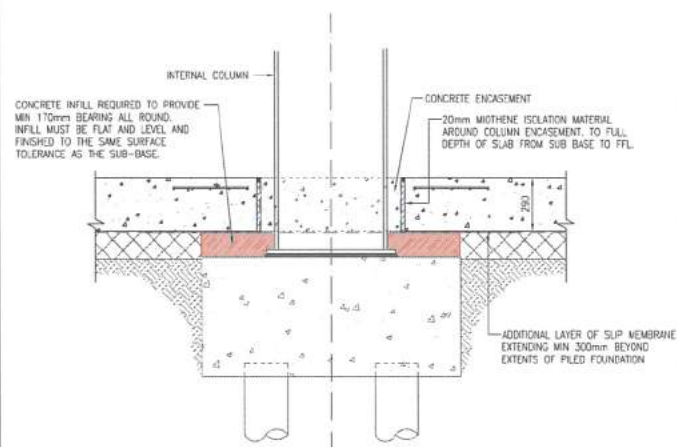
TYPICAL SECTION THROUGH INTERNAL COLUMN  
SCALE 1:20

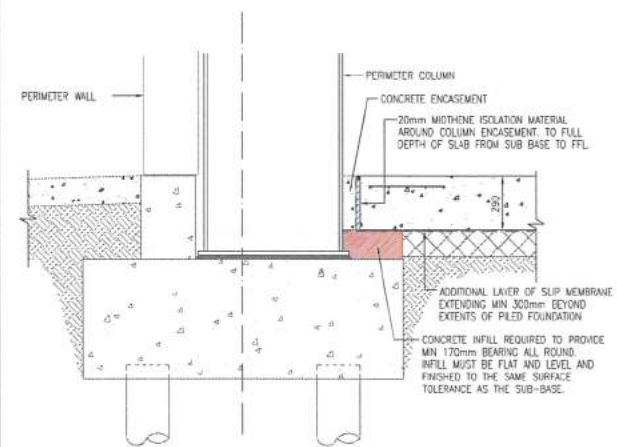
TYPICAL SECTION THROUGH PERIMETER COLUMN  
SCALE 1:20

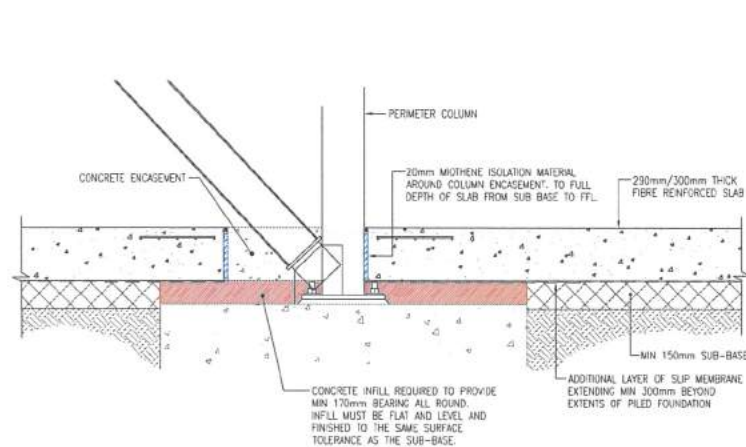
PERIMETER COLUMN BRACING  
TYPICAL SECTION  
SCALE 1:20

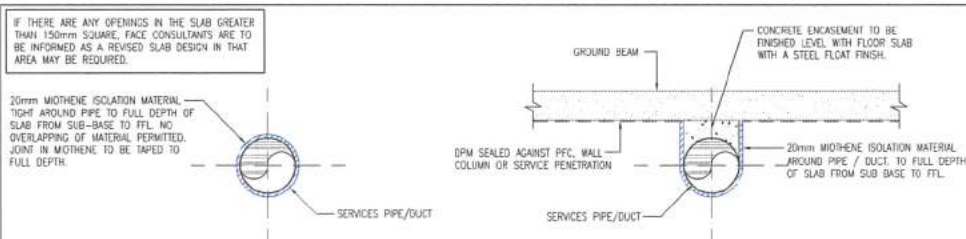
TYPICAL PLAN  
PIPE / DUCT ISOLATION DETAIL  
SCALE 1:20
