Project No 21/3600

Project Name L4 Colt DCS Data Centre

**LONDON 4 OPTIMUM DATA CENTRE
Tudor Works and Veetec Motor Group Facility
North of Beaconsfield Road
Hayes
London UB4 0SL**

Geoarchaeological watching brief report

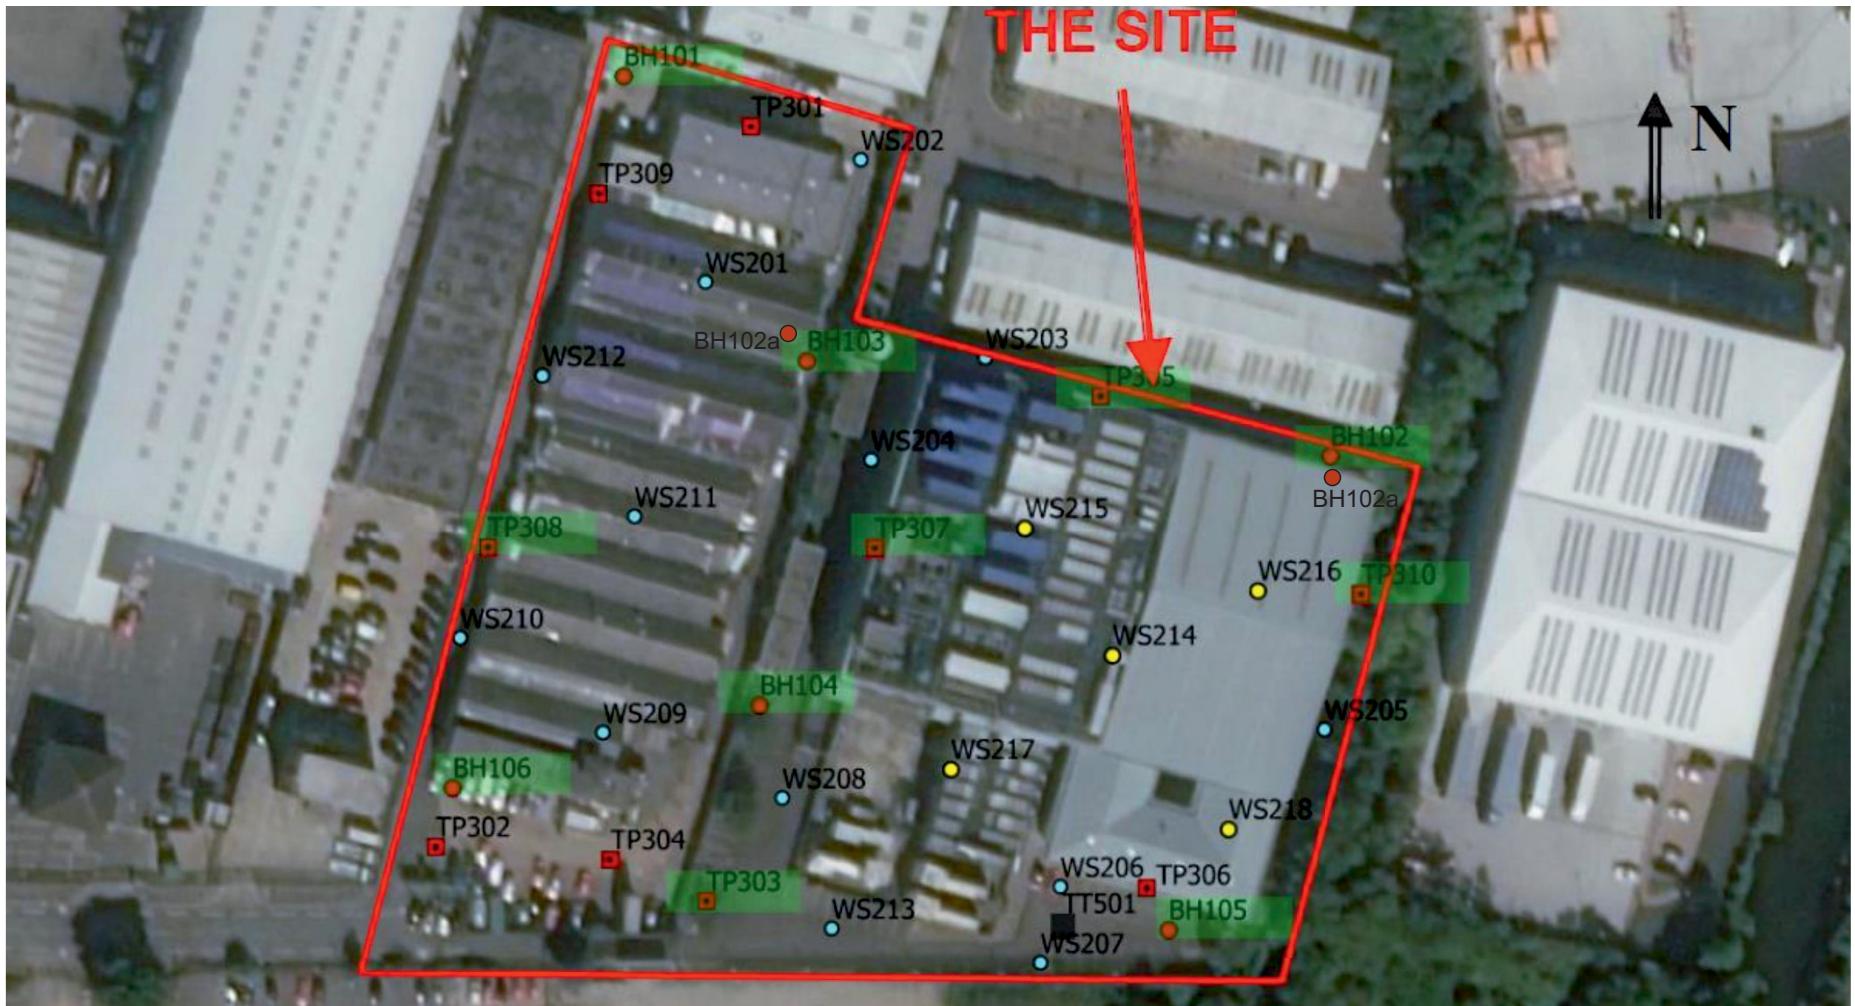
Fig 2 Borehole and trial pit locations (MOLA watching brief interventions highlighted in green)

- 3.1.1 The geoarchaeological watching brief was carried out according to the WSI (MOLA 2021).
- 3.1.2 A total of 8 boreholes (BHs) and 5 trial pits (TPs) were logged by a MOLA Geoarchaeologist during the site investigation works. The original scope of the works included 5 TPs and 6 BHs, although this was subsequently increased by two additional boreholes (BH102a and BH103a), due to concrete obstructions at the original locations (Fig 2).

- 3.1.3 Borehole and trial pit positions across the site are shown indicatively in Fig 2, and sedimentary logs and geoarchaeological interpretations of each unit are provided in the tables in the Appendix. An illustration of the comparative levels and nature of the deposits found during the watching brief can be seen in Fig 3.

- 3.1.7 The Lynch Hill Gravel Member (river terrace deposits) was encountered in 4 of the boreholes (BH101, BH103a, BH104, BH106) and in TP303 (Fig 2 & Fig 3). Their elevations range from 27.81m OD to 28.95m OD.

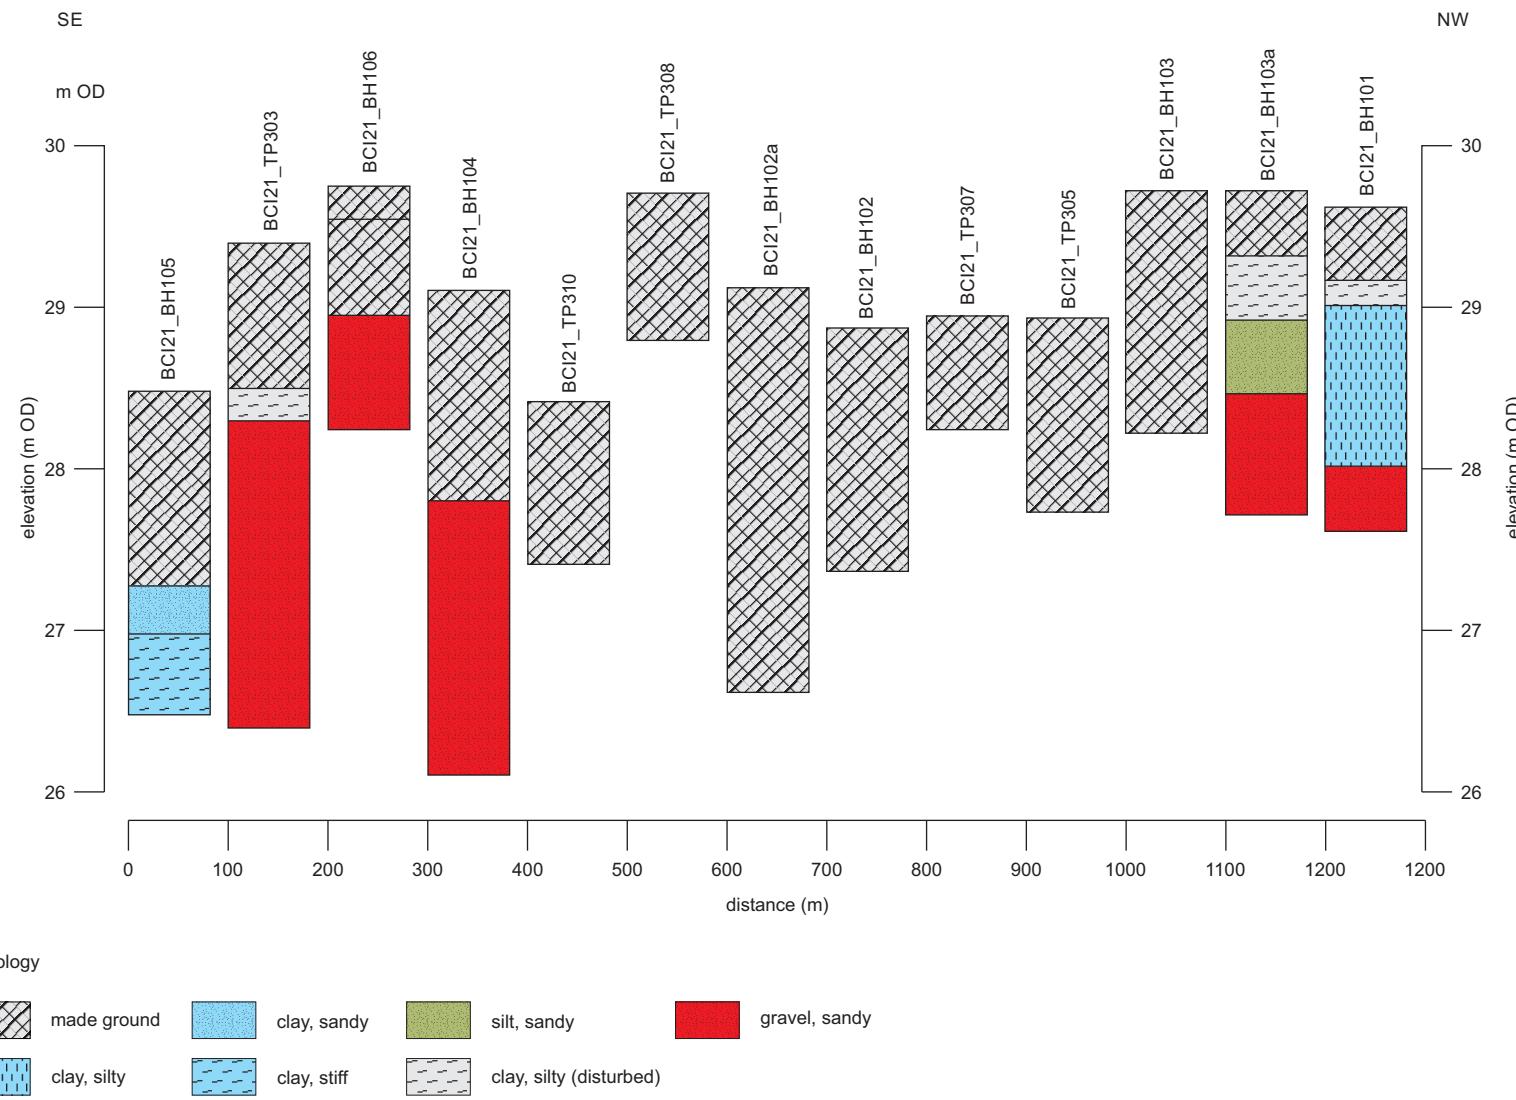
Fig 3 Site wide transect
