Mr A Rogers 10 The Close, Uxbridge, Middlesex UB10 0BP

## Feasibility Check Soil Stabilisation

Soil Stabilisation Barrier October 2018 rev1

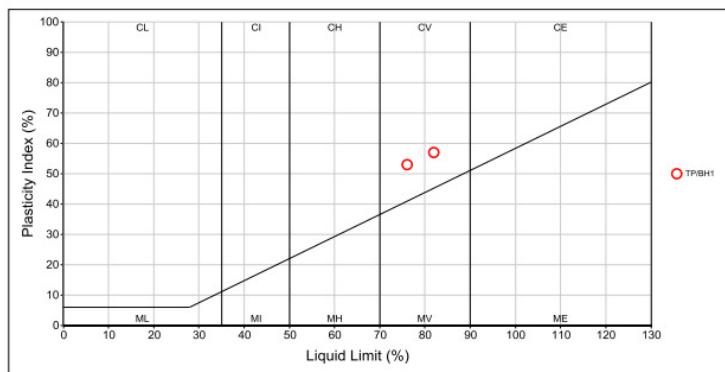
### Plasticity Chart for Casagrande Classification

Lab Ref	Depth (m)	MC (%)	Corr MC (%)	LL (%)	PL (%)	PI (%)	% Passing .425mm
<b>Samples from TP/BH1</b>							
001	2.00	26	26	82	25	57	100
002	2.50	26					
003	3.00	23	23	76	23	53	100
004	3.50	25

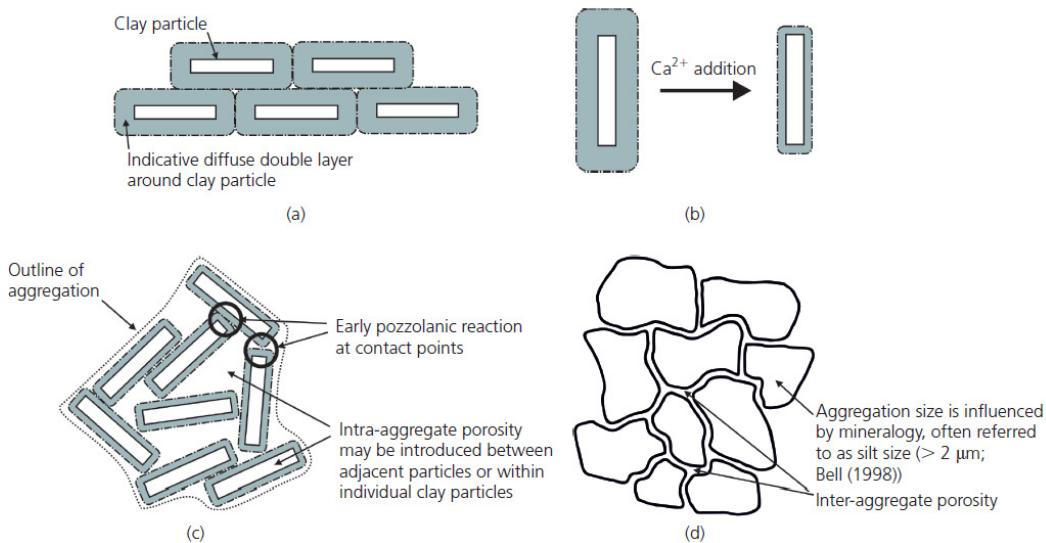
The thickness of the diffuse double layer is controlled by several factors (Reeves et al., 2006) although the valence of the charge-balancing cations has primary influence. Incoming divalent cations exert a greater attractive force towards the clay particle surface than any monovalent cations (which are common to natural clay soils). This balances the clay surface charge with fewer hydrated cations and the thickness of the diffuse double layer shrinks in response (Bohn, 2002). As the diffuse double layers shrink, the electro-static charges on adjacent clay particles interact to a greater extent.

Opposing negative charges of parallel aligned (face to face) clay particles are repelled and reconfigure to promote a flocculated, positive/negative charge (e.g. edge to face) arrangement. This causes silt-sized aggregations of clay particles to group together (Bell, 1996) and two influences on the clay soil structure are suggested: an increase in micro-porosity, intra-aggregate to the flocculated particles and a change to the mesoporosity, inter-aggregate to the flocculated particles. This reduces the effective surface area of clay minerals in contact with the inter-aggregate pore water accounting for much of the immediate change in physical properties of the clay soil associated with lime improvement.

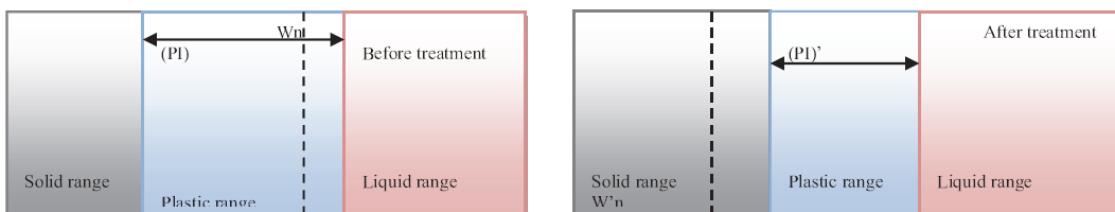
### Effect of liming on the consistency of soil

Soil pH directly affects the life and growth of vegetation because it directly affects the availability of *all* plant nutrients. A nutrient is in its most available state between pH 6.0 and pH 6.5. A nutrient must be soluble long enough and remain soluble long enough to successfully travel through the solution into the roots. Nitrogen for example has its greatest solubility between soil pH 4 and soil pH 8. Outside of that range, its solubility is seriously restricted. The usual recommendation in order to raise the pH of soils is the application of lime. Clay soils are typically neutral displaying a pH of 7; as mentioned previously the pH value of a soil has a huge influence on what plants will grow. The addition of lime and consequent raising of the pH value will moreover limit the extent to which vegetation develop in the zone of soil stabilisation.

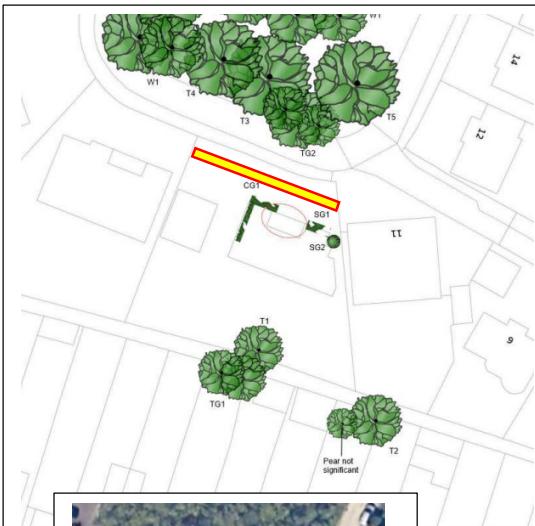
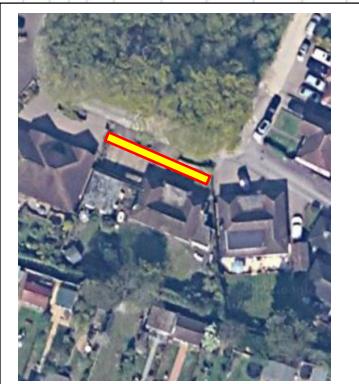
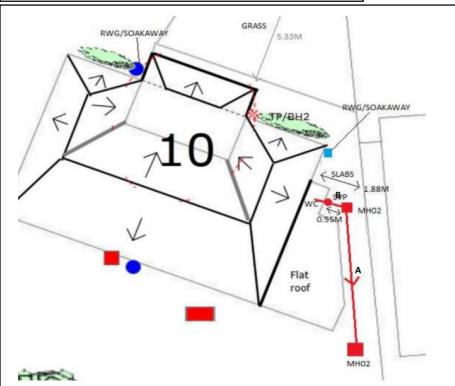
### General Schematic

Lime soil improvement channel to be installed as shown opposite in order to intervene successfully between the tree and area of damage.

Barrier length approx. 20m (See later opposite)

Specification of Soil improvement				
Stabilisation Type	length	Max Root Depth	Depth of stabilisation	Distance between tree / Vegetation and barrier
Lime	20m	2.3m	3.0m	As dictated on-site – the underside of foundations is 2000mm bgl
