TITLE		
IRONBRIDGE ROAD, HAYES		
DRAWING		
SITE LAYOUT PLAN		
CLIENT		
PROLOGIS UK LTD		
DATE	SCALE	DRAWN
JUNE 2020	1:1000@A1	PF
STATUS		CHECKED
PLANNING		MS/GZ/SD
DRAWING NUMBER		
30928-PL-201A

Project Prologis Park West London
Expansion

Title Proposed Levels

TITLE	Topographical Survey
-------	---------------------------------

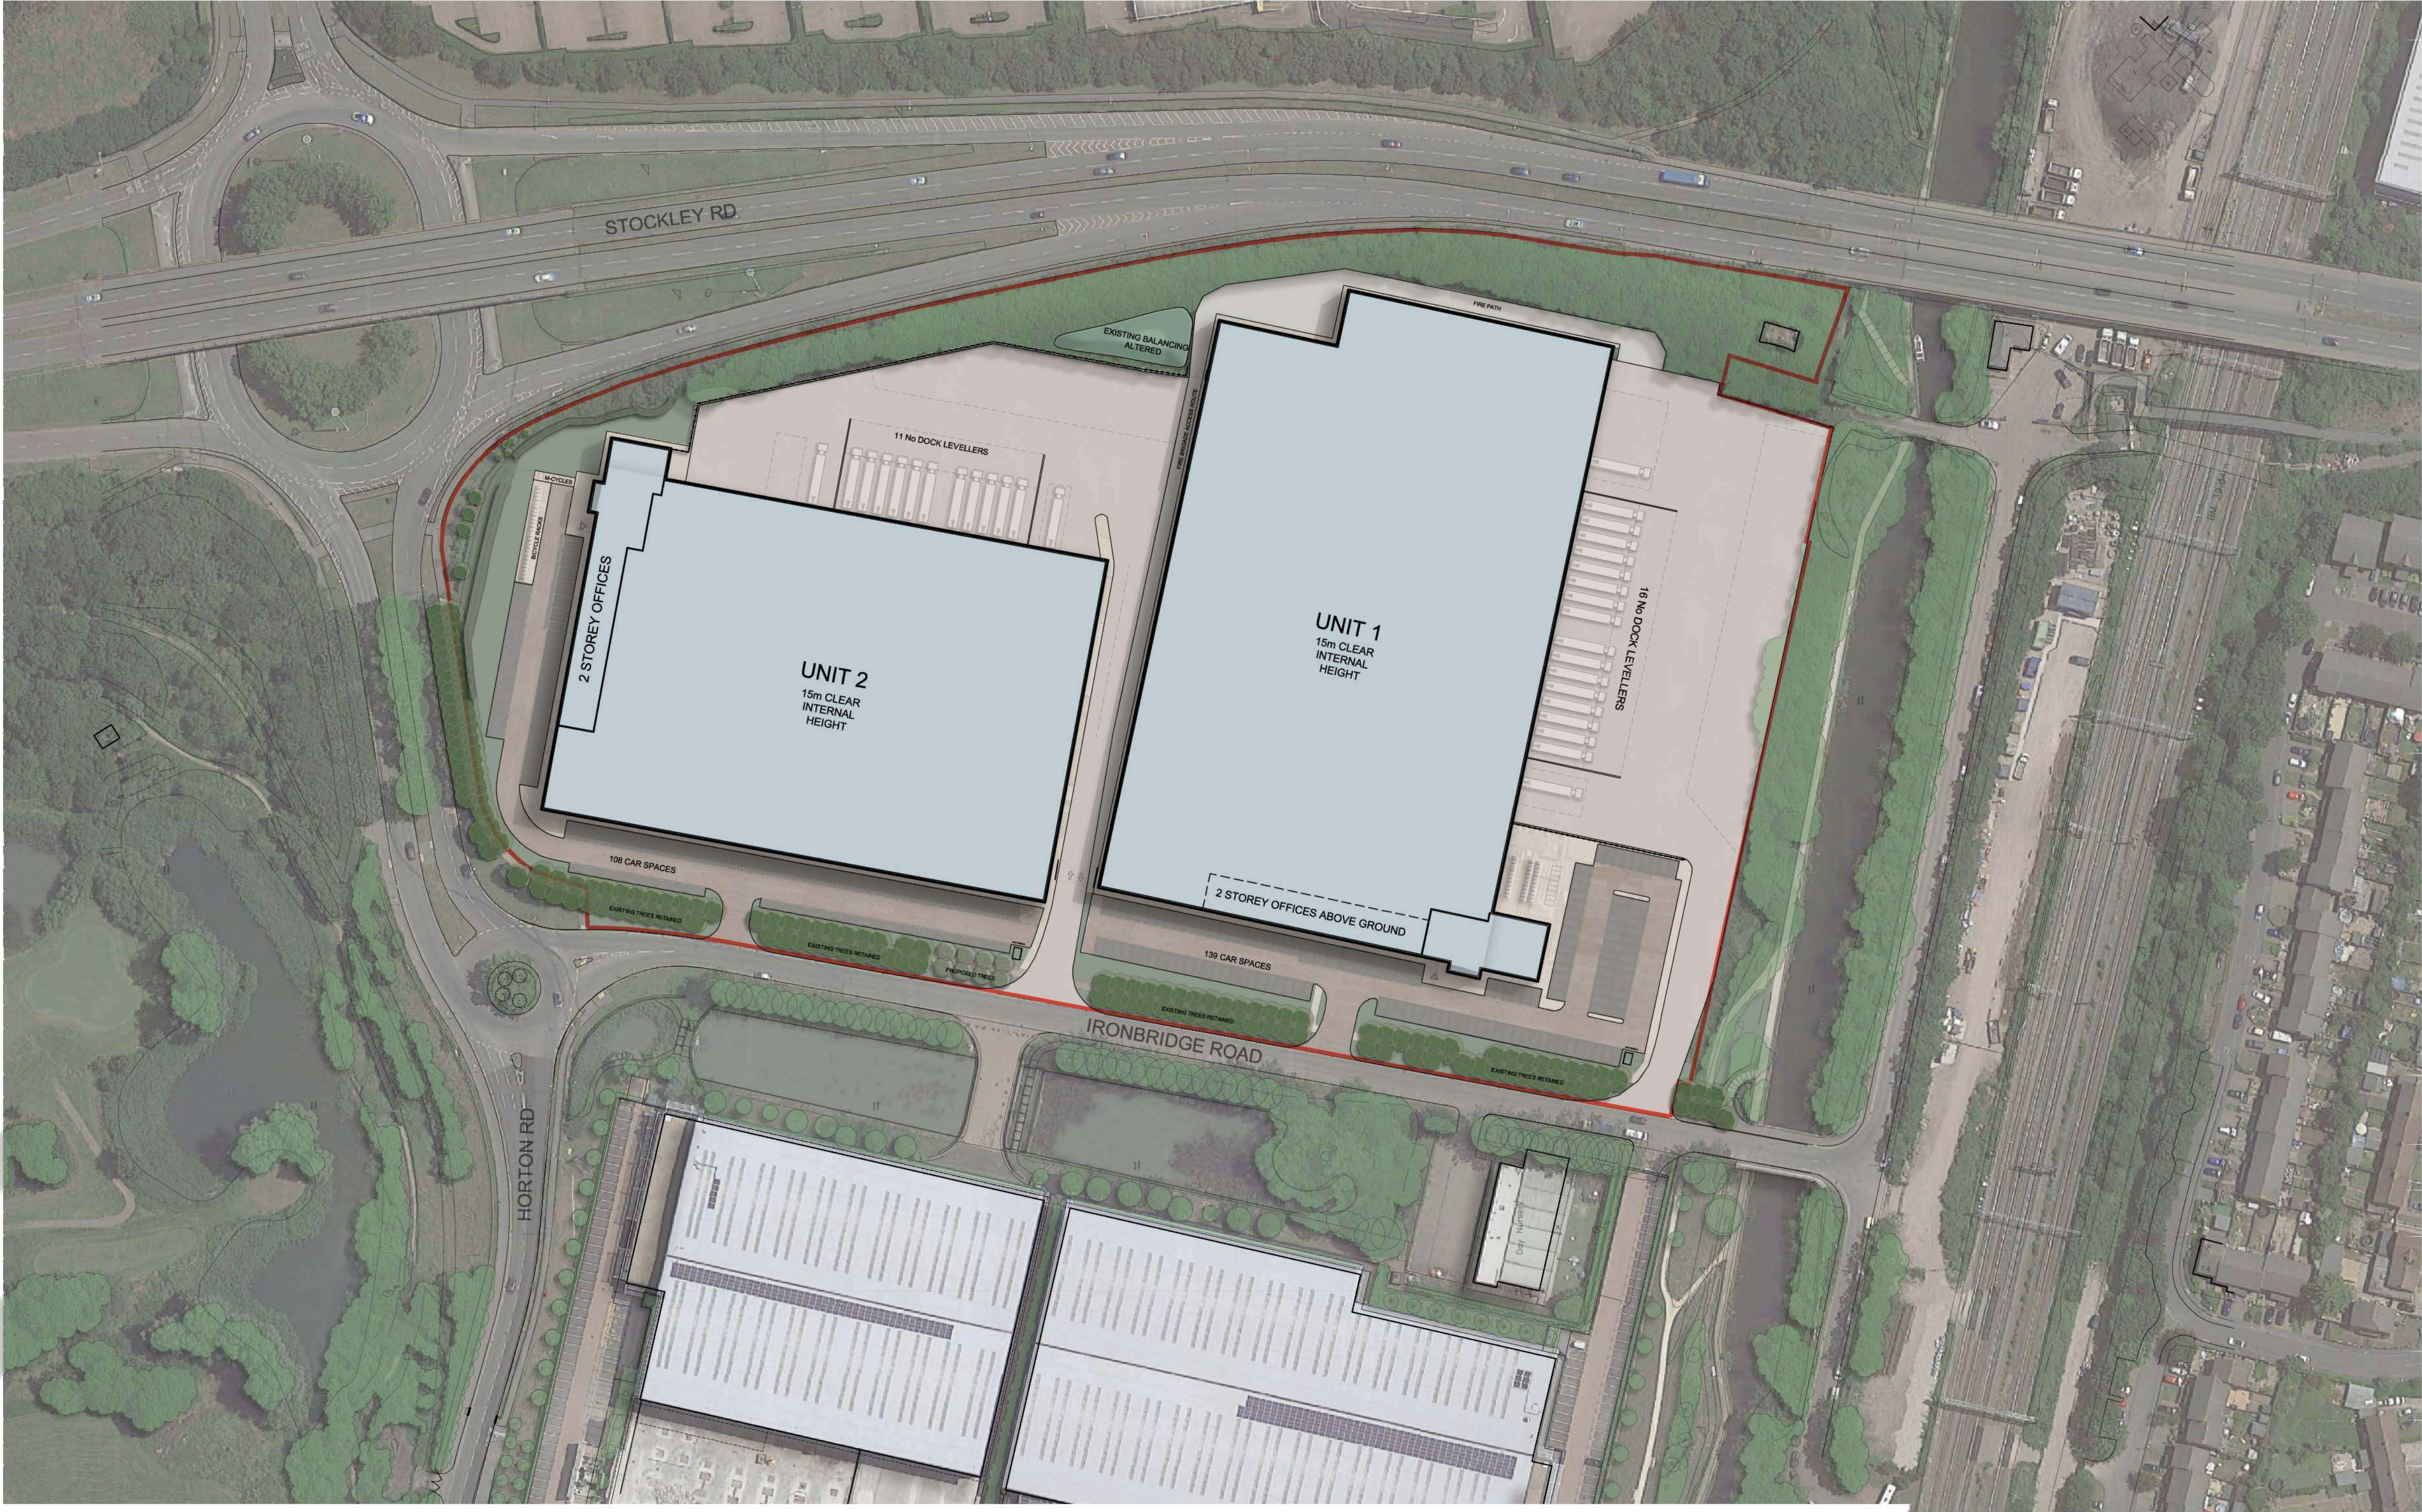
TITLE IRONBRIDGE ROAD, HAYES		
DRAWING COLOUR SITE LAYOUT PLAN		
CLIENT PROLOGIS UK LTD		
DATE MAY 2020	SCALE 1:1000@A1	DRAWN PF
	STATUS FEASIBILITY	CHECKED MS/GZ/SD
DRAWING NUMBER 30928-FE-083

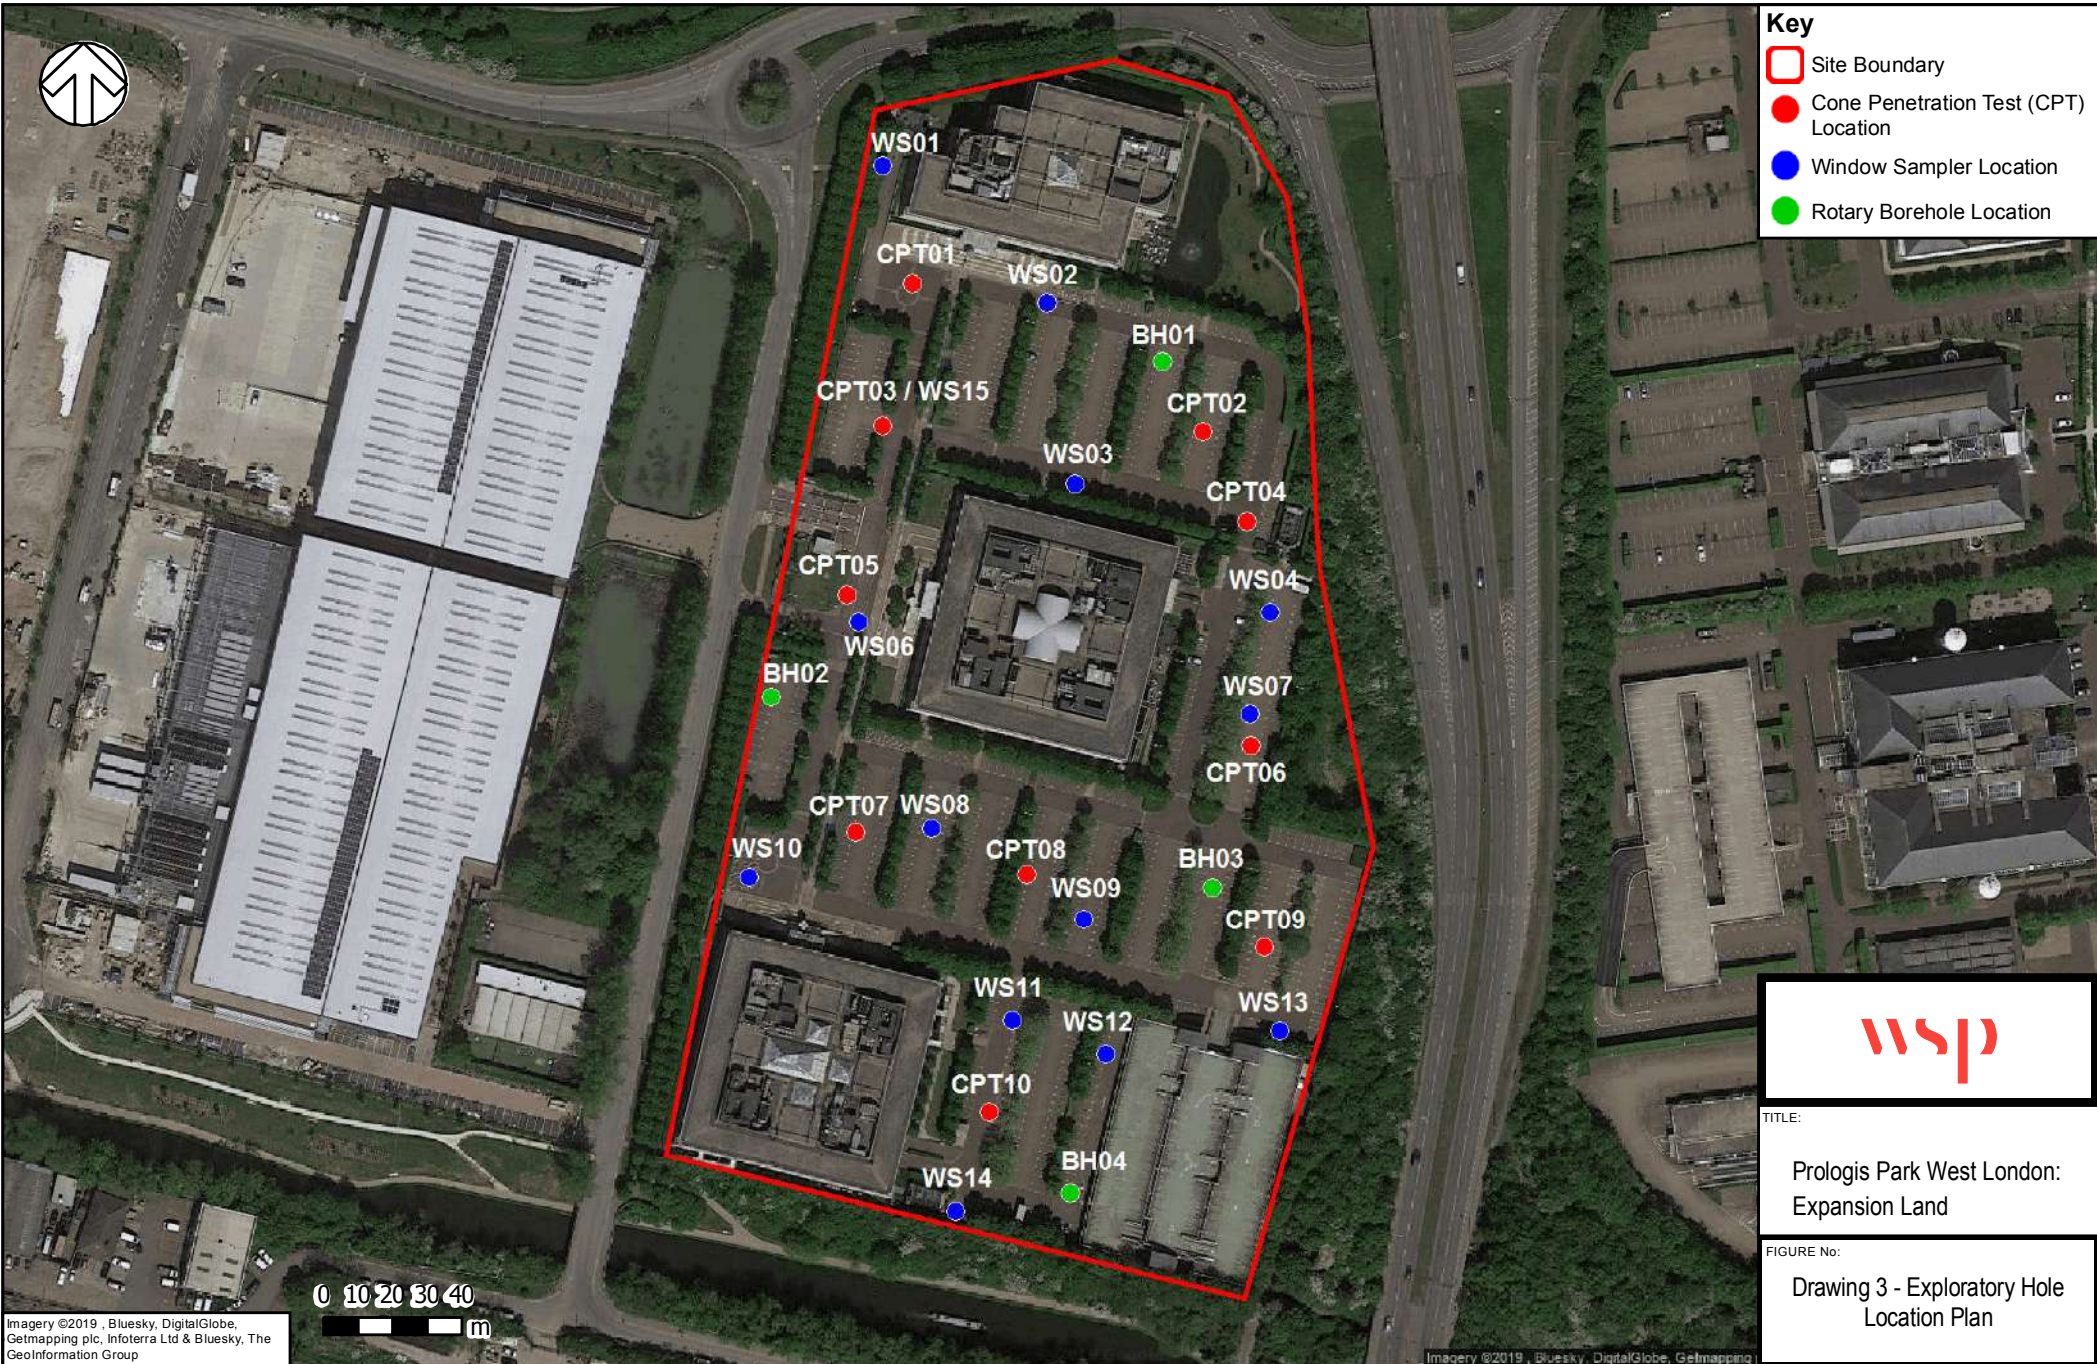
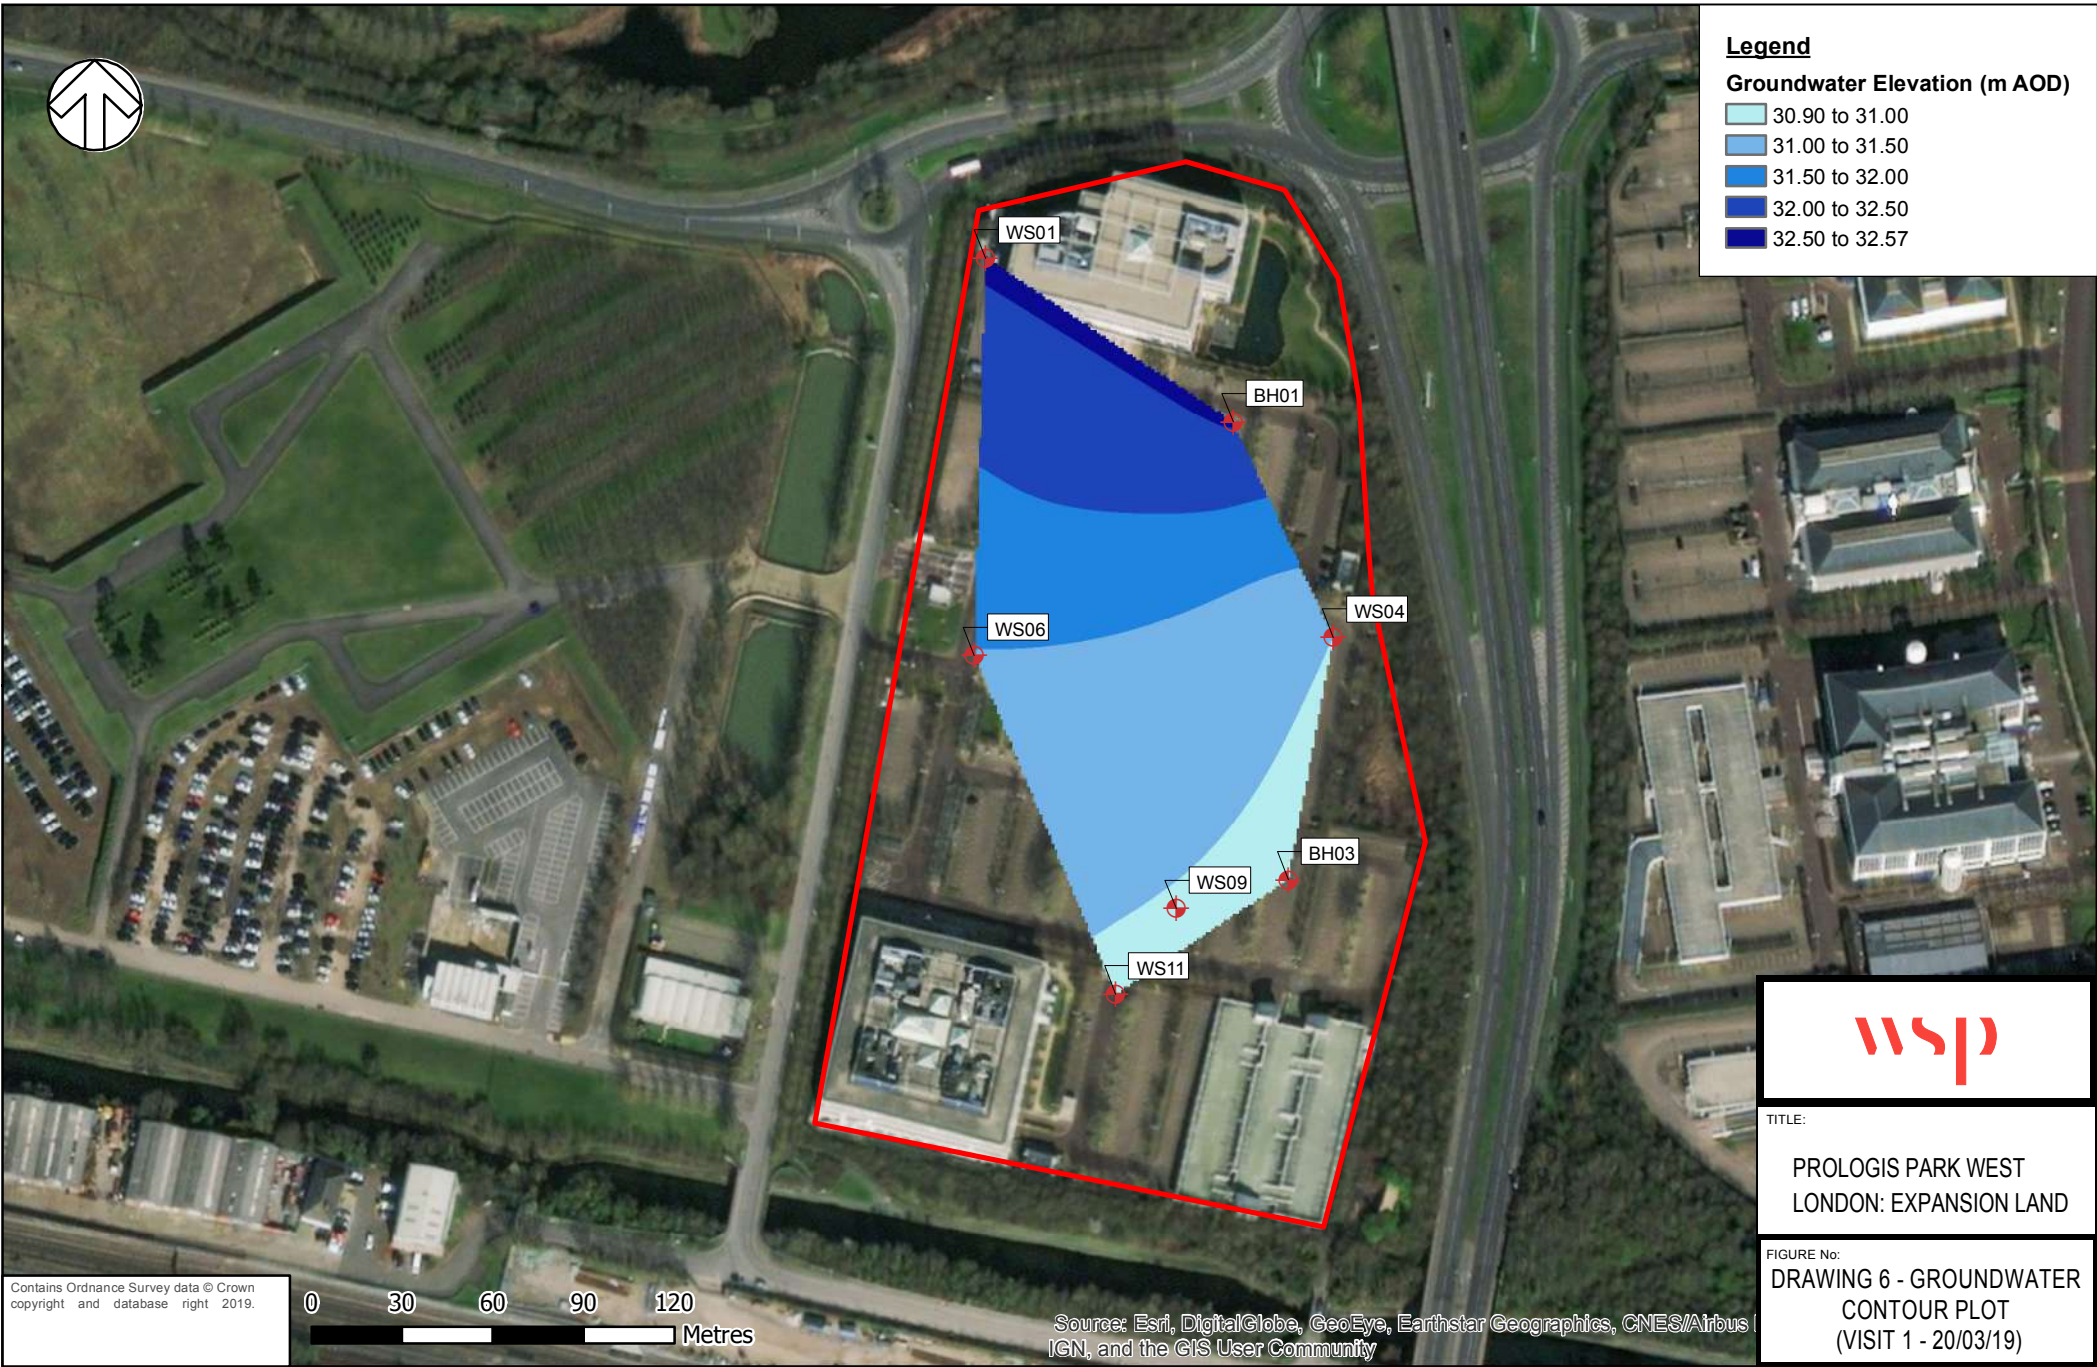
BH04 excluded due to groundwater elevation interference from water flush used during drilling

Hydrographs are included in **Appendix F**. The groundwater level within WS06 and WS08 continued to rise throughout the monitoring visit following sampling, indicating a low rate of recharge. Groundwater within BH04 also took over 24 hours to return to pre-sampling level. Groundwater within BH01, BH02 and WS01 was faster to recharge whilst limited drawdown was noted during sampling of BH03, WS04 and WS11. During the monitoring period, the water level within the canal rose slightly (by about 50 mm), assumed to be due to rainfall. An overall rise in groundwater level was also observed in BH01, BH04 and WS01.
