## **Preliminary Environmental Risk Assessment**

Land at Bridge House, Oxford Road, Uxbridge, UB8 1HS

**Client Name:** Legal & General Assurance (Pensions Management) Limited  
**Document Reference:** WIC15644-101-R-1-2-1-PERA  
**Project Number:** WIC15644

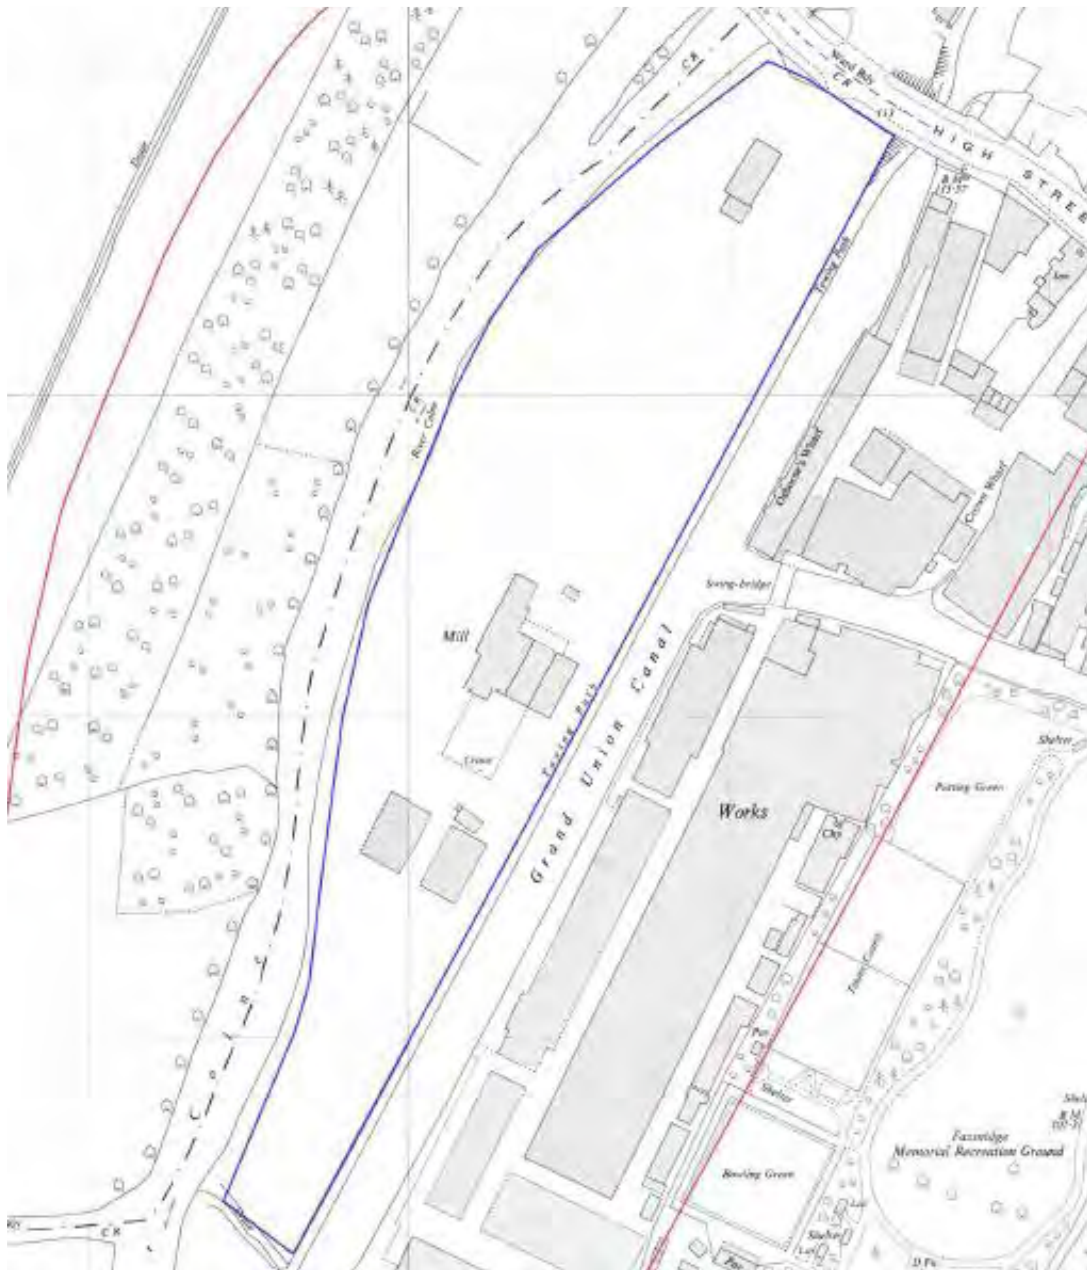
Figure 2: Historical Site Use

Source: Groundsure Map Insight (Report Ref: WTM1-3940281) Date: 1962-63

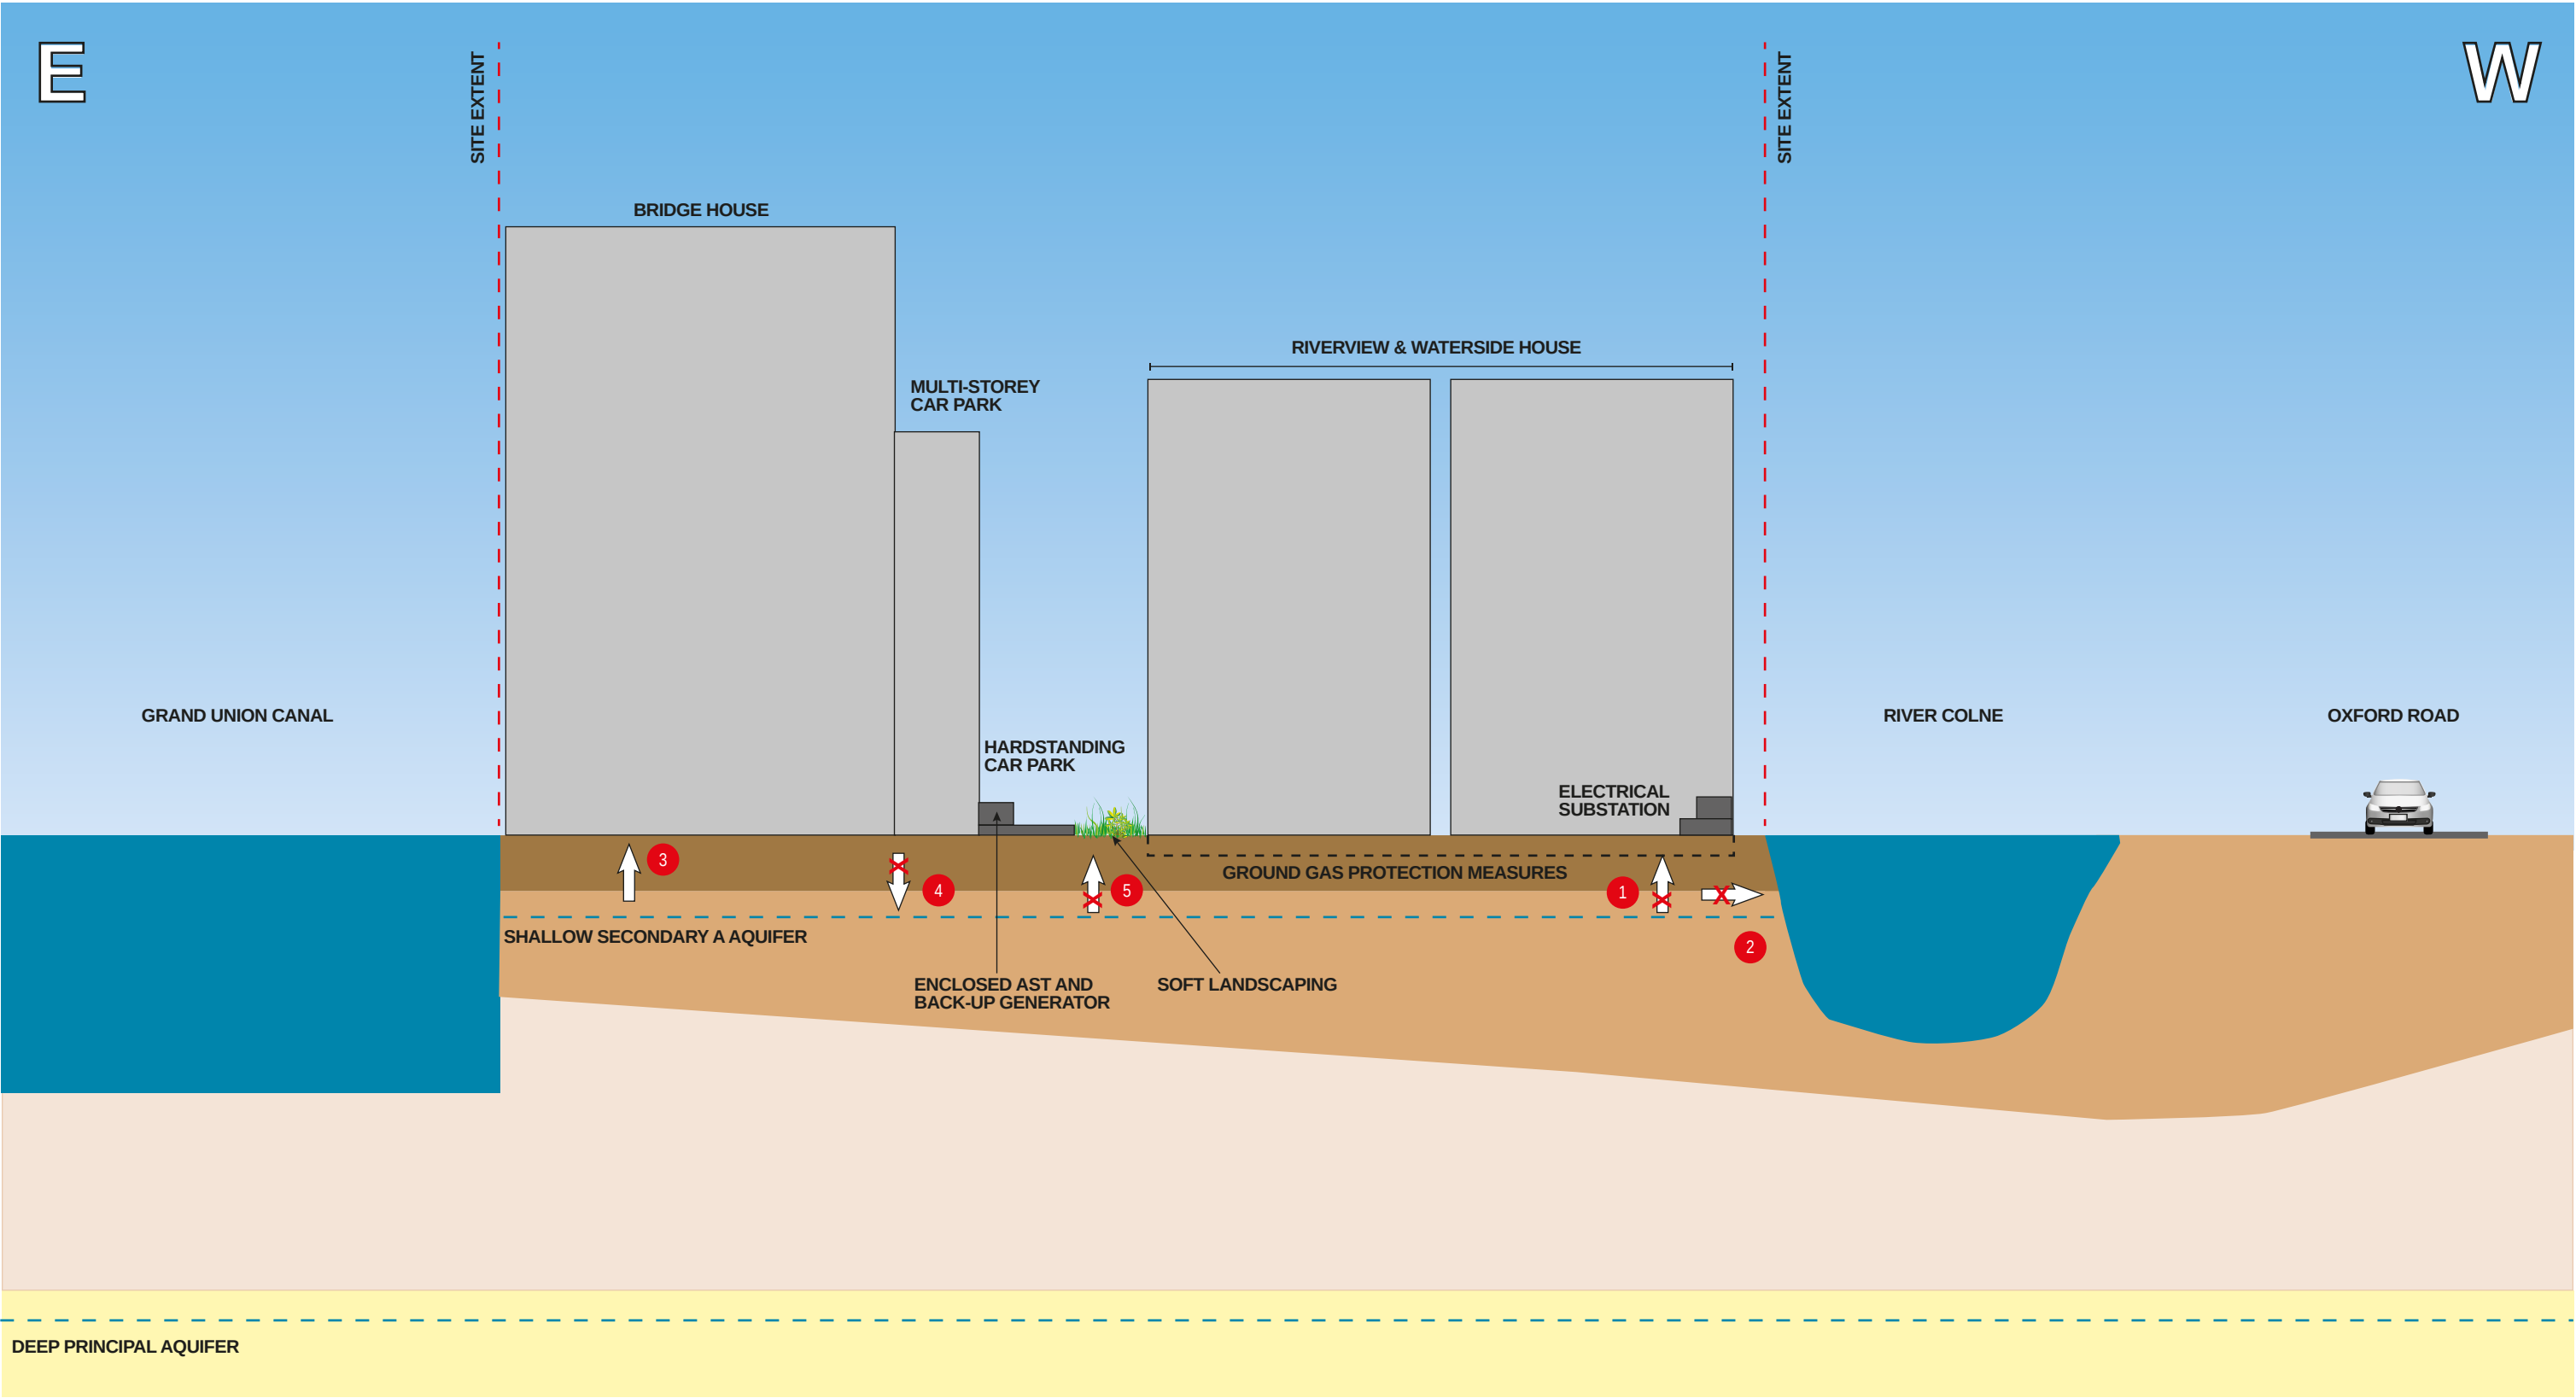
- Made Ground

Lambeth Group
- Alluvium

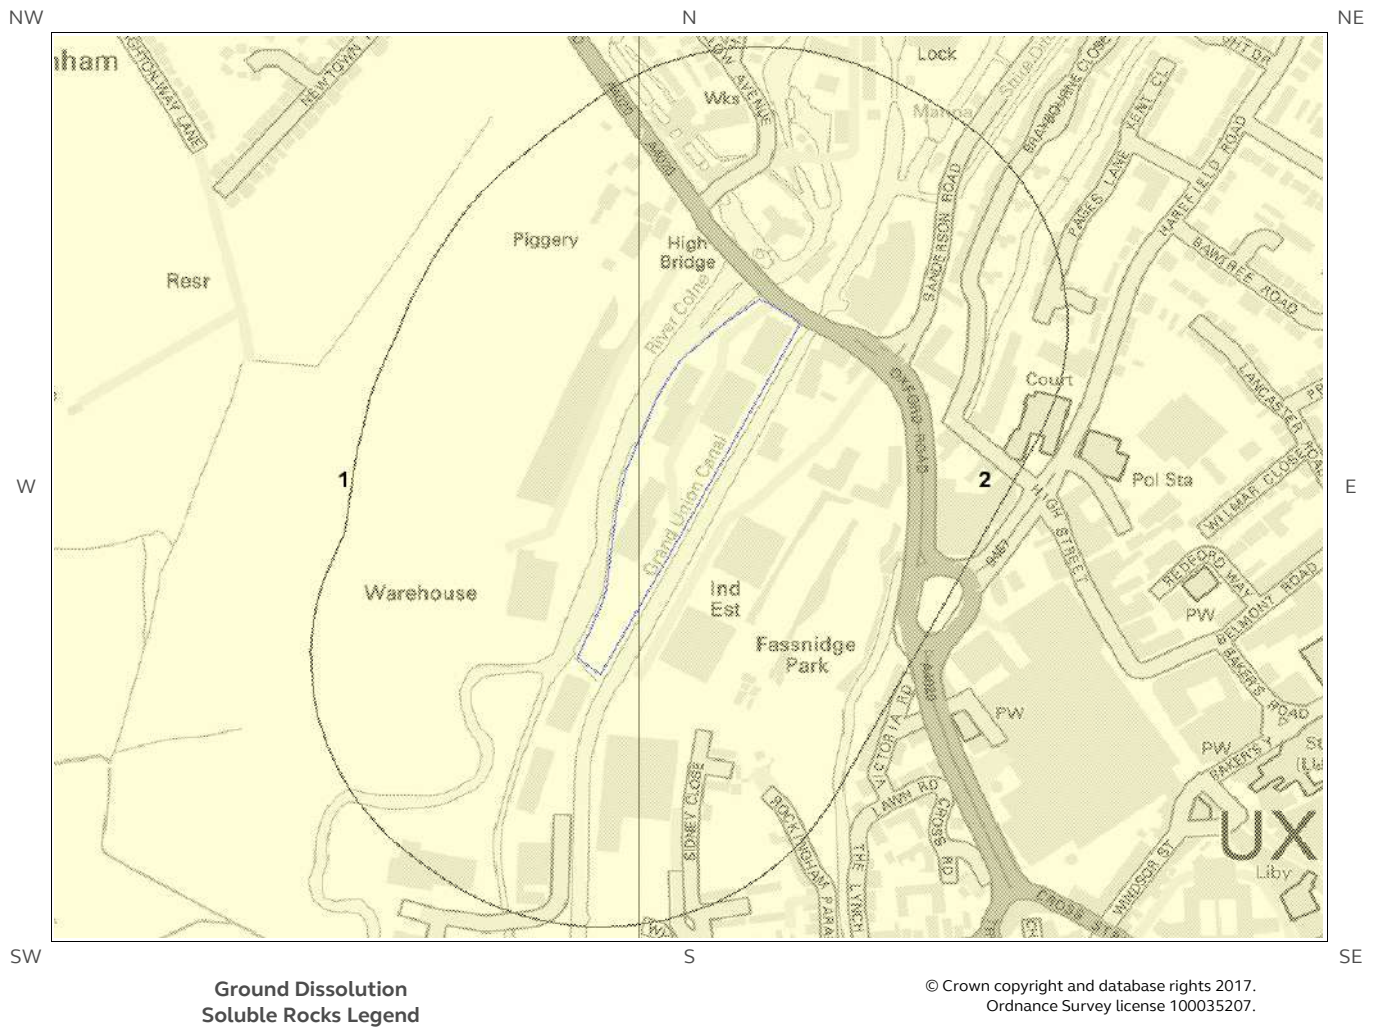
## 6.3 Ground Dissolution of Soluble Rocks Map

The map shows the River Colne flowing through Oxford, with the Grand Union Canal running parallel to it. The area is divided into three numbered regions: 1 (central canal area), 2 (western area), and 3 (eastern area). Key features include the River Colne, Grand Union Canal, Warehouse, Piggery, High Bridge, Fasnidge Park, and various streets like Victoria Rd, High St, and Cowley Rd. The map also shows the location of the Oxford City Centre and the River Thames.
