## 2.3 Site Considerations

## 2.5 Existing Site Overview

## 2.7 Estate Condition and Surveys

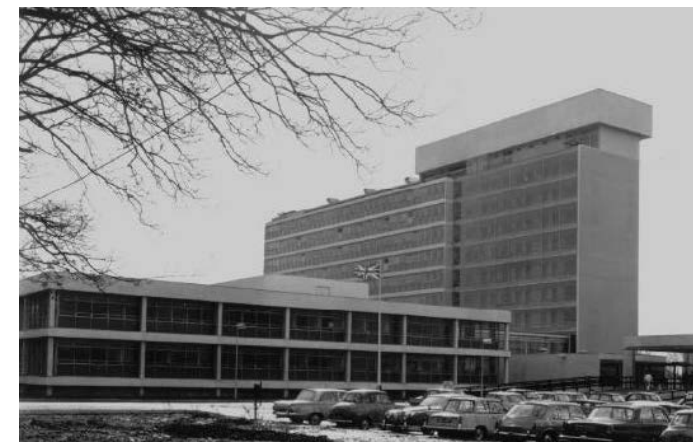
*The original Tower and Podium*

The Hillingdon Hospital Estate as we see it today is seen in the context of the delivery of the first Phase of this plan - the Maternity Hospital, 5th July 1969 and Main Hospital (tower and podium elements) January 10th 1967. Described at the time as one of the finest new hospital developments in the country the opening of what was intended a phase one of a three phase development was, according to the chairman of the Regional

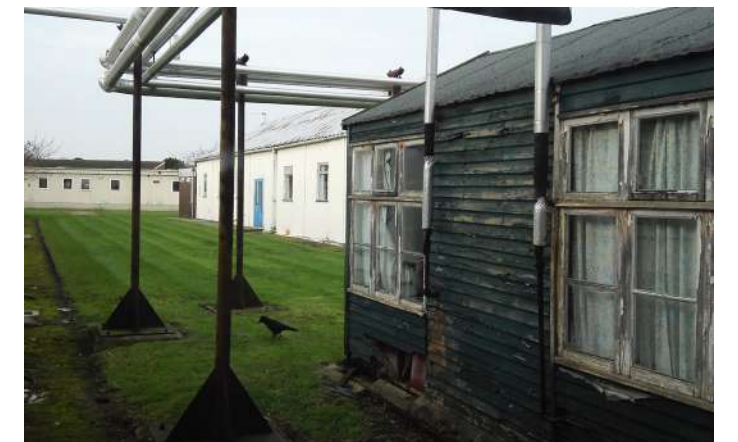
*EMS wards built in 1941*

Board, “a great occasion”. The second phase of three phases which would have seen the replacement of the temporary ward accommodation hastily constructed in the war years was planned for 1970 but was not implemented. New building stock has been added to the site since this time, leaving ‘the annex corridor’ and ‘annex wards’ in place.

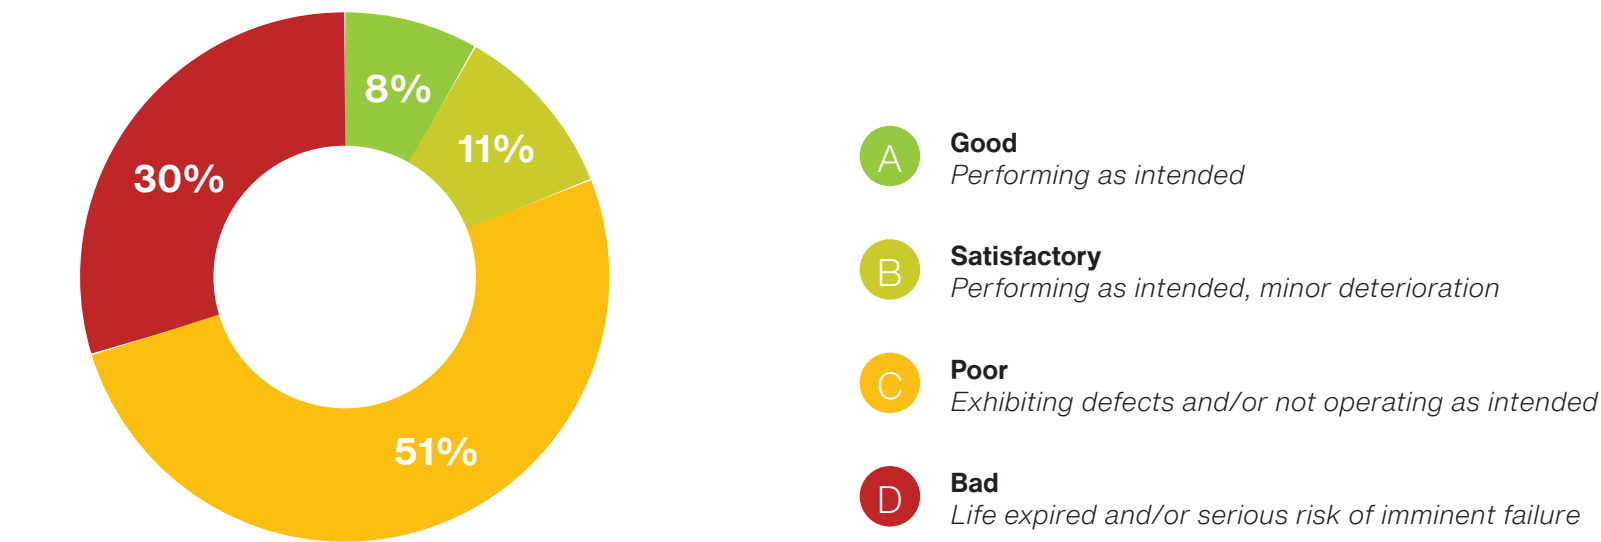
### HH – Breakdown of Overall Grades based on GIA

81% of the Estate by building area is category C or D being poor or bad

The majority of the Estate is rated at Condition C (Poor) or D (Bad) across all aspects of the Facets. Within these there are examples of individual buildings that are in a particularly poor condition as identified in detail within the main six facet report.
