# ATZ Assessment

- 1.1 This Active Travel Zone (ATZ) assessment accompanies a Transport Assessment and Technical Note prepared on behalf of Heathrow NCP Property Limited in relation to the proposed development at the Aprirose NCP Flightpath car park at Heathrow, West Drayton.
- 1.2 The ATZ is defined as a 20-minute cycle distance from a site where key travel destinations are likely to be reached using active modes of travel. The following maps, tables and ATZ analysis have been produced in reference to the TfL ATZ assessment instructions.

Aprirose NCP Flightpath Heathrow, A4 Bath Road, West Drayton

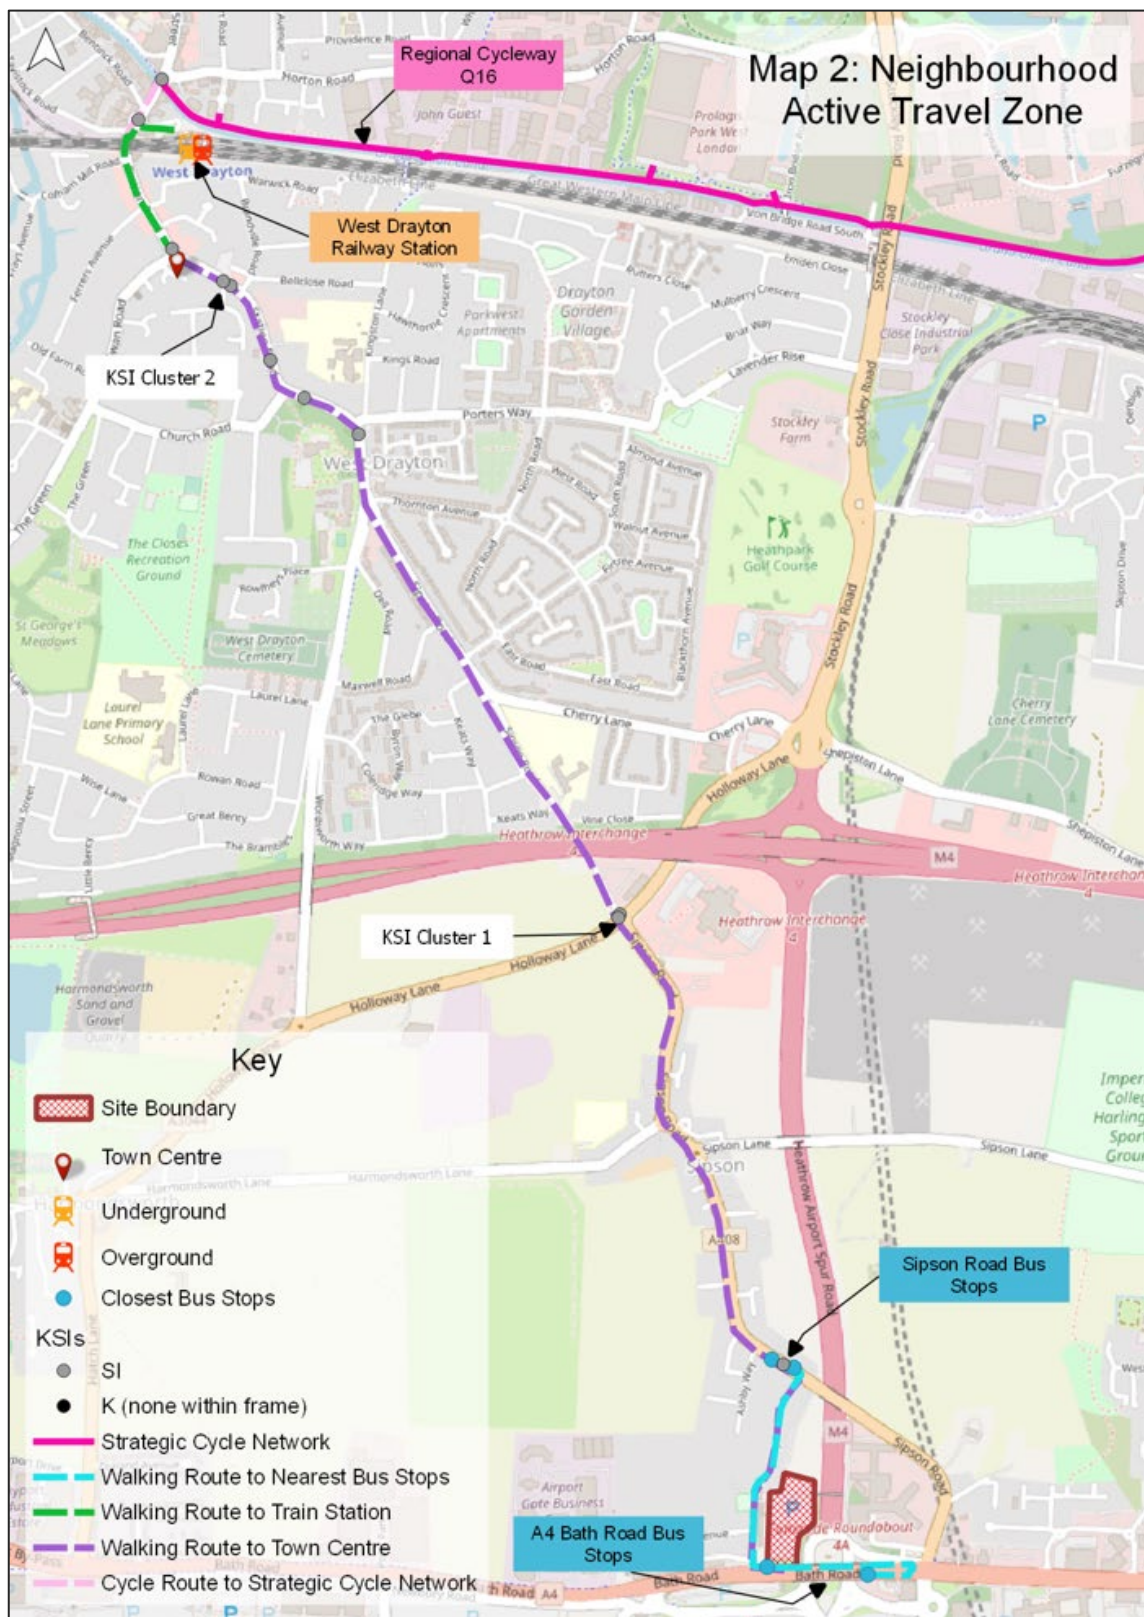
**Figure 1.2: ATZ at Neighbourhood Scale with Vision Zero Analysis (KSI Clusters)**

1.3 **Figure 1.2** presents the Neighbourhood Scale Active Travel Destinations.

- 1.4 As can be seen from **Figure 1.2**, the main desire lines from the site will be north towards the town centre, rail station and regional cycleway. To access the closest bus stops, pedestrians will head along desire lines both east and west from the site for a short distance.
- 1.5 Vision Zero for London relates the Mayor's goal that, by 2041, all deaths and serious injuries will be eliminated from London's transport network. This will be achieved through an action plan that targets safe speeds, safe streets, safe vehicles, safe behaviours and post-collision response.
- 1.6 **Table 1.2** identifies possible improvements to increase safety and reduce vehicle dominance in the areas seeing clusters of KSIs. This aligns with the safe streets element of the Vision Zero approach.

Location	Number of KSIs	Comments	Potential Improvements
Cluster 1: Holloway Lane / Sipson Road Roundabout	Two serious	Both incidents involved a pedal cyclist	Clearer cycle markings on all arms or addition of cycle boxes on Station Road arms
Cluster 2: Station Road / Drayton Gardens Junction	Two serious	Only one incident involved a pedestrian	Add tactile paving to Drayton Gardens crossover.

**Table 1.2: Potential Safety Improvements**

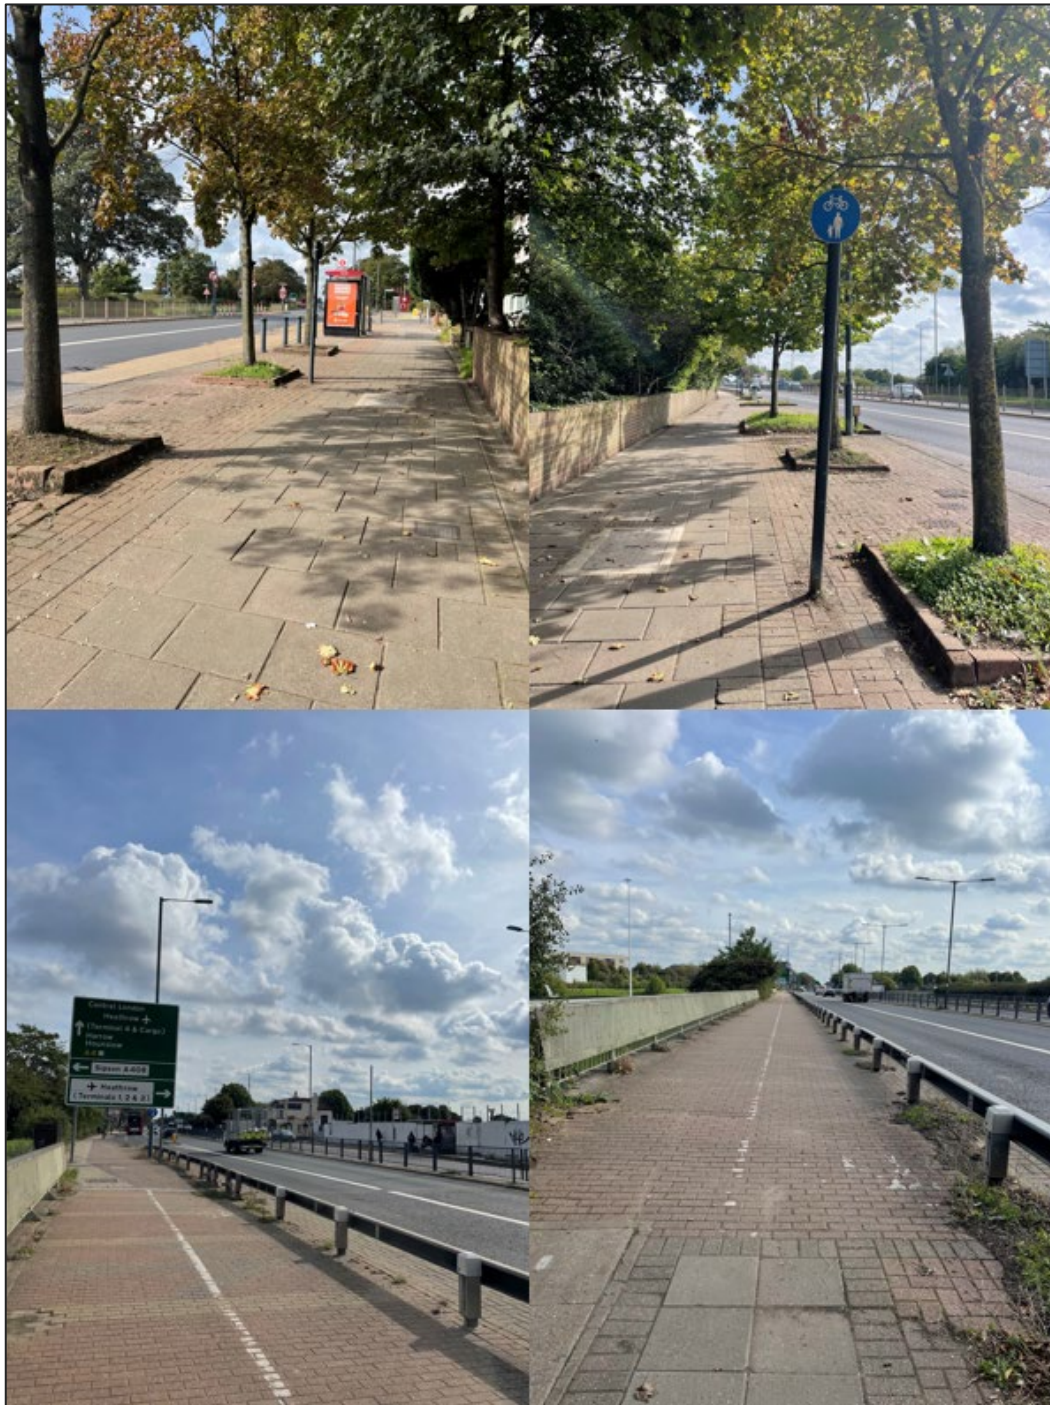
**Figure 1.5: Photographs Along Route 1**

1.15 **Figure 1.5** provides photos taken along the route to the nearest bus stops on the A4 Bath Road. **Table 1.3** assesses the route in light of the Healthy Streets Indicators:

<i>Healthy Streets Indicator/s Not Met</i>	<i>Observation/Why</i>	<i>Recommendation</i>
Not too noisy	High volume of traffic paired with noise from the airport runways means people often have to raise their voice to hold a conversation.	Seek lower traffic speeds on Bath Road
Places to stop and rest	No places to rest other than within the bus stop itself	Provide additional bench

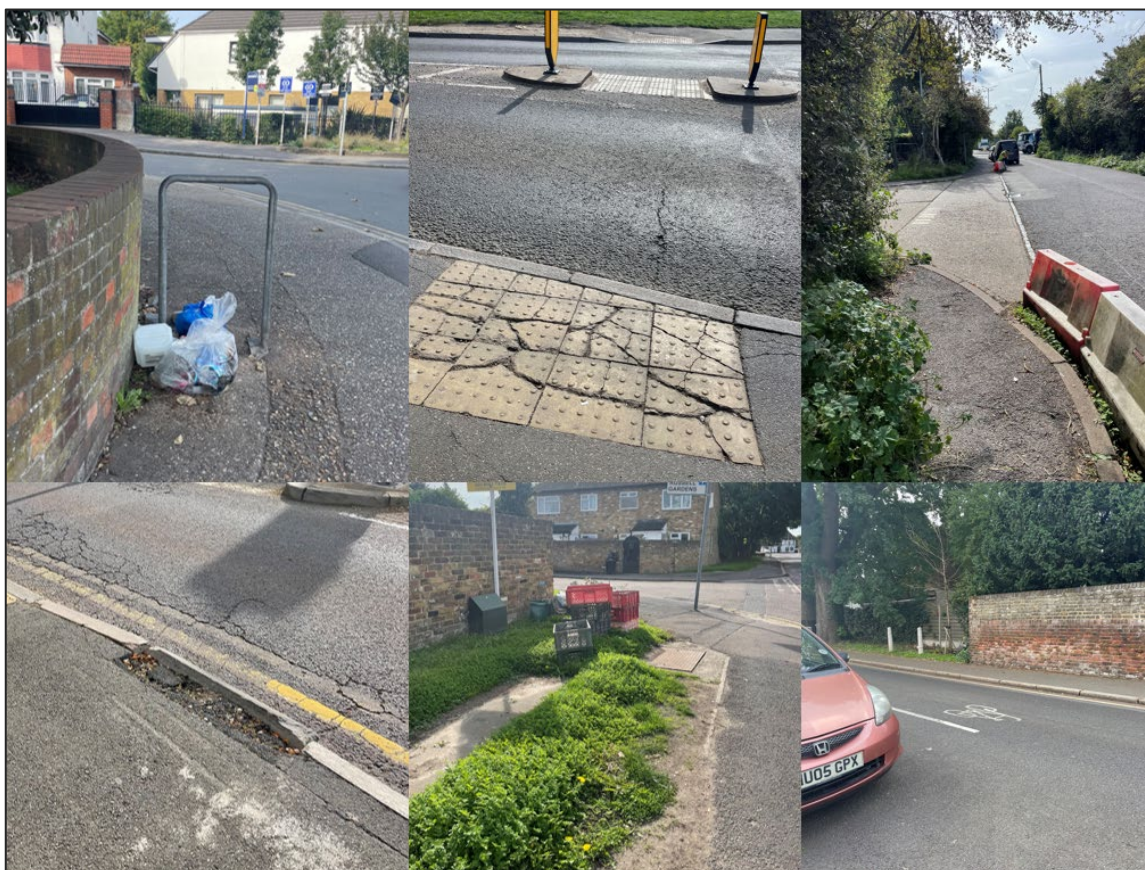
**Figure 1.6: Photographs along Route 2**

1.16 **Figure 1.6** provides photos taken along the route to West Drayton Town Centre. **Table 1.4** assesses the route in light of the Healthy Streets Indicators:

<i>Healthy Streets Indicator/s Not Met</i>	<i>Observation/Why</i>	<i>Recommendation</i>
People feel relaxed	Rubbish / fly tipping present along the route, on-road signage for cyclists at times confusing	Ensure council are aware of rubbish collection issue, re-paint cycle markings
People choose to walk and cycle	Cyclists may not feel that the street has been designed to prioritise their needs, they often have to move around or in close proximity to parked cars	Where possible, delineate the cycle route in a clearer manner, avoiding rows of parked cars
Easy to cross	Defective tactile paving and kerbs at some dropped kerbs	Re-install tactile paving/kerbs (see TA)
Places to Stop and Rest	Some long sections of the route have no places to stop and rest.	Consider if any benches could be installed along the route.

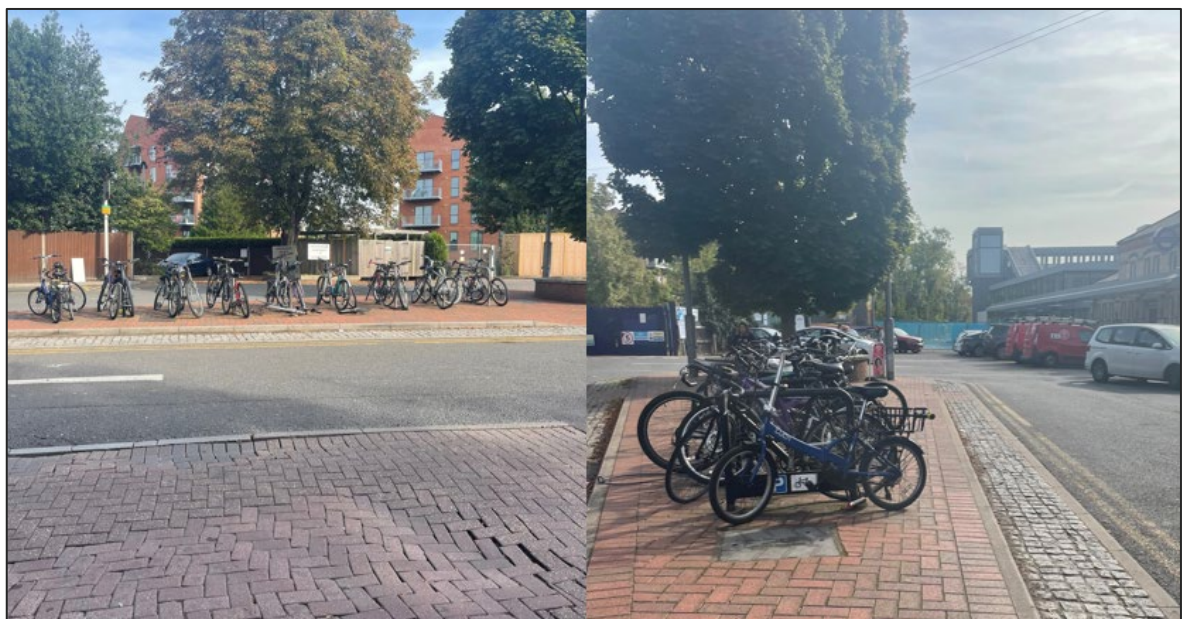
**Figure 1.7: Photographs along Route 3**

1.17 **Figure 1.7** provides photos taken along the route to the Railway Station from the Town Centre. **Table 1.5** assesses the route in light of the Healthy Streets Indicators:

<i>Healthy Streets Indicator/s Not Met</i>	<i>Observation/Why</i>	<i>Recommendation</i>
People choose to walk and cycle	Insufficient cycle parking at the railway station – racks all full.	Increase the number of Sheffield stands at the station.
People choose to walk and cycle	Cyclists have to share Station Approach with vehicles.	Consider introduction of cycle box coming out of Station Approach.

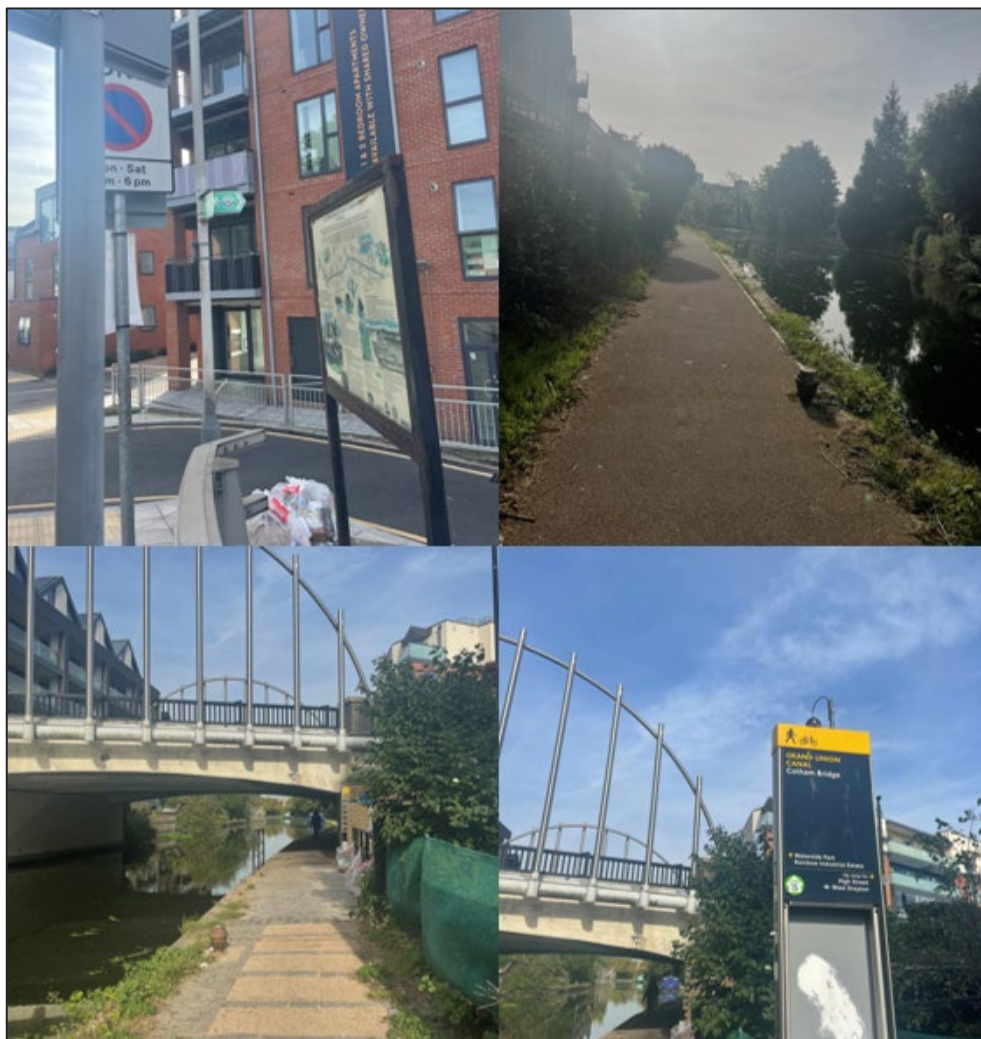
**Figure 1.8: Photographs along Route 4, Including Point of Entry to Cycle Network**

1.18 **Figure 1.8** provides photos taken along the route to the Regional Highway Network from the Railway Station, and the point of entry to the Regional Highway Network from this location. **Table 1.6** assesses the route in light of the Healthy Streets Indicators:

<i>Healthy Streets Indicator/s Not Met</i>	<i>Observation/Why</i>	<i>Recommendation</i>
People choose to walk and cycle	People walking and cycling expected to share the same space.	Ensure signage is clear
Places to stop and rest	No cycle parking at this entry point to route	Consider adding in a couple of Sheffield Stands
People Feel Relaxed	Street signage on approach doesn't promote regional cycle route very clearly, you have to know where to look. Rubbish abandoned on corners.	Ensure signage is sufficient, ensure council are aware of rubbish collection issues.

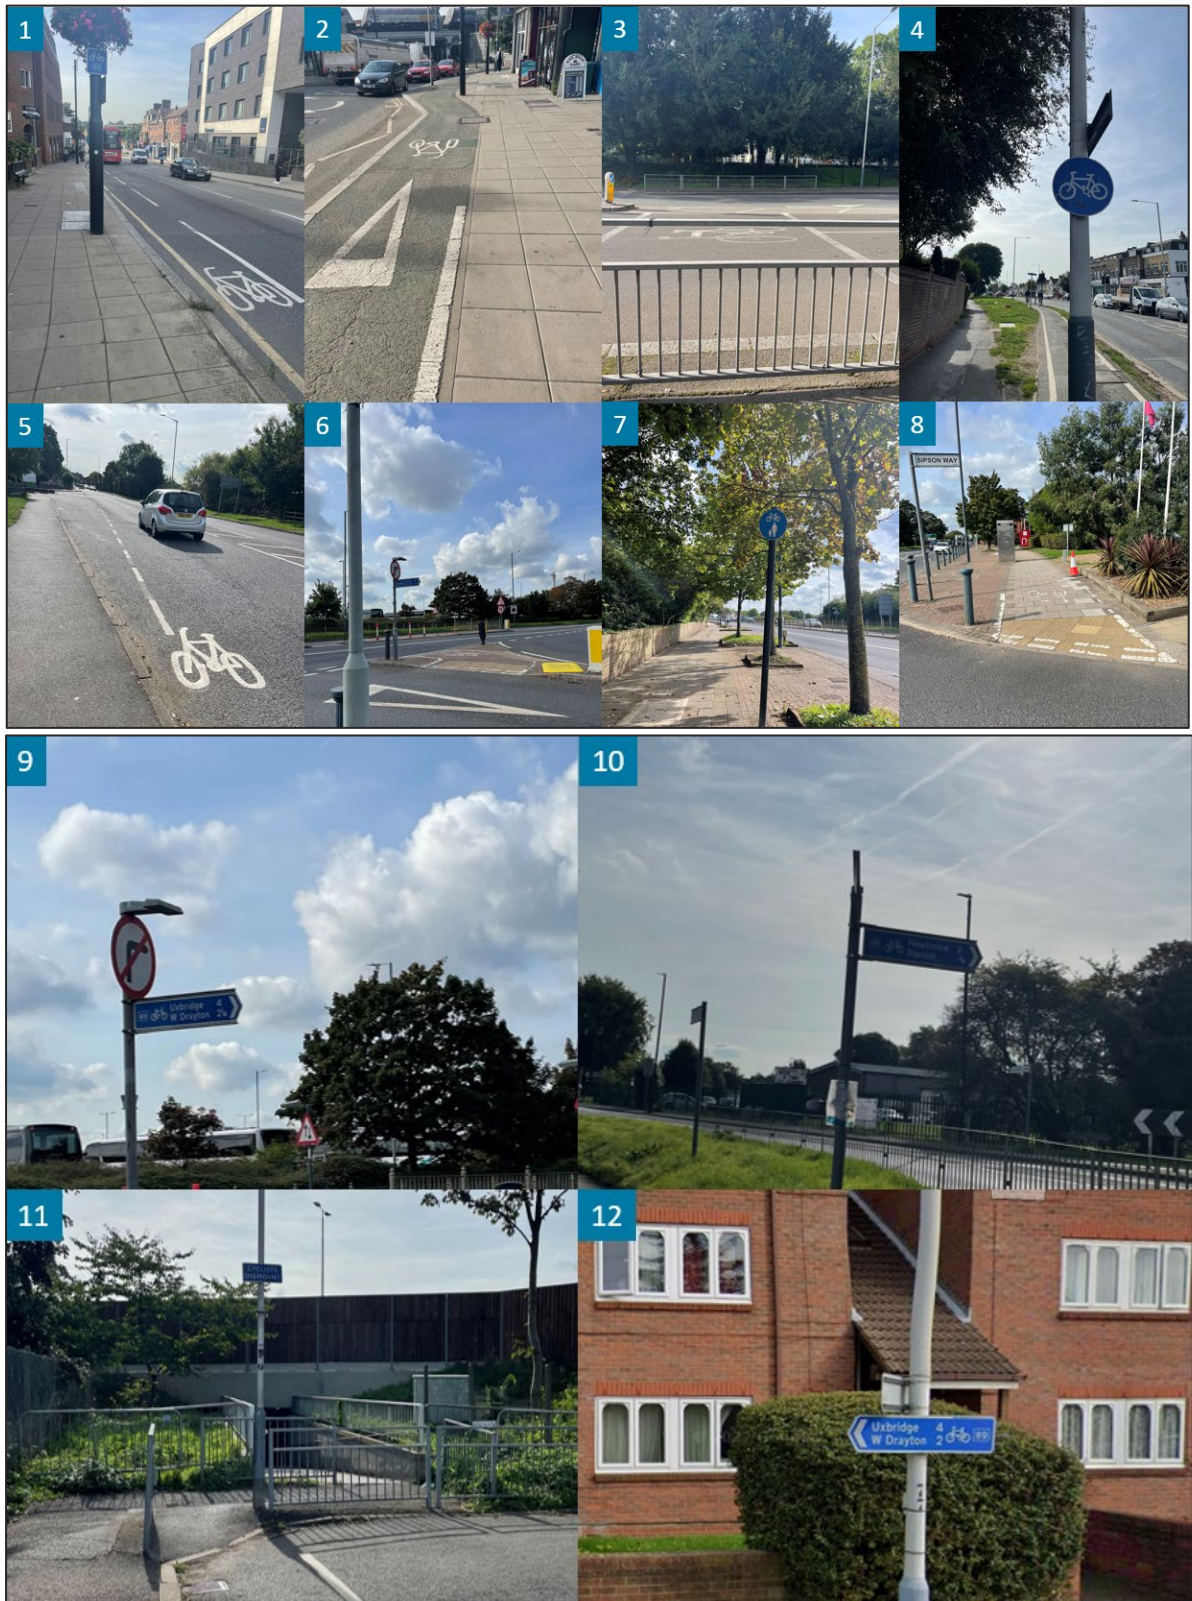
Figure 1.9: Cycle Facilities Between the Site and Regional Cycle Network

- 1.20 While Tables 1.3-1.6 all identify potential improvements to cycle facilities, it should be noted that from the site to the regional cycle network, there is a fairly comprehensive local cycle route which is formed by both on-road and off-road facilities. **Figure 1.9** illustrates these provisions for reference.
