ATZ Assessment

- 1.1 This Active Travel Zone (ATZ) assessment accompanies a Transport Assessment and Travel Plan Statement prepared on behalf of Lysara in relation to the proposed development of an Electric Vehicle (EV) Fast Charging Station with supporting facilities including a new food and beverage unit (F&B unit) at the Heathrow Flightpath Car Park, Sipson.
- 1.2 The ATZ is defined as a 20-minute cycle distance from a site where key travel destinations are likely to be reached using active modes of travel. The following maps, tables and ATZ analysis have been produced in reference to the TfL ATZ assessment instructions.

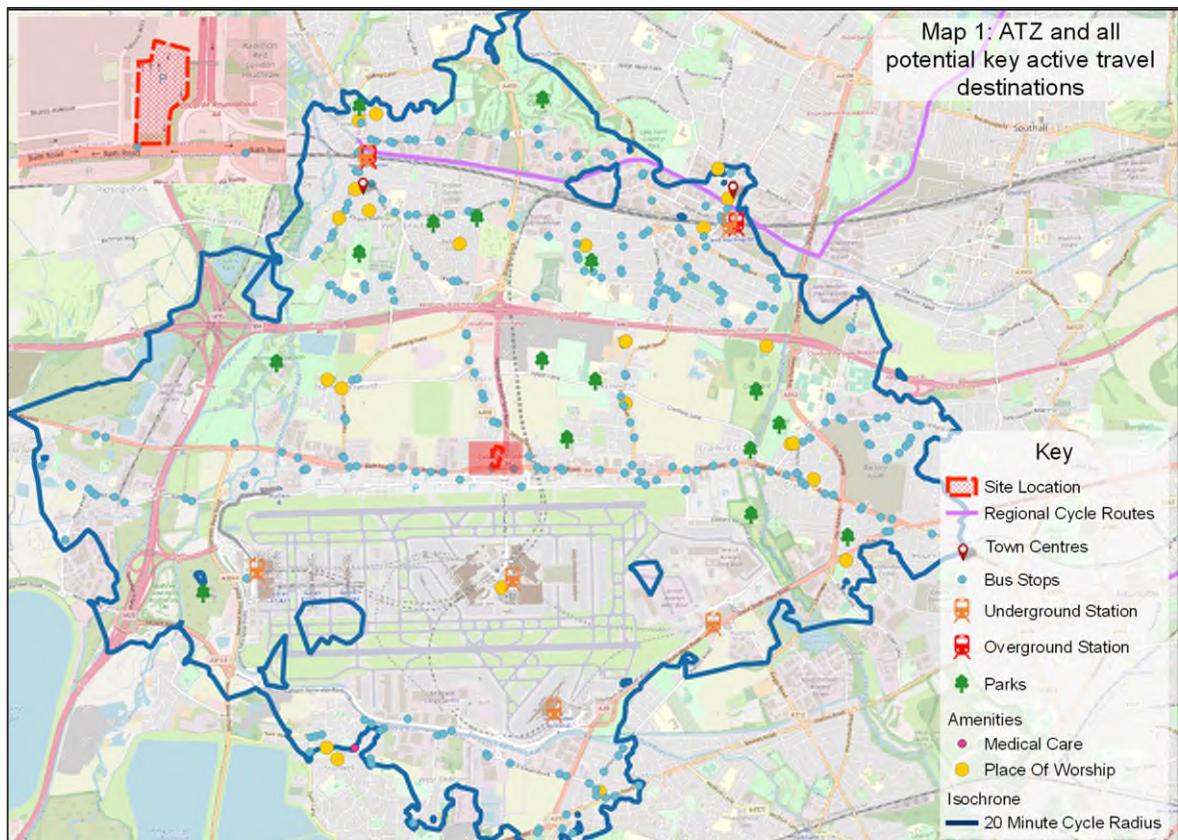
Figure 1.1: Active Travel Zone

- 1.3 **Figure 1.1** shows the ATZ for the proposed site, with a 20-minute cycling catchment shown by the dark blue boundary line.

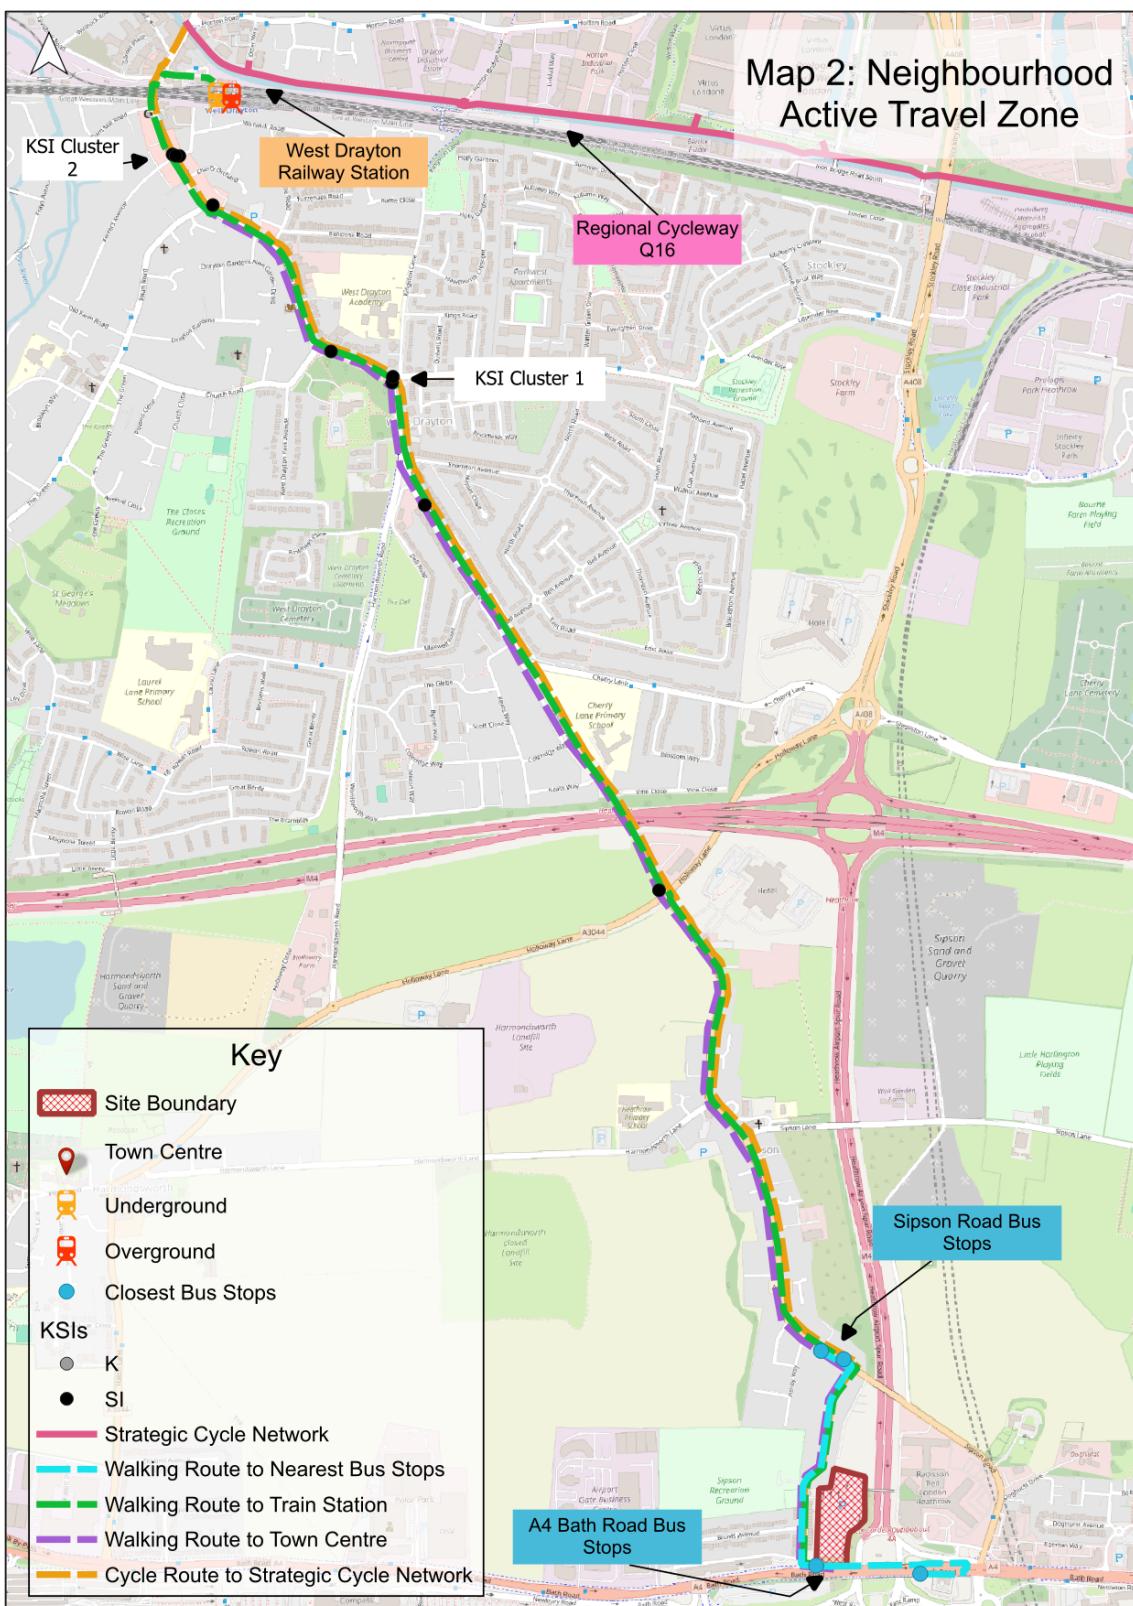
Figure 1.2: ATZ at Neighbourhood Scale with Vision Zero Analysis (KSI Clusters)

1.3 **Figure 1.2** presents the Neighbourhood Scale Active Travel Destinations.

1.4 As can be seen from **Figure 1.2**, the main desire lines from the site will be north towards the town centre and railway. To access the closest bus stops, pedestrians will head along desire lines both east and west from the site for a short distance.

| Location | Number of KSIs | Comments | Potential Improvements* |
|---|---|---|--|
| Cluster 1: Porters Way / Station Road Junction | 2 SI's | 1 pedestrian casualty, 1 motorcycle rider casualty. The incident involving the pedestrian occurred in darkness, with the car colliding with the pedestrian who was on a crossing or refuge. The motorcycle driver turned right across car drivers path. | The pedestrian refuge area could be widened. |
| Cluster 2: Station Road / Ferrers Avenue Junction | 3 SI's | 2 cyclist casualties, 1 car driver casualty. Once incident involved a car turning left across a cyclists path, another incident involved a vehicle colliding with another vehicle parked in the carriageway, with one incidents details unknown. | Consider an off-road cycle facility or enhanced cycle segregation for the on-road route. |

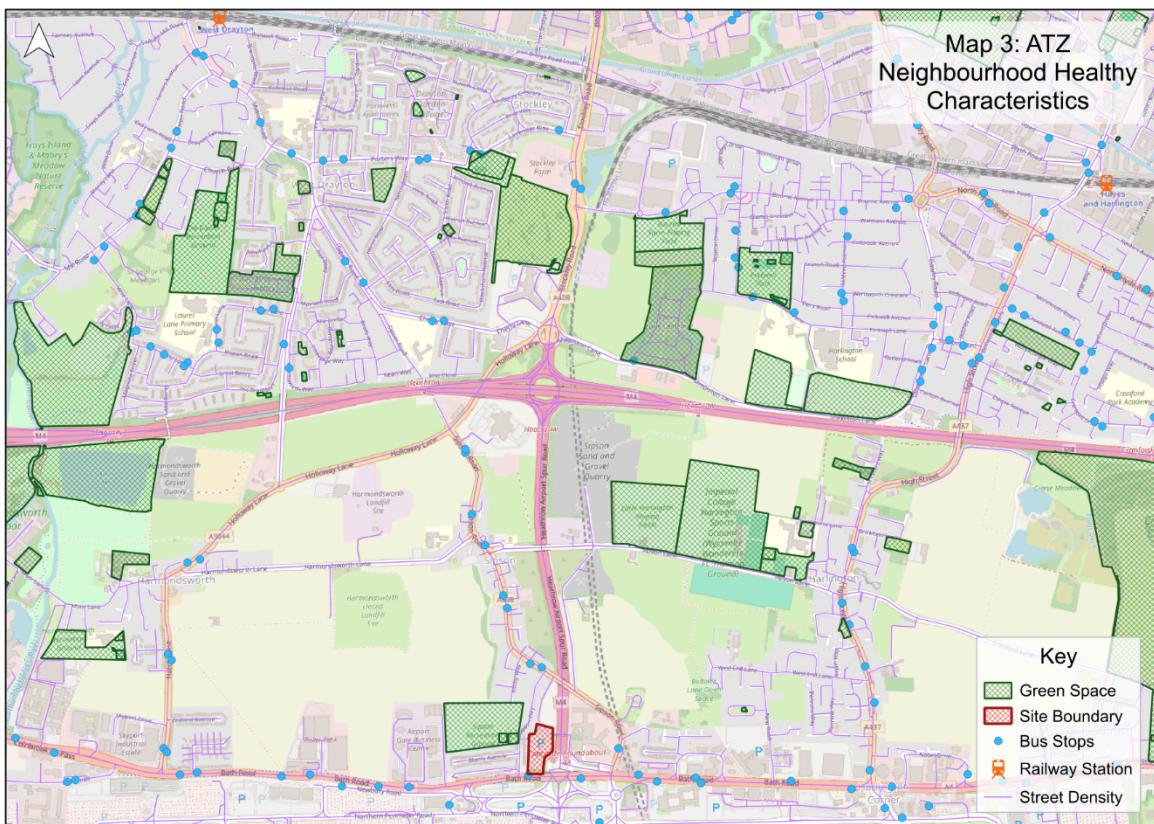
Figure 1.3: ATZ Neighbourhood Healthy Characteristics

1.7 **Figure 1.3** identifies the key characteristics of a typical healthy neighbourhood. This includes permeable streets, public transport and green spaces which are mapped alongside other development and transport improvements happening locally.

1.8 As can be seen from **Figure 1.3**, the site benefits from well-connected streets which shorten travel distances to key destinations, as well as excellent access to public transport stops and services. The site is also in close proximity to a large number of areas of green space.

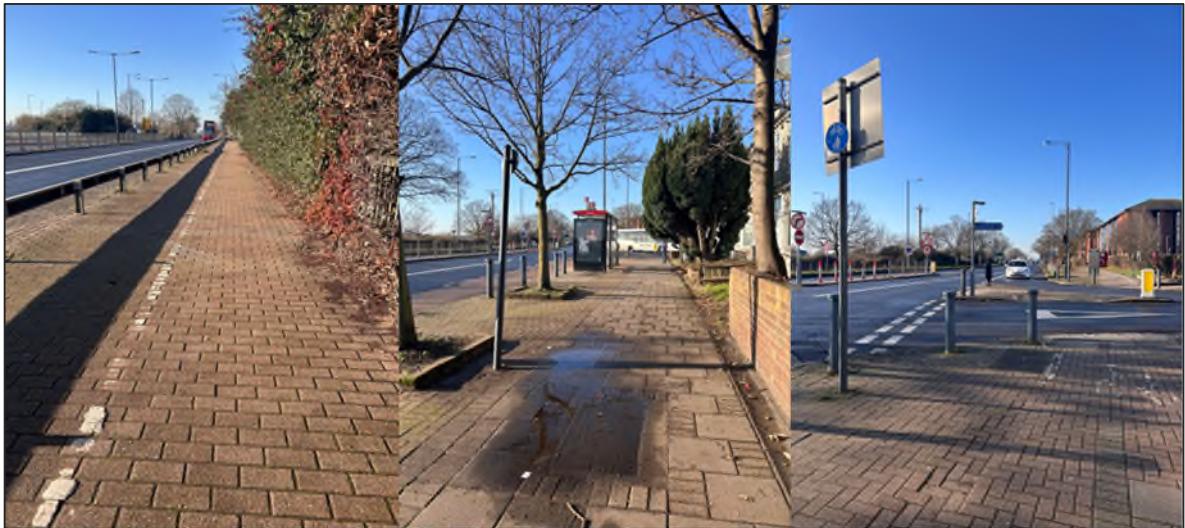
Figure 1.5: Photographs Along Route 1

1.15 **Figure 1.5** provides photos taken along the route to the nearest bus stops on the A4 Bath Road. **Table 1.3** assesses the route in light of the Healthy Streets Indicators:

| Healthy Streets Indicator/s Not Met | Observation/Why | Recommendation |
|--|--|---|
| Not too noisy | High volume of traffic paired with noise from the airport runways means people often have to raise their voice to hold a conversation. | An acoustic barrier could be considered, however the balance of this should be weighed up with the safety and visual effects of screening at this location. |
| Places to stop and rest | No places to rest other than within the bus stop itself | Provide additional bench |

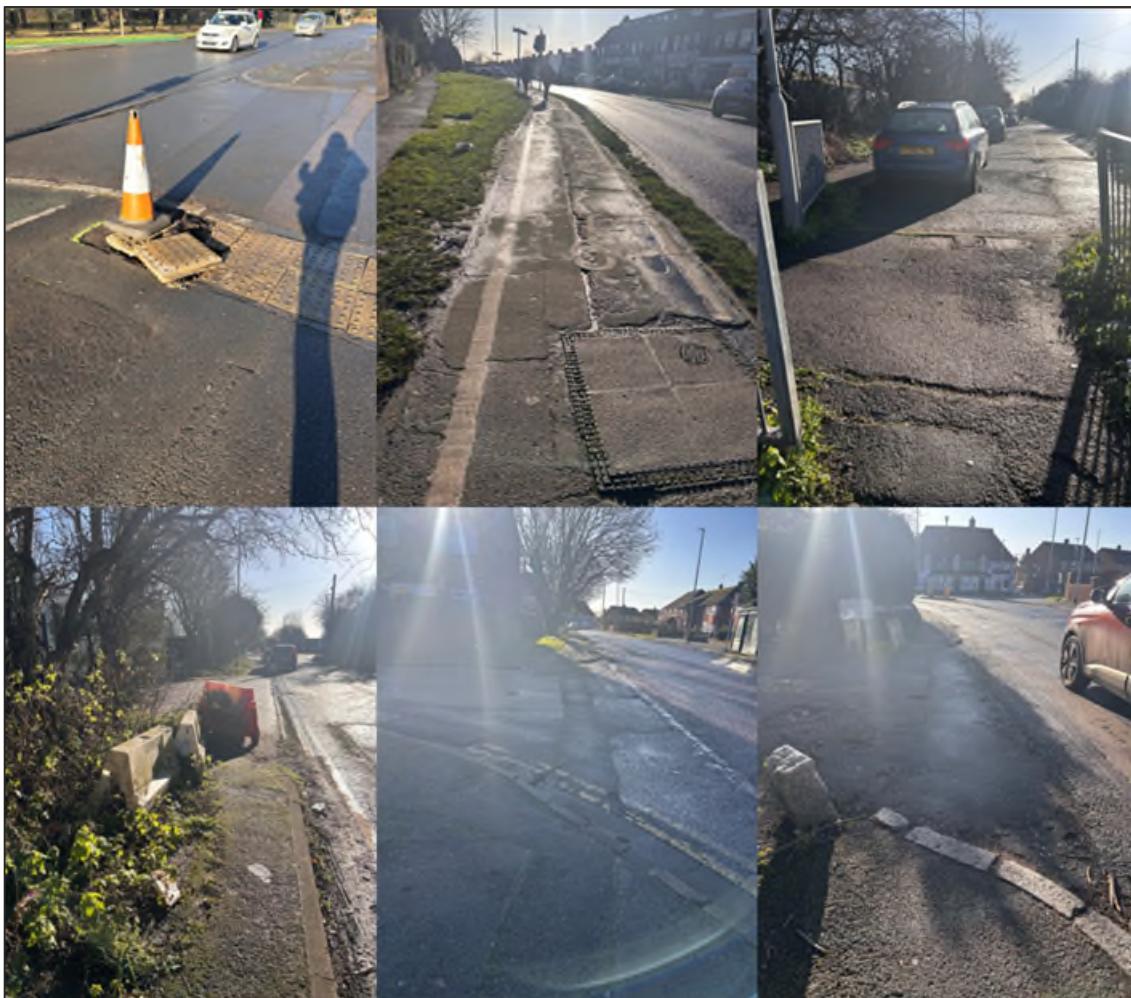
Figure 1.6: Photographs along Route 2

1.17 **Figure 1.6** provides photos taken along the route to West Drayton Town Centre. **Table 1.4** assesses the route in light of the Healthy Streets Indicators:

| Healthy Streets Indicator/s Not Met | Observation/Why | Recommendation |
|--|--|---|
| People feel relaxed | Rubbish / fly tipping present along the route, particularly in underpass and along eastern side of Sipson Road. Litter so bad, rats were spotted at Sipson Road side of underpass. | Ensure council are aware of rubbish collection issue, provide more public bins along Sipson Road and remove street clutter. |
| People feel safe | Cycle markings fading on Station Road. Cars parked on footway on Sipson Road making it difficult to walk on the footpaths and forcing pedestrians to walk in the carriageway. | Where possible, delineate the cycle route in a clearer manner. Enforce parking on-road rather than on footway. |
| Easy to cross | Missing tactile paving at a number of side road crossing points (see pedestrian route audit in TA). Also broken tactile paving at Station Road crossing, adjacent to Tesco. Footpath ends on Sipson Road adjacent to Raddison (if walking alternative route to site on Sipson Road rather than Sipson Way), with no dropped kerbs or tactile encouraging crossing to other side. | Install tactile paving/dropped kerbs where absent. |

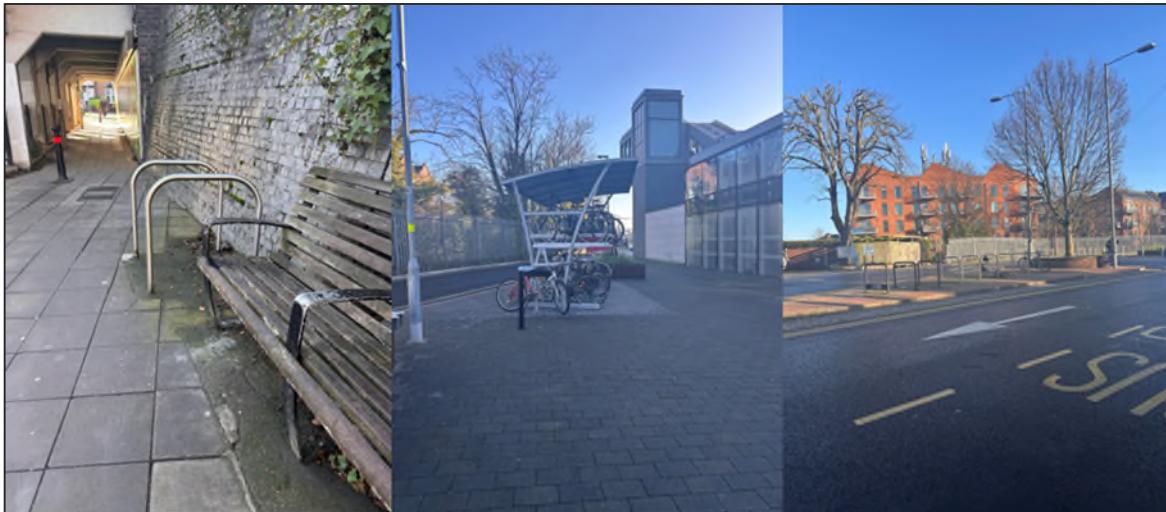
Figure 1.7: Photographs along Route 3

1.19 **Figure 1.7** provides photos taken along the route to the Railway Station from the Town Centre. **Table 1.5** assesses the route in light of the Healthy Streets Indicators:

| Healthy Streets Indicator/s Not Met | Observation/Why | Recommendation |
|--|--|--|
| People feel safe | Cyclists have to share Station Approach with vehicles. | Consider introduction of cycle box coming out of Station Approach. |

1.20 As detailed within the Transport Assessment, the crossings along this route are in good condition and are well lit. It is noted that cycle storage is provided at the railway station, which appears to be well used.

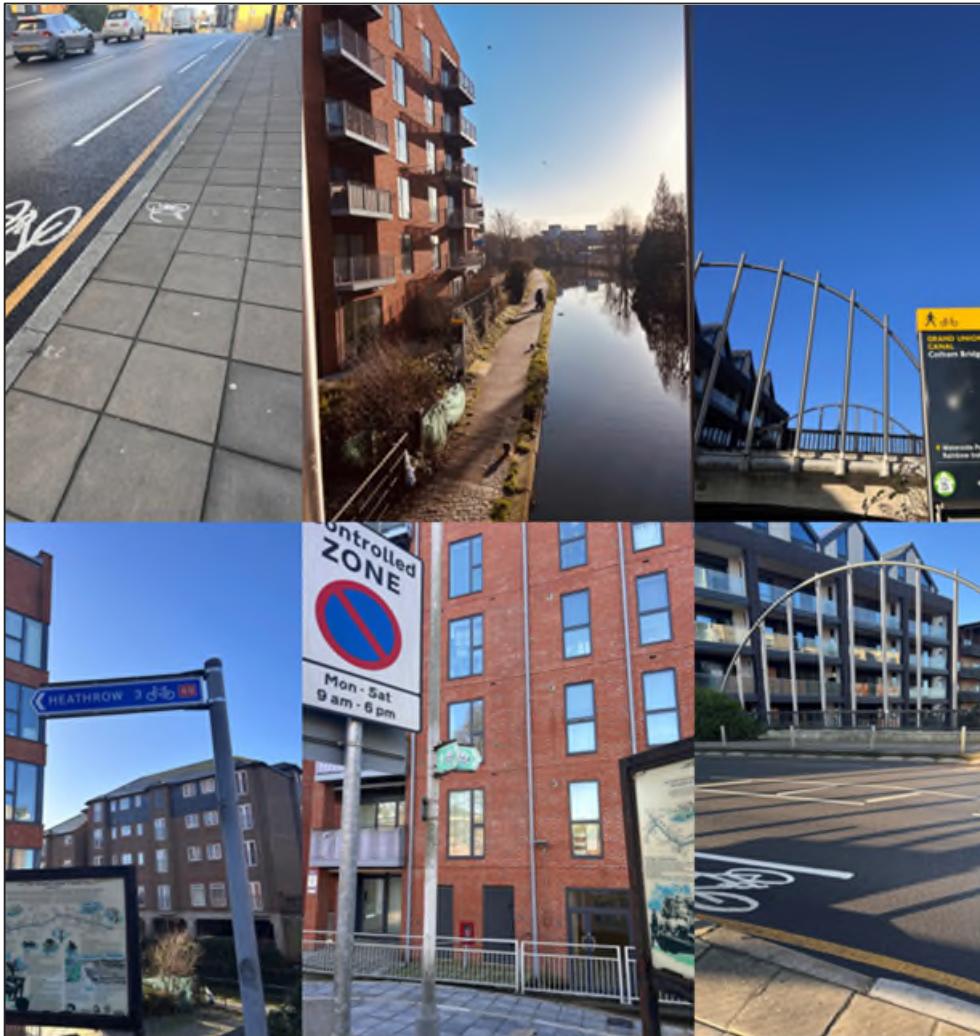
Figure 1.8: Photographs along Route 4

1.21 **Figure 1.8** provides photos taken along the route to the Regional Highway Network from the Railway Station, and the point of entry to the Regional Highway Network from this location. **Table 1.6** assesses the route in light of the Healthy Streets Indicators:

| Healthy Streets Indicator/s Not Met | Observation/Why | Recommendation |
|--|--|---|
| People feel safe | People walking and cycling expected to share the same space once on the Grand Union canal. | Segregation of cycle and pedestrian traffic where space allows. |
| Places to stop and rest | No cycle parking at this entry point to route | Consider adding in some Sheffield Stands |

1.22 This is a well signposted route with high quality markings in the majority.

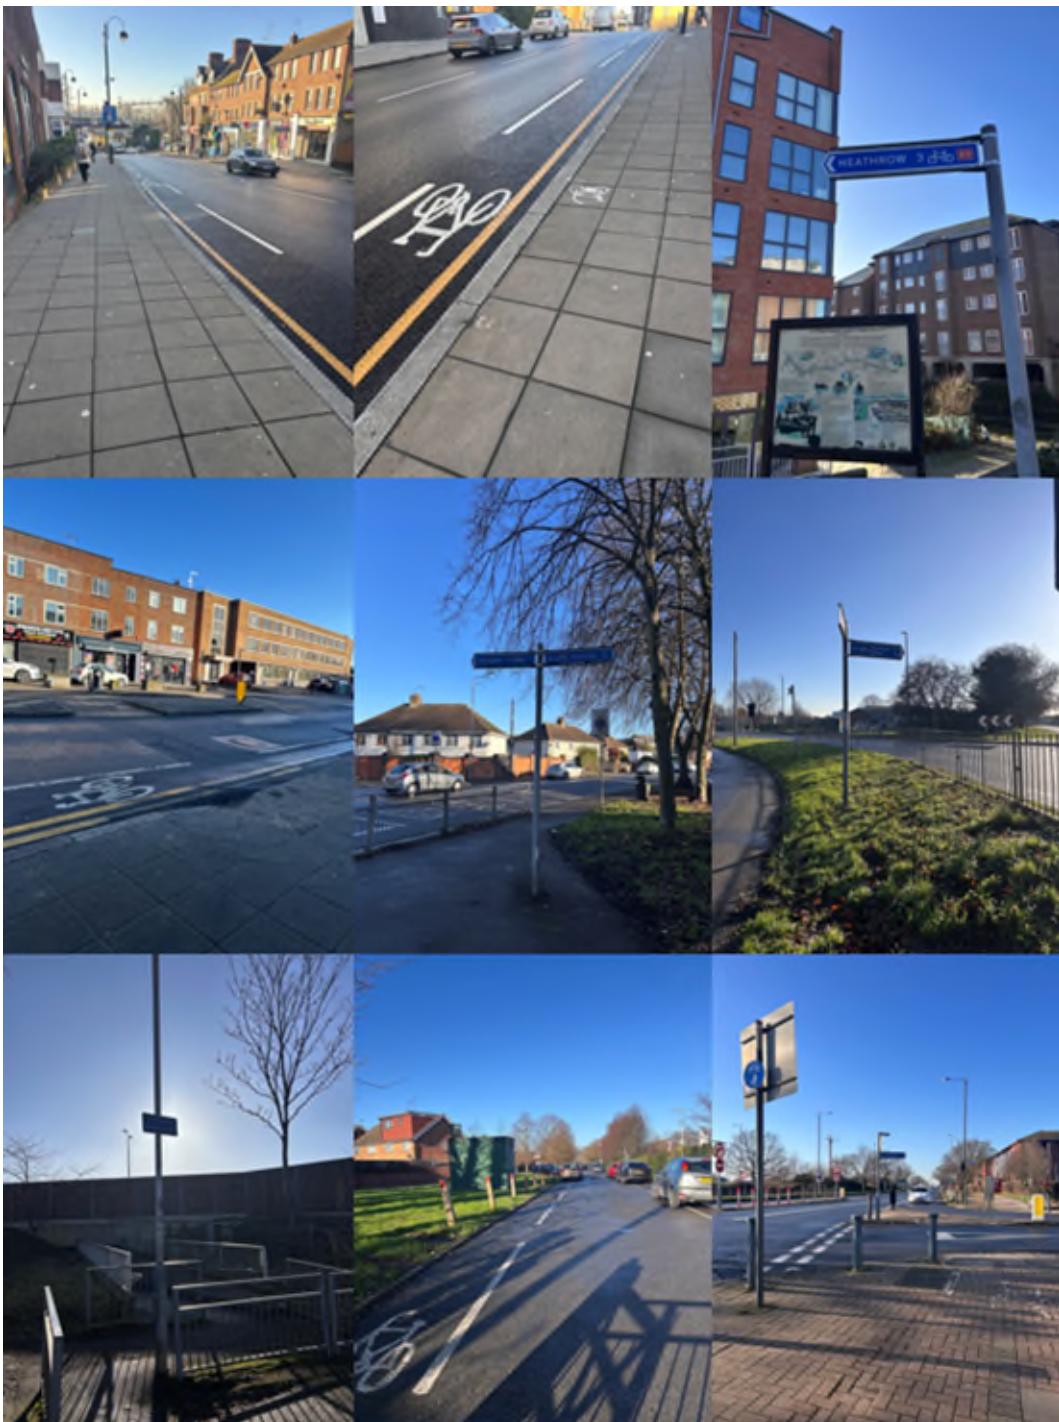
Figure 1.9: Cycle Facilities Between the Site and Regional Cycle Network

1.24 While Tables 1.3-1.6 identify potential improvements to cycle facilities, it should be noted that from the site to the regional cycle network, there is a fairly comprehensive local cycle route which is formed by both on-road and off-road facilities. **Figure 1.9** illustrates these provisions for reference. The cycle network is accessed from adjacent to the site on Bath Road.
