Site Investigation Report

102230.5.BSI

Auger were commissioned by Sedgwick International UK to undertake a site investigation within the area of concern at the property.

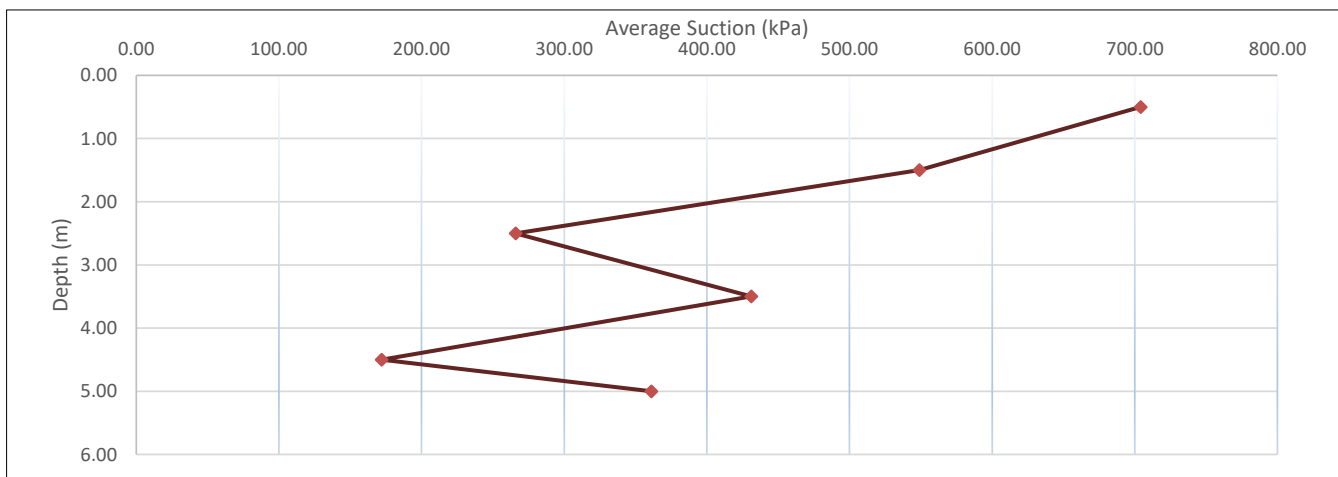
TH Trial Hole	Depth (m)	Filter Paper Location	Filter Paper	Sample Prep Method	Test Duration (Days)	Water Content (%)	Soil Suction Pk (kPa)	Average Soil Suction Pk (kPa)	Cumulative Heave Potential (mm) from bottom of the hole
TH1	0.50	Top	I	D	5	31.2	796	704	20
TH1		Middle	II	D	5	32.1	693		
TH1		Bottom	III	D	5	32.9	624		
TH1	1.00								
TH1									
TH1									
TH1	1.50	Top	I	D	5	35.4	435	549	20
TH1		Middle	II	D	5	34.6	485		
TH1		Bottom	III	D	5	31.8	727		
TH1	2.00								
TH1									
TH1									
TH1	2.50	Top	I	D	5	38.9	263	266	11
TH1		Middle	II	D	5	40.2	218		
TH1		Bottom	III	D	5	37.6	317		
TH1	3.00								
TH1									
TH1									
TH1	3.50	Top	I	D	5	33.2	598	431	8
TH1		Middle	II	D	5	33.8	544		
TH1		Bottom	III	D	5	42.8	150

Heave potential is calculated from the bottom of the hole and heaves above the bottom of the hole are reported as a cumulative value.

The values reported for heave above only apply to the strata the suction and plasticity have been performed on. The shallowest depth reported is assumed to be a strata thickness to GL and Heave is calculated based on that layer thickness, if the next sample is in 0.5m increments the heave is calculated based on the layer thickness of 0.5m and depths 1m from the sample above will include heave over 1m.
