# The Greenway Sewer Diversion – Ecology Report

May 2021

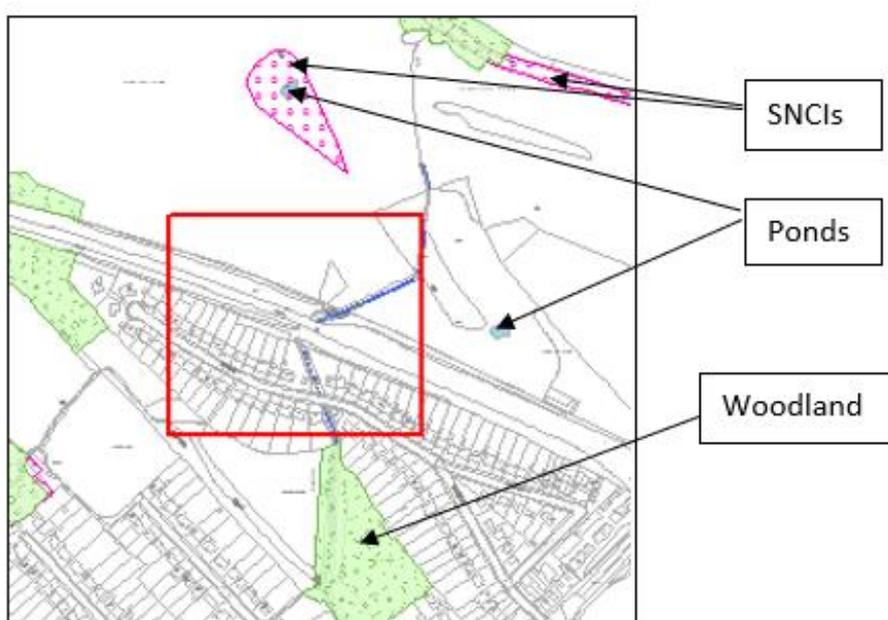
Figure 1 - ArcGIS Ecology Designations

There are no statutory designations located within 500m of the proposed works. However, the proposed scheme type falls within a relevant Site of Special Scientific Interest (SSSI) Impact Risk Zone (IRZ). The nearby SSSIs are Ruislip Woods SSSI 1.5km northeast at the closest point and Denham Lock SSSI 1.9km west. However, no impacts are foreseen on these designated sites due to the intervening distance and absence of hydrological pathways for effects between these and the site.

Non-statutory designations are located within 500m of the proposed works. West Ruislip Golf Course and Old Priors Meadows Site of Nature Conservation Interest (SNCI) and Site of Borough Importance Grade I (SBI.I) are located adjacent to (approx. <25m east of the haul road leading up to Compound 1 and 25m north of Compound 1). There are no pathways for effects upon designated sites with embedded best practice methods of construction; however, temporary dewatering pipes will need to be laid across a designated site in the northern site in order to discharge to the River Pinn (main river).

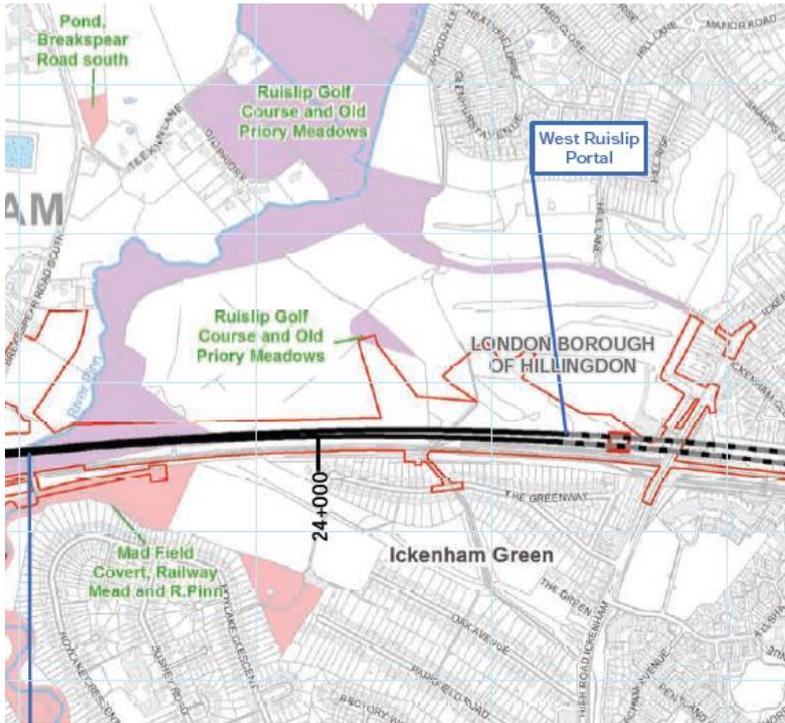
Figure 2 - HS2 Designated Sites Plan

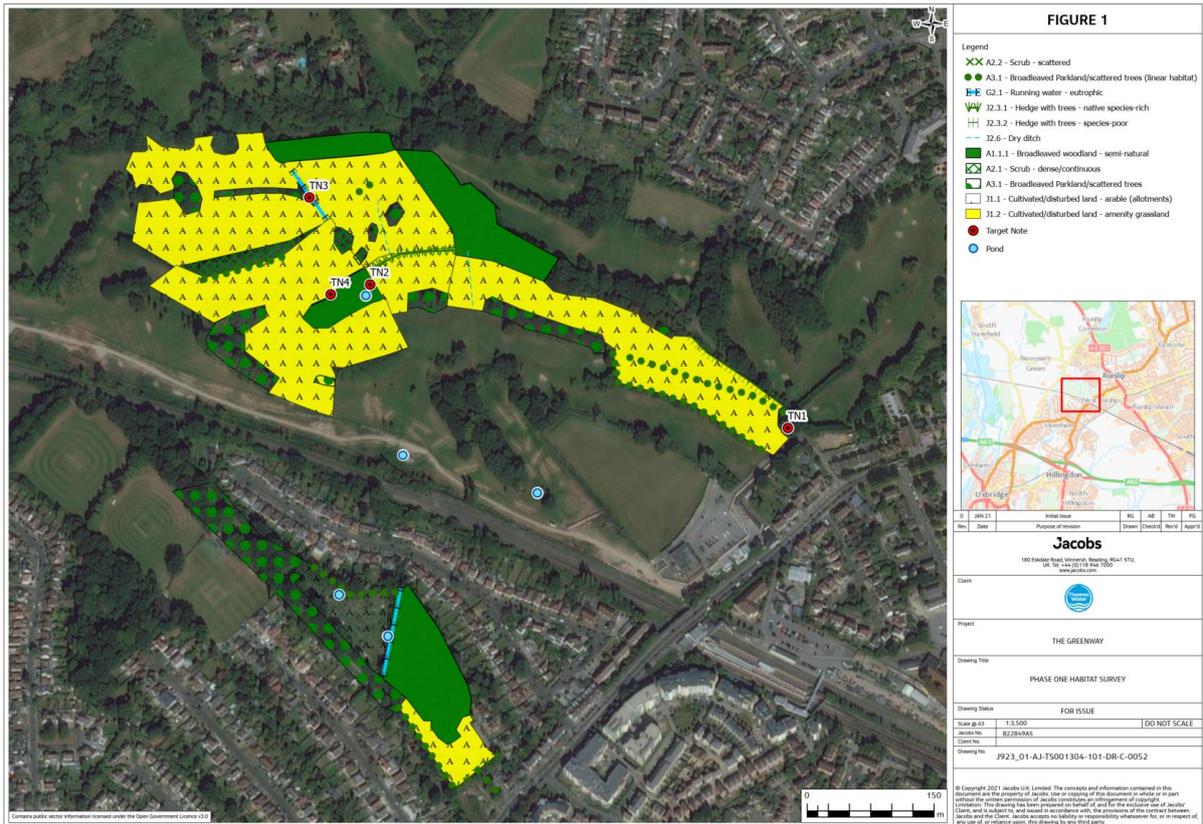
Figure 3 - Phase 1 Habitat Survey Map (Jan 2021)

The **Phase 1 Habitat Survey Maps** are shown overleaf.

Himalayan balsam *Impatiens glandulifera* was recorded along a number of water courses that bisect the golf course during the previous survey (see the Phase 1 Habitat Survey Map for confirmed locations). However, the species was not recorded within the footprint of the scheme at the time of survey. No other invasive species were recorded across the scheme (including the allotment and woodland south of the railway corridor during the survey).

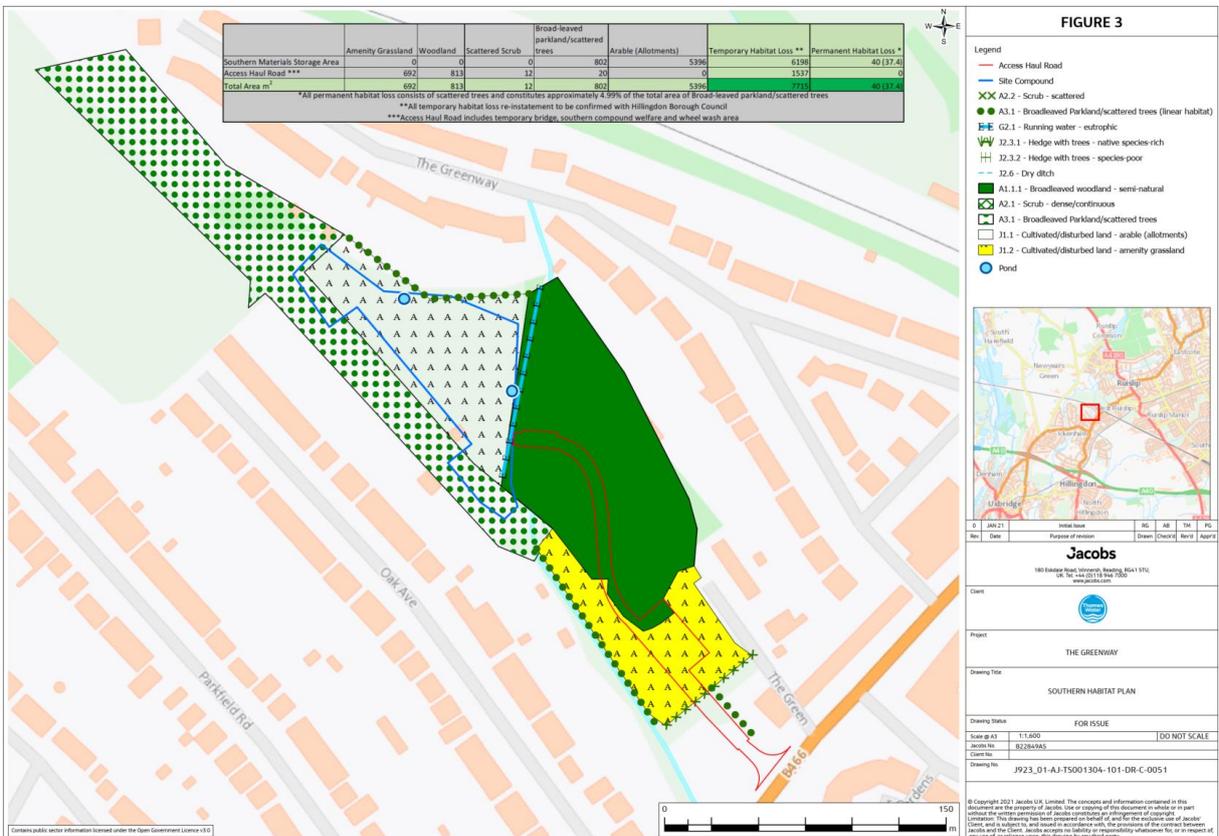
Figure 4 - Phase 1 Habitat Survey Map – Southern Section - allotments and woodland including ponds (Jan 2021) – note that the site compound boundary shown is now superseded (see drawing J923\_01-AJ-TS001304-101-DR-C-0030)

The area to the south of the railway line is characterised by the allotment gardens and deciduous woodland (priority habitat). Both of these will be directly impacted by the proposed works. A nearby playing field/amenity grass area is to be required for a site compound.

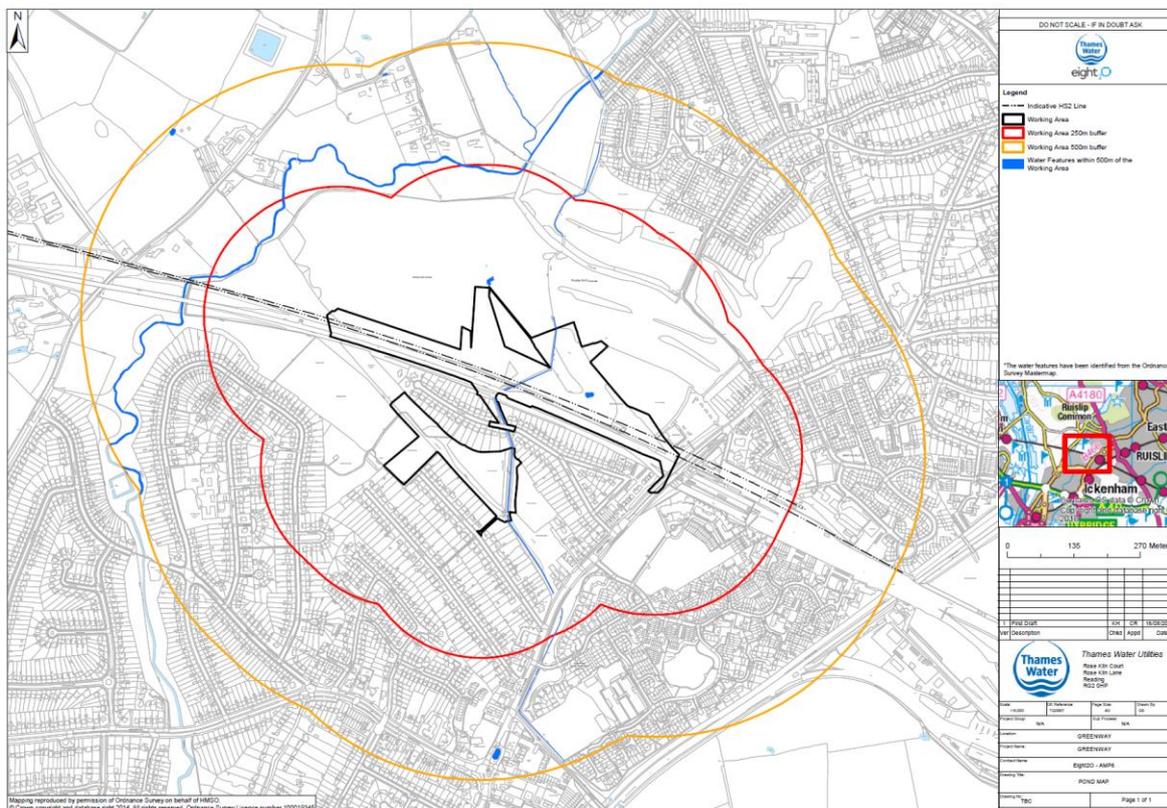
Figure 5 - Pond Map ArcGIS

Four ponds are located within to the north of the railway corridor (Ruislip Golf Course) approx. 25m, 45m, 90m, and 375m from the proposed works. To the south of the railway corridor, two ponds were also identified within the allotments during the ecology survey by the SMB ecologist (on behalf of Thames Water).

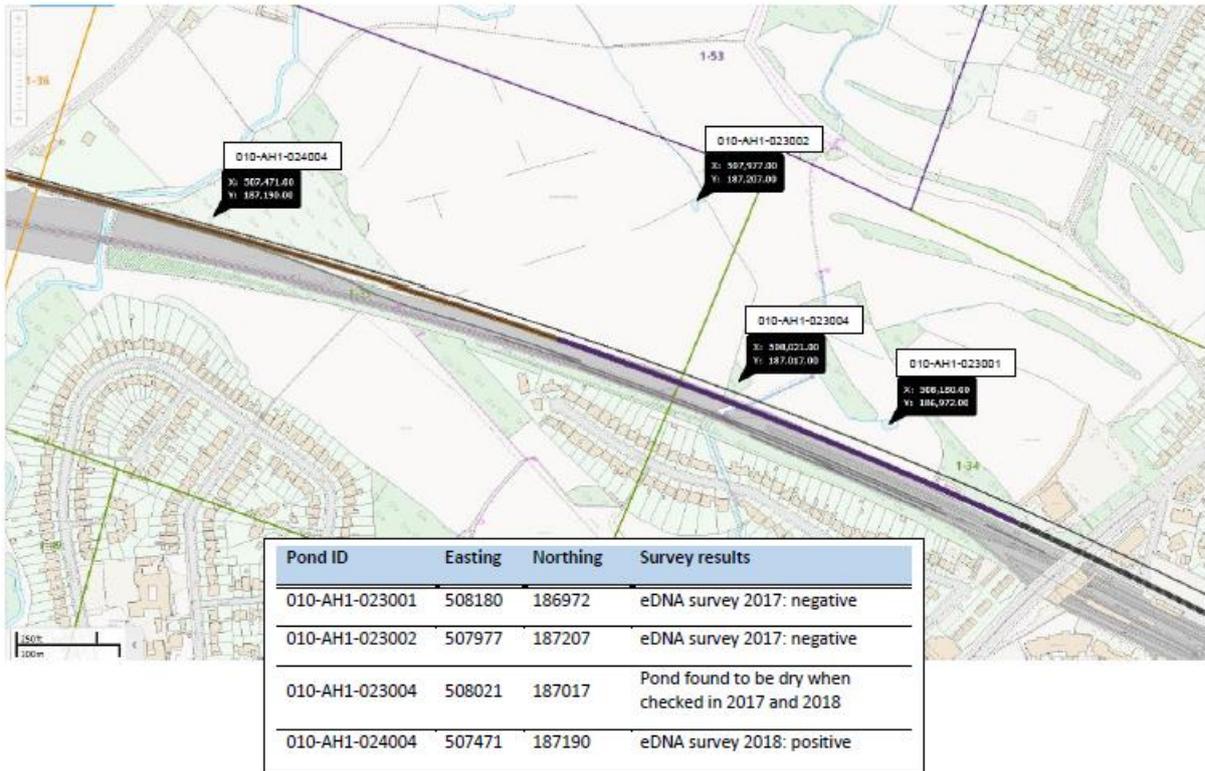
Figure 6 - CSjv GCN Survey Results 2017 - 2018

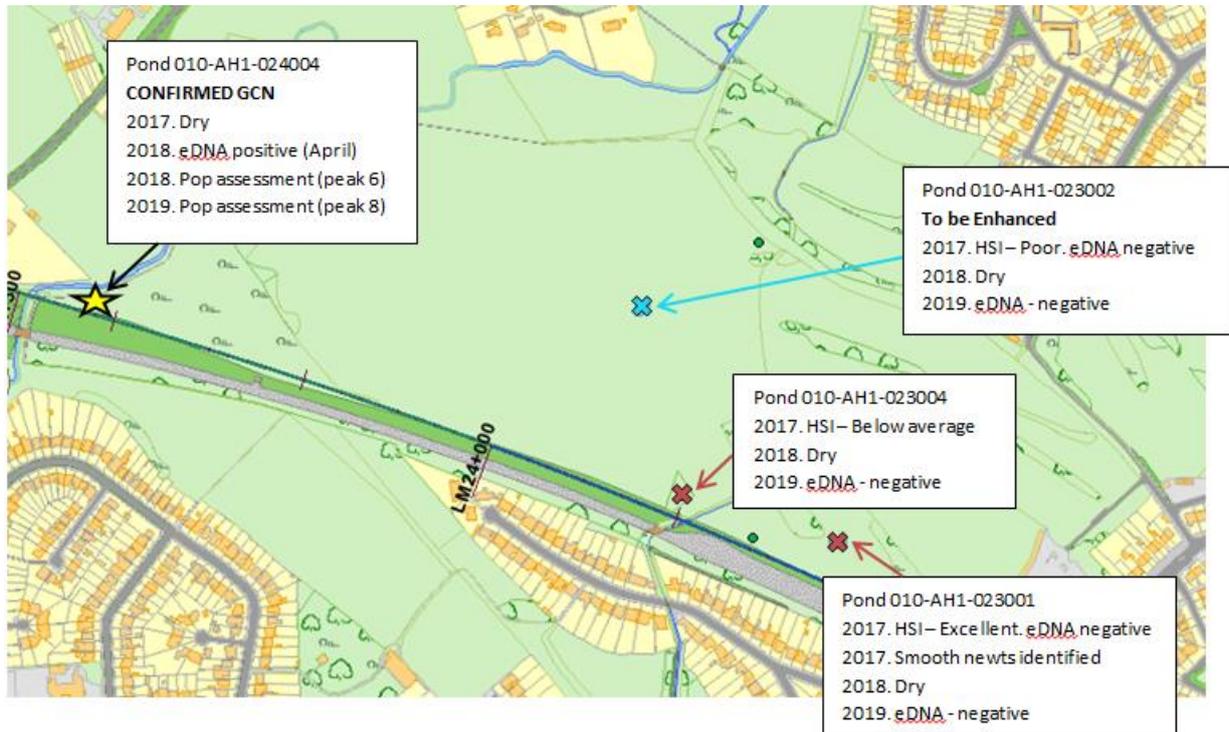
Figure 7 - CSjv GCN Survey Results 2017 – 2019

- A manhole / shaft is required just to the north of the railway line. This falls just outside the 500m buffer zone of the pond supporting a population of GCN identified by HS2 to the west of the golf course. However, during the drain down of this pond for CSjv and SCS enabling works, 94 GCN were identified and translocated to an enhanced pond

within the Ruislip Golf Course (Feb/March 2020). This enhanced pond is 45m from the haul road, 60m from site Compound 1, 100m from Compound 2 and 45m from the working areas. Appropriate mitigation is to be agreed with HS2, CSjv and SCS for the Thames Water main works. GCN are protected under the Conservation of Habitats and Species Regulations (2017) as amended and under WCA (1981).

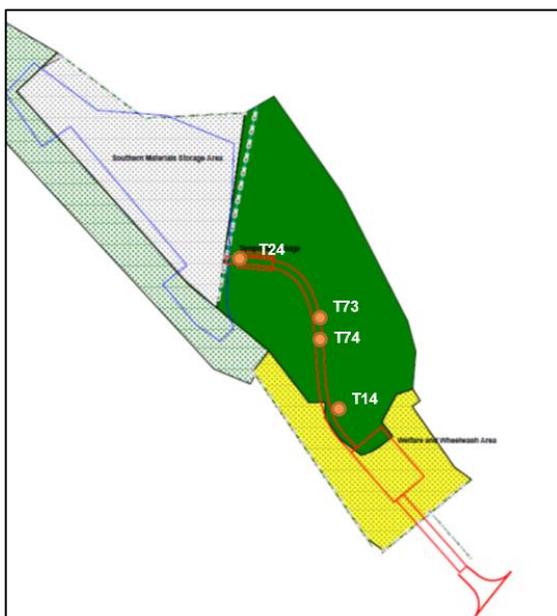
Figure 8 - Location of trees with moderate bat roost potential in the woodland to south-east of allotments. Note that the site compound boundary shown is now superseded (see drawing J923\_01-AJ-TS001304-101-DR-C-0030)

- Four trees within the woodland to the south-east of the allotments through which the access road will be constructed:
  - A mature English oak adjacent to the allotment fence with heavy ivy cover, and a fallen limb which suggests there may be concealed potential roost features (PRFs) within the upper canopy of the tree. The tree was provisionally assigned as having moderate bat roost potential as a precaution (subject to a climbing inspection and potential emergence / re-entry surveys).

- A mature Willow *Salix* sp tree is present within the woodland; at least two woodpecker holes were visible from the footpath, further PRFs may be present.

- A mature Willow sp tree is present within the woodland; no features could be seen from the footpath, however, only the west aspect could be viewed.

- A mature English oak to the south east of the woodland with heavy ivy cover creating PRFs and potentially concealing others.
- Some of the trees within the woodland area to the south-east of the allotments could not be accessed due to dense scrub and therefore there may be a requirement for more trees to be surveyed unless impact to them can be avoided.
