**152-154 UXBRIDGE ROAD  
HAYES (UB4 0JH)**  
**DRAINAGE TECHNICAL NOTE**

## **Purpose**

This Technical note has been prepared to discharge planning condition 19 as stated on Hillingdon Application Report, (ref. 4482/APP/2022/213), recreated as follows;

# 152-154 Uxbridge Road, Hayes, UB4 0JH

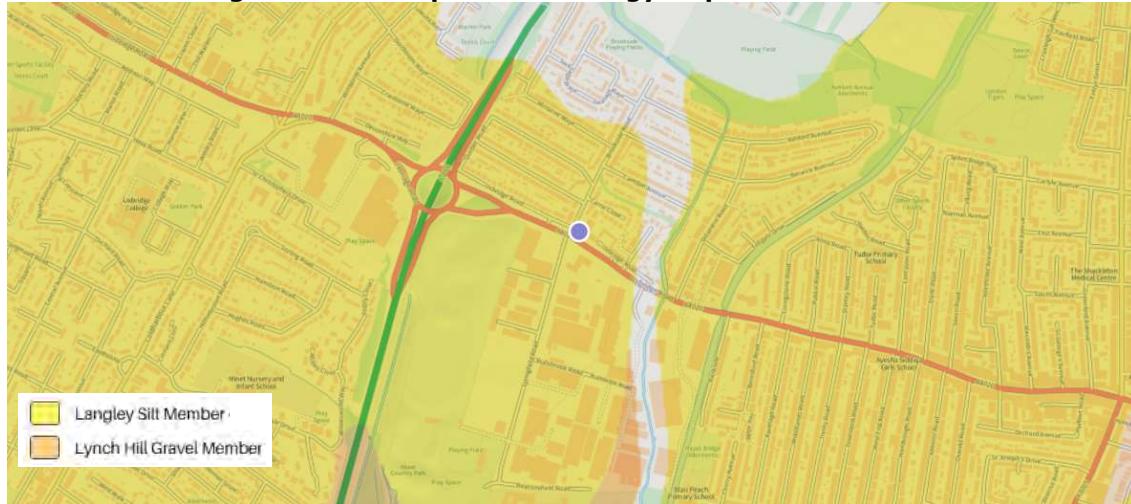
**Figure 3: BGS Superficial Geology Map at Site Location**

According to the published geology, based on the British Geological Survey (BGS) map 1:50,000 geological map series, the site is underlain by the Langley Silt Member superficial deposits, as seen in Figure 3. The BGS describes the Langley Silt Member as silt to clay,

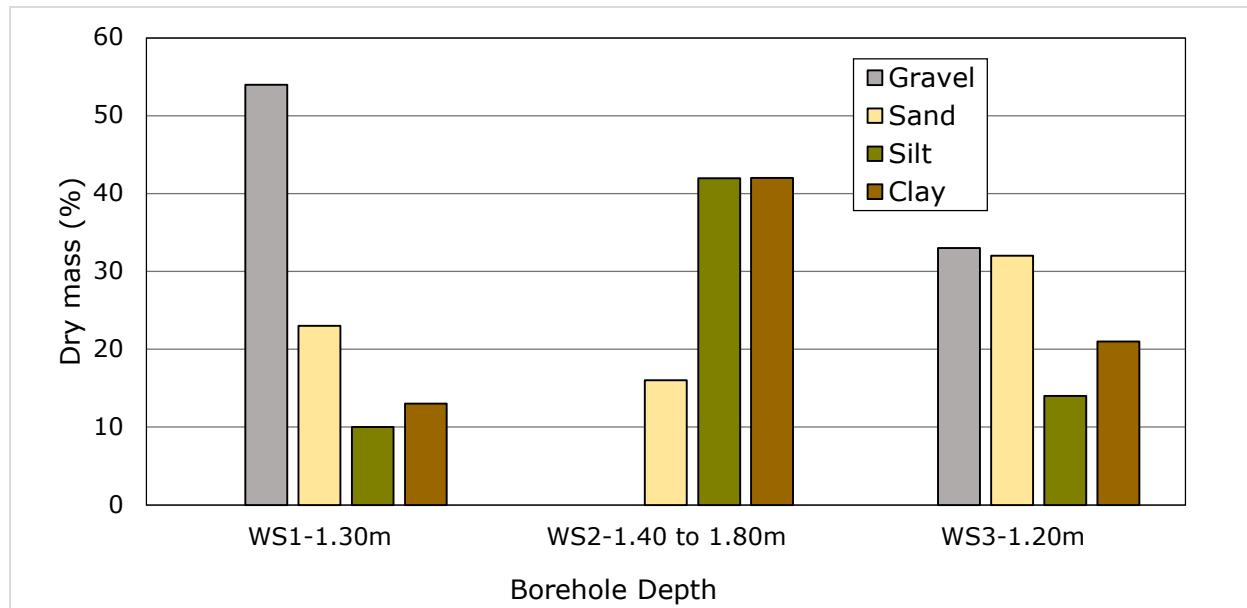
**Figure 5: Particle size distribution of the Langley Silt Member**

The sample from WS2 is the most indicative of the general composition of this stratum. It is expected that the high proportion of sand and gravel in the sample from WS1 is due to the sample being within a transition layer with the River Terrace Deposits, and the sample from WS3 appears to include a lens of sand and gravel at the sampled location.

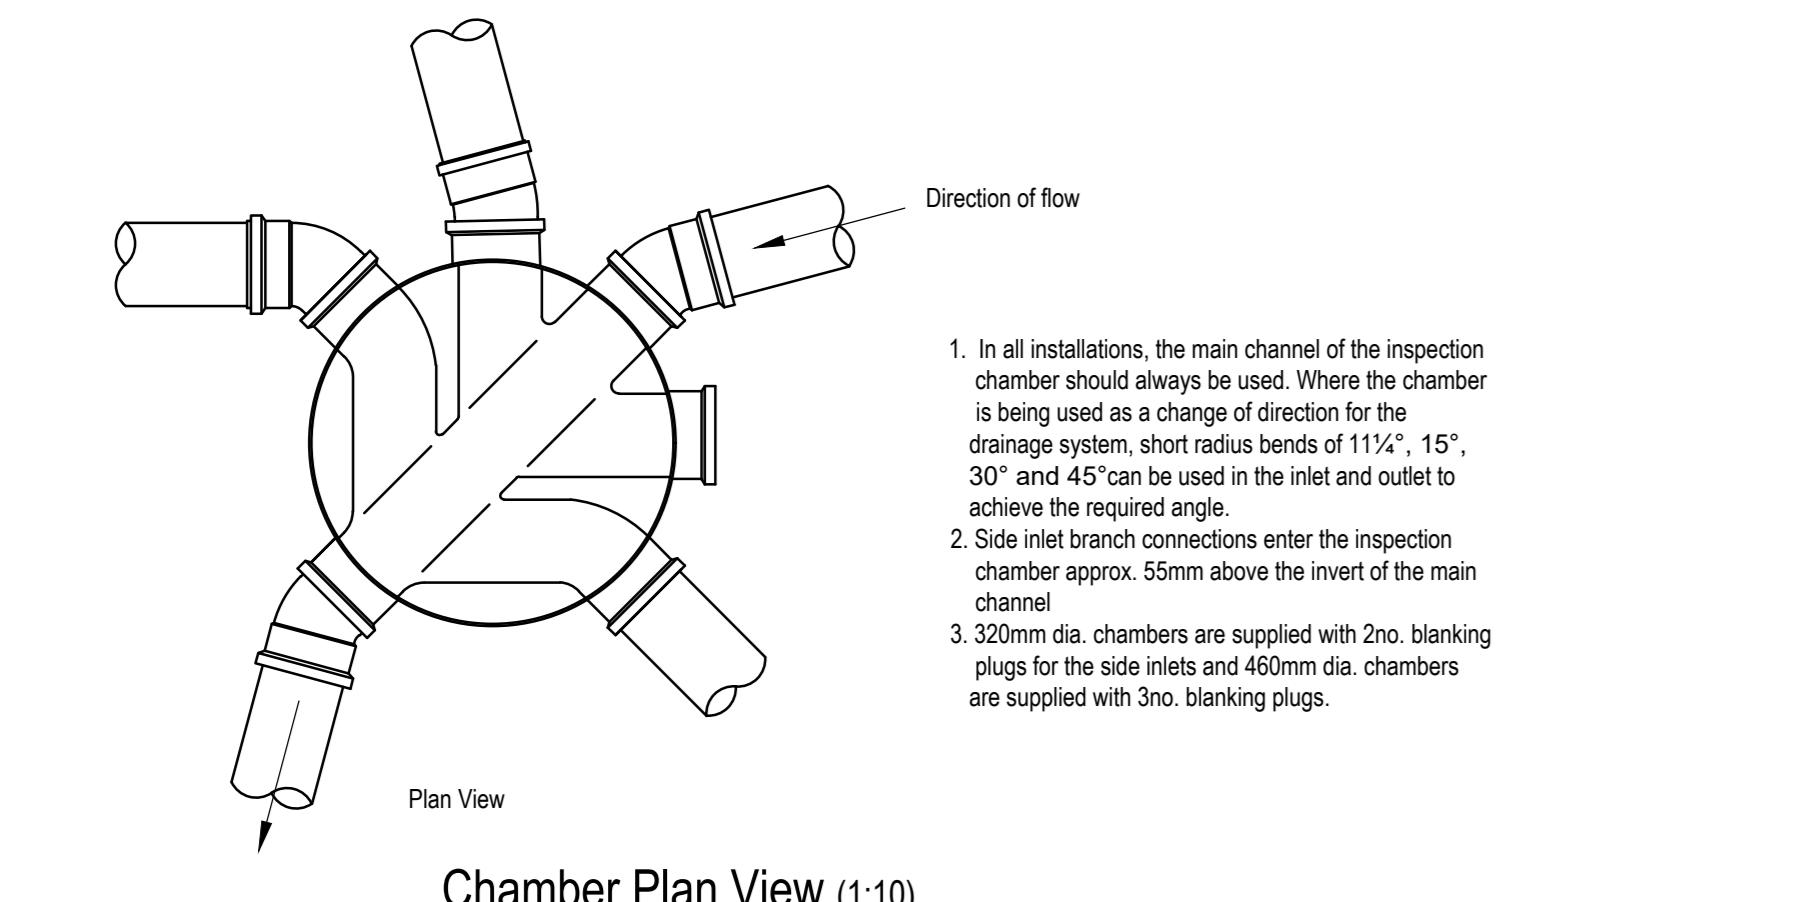
Typical Hepworth PPIC Manhole Detail (1:1)
