152-154 Uxbridge Road, Hayes, UB4 0JH

Ground Investigation Interpretative Report

Report No: 2024-065-PRE-UXB_REP001_REV03

Date: 13/08/2025

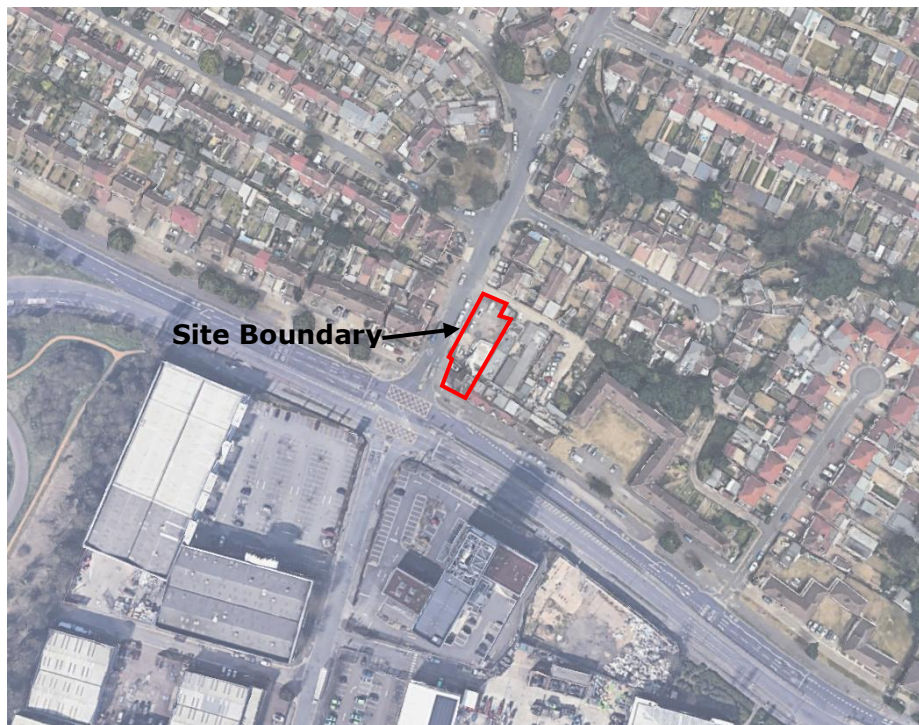
Figure 2: Site Location

Location	The existing site is approximately 0.17 acres in plan and is shown (outlined in red) in Figure 2. The approximate British National Grid coordinates for the main building is Easting 511419 Northing 180817.
Full Address	152-154 Uxbridge Road, Hayes, London, UB4 0JH
Development Proposals	<p>The proposed redevelopment involves the construction of a three-story mixed-use building comprising retail space and nine residential apartments, along with ancillary parking, modifications to dropped kerbs, and provisions for refuse and bicycle storage.</p> <p>The development will feature two structures positioned to the north and south, with a car parking area situated between them.</p>

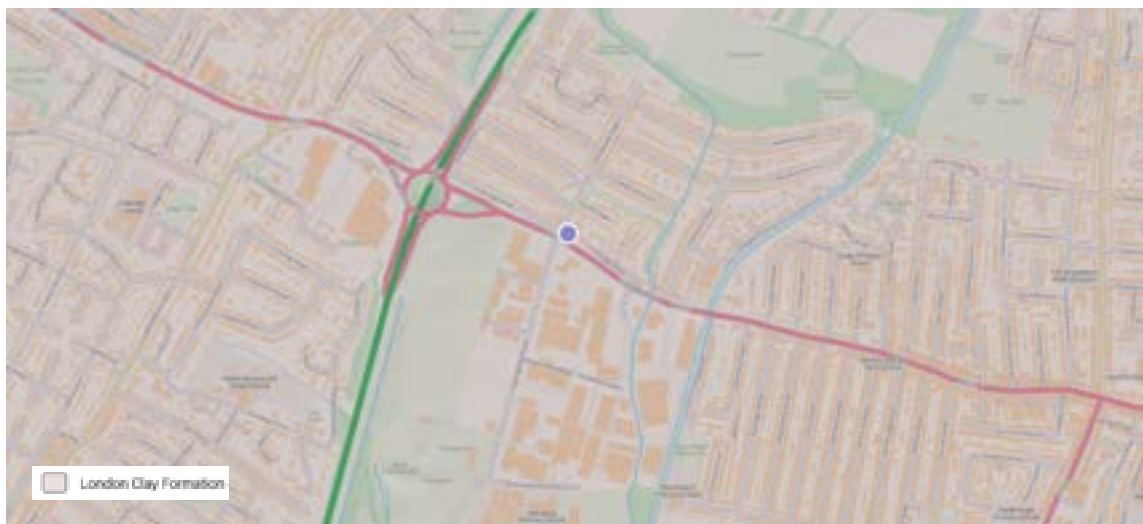
Figure 4: BGS Bedrock Geology Map at Site Location

commonly yellow-brown and massively bedded. There are localised areas of Lynch Hill Gravel Members shown to the south of the site, but well outside the site boundary. The bedrock geology is from the London Clay Formation, as shown in Figure 4. The BGS describes the London Clay Formation bioturbated or poorly laminated, blue-grey or grey-brown, slightly calcareous, silty to very silty clay, clayey silt and sometimes silt, with some layers of sandy clay.

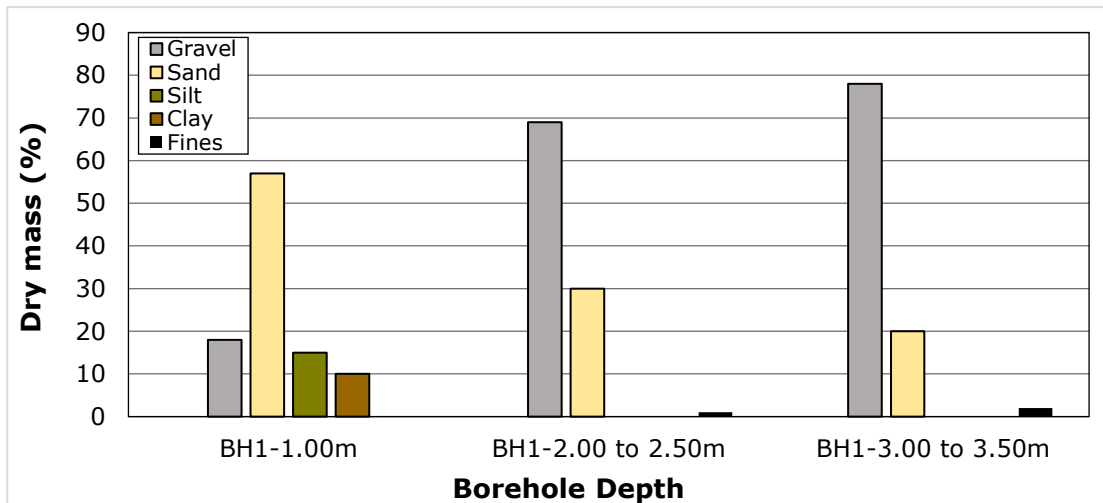
Figure 6: Particle size distribution overview of River Terrace Deposits samples

It is noted that to progress through the dense River Terrace Deposits water was added to the borehole, which may have washed out some of the fines from the River Terrace Deposits, leading to a lower fines content in the sampled material than may be present in the in-situ material.

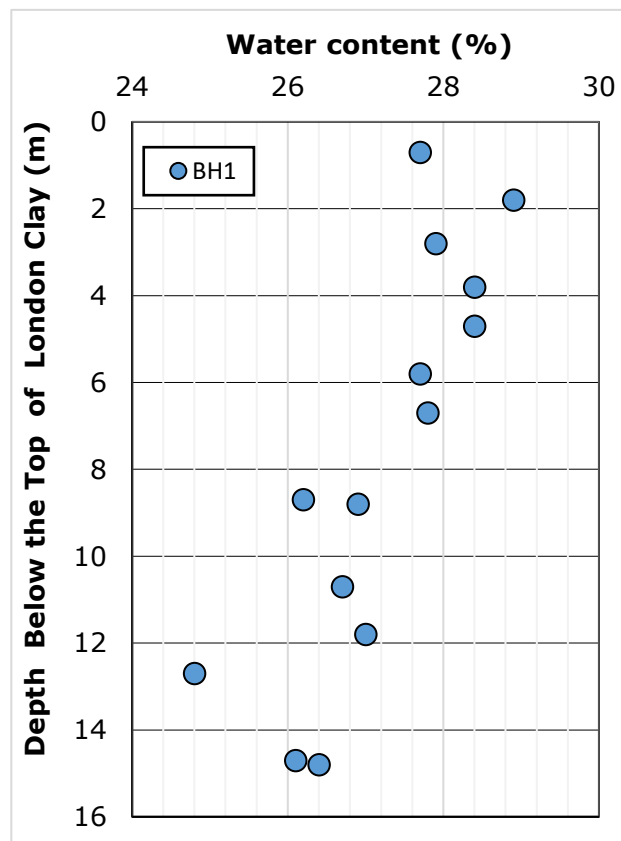
Figure 8. Moisture content against depth plot for London Clay

A total of 14No. natural moisture content tests were conducted on selected samples from depths of 4.9 m to 26.4 m bgl. The results indicate that the moisture content of the London Clay Formation across these depths is between 25 to 29%. The distribution of water content with depth is illustrated in Figure 8.

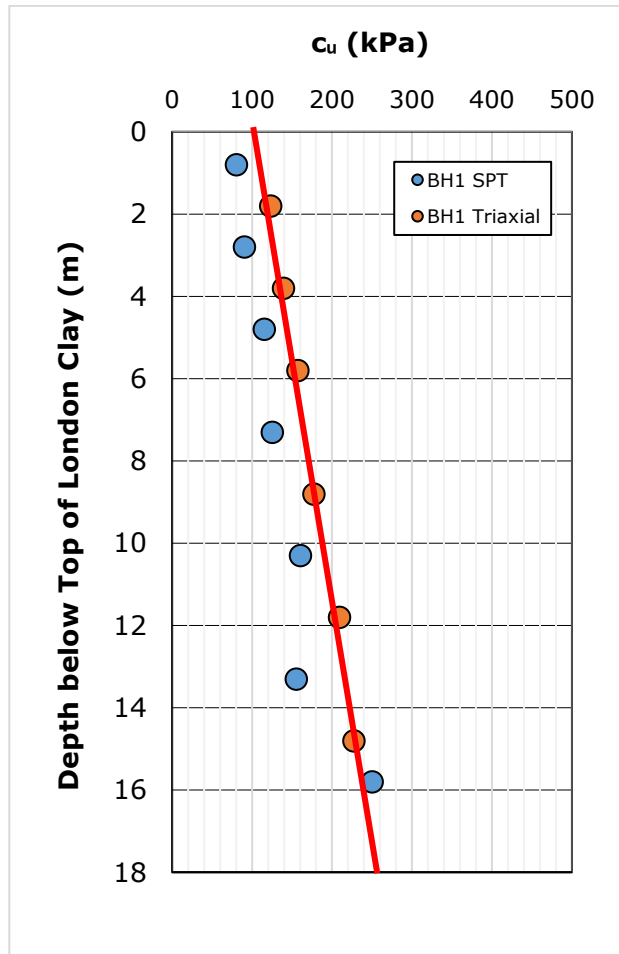
Figure 9: Undrained Shear Strength vs Depth of London Clay

Standard Penetration Testing (SPT) was carried out and the uncorrected SPT 'N' Values were recorded on the exploratory hole records. The data shows results ranging from 16 to 50 blows and a general trend of increasing N-value with depth. Shear strengths were derived from the SPT 'N' using the empirical formula $c_u = 5N$ (Stroud and Butler and CIRIA R143). The results from the triaxial testing and undrained shear strengths derived from the SPTs are plotted in Figure 9. Based on the SPT and triaxial results, the material description and moisture content, the following undrained shear strength vs depth relationship has been adopted:

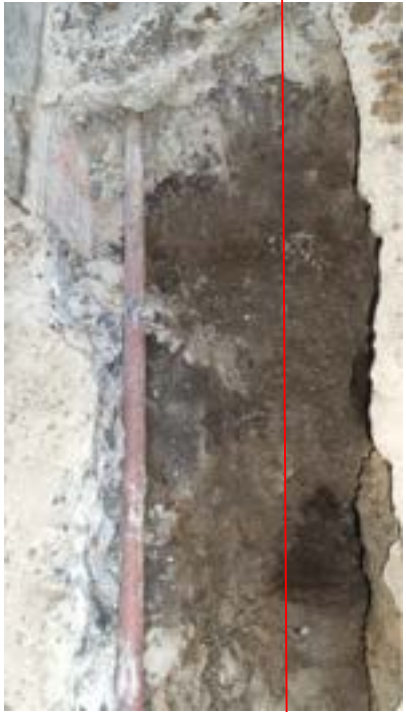
Section A - A'

Plan view

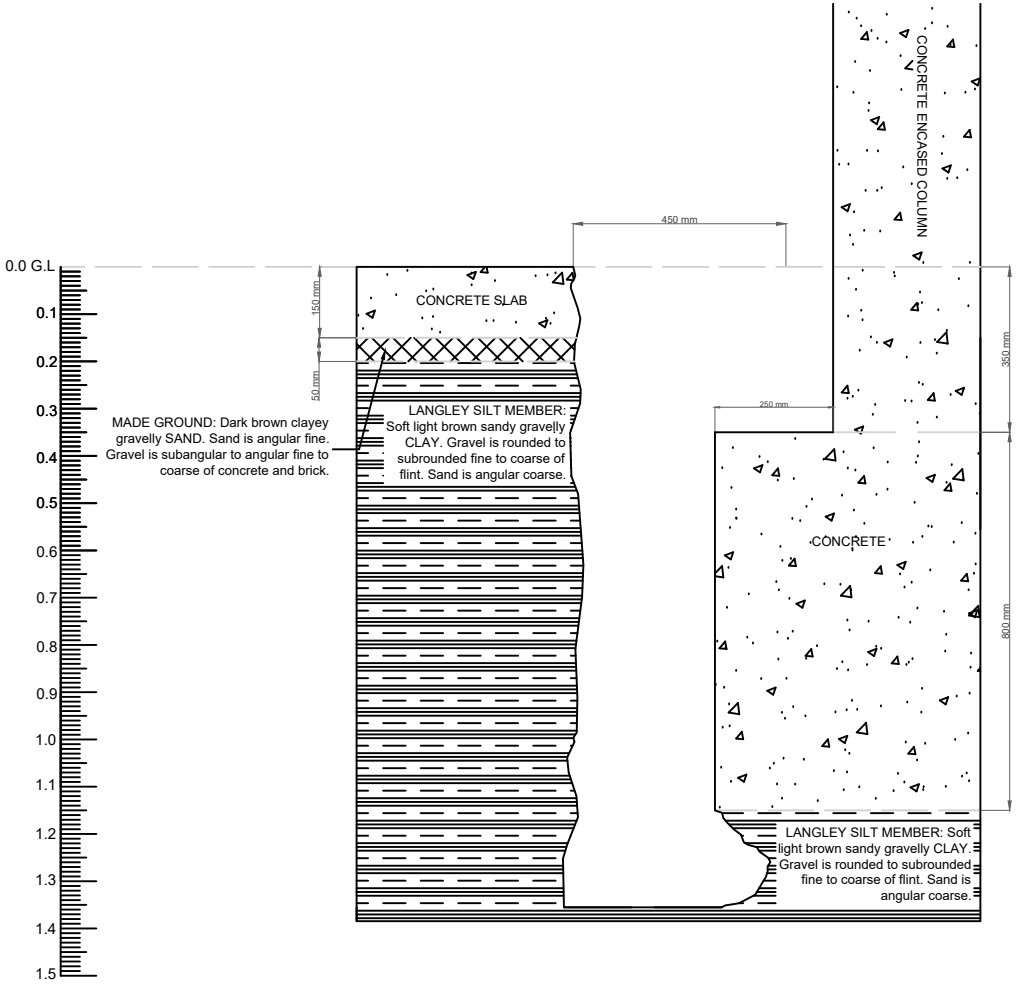
Excavation Method Hand Excavated Trial Pit	Dimensions 0.45 m x 0.60 m
	Location

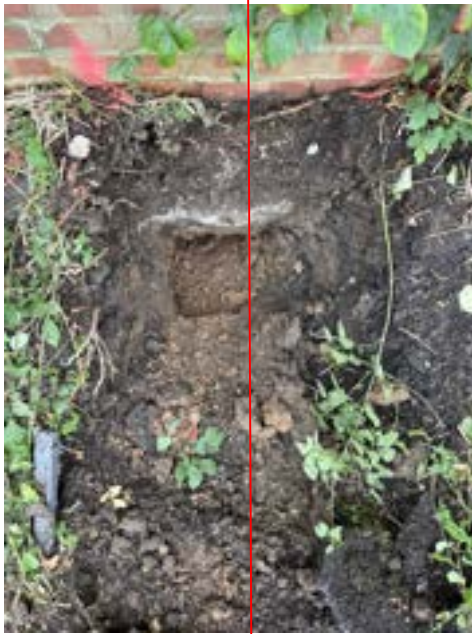
Section B - B'

Plan view

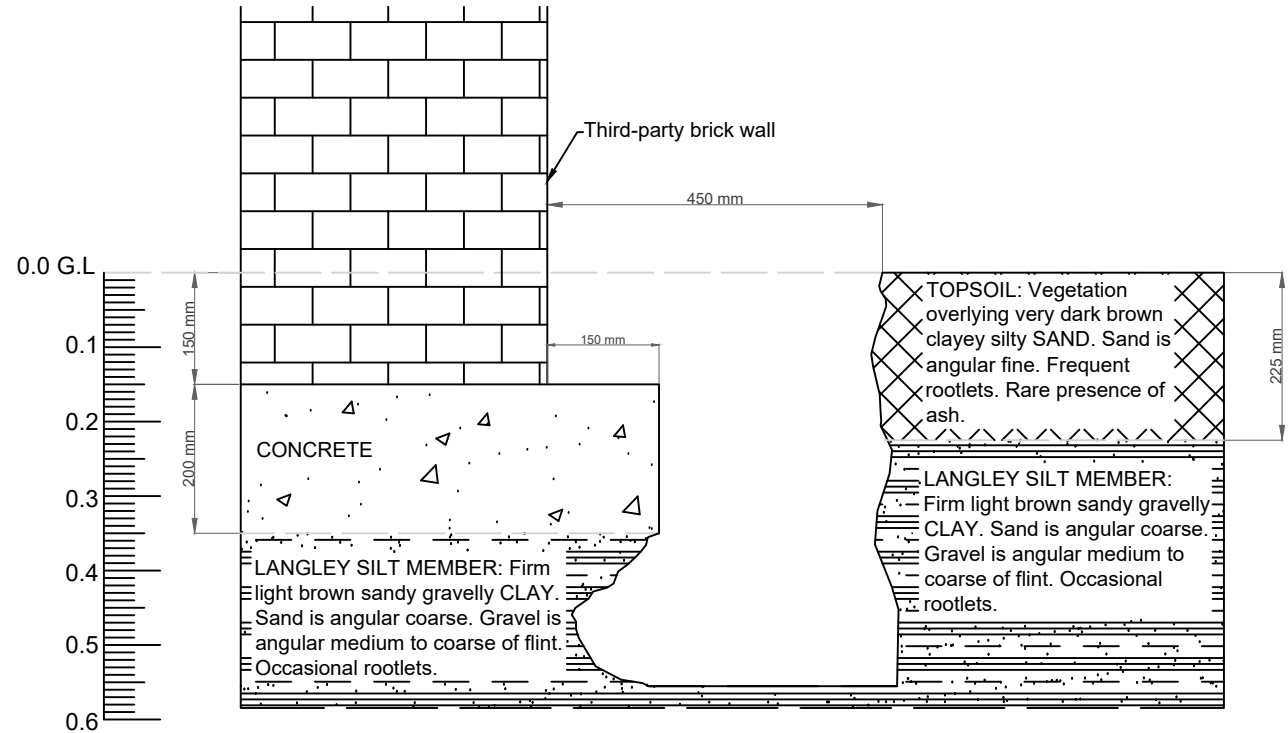
Excavation Method Hand Excavated Trial Pit	Dimensions 0.35 m x 0.30 m
	Location

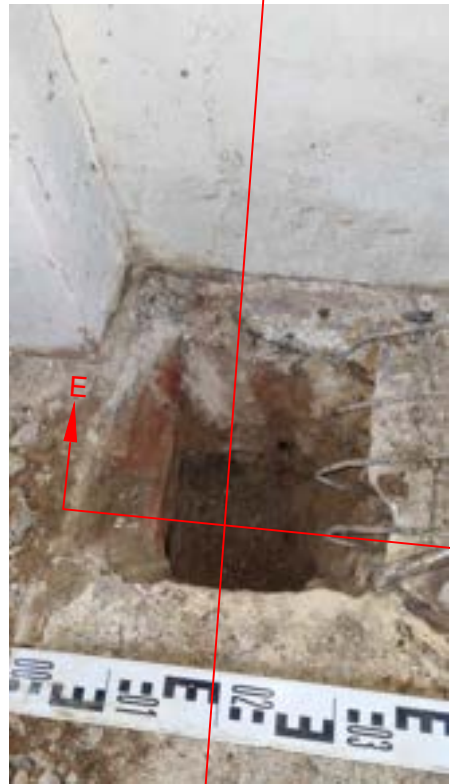
Section D - D'

Plan view

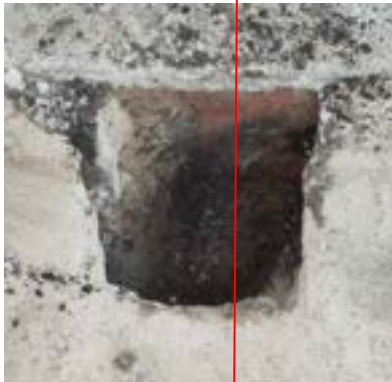
Section F - F'

Plan view

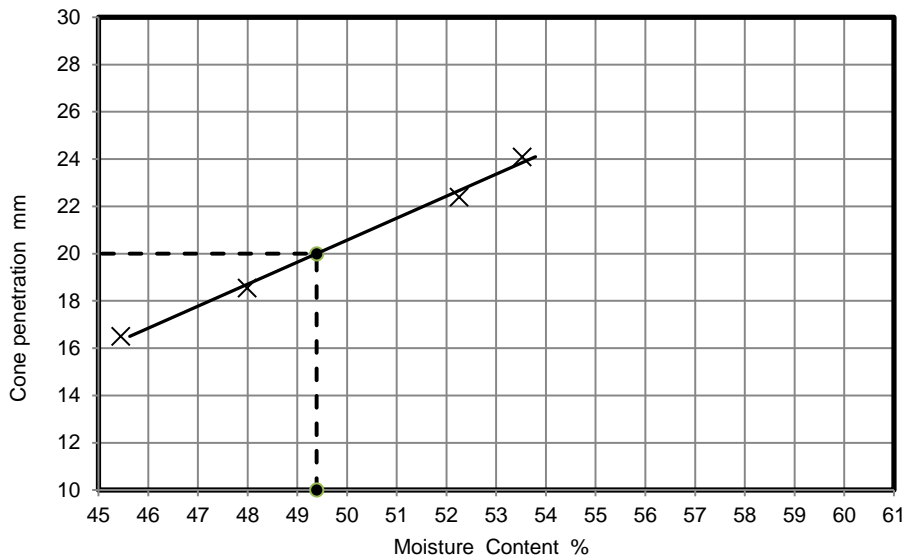
Site Name	152-154 Uxbridge Road		
Project No.	2024-065-PRE-UXB	Client	Geofirma
Soil Description	High strength brown slightly sandy silty CLAY

WATER CONTENT	23.9	%
% PASSING 425µm SIEVE	98	%
LIQUID LIMIT	49	%
PLASTIC LIMIT	18	%
PLASTICITY INDEX	31	%

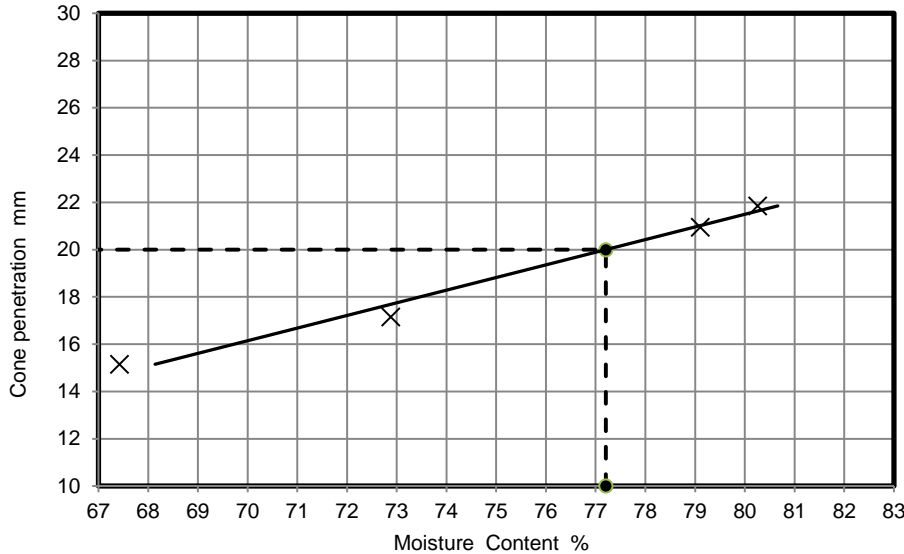
Site Name	152-154 Uxbridge Road		
Project No.	2024-065-PRE-UXB	Client	Geofirma
Soil Description	Dark grey silty CLAY

WATER CONTENT	28.4	%
% PASSING 425µm SIEVE	100	%
LIQUID LIMIT	77	%
PLASTIC LIMIT	30	%
PLASTICITY INDEX	47	%

2No. Atterberg limit tests were conducted on samples taken from depths of 10 m and 14.9 m bgl from BH1. The tests recorded a liquid limit ranging from 71% to 77%, a plastic limit between 28% and 30%, and a plasticity index from 43% to 47%. Given that the percentage of particles passing the 425 µm sieve was 100% for both samples, the modified plasticity index (I_p) is the same as the plasticity index in this case.

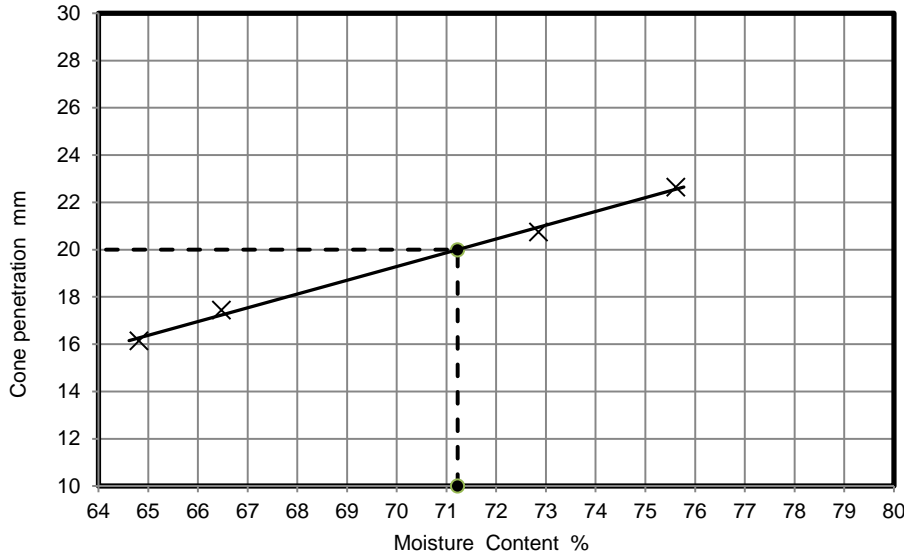
Site Name	152-154 Uxbridge Road		
Project No.	2024-065-PRE-UXB	Client	Geofirma
Soil Description	Dark grey silty CLAY

WATER CONTENT	26.7	%
% PASSING 425µm SIEVE	100	%
LIQUID LIMIT	71	%
PLASTIC LIMIT	28	%
PLASTICITY INDEX	43	%

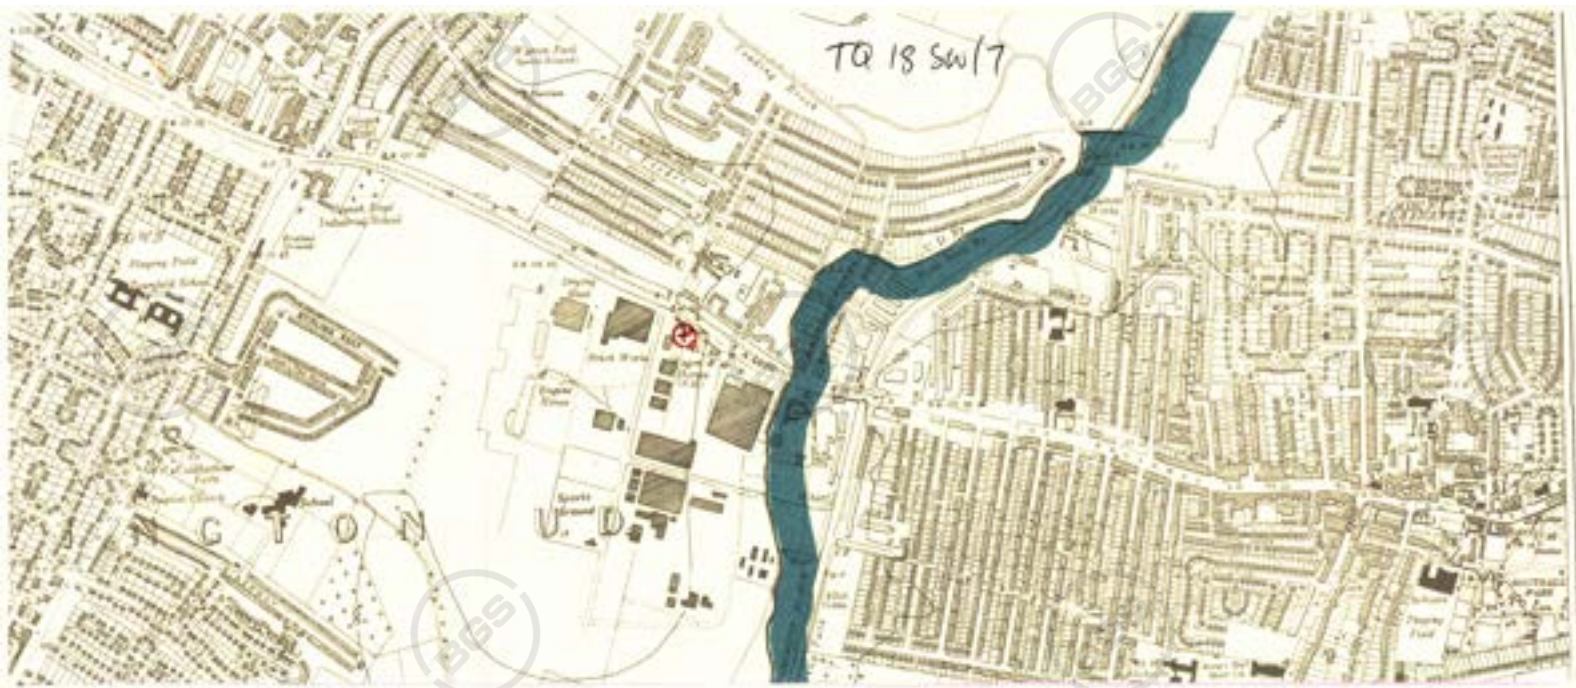
TAKEN FOR 12 STORY OFFICE BLOCKS
DATE:- JUNE 1961
TOTAL DEPTH 35'-6" DIA. 6"
LOCATION UXBRIDGE ROAD AND
SPRINGFIELD ROAD (EAST SIDE)

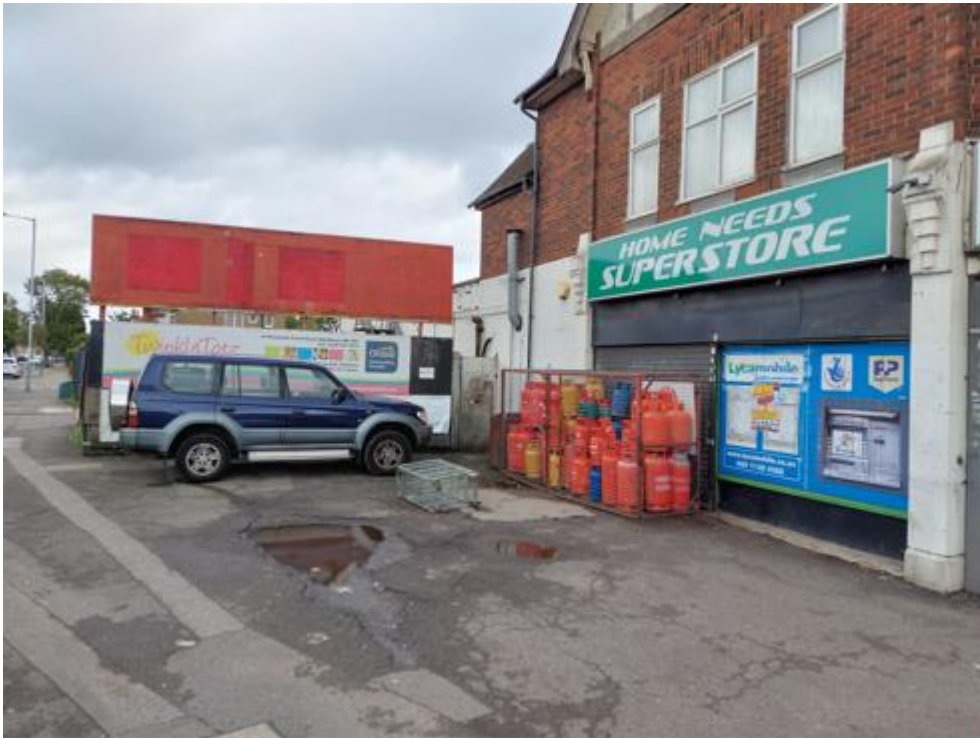
Photograph 3: View of side of property showing gas cylinder storage

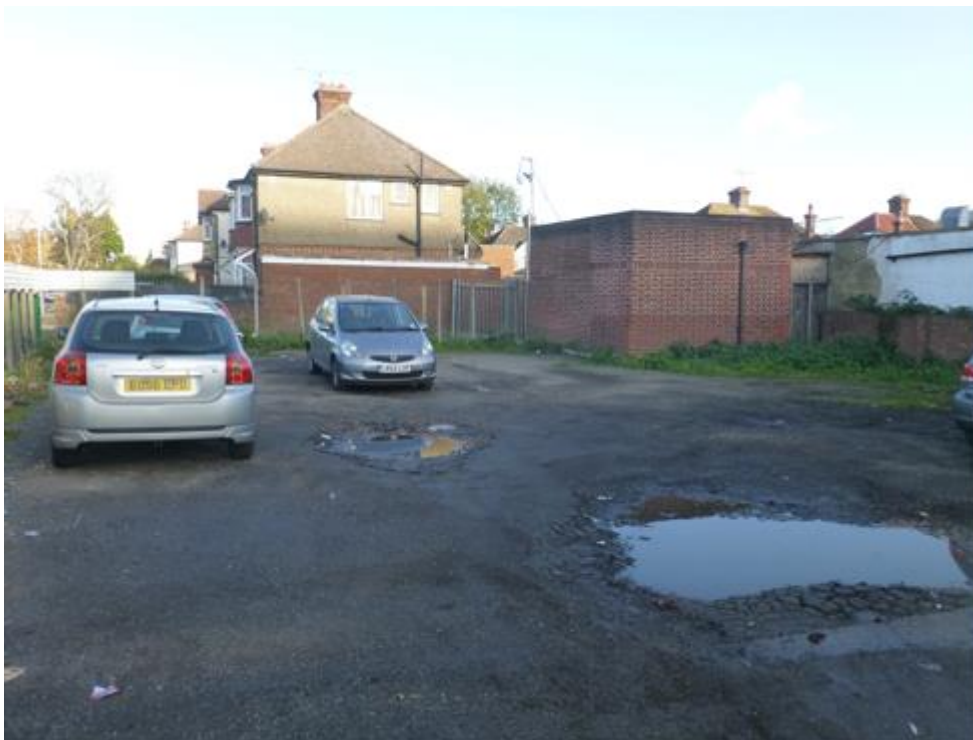
Photograph 6: View of rear yard area showing electricity substation

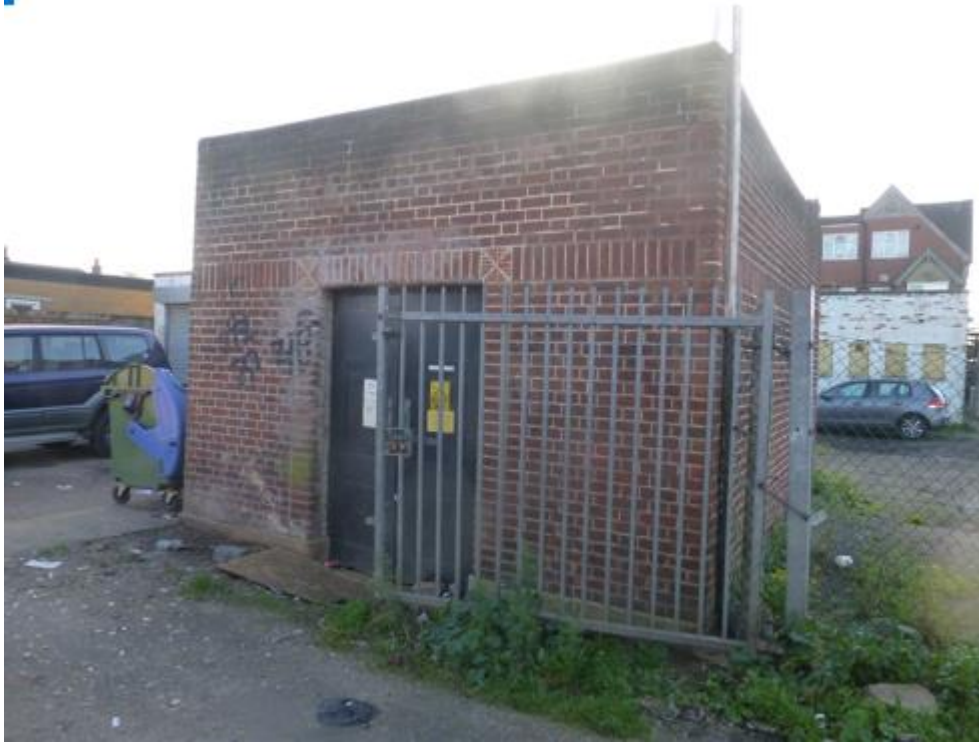
Photograph 9: View of electricity substation showing enclosed brick structure

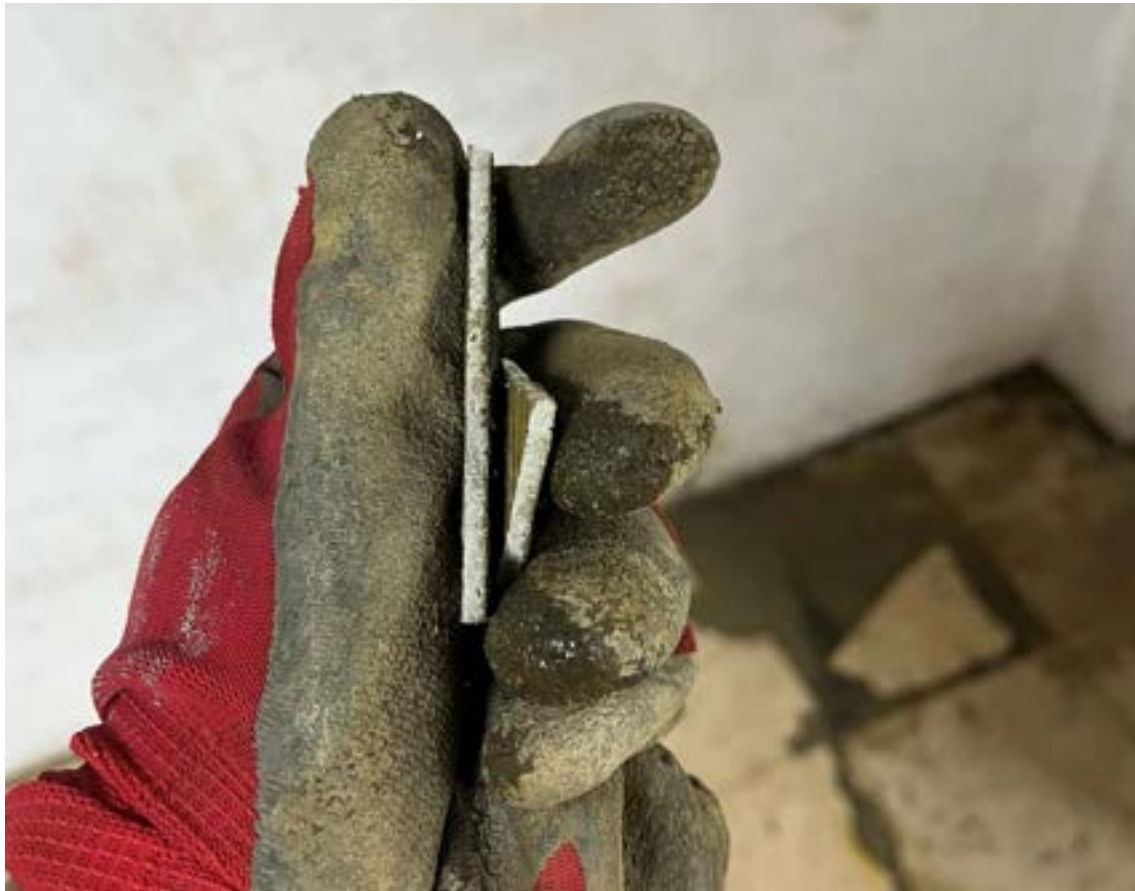
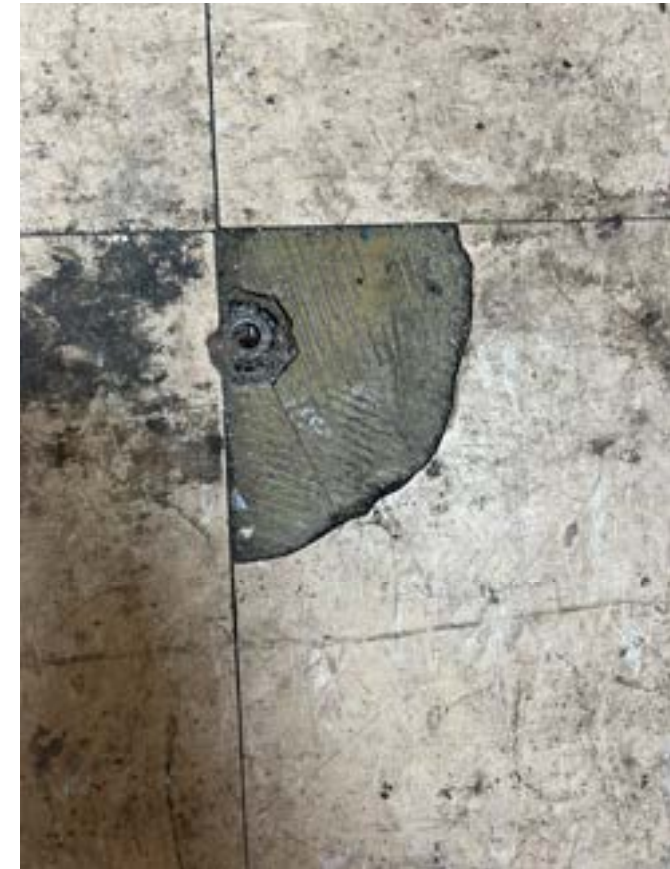
Views of asbestos containing materials found on site within the existing, on-site, 1-2No. storey building.

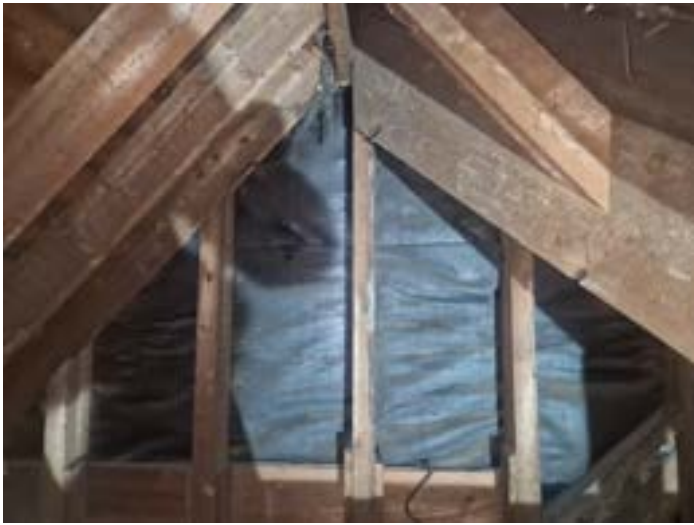
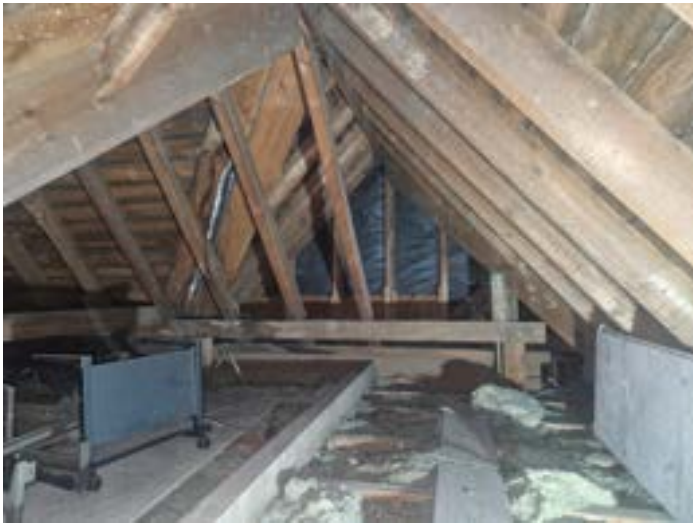
Unique Inspection Reference		1		No Asbestos Detected

Building, Floor, Room	Second floor, roof void, RV.01	Location	Lining to the former water tank area		
Material	Bituminous felt	Extent	10 sq. m.		
Strategy	Sampled	Fibre Type	NADIS		
Additional Comments

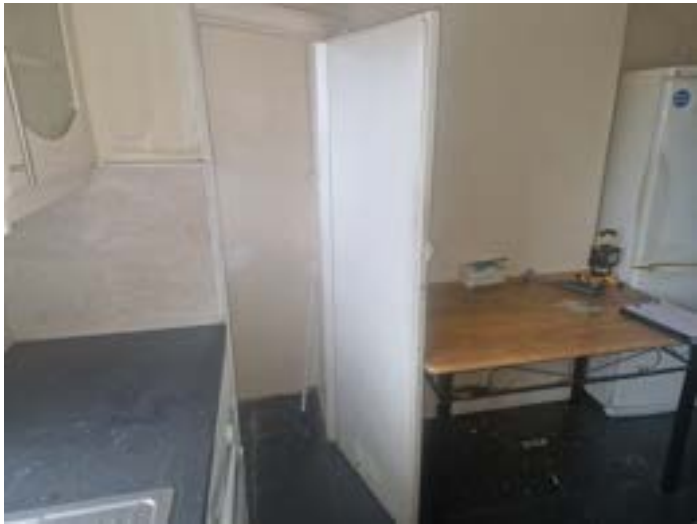
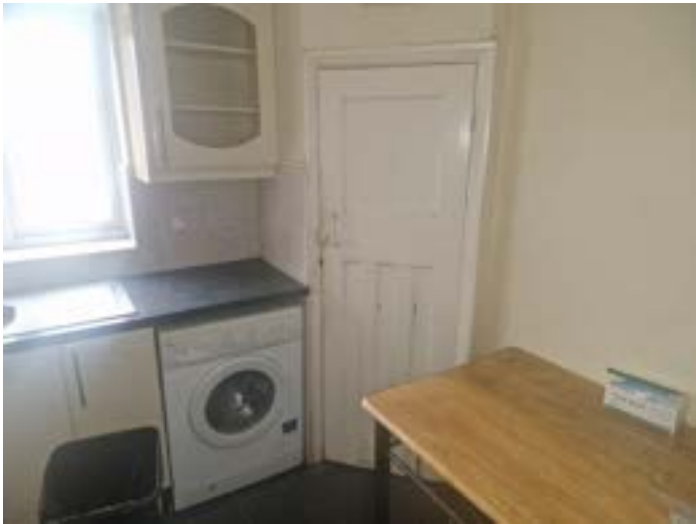
Unique Inspection Reference		6		No Asbestos Detected

Building, Floor, Room	First floor, 1.01	Location	Panel lining the boiler cupboard door		
Material	Insulating board	Extent	2 sq. m.		
Strategy	Sampled	Fibre Type	NADIS		
Additional Comments

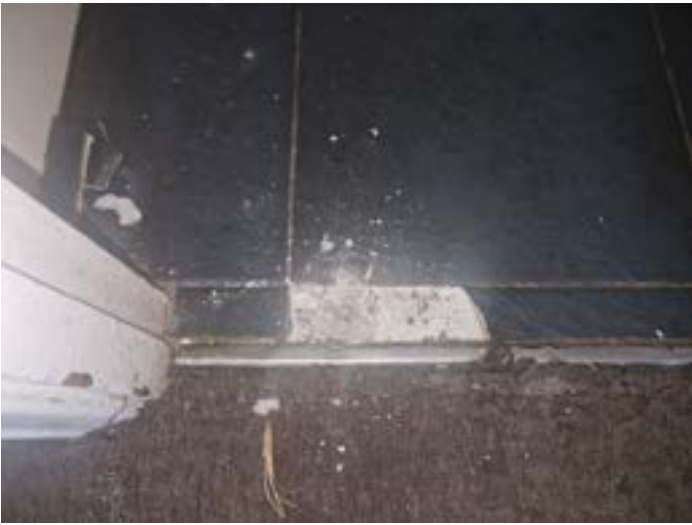
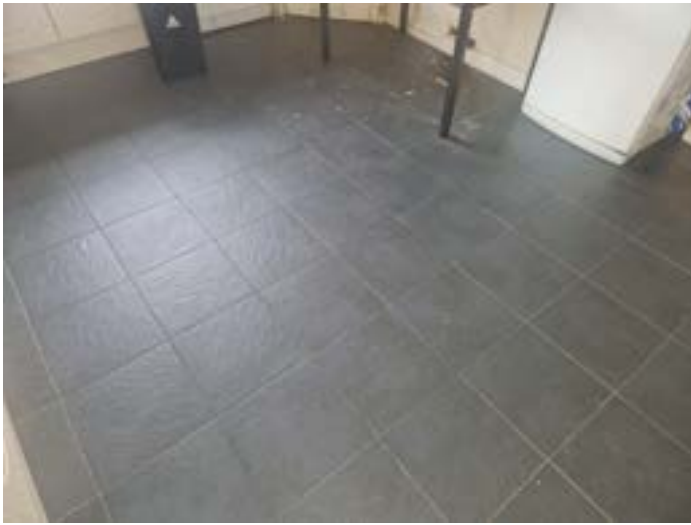
Unique Inspection Reference		7		No Asbestos Detected

Building, Floor, Room	First floor, 1.01	Location	Floor levelling boards beneath the ceramic floor tiles		
Material	Insulating board	Extent	24 sq. m.		
Strategy	Sampled	Fibre Type	NADIS		
Additional Comments

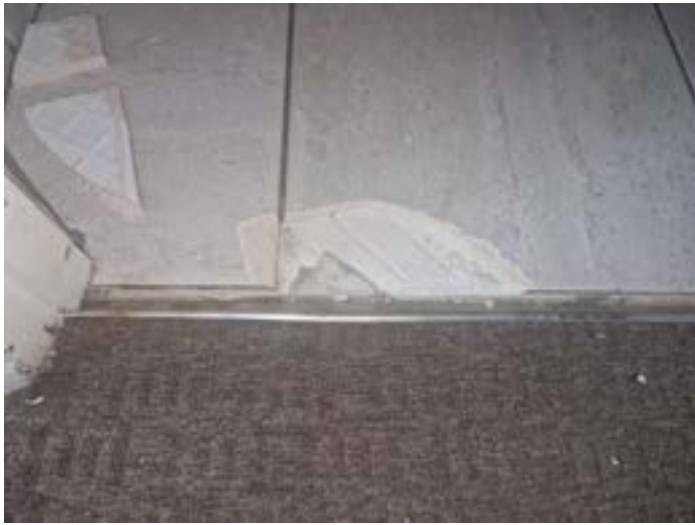
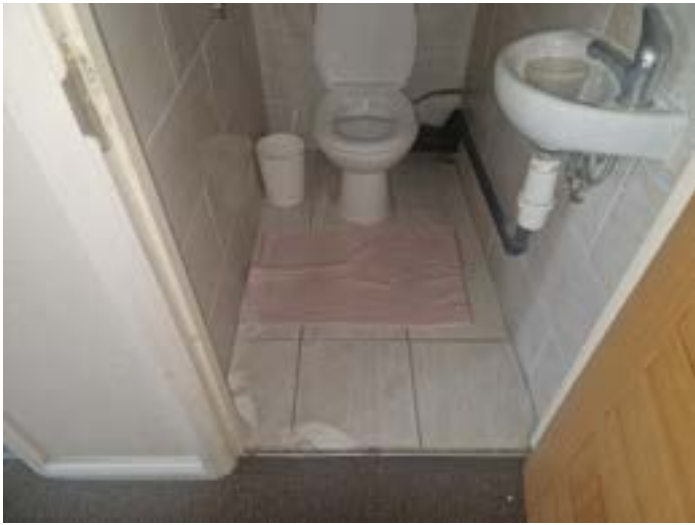
Unique Inspection Reference		9 VI 7		No Asbestos Detected

Building, Floor, Room	First floor, 1.02	Location	Floor levelling boards beneath the ceramic floor tiles		
Material	Insulating board	Extent	2 sq. m.		
Strategy	Visually Identical	Fibre Type	NADIS		
Additional Comments

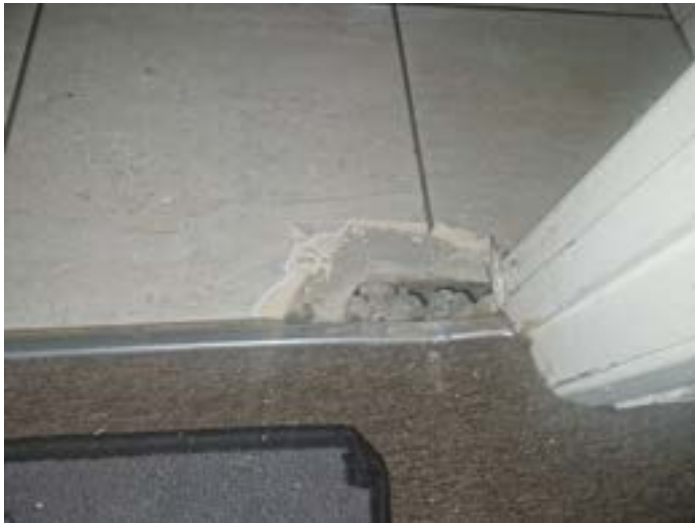
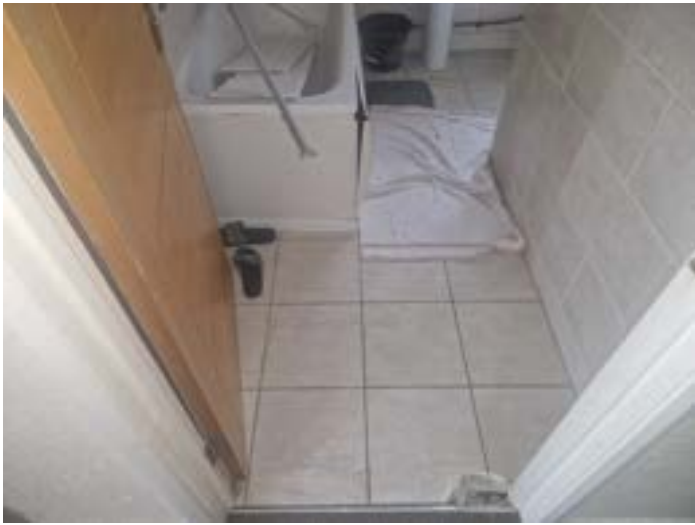
Unique Inspection Reference		11 VI 7		No Asbestos Detected

Building, Floor, Room	First floor, 1.03	Location	Floor levelling boards beneath the ceramic floor tiles		
Material	Insulating board	Extent	6 sq. m.		
Strategy	Visually Identical	Fibre Type	NADIS		
Additional Comments

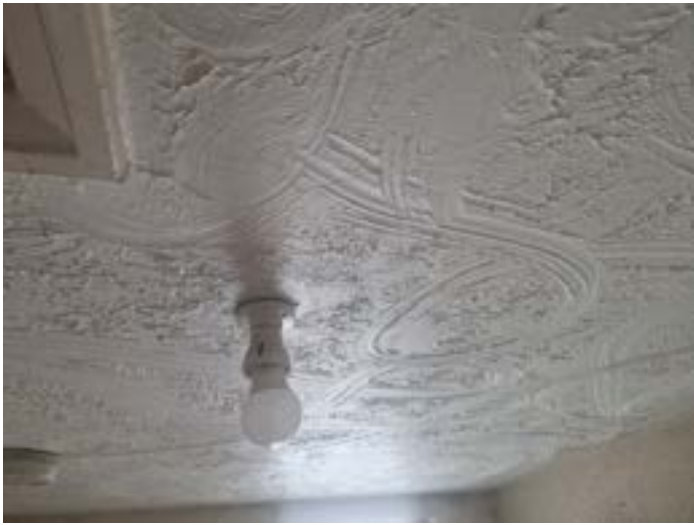
Unique Inspection Reference		15		No Asbestos Detected

Building, Floor, Room	First floor, staircase, ST.01	Location	Applied to the lath and plaster ceiling		
Material	Textured coating	Extent	12 sq. m.		
Strategy	Sampled	Fibre Type	NADIS		
Additional Comments

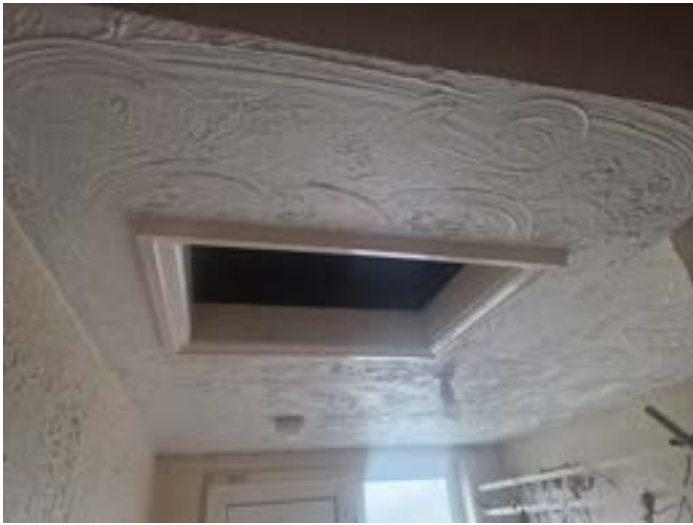
Unique Inspection Reference		16		No Asbestos Detected

Building, Floor, Room	First floor, 1.06	Location	Applied to the lath and plaster ceiling		
Material	Textured coating	Extent	8 sq. m.		
Strategy	Sampled	Fibre Type	NADIS		
Additional Comments

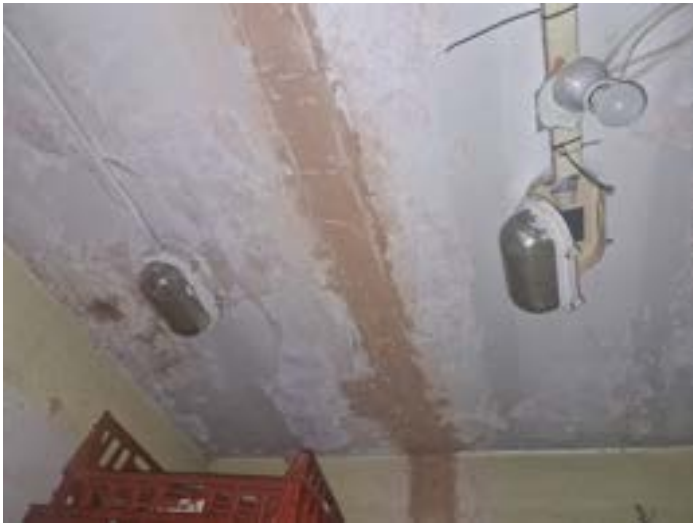
Unique Inspection Reference		17		No Asbestos Detected

Building, Floor, Room	First floor, 1.06	Location	Applied to the masonry walls		
Material	Textured coating	Extent	16 sq. m.		
Strategy	Sampled	Fibre Type	NADIS		
Additional Comments

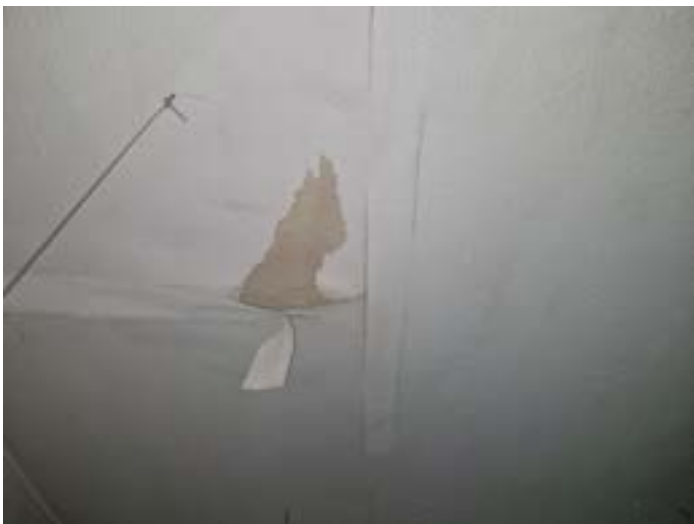
Unique Inspection Reference		18		No Asbestos Detected

Building, Floor, Room	Ground floor, G.01	Location	Seals to the light fitting casings		
Material	Putty	Extent	2 units		
Strategy	Sampled	Fibre Type	NADIS		
Additional Comments

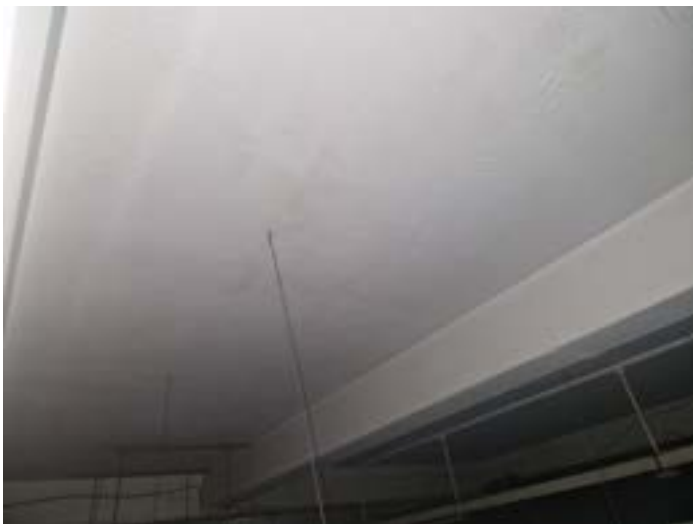
Unique Inspection Reference		20		No Asbestos Detected

Building, Floor, Room	Ground floor, G.01 to G.05 (inclusive)	Location	Ceiling covering, above the suspended ceiling		
Material	Paper lining	Extent	175 sq. m.		
Strategy	Sampled	Fibre Type	NADIS		
Additional Comments

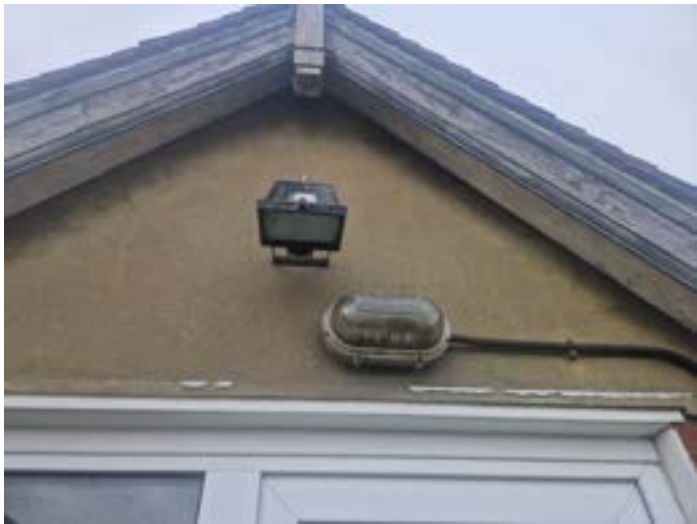
Unique Inspection Reference		21 VI 17		No Asbestos Detected

Building, Floor, Room	Second floor, external	Location	Fascia panels to the pitched roofs		
Material	Cement sheeting	Extent	20 sq. m.		
Strategy	Sampled	Fibre Type	NADIS		
Additional Comments

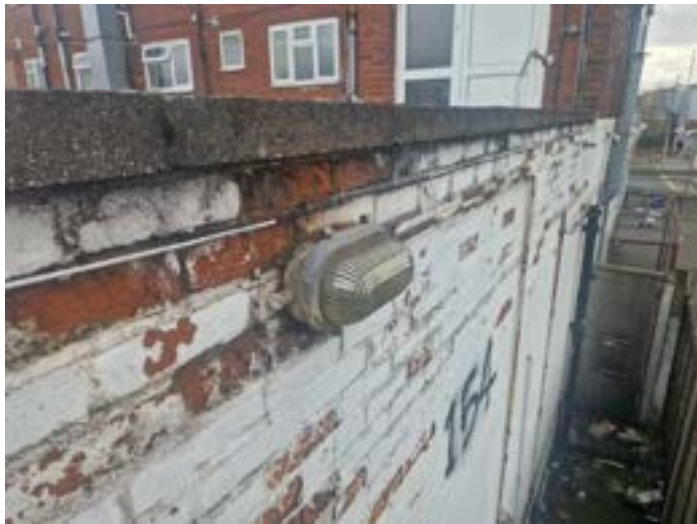
Building, Floor, Room	First floor, external	Location	Seals to the light fitting casings		
Material	Putty	Extent	2 units		
Strategy	Visually Identical	Fibre Type	NADIS		
Additional Comments	These light fittings are positioned above the flat entrance door and external access staircase.
