**Berrite Works
Iron Bridge Road South
West Drayton
UB7 8HY**

Preliminary Roost Assessment

Report ref.: R2832_PRA_a

February 2025

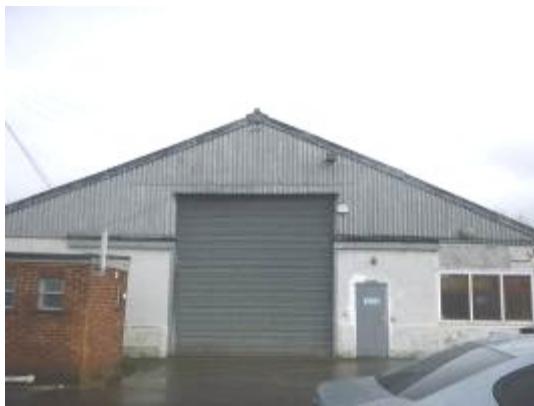
5.2.2 The largest commercial building (B1) was of rendered blockwork construction, with corrugated metal on the western gable and a corrugated metal sheet roof (**Photographs 1 & 2**).

Photograph 1. Side of B1 viewed from west.

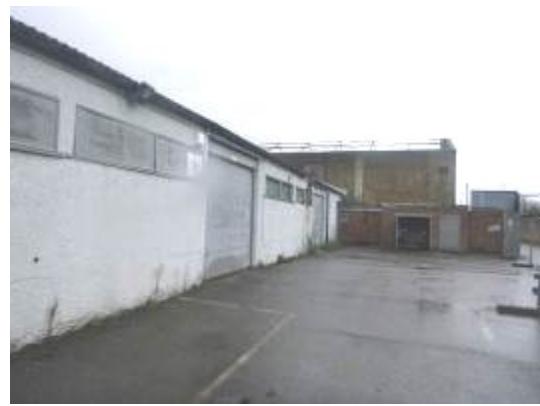
Photograph 2. Front of B1 viewed from south-west.

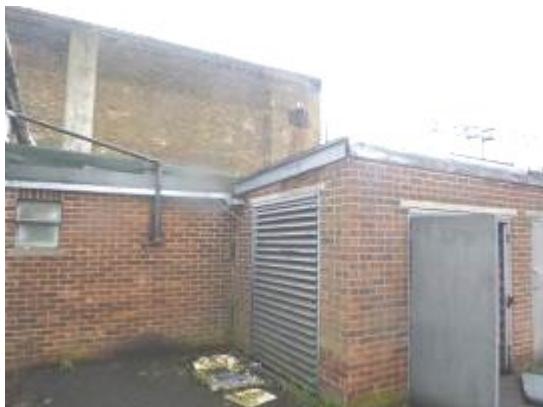
5.2.3 There was a flat-roofed, brickwork engine building at the eastern end of B1, which had damaged sections of the roof (**Photograph 3; Target note 1**). The timber fascia along the flat roofs were damaged in places but no gaps suitable for use by bats were observed. A section of the timber fascia was missing at the eaves of B1 with gaps under the roof sheeting visible, but this was not accessible for bats due to the presence of guttering across the roof (**Photograph 4; Target note 2**).

Photograph 3. Attached brickwork engine building; damaged fascia offering no roosting potential (western elevation).

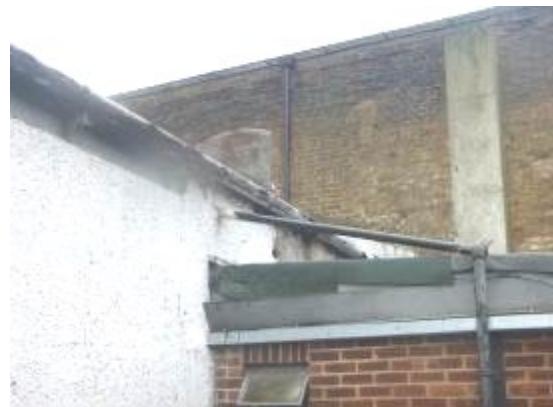
Photograph 4. Missing section of fascia along eaves of B1 (southern elevation).

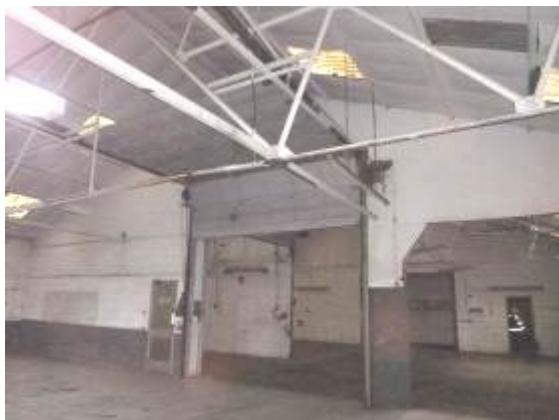
5.2.4 The building had no roof void internally, and was open to the ceiling throughout (**Photograph 5**). Daylight was visible at the eaves over the blockwork on the southern elevation with water ingress and damage visible (**Photograph 6**). No evidence of roosting bats was observed within the building.

Photograph 5. Interior of B1.

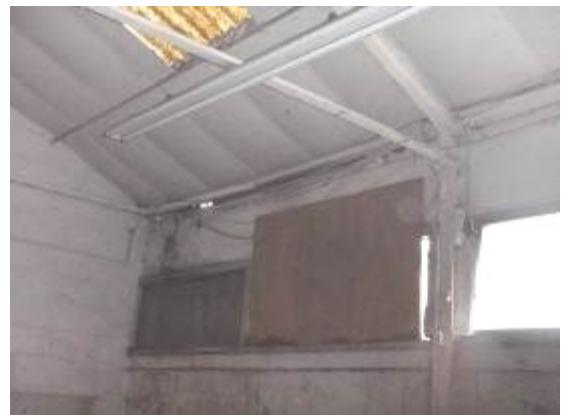
Photograph 6. Daylight visible at the eaves on the southern side of B1.

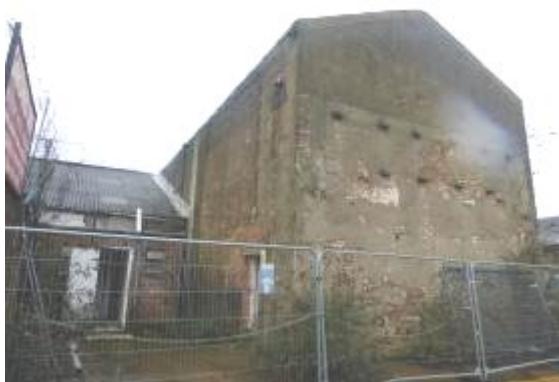
5.2.5 The second building was in a dilapidated state due to a fire resulting in the roof being removed and was attached to the eastern end of B1. A fire damaged building was attached on the eastern elevation and a flat roofed extension on the northern elevation (**Photographs 7 - 9**).

Photograph 7. Front of B2 viewed from south.

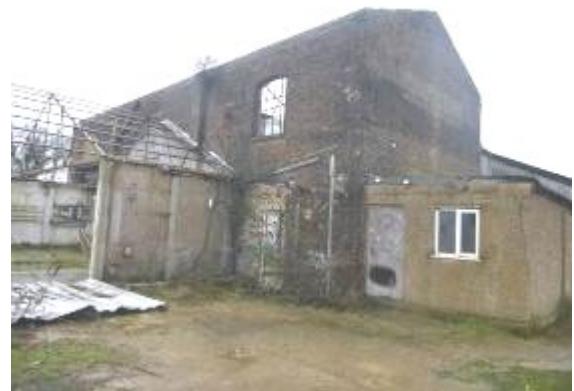
Photograph 8. Rear of B2 viewed from north-east.

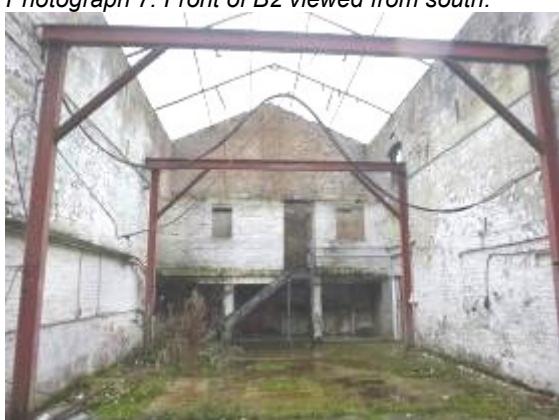
Photograph 9. Internal of B2.

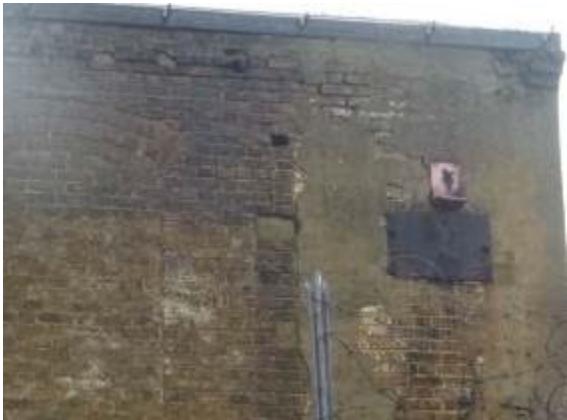
5.2.6 There were occasional cracks in the external brickwork of the building, which were of limited size and due to the single-skin construction, and were deemed to be of negligible suitability for use by bats (**Photograph 10; Target note 3**). There were gaps on the

Photograph 10. Superficial cracks in single-skin brickwork of B2 (western elevation).

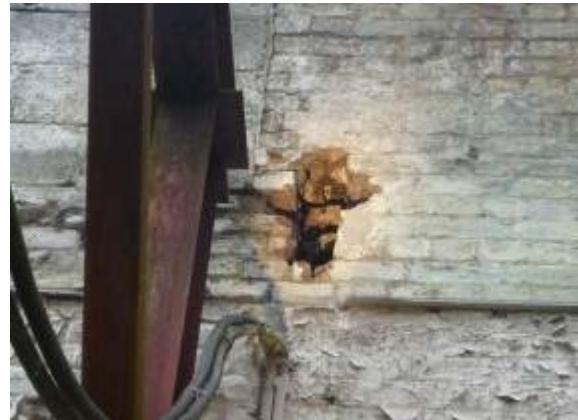
internal walls of the single-skin brickwork where beams had been present, leaving open and exposed gaps that were inspected with a high powered torch and binoculars, and showed to have no internal cavity suitable for use by bats (**Photograph 11; Target note 4**).

Photograph 11. Open gap in single-skin brickwork; offering no roosting potential (internal B2).

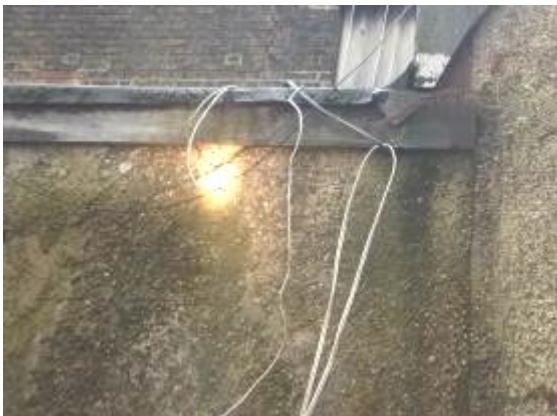
5.2.7 A single-storey flat roofed building was present on the northern elevation of the building with the timber fascia being tight to the wall around the roof (**Photograph 12**). There was an open gap at the eaves above a door way, with old bird nesting material visible, but the gap was of limited extent for use by bats (**Photograph 13; Target note 5**).

Photograph 12. Tight timber fascia to wall on single storey extension (northern elevation).

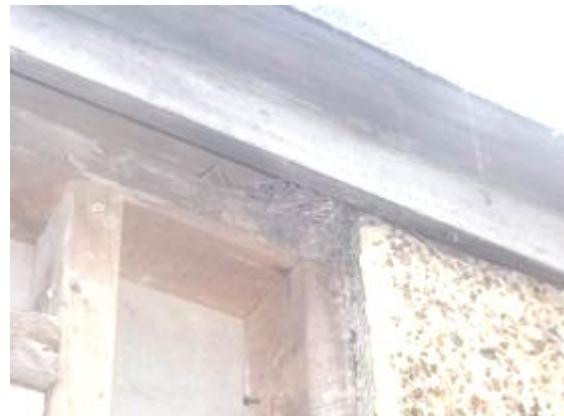
Photograph 13. Bird nesting material present in gap under fascia (northern elevation).

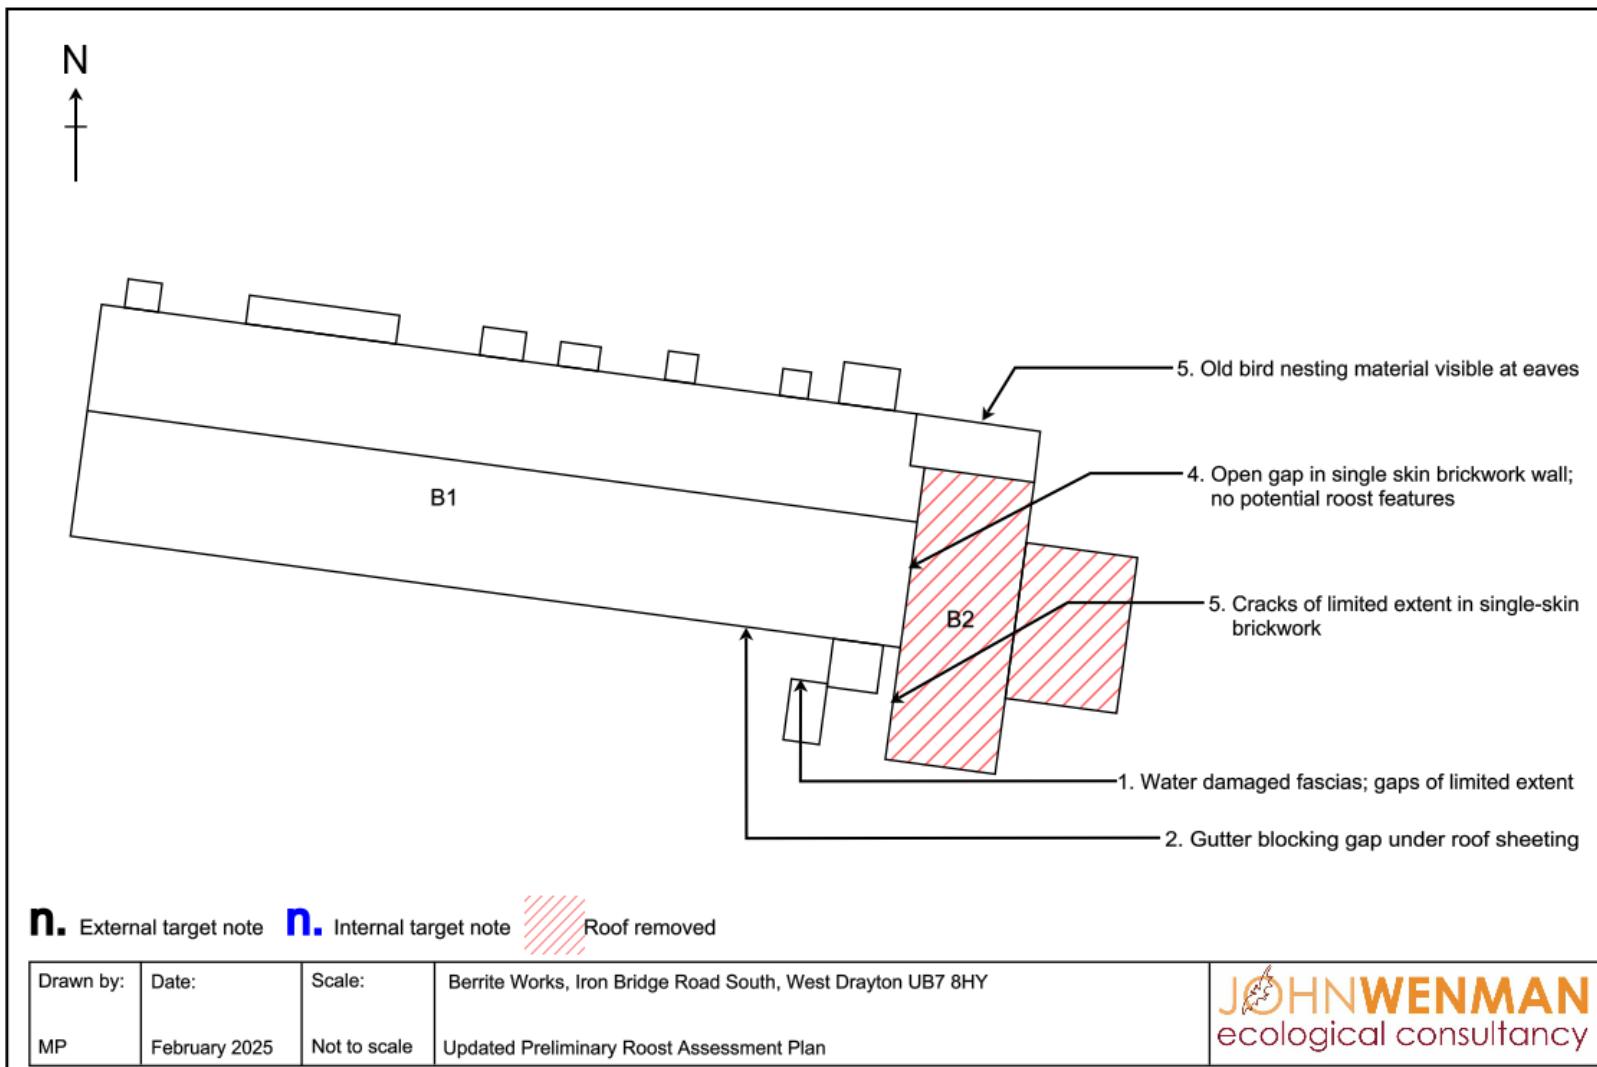
5.2.1 The findings from the external and internal inspections carried out for the two buildings are described with photographs, and annotated in a plan (see **Figure 1**), as follows:

Figure 1. PRA survey findings.
