For the Site of: Willowtree Marina, Yeading, W Quay Dr, Hayes UB4 9TB

# Preliminary Roost Assessment (PRA)

The following report details the findings and recommendations for the site of Willowtree Marina, Yeading, W Quay Dr, Hayes UB4 9TB.

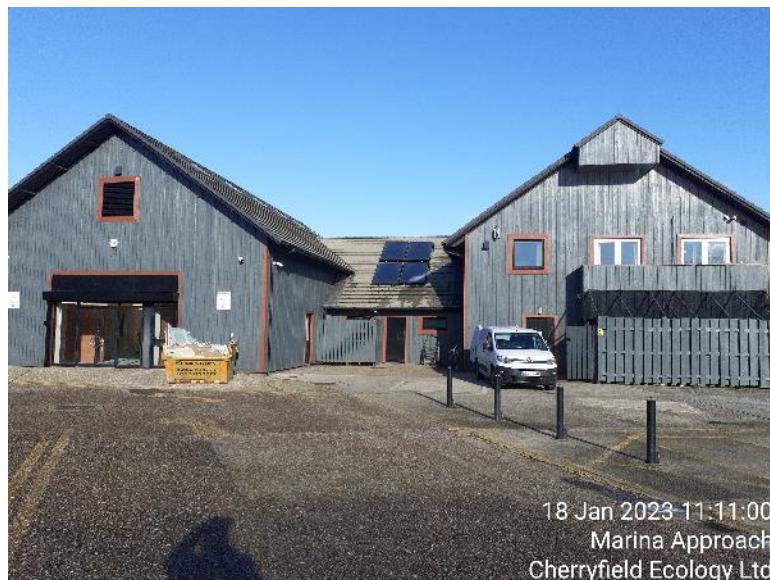
Figure 2: front of B1

B1 is a timber clad two storey building with a complex roof structure and multiple open gable ends. The roofing tiles are interlocking concrete tiles. Bird proofing implements, including pigeon spikes, are found throughout the roof. The soffit boxes, window and door frames are made of wood.

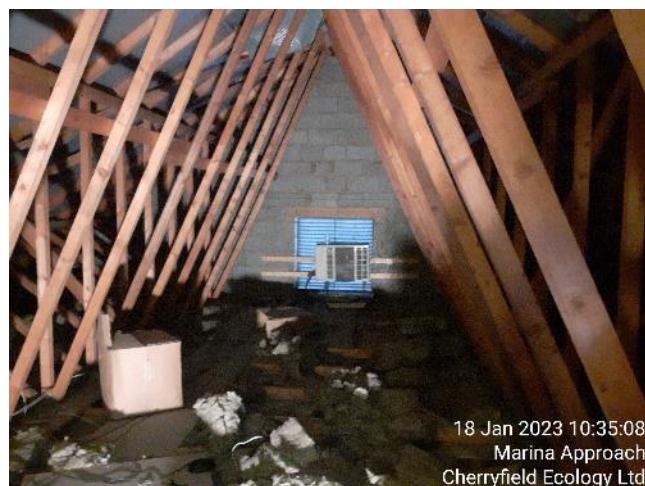
Figure 5: example of loft no. 1

There are two loft voids within the property. Both have timber frames with fiberglass boarding. Both lofts are partially boarded and partially insulated with a mixture of rockwool and gypsum panels.

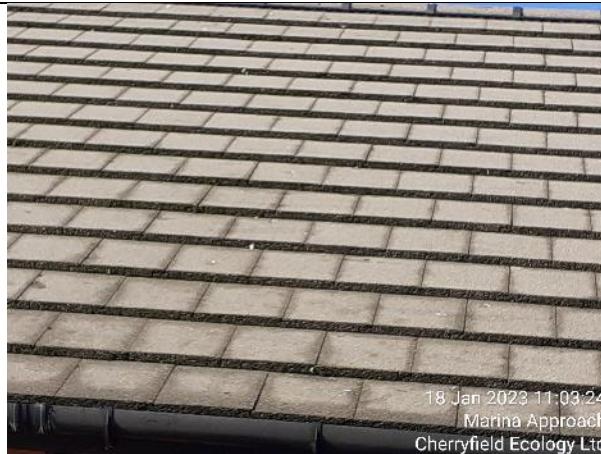
Bats found	No bats were found at the time of the survey.
Evidence of bat use	No evidence of bats was found at the time of the survey.
Potential for bat use	<p>Level of likelihood of presence -</p> <p>B1 - Negligible</p> <p>B1 provides negligible potential for bats due to the lack of gaps leading to the loft voids. Additionally, there are a lack of gaps under the interlocking roof tiles and the wooden cladding. Furthermore, the soffit, window and door frames do not have sufficient gaps.</p>

Figure 7: example of roofing tiles with no sufficient gaps
