# Tudor lodge Hotel

50 Field End Road HA5 2QN

Roof tile replacement methodolgy  
Issue date: 13-03-2024 / issue no: P1

**J79 STUDIO**

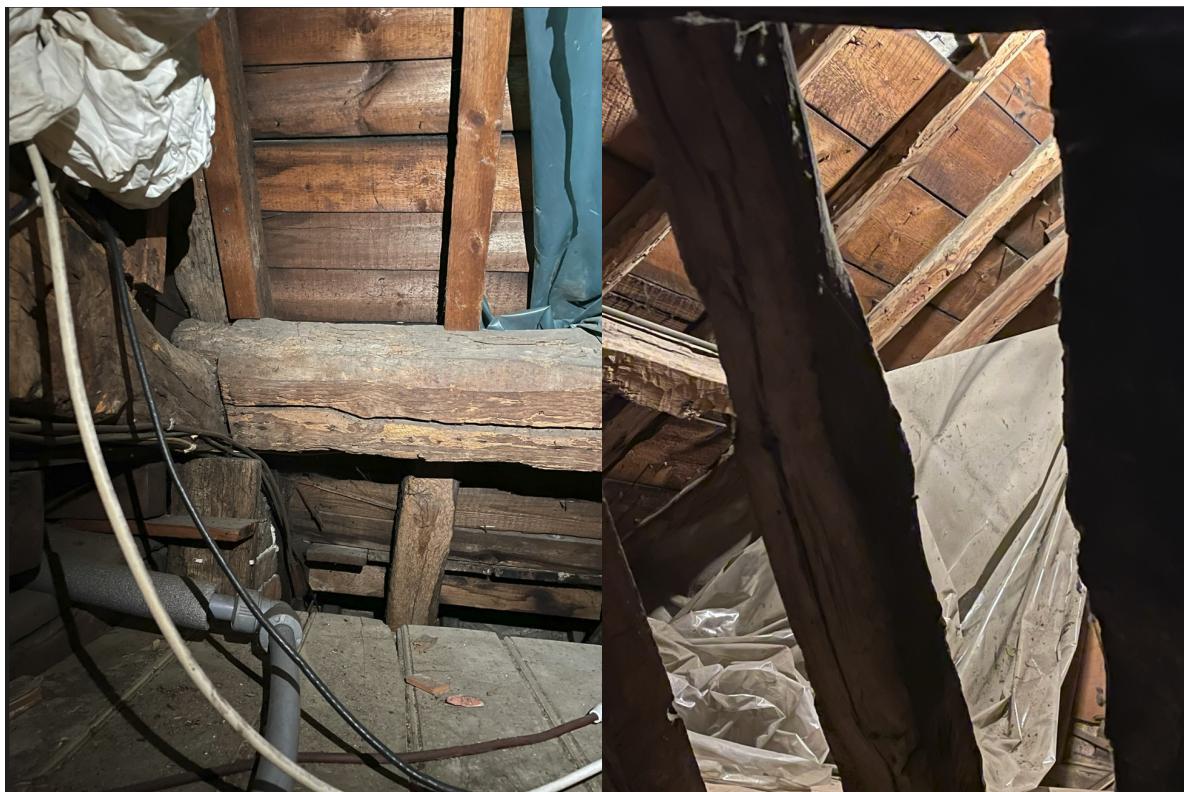
**Fig 2 & 3: Existing main roof to centre of original buildings**

**Main roof to centre of original building:** The following was noted from the local areas that were visible. Traditional cut timber roof. Note that varying timber sizes are present as original timbers used rather than modern planed joists. 80mm x 60mm timber rafters, spanning from eaves up to timber ridge board. 160mm x 100mm purlins are present and breaking the rafters' span. 70mm x 50mm ceiling joists present.

**Rear wing of the main building (opposite end of building to area with proposed dormer):** The following was noted from the local areas visible. Traditional cut timber roof. 50mm x 100mm timber rafters at 400mm c/c, spanning from eaves to ridge board. 50mm x 150mm ceiling joists present.

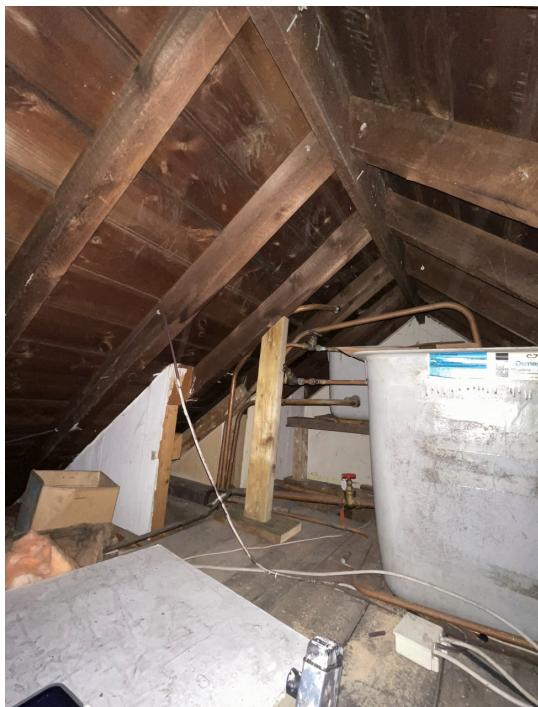
**Fig 3: Existing extension roof structure local to proposed dormer**

**Existing extension roof structure local to proposed dormer:** From the local areas visible, the following was noted. Traditional cut timber roof. 50mm x 100mm rafters at 400mm c/c, spanning from eaves wall plate up to timber ridge board. 50mm x 100mm timber collar ties present. Loft floor joists are 50mm x 125mm timber joists at 400mm c/c.
