# Tudor lodge Hotel

50 Field End Road HA5 2QN

## Roof tile replacement methodolgy

Issue date: 01-05-2024 / issue no: P2

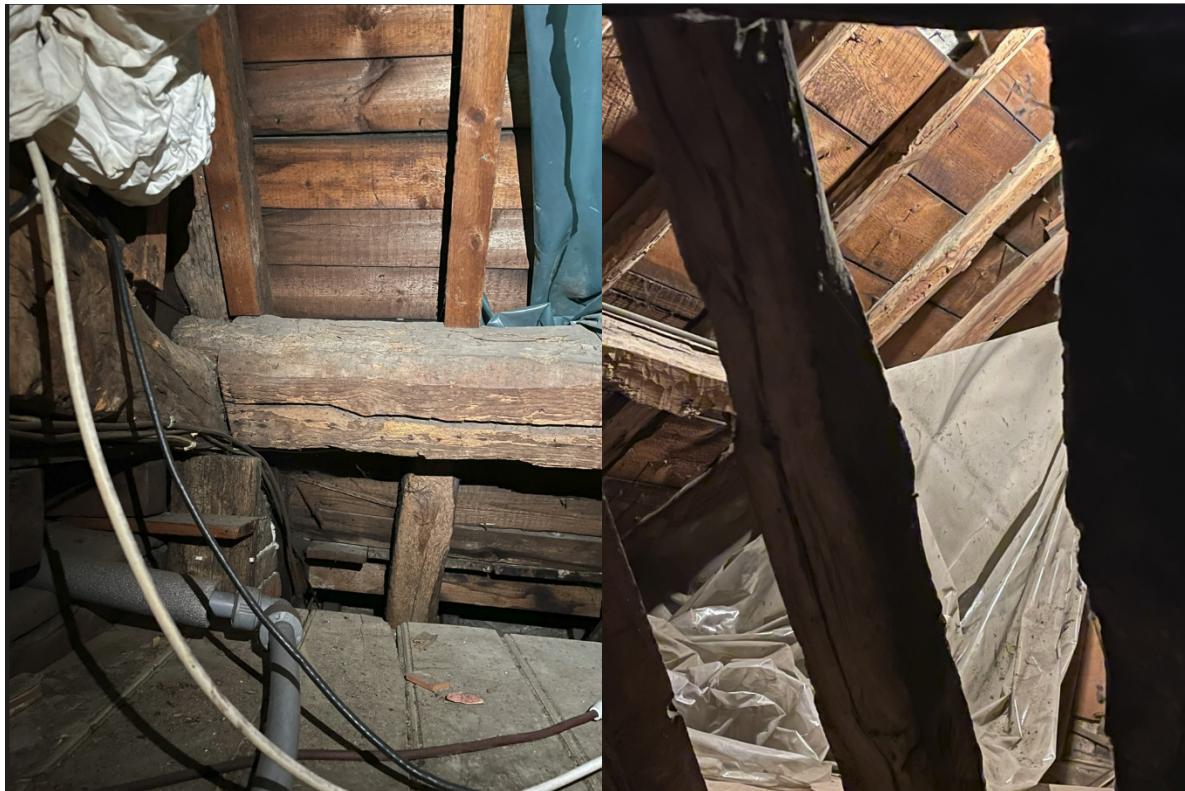
**Fig 2 & 3: Existing main roof to centre of original buildings**

**Main roof to centre of original building:** The following was noted from the local areas that were visible. Traditional cut timber roof. Note that varying timber sizes are present as original timbers used rather than modern planed joists. 80mm x 60mm timber rafters, spanning from eaves up to timber ridge board. 160mm x 100mm purlins are present and breaking the rafters' span. 70mm x 50mm ceiling joists present.

**Rear wing of the main building (opposite end of building to area with proposed dormer):** The following was noted from the local areas visible. Traditional cut timber roof. 50mm x 100mm timber rafters at 400mm c/c, spanning from eaves to ridge board. 50mm x 150mm ceiling joists present.

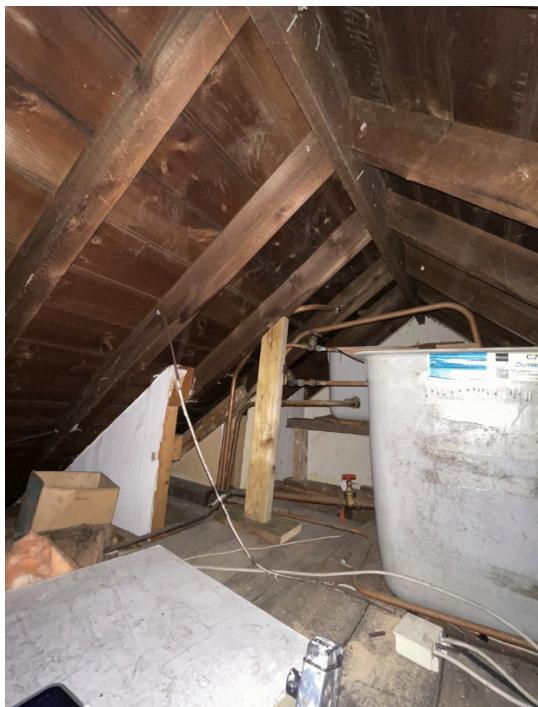
**Fig 3: Existing extension roof structure local to proposed dormer**

**Existing extension roof structure local to proposed dormer:** From the local areas visible, the following was noted. Traditional cut timber roof. 50mm x 100mm rafters at 400mm c/c, spanning from eaves wall plate up to timber ridge board. 50mm x 100mm timber collar ties present. Loft floor joists are 50mm x 125mm timber joists at 400mm c/c.
