**Amended Arboricultural Impact Assessment and  
Method Statement**

**CAS/2022/157D**

**Proposed Development Site  
Tudor Lodge Hotel, 50 Field End Road, Harrow, HA5  
2QN.  
4726/APP/2024/979**

**Boyd Saunders  
Dip Arb L4- Tech 'Arbor A'**

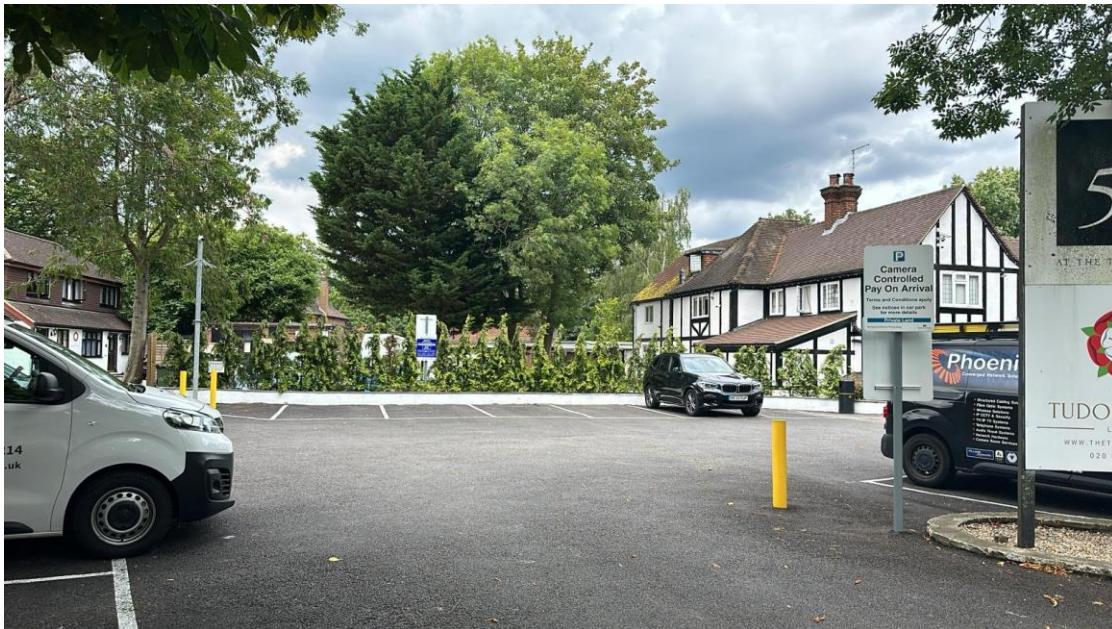
2.2.3 Two detached buildings of a more modern design are present on the site, one located along the boundary to the West of the main building and the other located to the North of the main building. These buildings are identified as “Building 2” and “Building 3” on the Arboricultural Constraints Plan. This proposal is concerned with the extending of Building 3 (pictured below).

Building 3 seen to left of picture

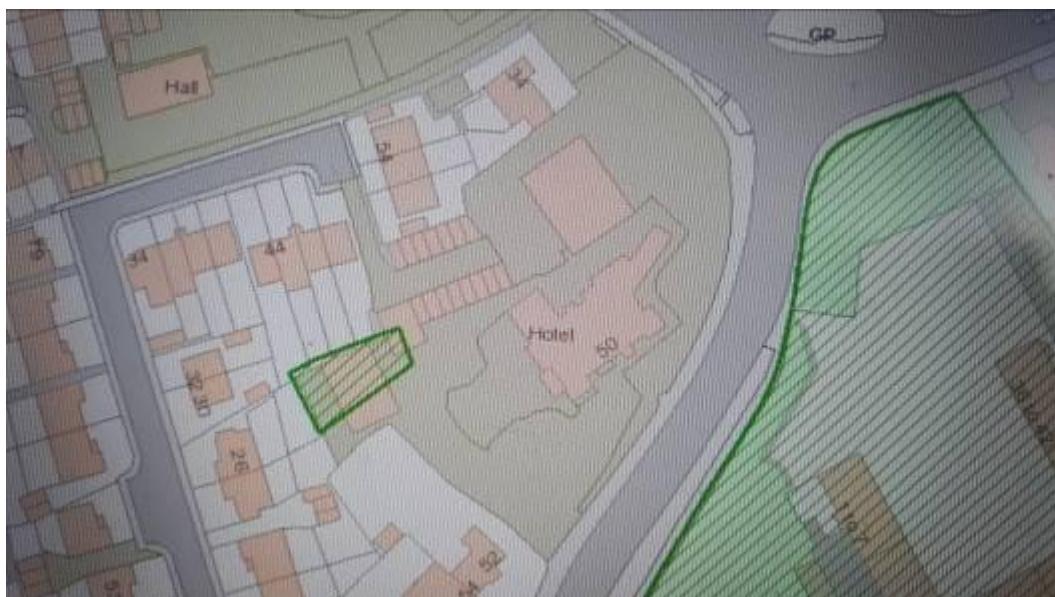
2.5.5 Searches carried out on Hillingdon Councils interactive map revealed that the site does not fall within a Conservation Area. However, the site is subject to a group Tree Preservation Order (TPO 461 20/06/1989) which affects an area in the Western section of the plot (please see below picture). This TPO covers –

This relates to trees numbered T28 Hazel, T29 Hornbeam and G05 Holly & Blackthorn within this report.

Tree Preservation Order - TPO 461 20/06/1989 in Green Hatch

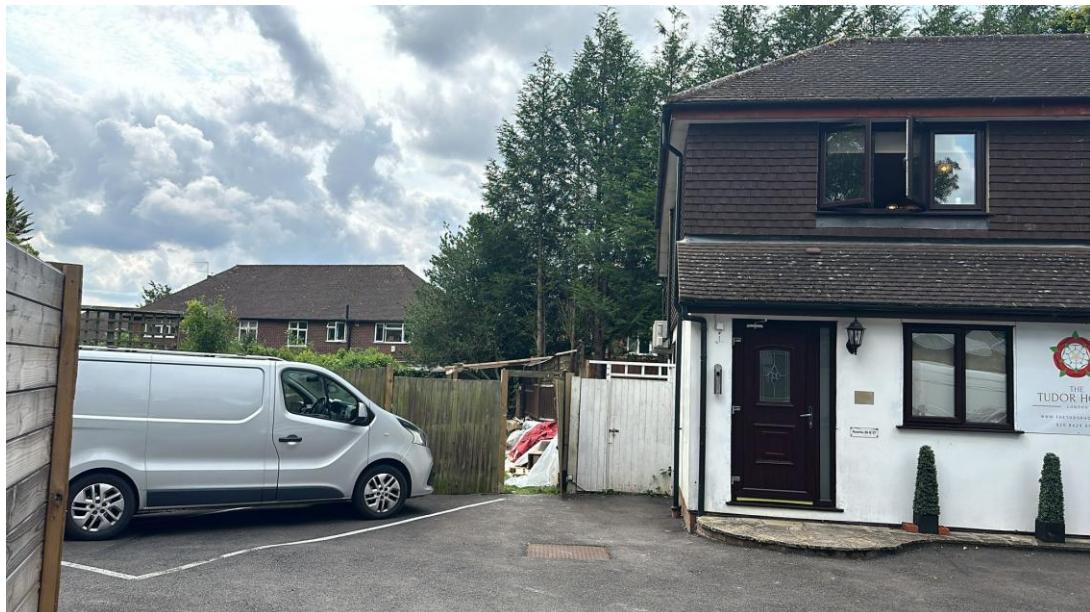
Building 3 & area of proposed development (left)

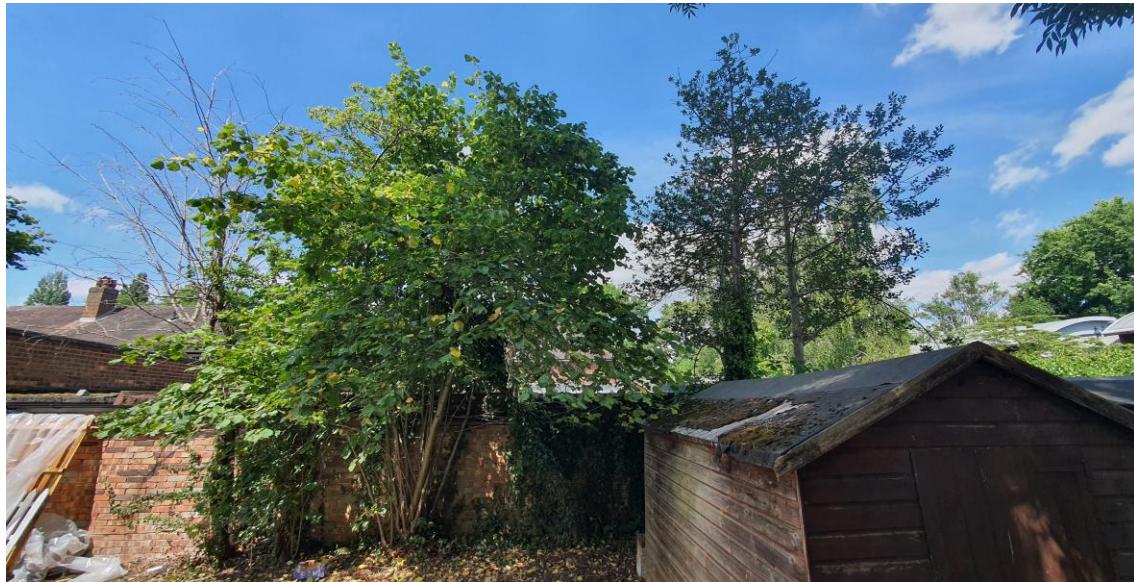
3.3.1 The proposal requires the removal of one small category c group of trees (pictured below)

- 4.1.1 The proposal requires the removal of one small category C group of trees.
- 4.1.2 Pre-emptive root pruning will be undertaken where very small conflicts exist between the foundations of the proposed design and the measured RPAs' of trees marked for retention.
- 4.1.3 Pile foundations will be utilised where conflicts exist between the new shed and trees marked for retention.
- 4.1.4 So long as the precautionary and protective measures outlined within this report are strictly observed and adhered to then the proposed development will have neutral impact upon trees marked for retention.

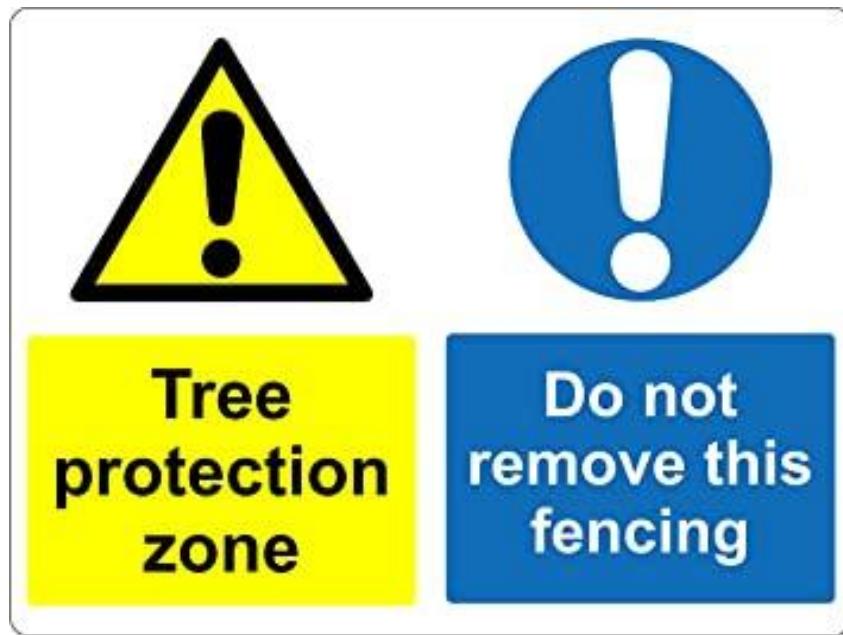
P3.4 Clear notices as shown below are to be fixed to the outside of the fencing with words such as 'Tree Protection Zone – Do not remove this fencing'. All operatives and other relevant personnel are to be informed of the role of the exclusion barriers and their importance. Protective fencing should remain in situ throughout the entire construction process. The site manager should be aware that it is his responsibility to maintain protective measures adequately and these should be casually inspected at regular intervals with written records of inspection.

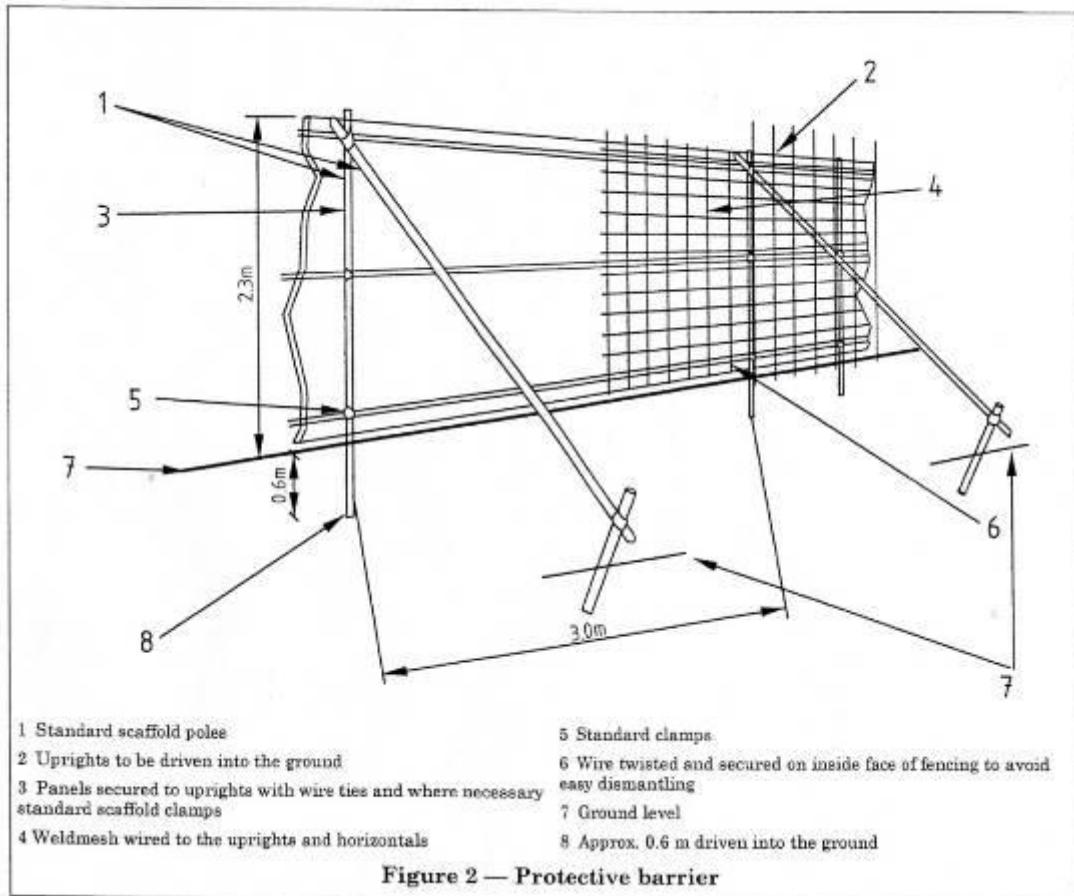
### High Traffic Areas

P3.1 In order to protect the tree stems from significant construction activity, protection barriers will be erected. See Plan for fencing location. Fencing should be of a reasonable standard and suitable for the purpose of preventing machinery entering the protected zones see example given below in appendix 1.

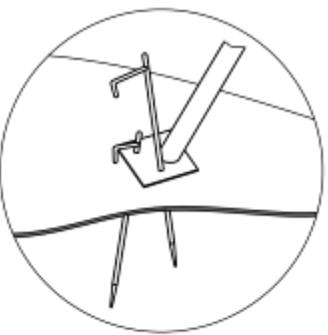
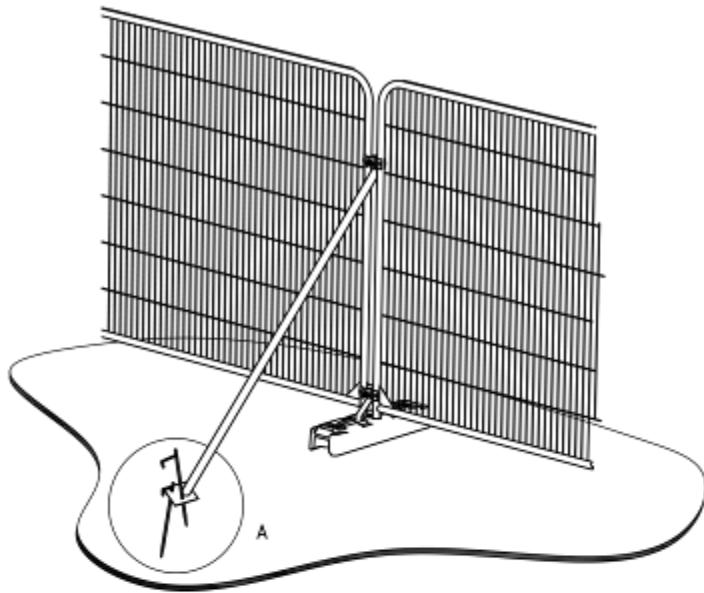
a) Stabilizer strut with base plate secured with ground pins

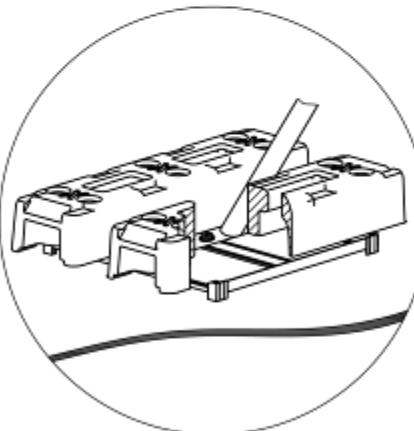
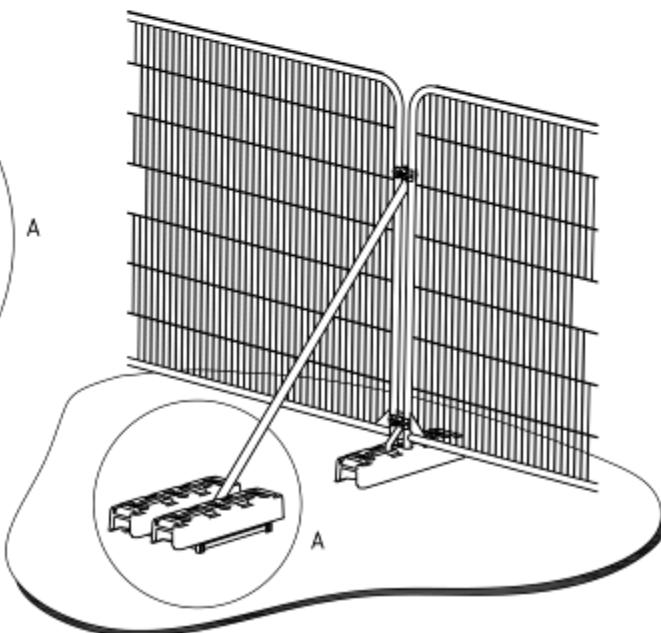
b) Stabilizer strut mounted on block tray

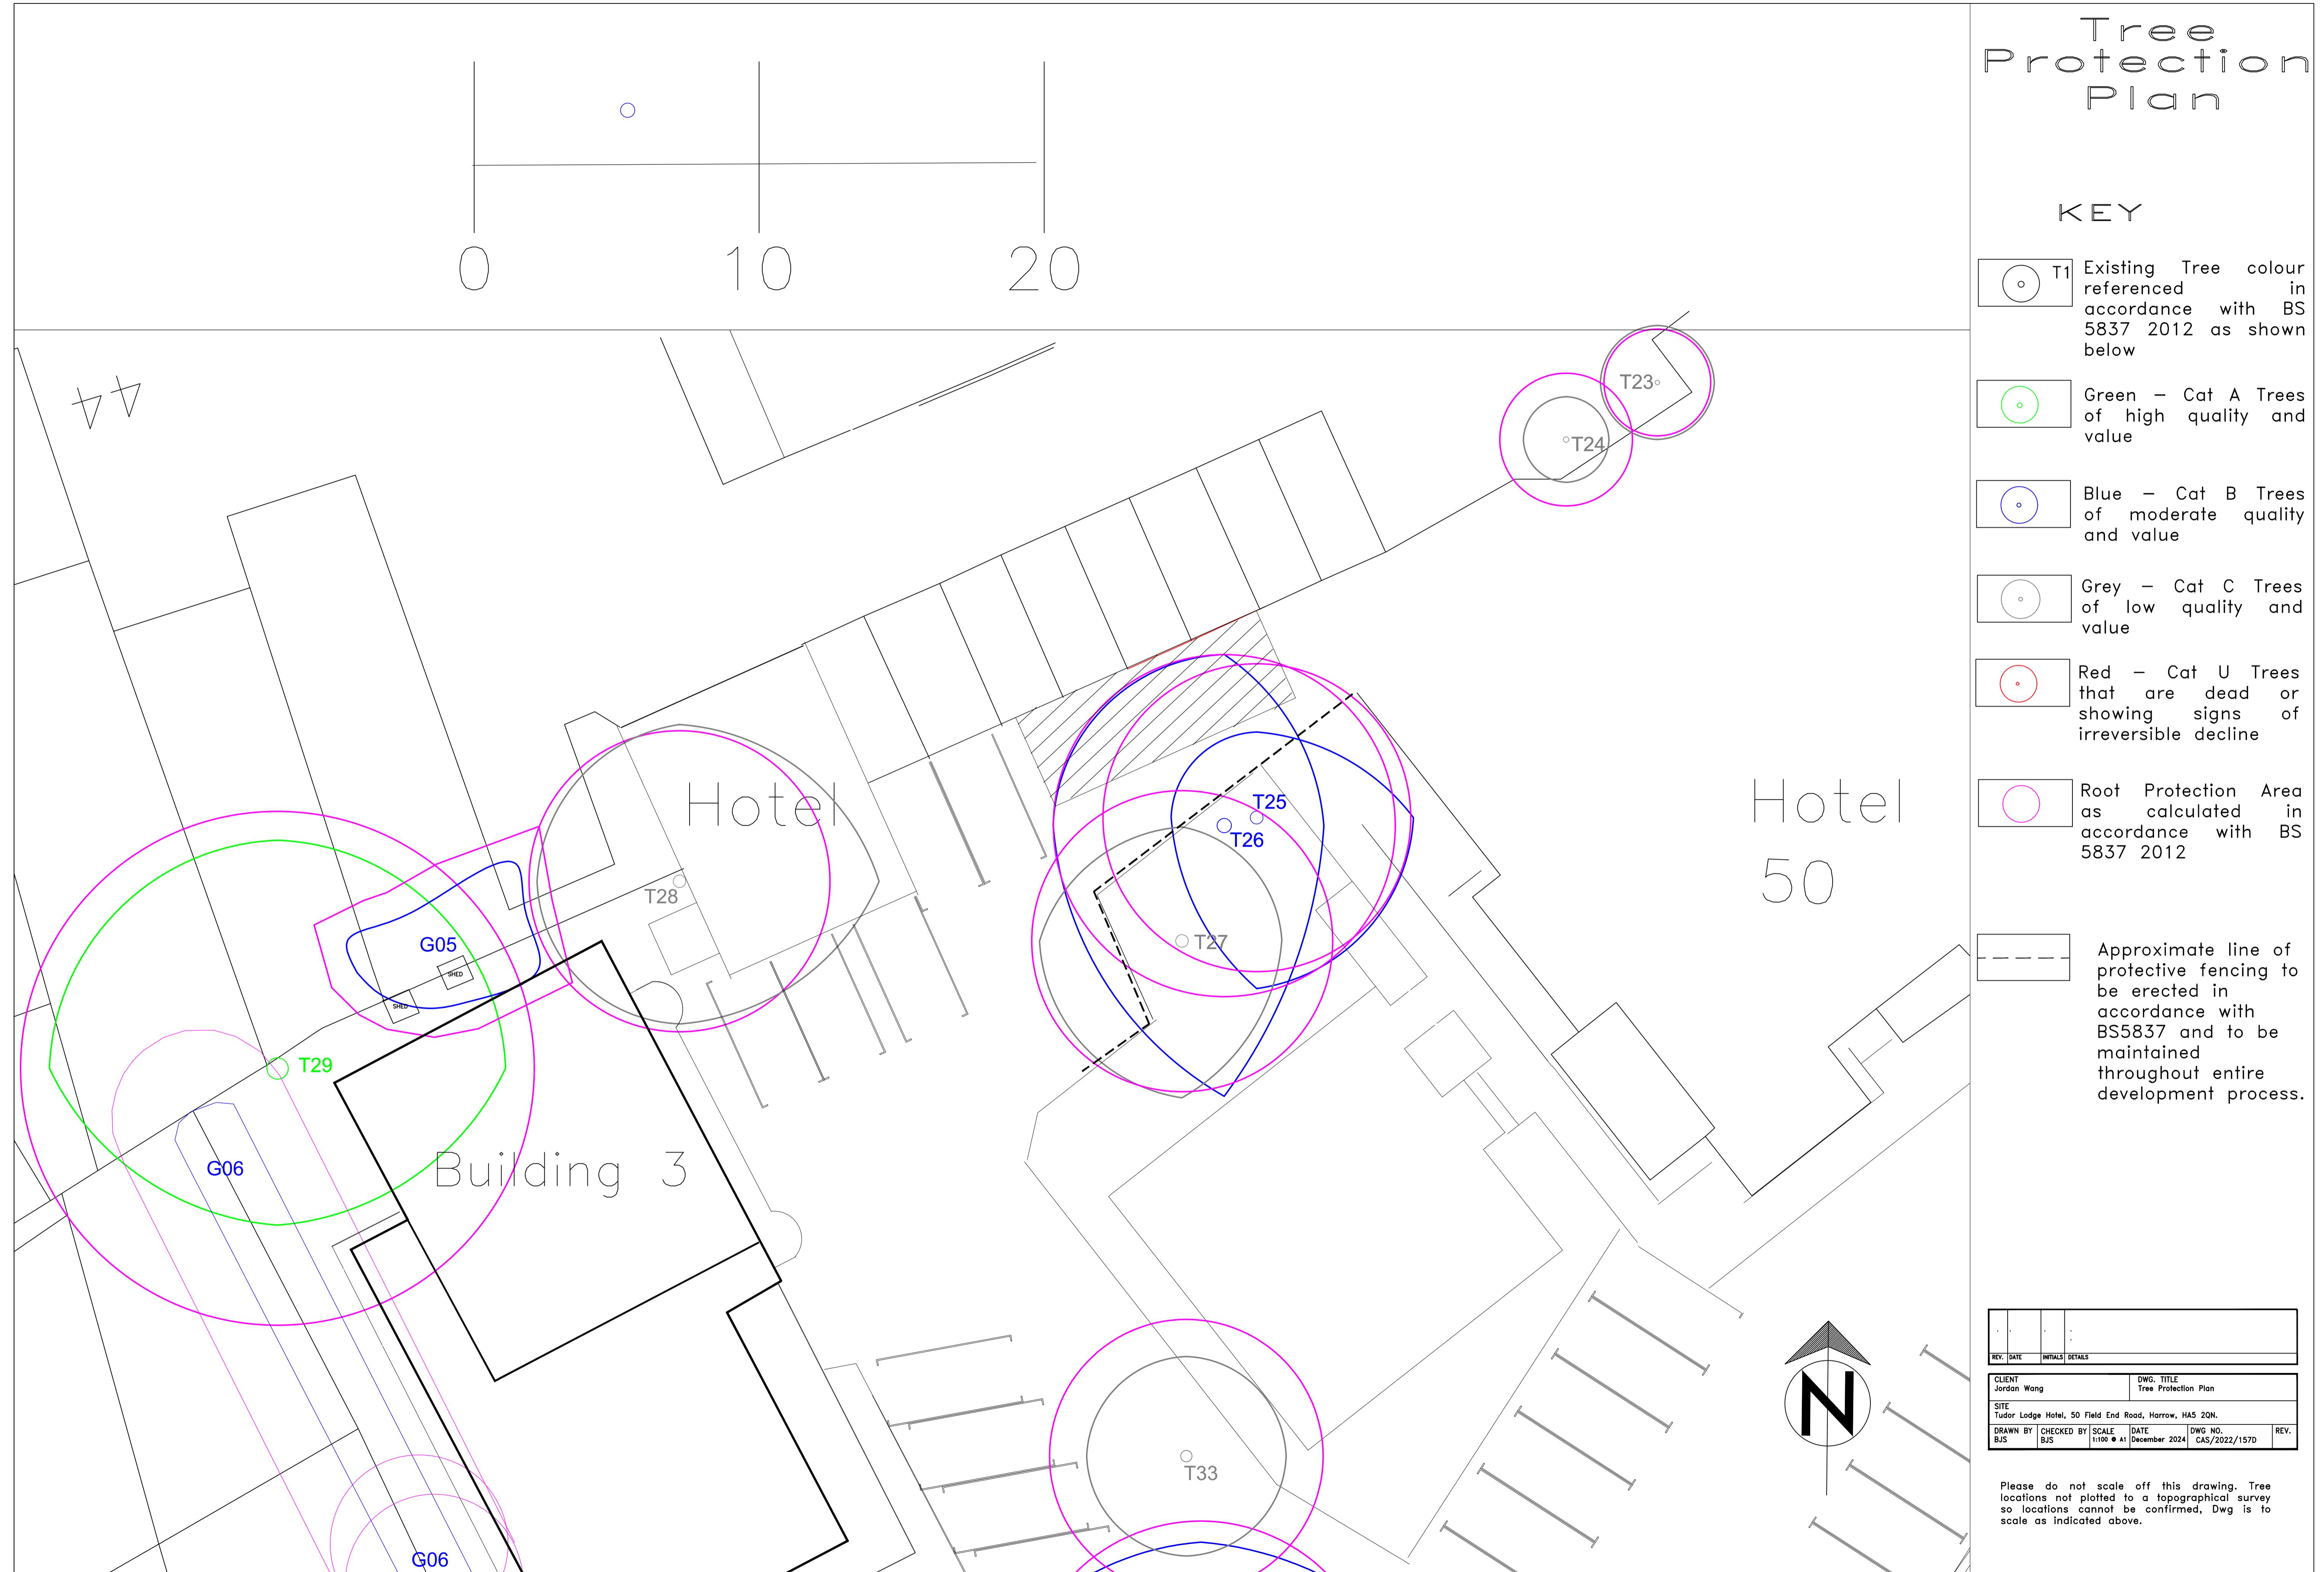
Approximate line of protective fencing to be erected in accordance with BS5837 and to be maintained throughout entire development process.

Therefore, a pre-emptive root pruning trench will be excavated. This must be implemented as outlined in section P4.2 of the Arboricultural Method Statement and where shown on the Tree Protection Plan CAS/2022/157C.

P3.3 Tree protection fencing will be required to be installed as shown on the Tree Protection Plan CAS/2022/157D. Fit for its purpose fencing must be installed after any required tree works and prior to any construction operations on site. Once the barriers have been properly erected in position, they are to be considered as sacrosanct and are not to be removed or altered in any way without prior approval from the LPA.
