# Preliminary Ecological Appraisal Report

**Relating to a development at  
25 St. Martin's Approach  
Ruislip  
Middlesex  
HA4 7QB**

**Ref: 1186(PEAR)01**

**Date: 11 February 2025**

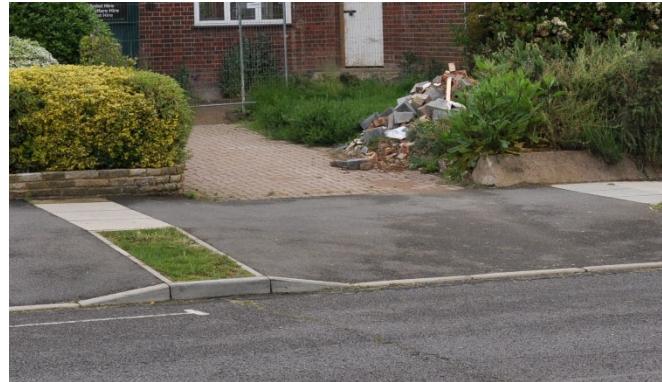
There are areas of hard standing to the south-east. Common ruderals and moss occur occasionally between the interlocking block paving. The front garden consists of a lawned area with perimeter planting to the road edge. The lawned area is supported at the road edge by a concrete retaining wall.

Existing block paving and concrete retaining wall

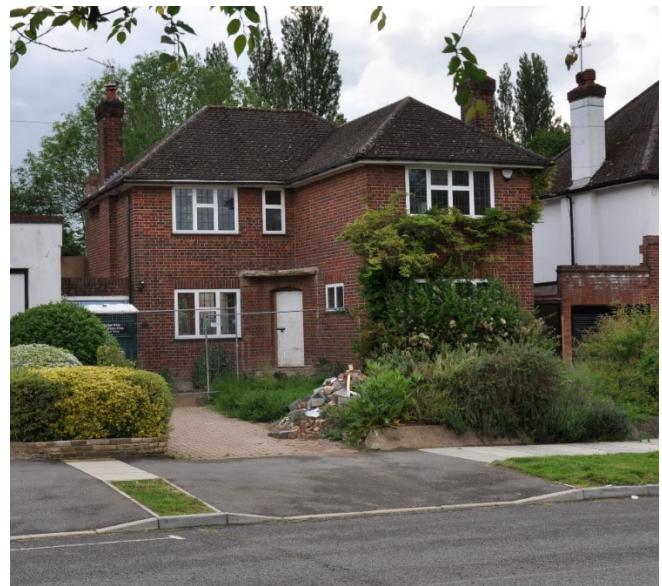
The existing dwelling is a detached is a detached two-storey brick-built building. It has a simple roof structure with hipped, pitched and flat roof sections. The building is currently unoccupied. The windows and external doors are UPVC with timber soffits/ fascia which are all in relatively good condition. The elevation is predominantly a two-storey structure with a flat roof over the garage and entrance porch.

Front Elevation (Southeast Facing)

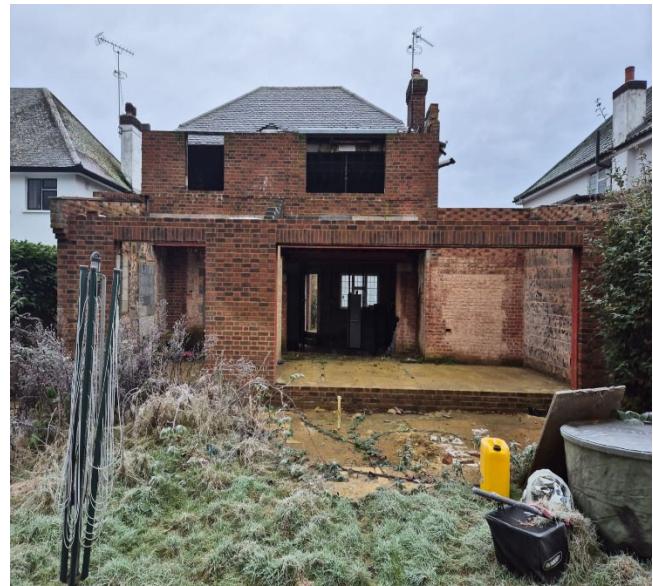
The windows, doors and the mono-pitched roof to the rear elevation have been removed as part of the refurbishment works that were underway before the work was stopped and a planning application submitted in November 2023.

Rear Elevation (Northwest Facing)

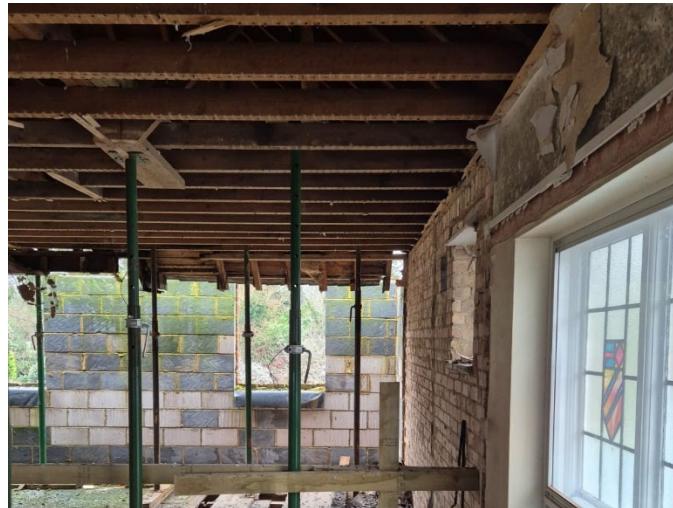
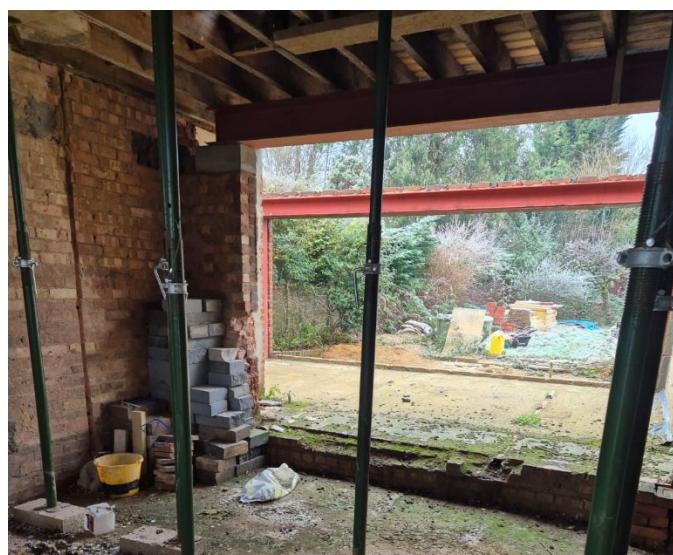
**Interior – Ground and First Floor:**

The ground and first floor of the house is open to the elements at the rear of the house. There is clear evidence that the house has become a roost for pigeons and there is an accumulation of pigeon droppings, including feathers, detritus and debris.

A careful investigation of the accumulated detritus did not contain any evidence of Bat droppings and on the day of the survey there were no pigeons roosting in the house.

There is a significant accumulation of Pigeon droppings which must be cleared prior to any construction work recommencing.

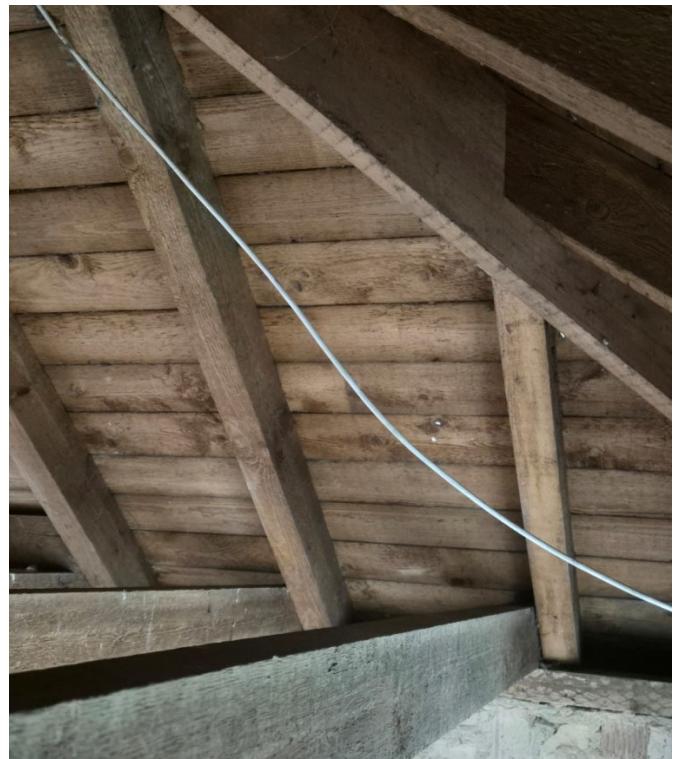
**Interior - Roof and Loft:**

The roof structure is a traditional closed couple roof consisting of timber rafters, purlins, ridge board, ceiling joists and horizontal binders.

A careful investigation of the entire loft space was conducted, there were many cobwebs within the loft void and on the date of the survey no evidence of bat roosting was seen. No bat droppings were found in any of the loft void.
