Phase I
Geo-
Environmental
Report

May 2014

2 Midcroft, Ruislip, HA4 8ES

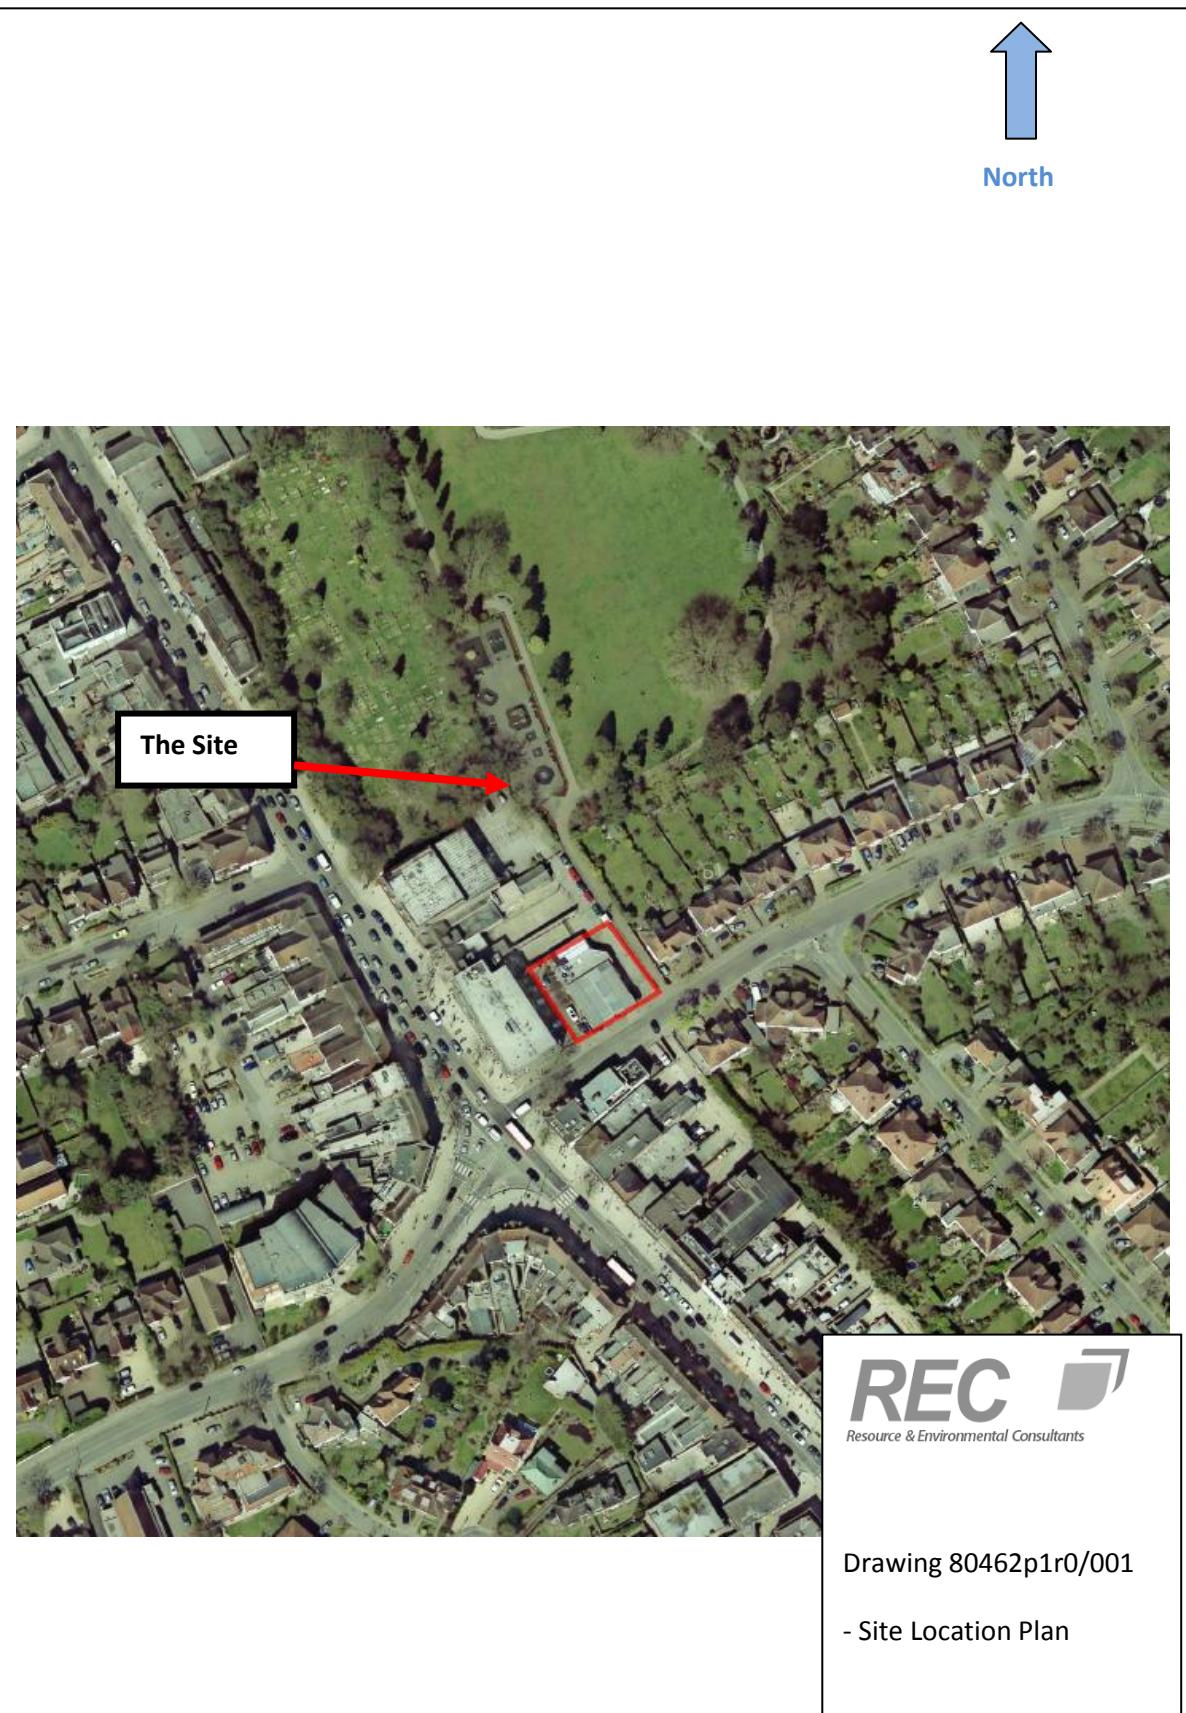
Drawing No 80462p1r0/001 – Site Location Plan

A site location plan is presented in Appendix II as Drawing No 80462p1r0/001.

The main site features are shown on Drawing No 80462p1r0/001 in Appendix II and selected photographs are presented in Appendix III.

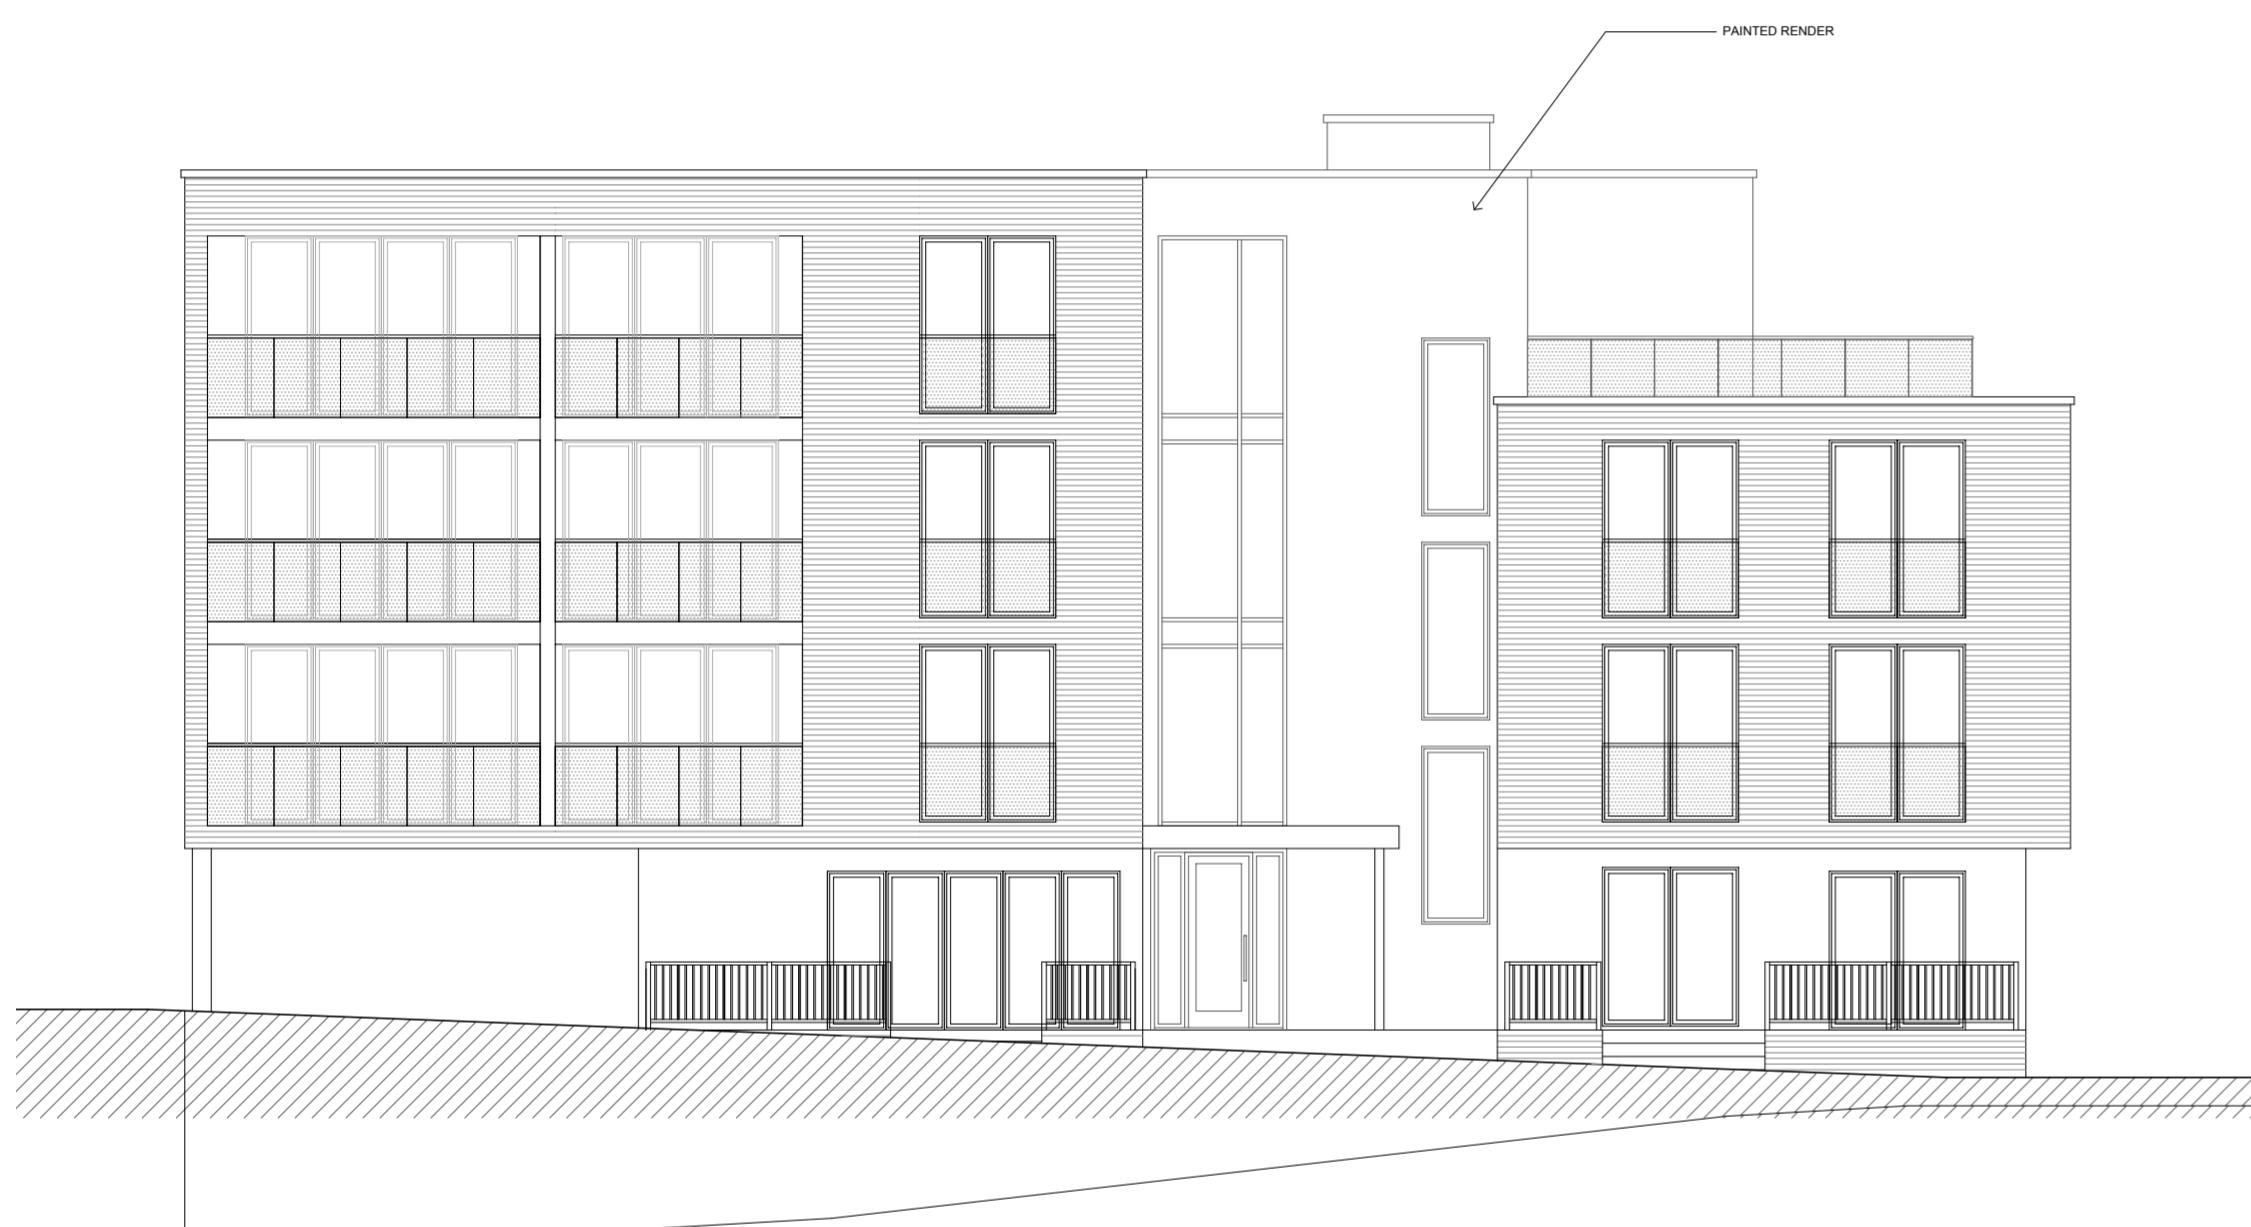
PROPOSED FRONT ELEVATION
SCALE 1:100

The client intends to redevelop the site for a residential end use, comprising of a new residential building arranged over four floors with 14 flats, two commercial units at the ground floor level and underground car parking. The works will include the demolition of existing petrol station and removal of underground fuel storage tanks. A proposed layout plan for the site is presented within Appendix II, as SCP Architects Ltd drawing no. S201, Rev F.

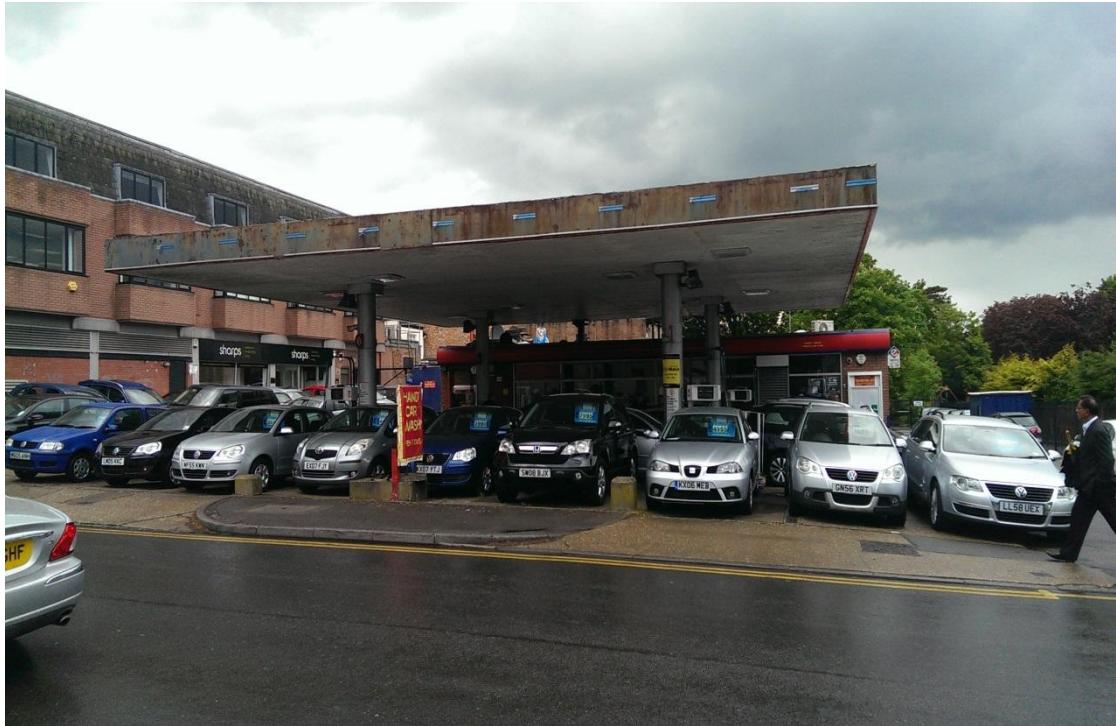
The site is covered in concrete hardstanding which was noted to be heavily worn in some areas which may have allowed surface water run-off and infiltration into shallow made ground beneath the site. A drainage gully was noted on site to collect surface water run off and four manhole covers associated with an oil water interceptor were noted on the western central section of the site as well.

PLATE 1 – VIEW OF SITE FROM MIDCROFT STREET

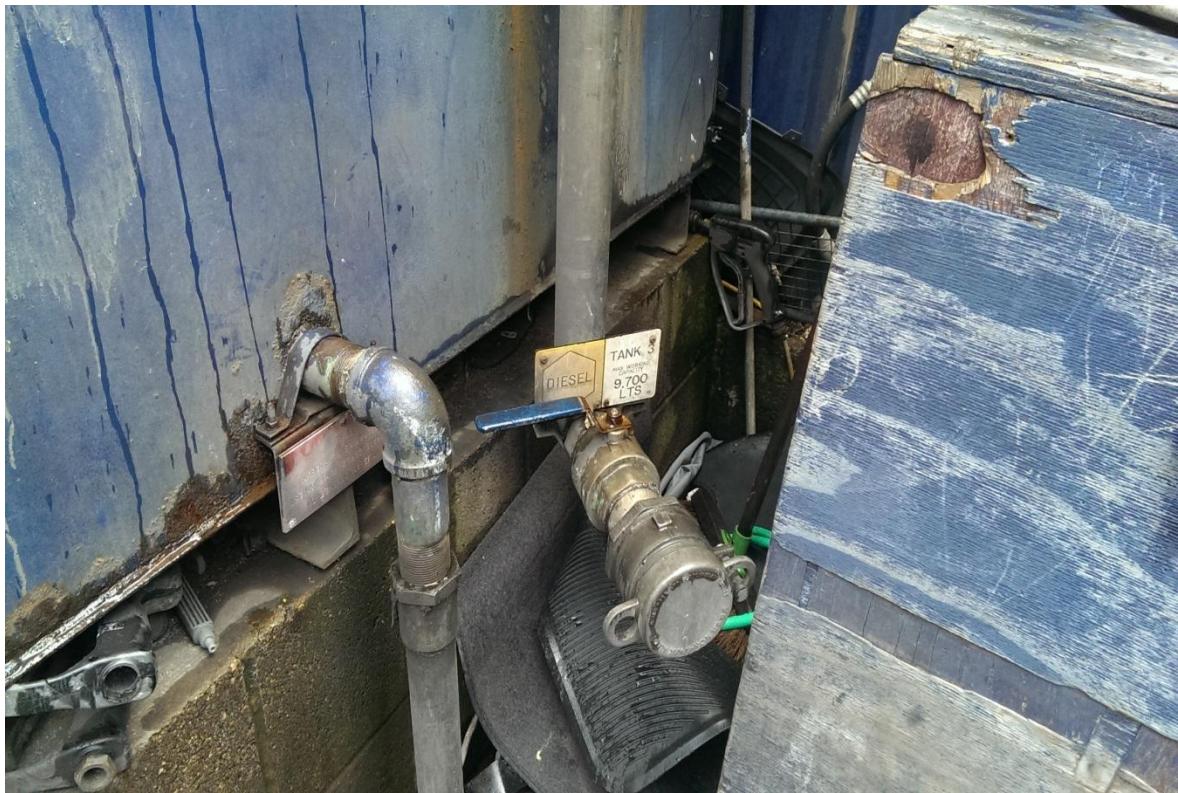
A single above ground storage tank (AST) was noted at the rear of the site, in the north-west corner. This was an 11,000 litre metal diesel tank and fed a filling point located on the western side of the petrol station building. Evidence of hydrocarbon spillage on the surface of this site and into the surface water drainage was observed.

PLATE 4 – DIESEL TANK ON SITE

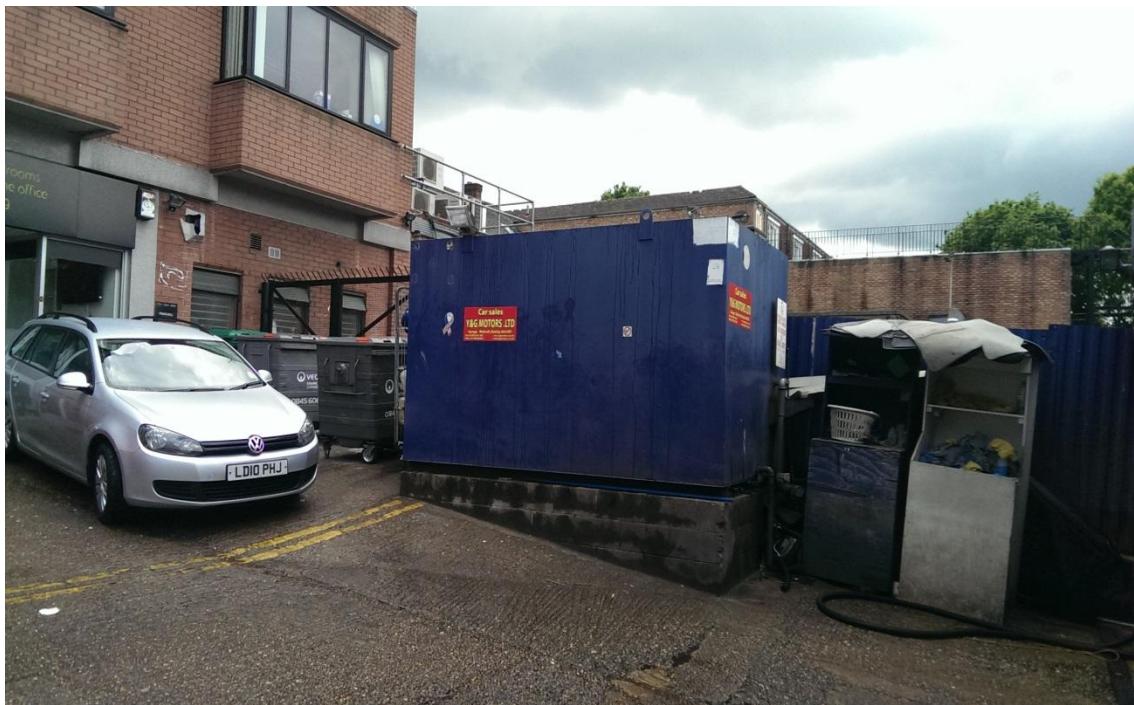
PLATE 5 – DIESEL AST ON SITE

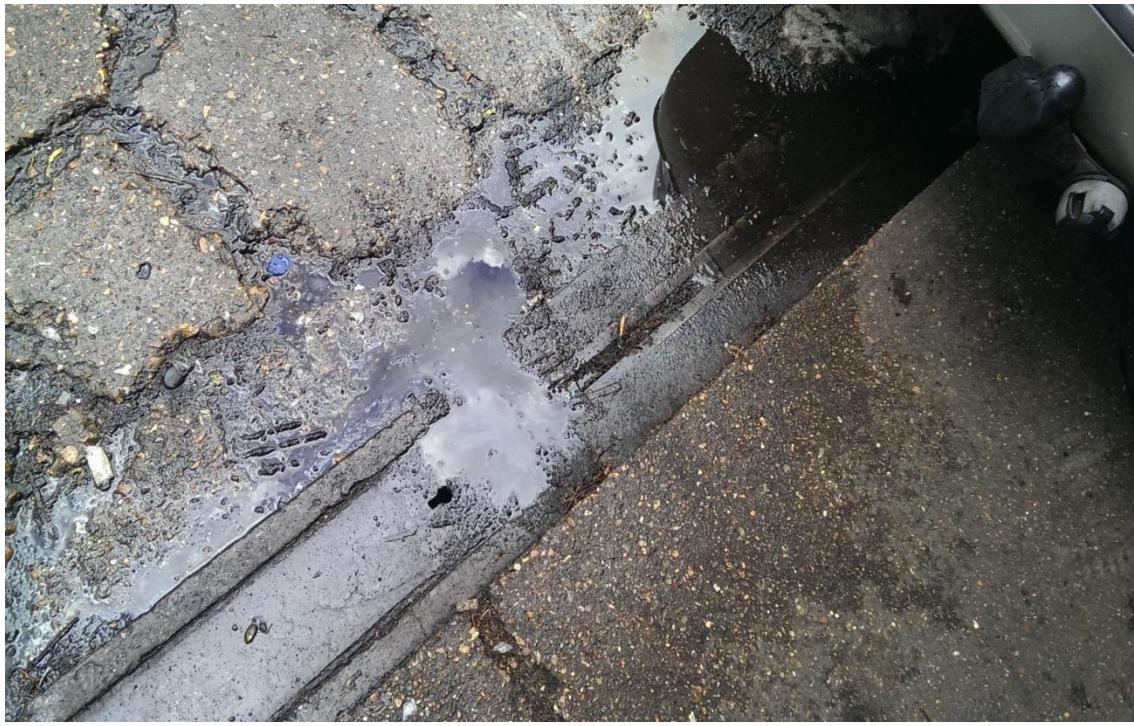
PLATE 6 – POTENTIAL HYDROCARBON SPILLAGE FROM DIESEL TANK

Moderate to High
Recommendations	<p>A detailed Phase II intrusive Geo-Environmental ground investigation should be undertaken in order to confirm the findings of the initial conceptual site model, to determine foundation design and to assess the underlying clay for its susceptibility to heave / swell.</p> <p>A Remediation Strategy (RS) for the site will be required. The degree of remediation required will be governed by the contamination impact encountered during the Phase II ground investigation. In addition a Material Management Plan (MMP) should be developed to ensure a cost effective and regulatory compliant approach to enabling works.</p> <p>A full set of service drawings should be obtained for the site prior to any intrusive works being undertaken. The intrusive works will return site investigation information with a higher degree of confidence if unobstructed access to the whole site area can be obtained (free of parked vehicles) prior to the Phase II intrusive works being undertaken.</p>

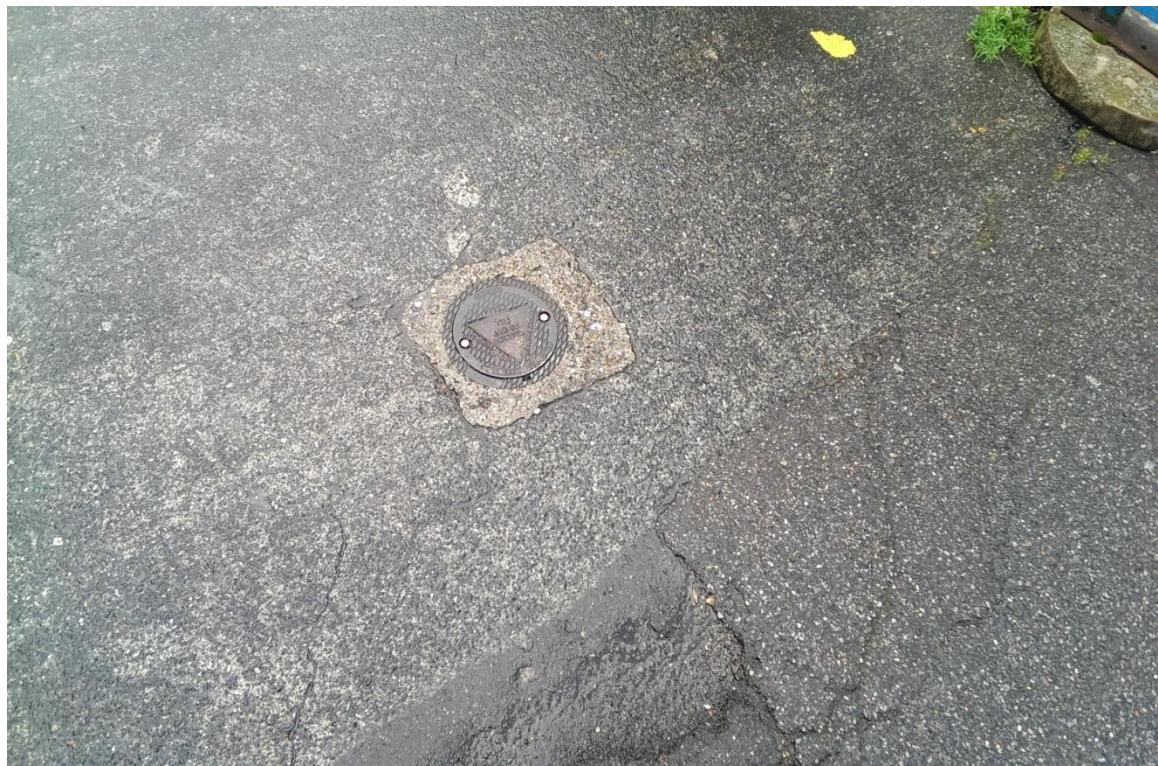
PLATE 10 – BOREHOLE LOCATION ON SITE
