Resilience and
Flood Risk

FLOOD RISK ASSESSMENT

RAB: 2519B

RAB Consultants has prepared this Flood Risk Assessment (FRA) in support of the proposed residential development at 2 Midcroft, Ruislip, HA4 8ES.

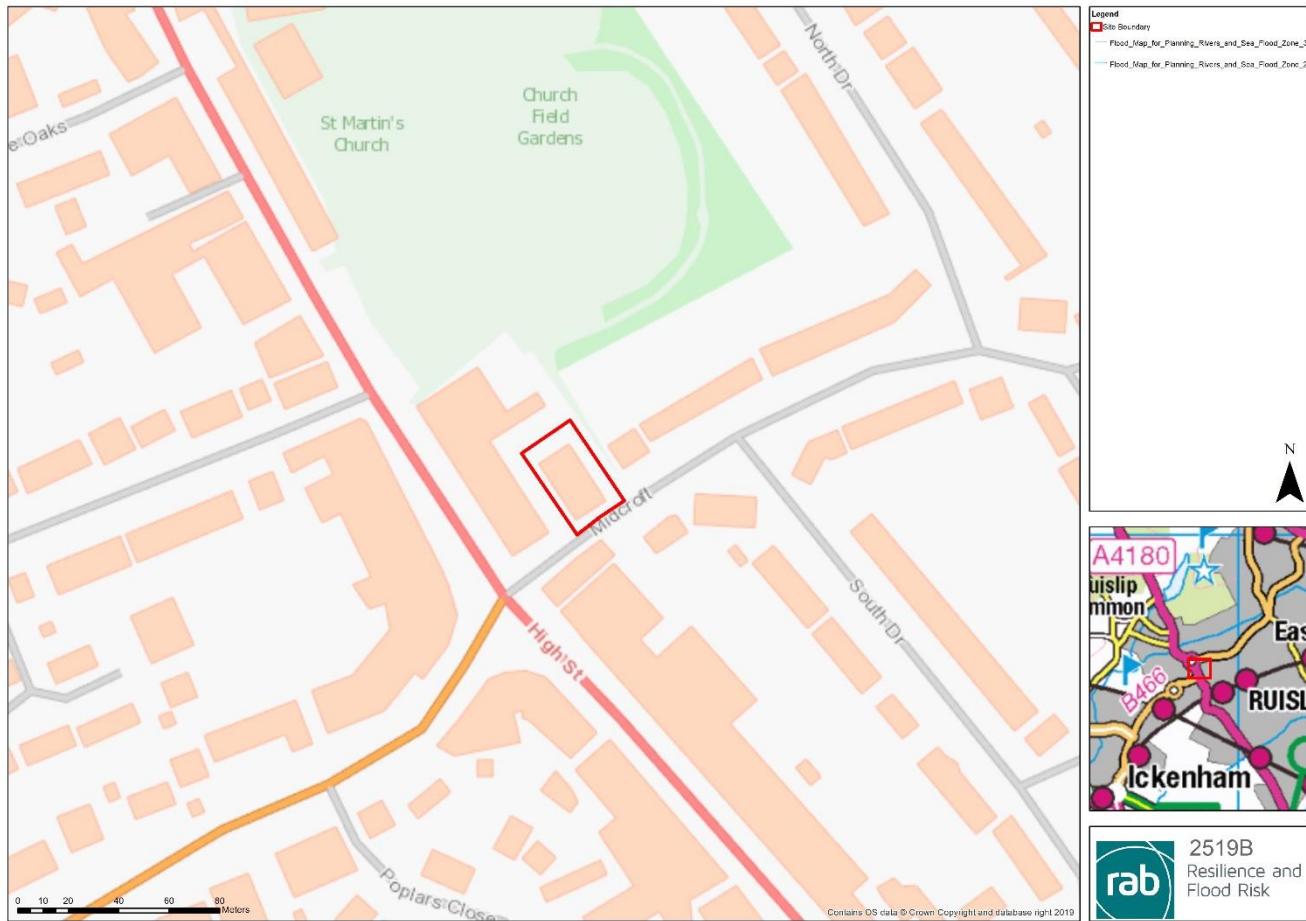
FIGURE 1: ENVIRONMENT AGENCY FLOOD MAP FOR PLANNING

According to the Environment Agency's Flood Map for Planning the site lies in Flood Zone 1, which is described in the NPPF as land having a less than 1 in 1,000 annual probability of river or sea flooding (less than 0.1% AEP).

According to the Environment Agency Flood Map for Planning, the site is located in Flood Zone 1 therefore has less than 0.1% AEP risk of flooding from this source.

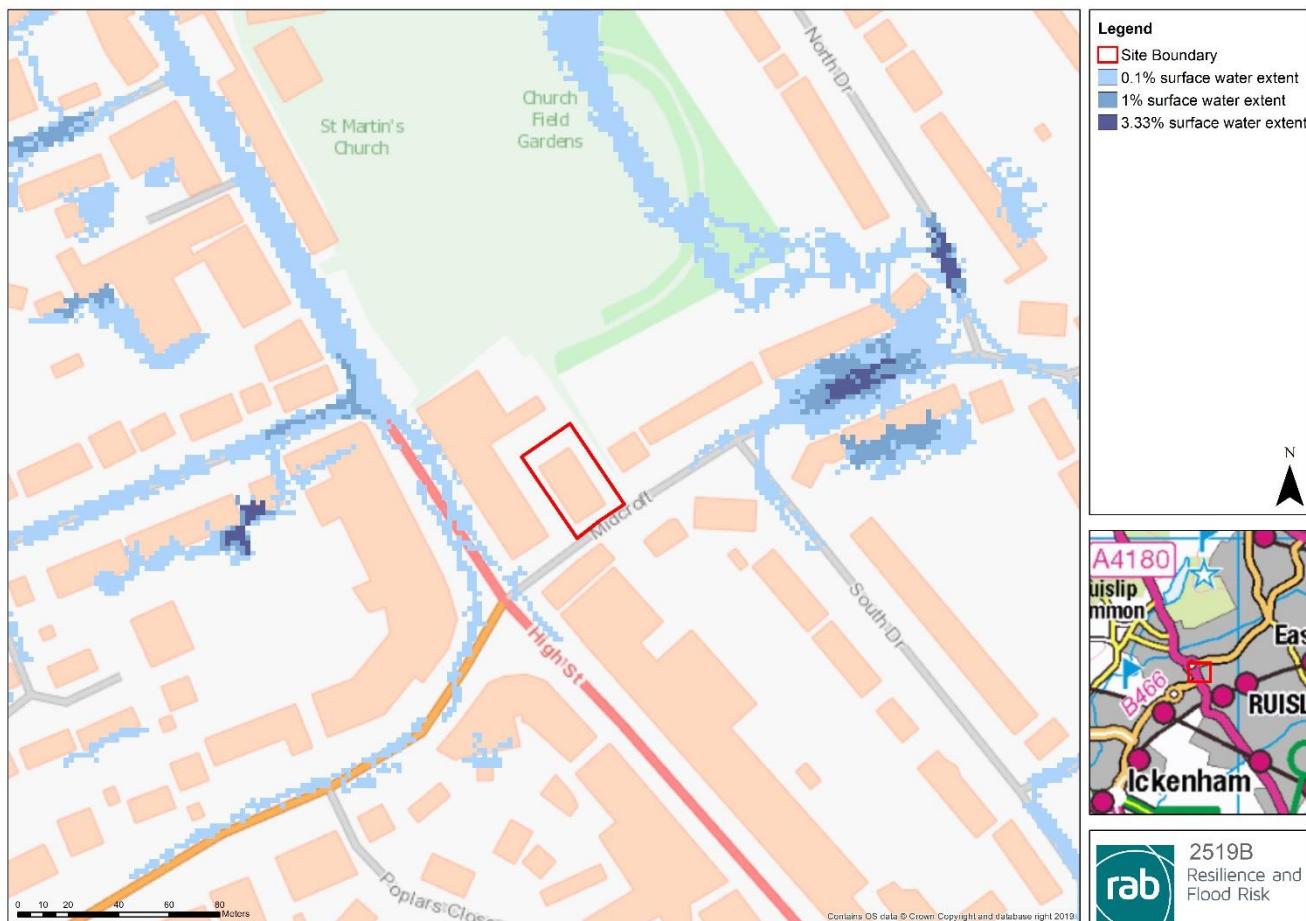
FIGURE 2: ENVIRONMENT AGENCY FLOOD RISK FROM SURFACE WATER

The Environment Agency Flood Map for Surface Water (Figure 2), can be used to see the approximate areas that would experience surface water flooding from a range of AEPs, which is used to categorise the risk (Table 2).

The site and access are shown to be at very low risk from surface water flooding.

During the 3.33% AEP, 1% AEP and 0.1% AEP surface water events the site is shown not to flood (Table 3).

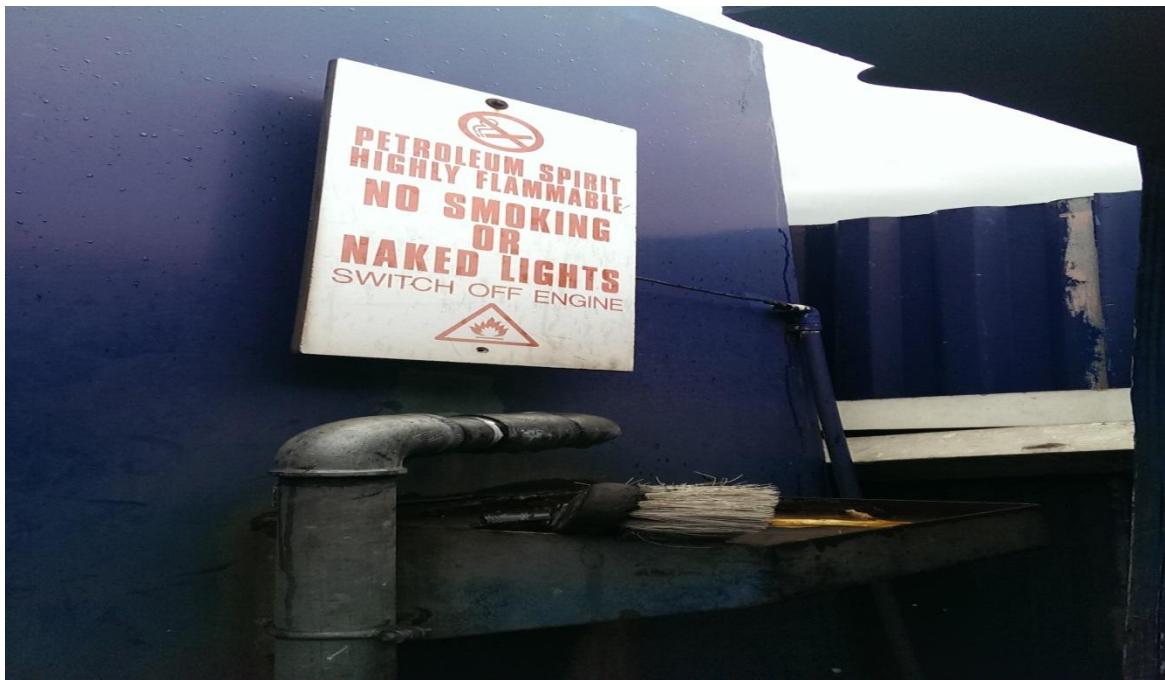
PLATE 3 – TANK PRESENT ON SITE

A single above ground storage tank (AST) was noted at the rear of the site, in the north-west corner. This was an 11,000 litre metal diesel tank and fed a filling point located on the western side of the petrol station building. Evidence of hydrocarbon spillage on the surface of this site and into the surface water drainage was observed.

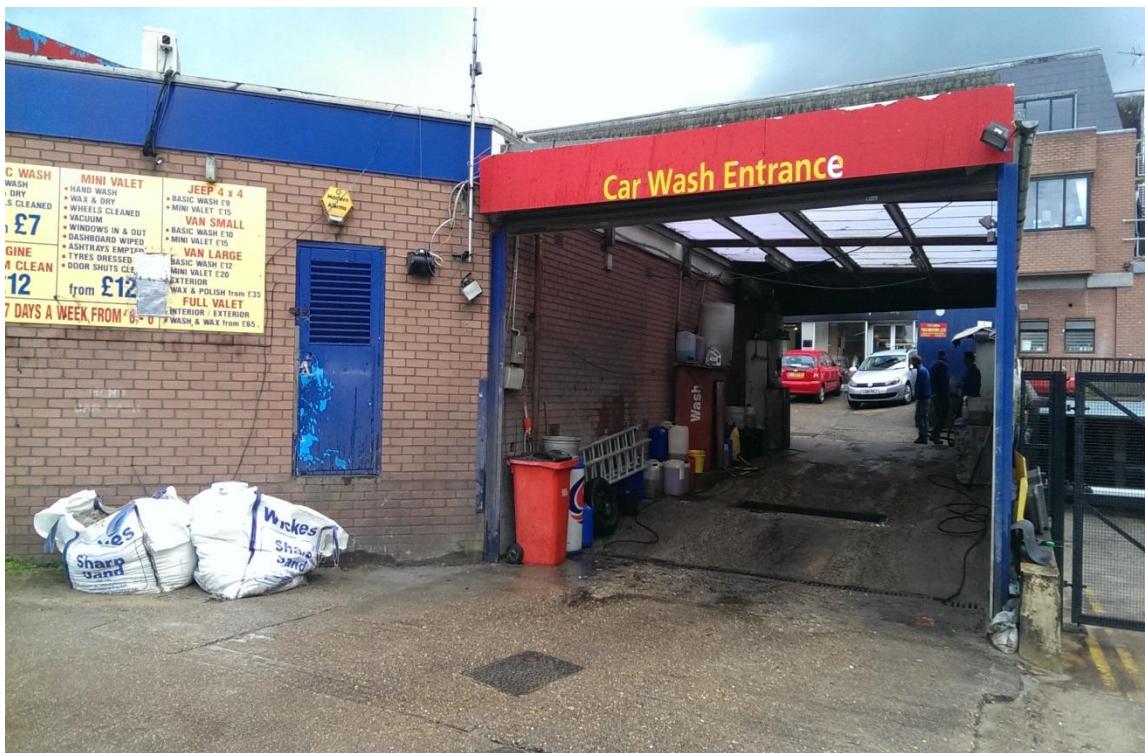
PLATE 8 – CAR WASH AREA

The chemicals used for the washing of cars on site may also be hazardous in nature. A full inventory of these materials was not undertaken by REC as the car wash was in operation at the time of the site walkover.
