Re: Manor Lodge, Northwood – Ground Investigation

Erda Associates Ltd. were requested by Merchant Land Investments Limited. (hereafter referred to as the client) to undertake a ground investigation at the subject site to assess the risk of potentially contaminated soils at the site known as *Manor Lodge, Northwood*.

Manor Lodge Rickmansworth Road, Northwood, HA6 2QT

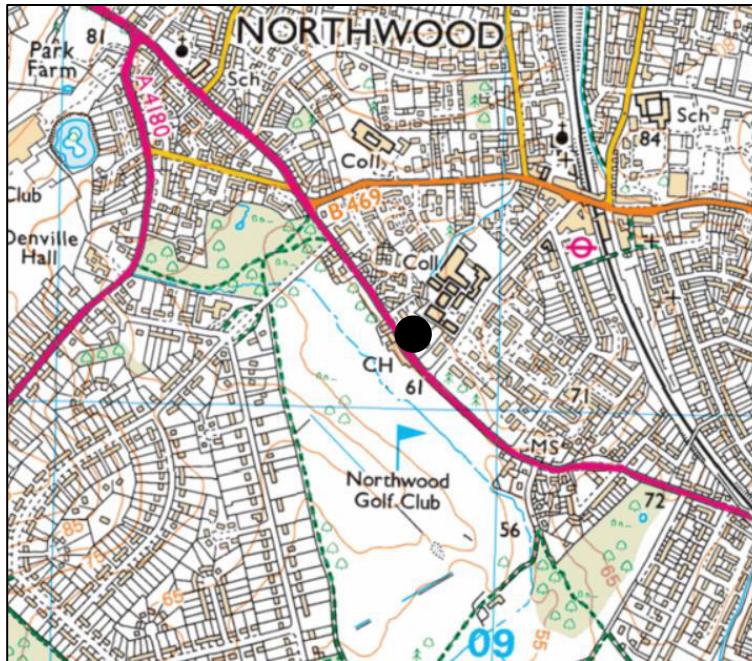
DWG No:
Figure 1

Site Location Plan

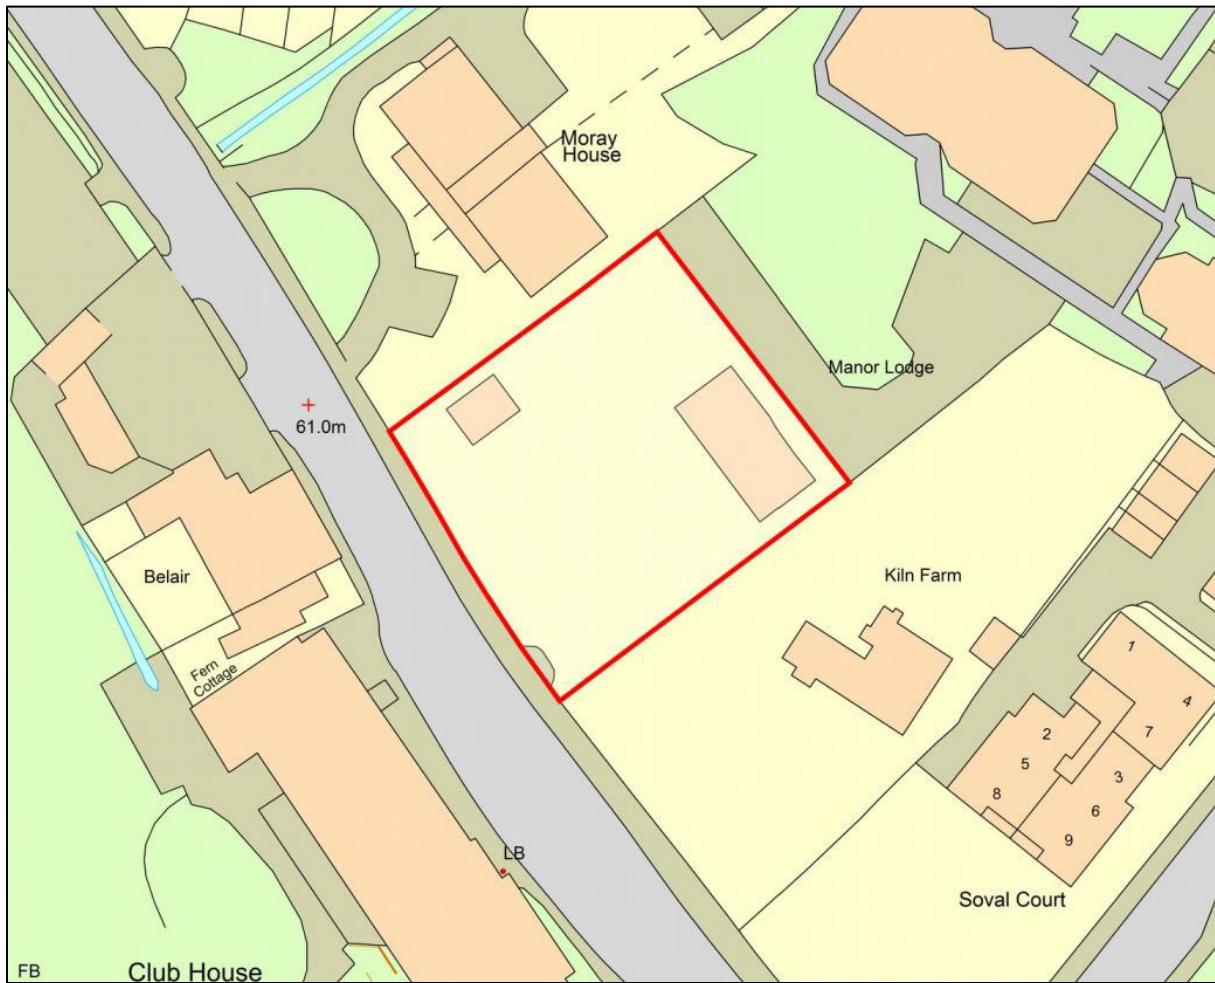
Figure 2

Site Layout

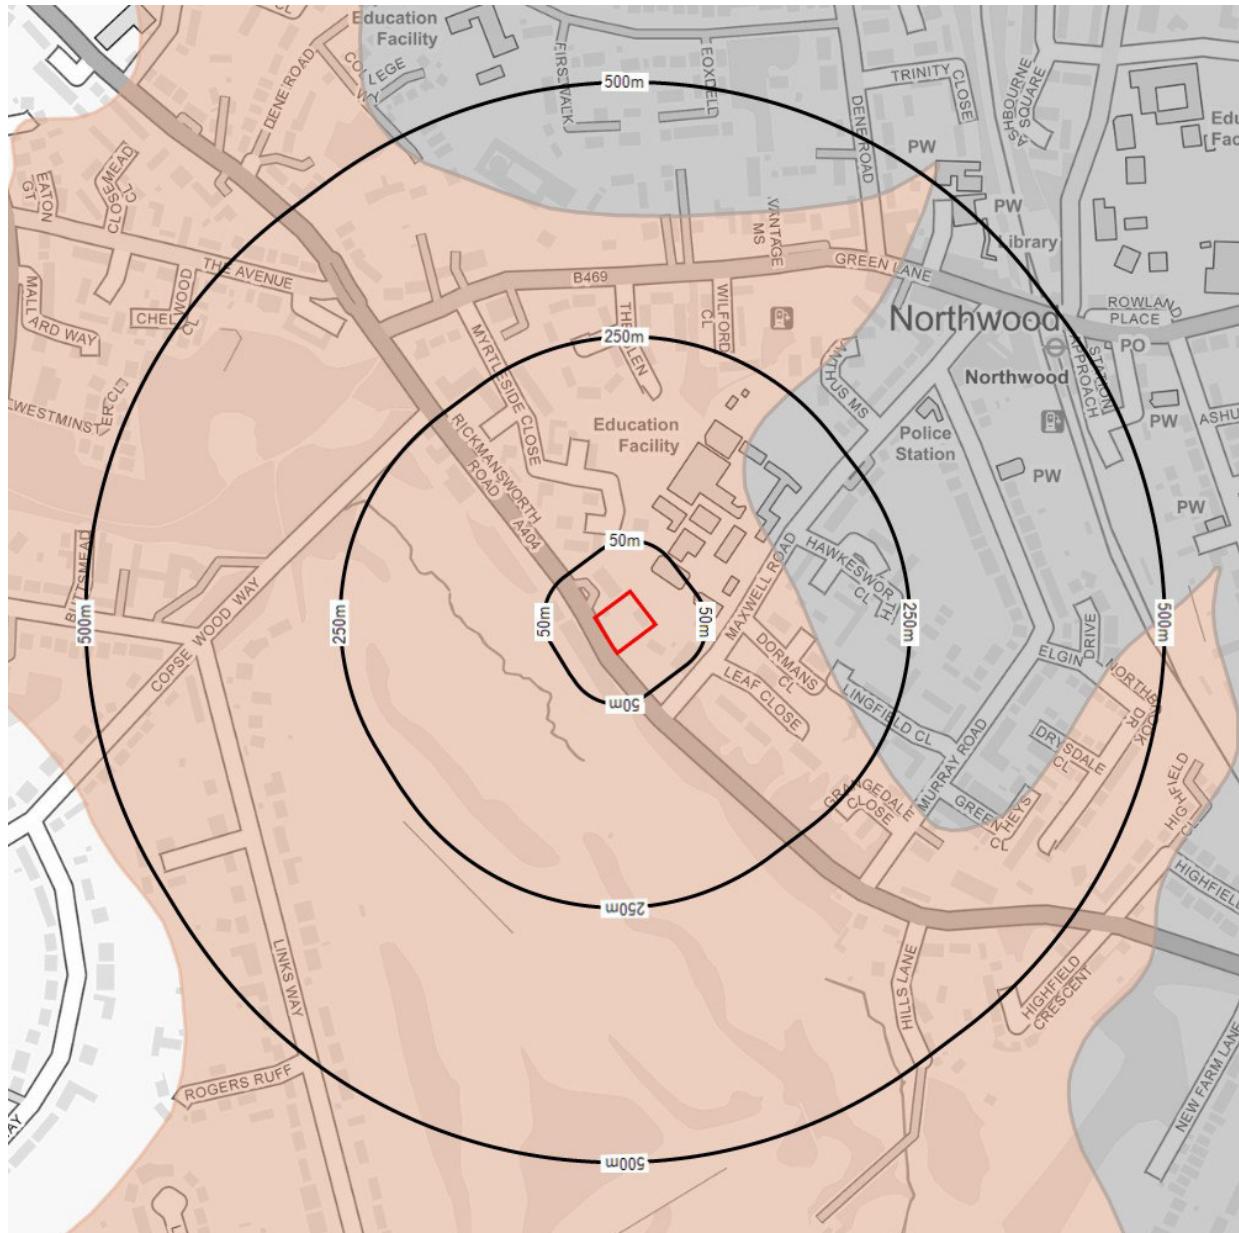
Bedrock

No superficial deposits have been identified underlying the Site. The bedrock hydrogeology is classified as a Secondary Aquifer - A.

- ◆ Site
- Principal Aquifer
- Secondary Aquifer A
- Secondary Aquifer B

- Secondary Aquifer Undifferentiated
- Unproductive Strata
- Unknown

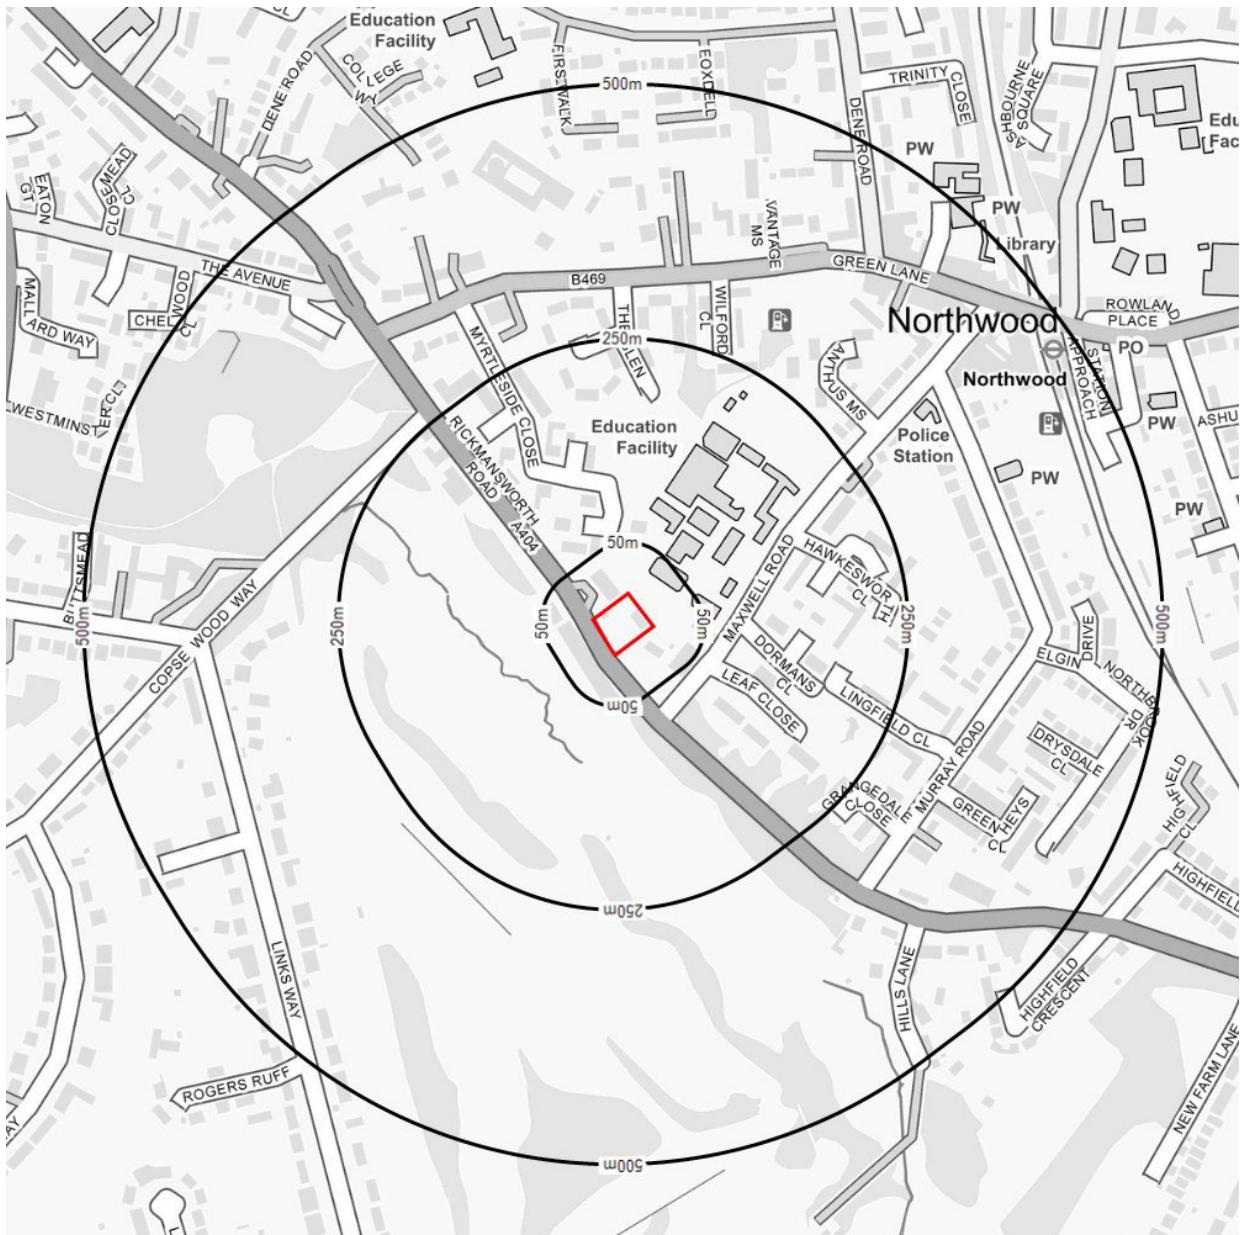
Flood Risk: River and Coastal (map 1)

- Site (Red Diamond)
- Flood Zone 3 (Blue Hatched)
- Flood Defences (Red Dashed Line)

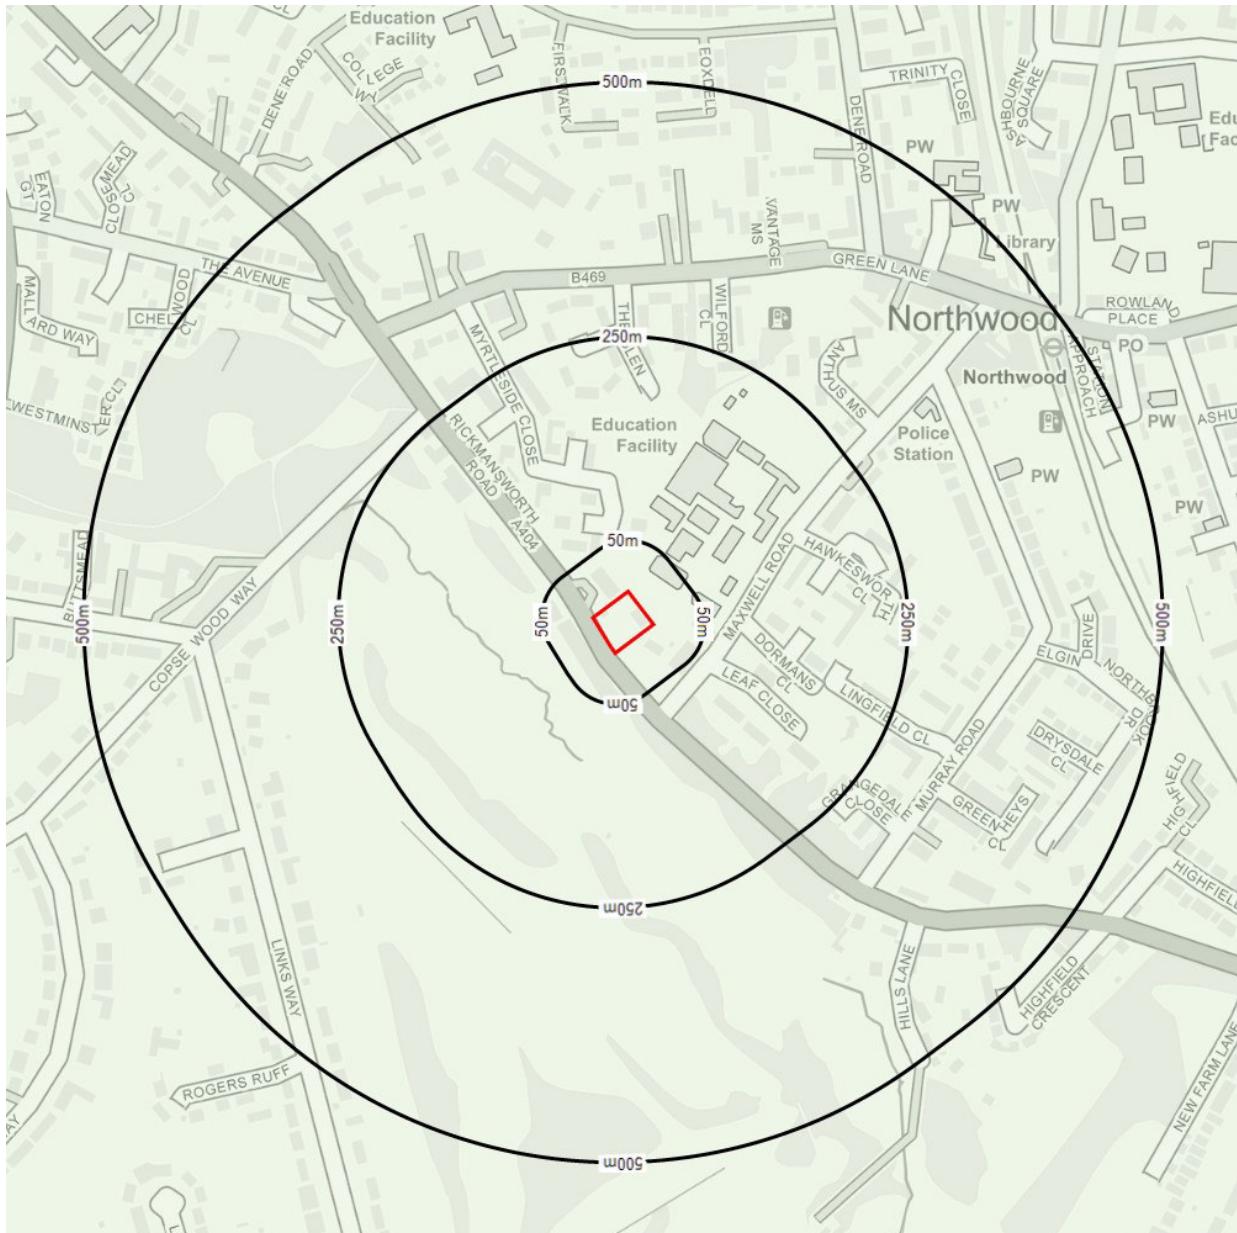
Flood Risk: Groundwater

- Site (Red Diamond)
- High Risk (Dark Green)
- Moderate Risk (Light Green)

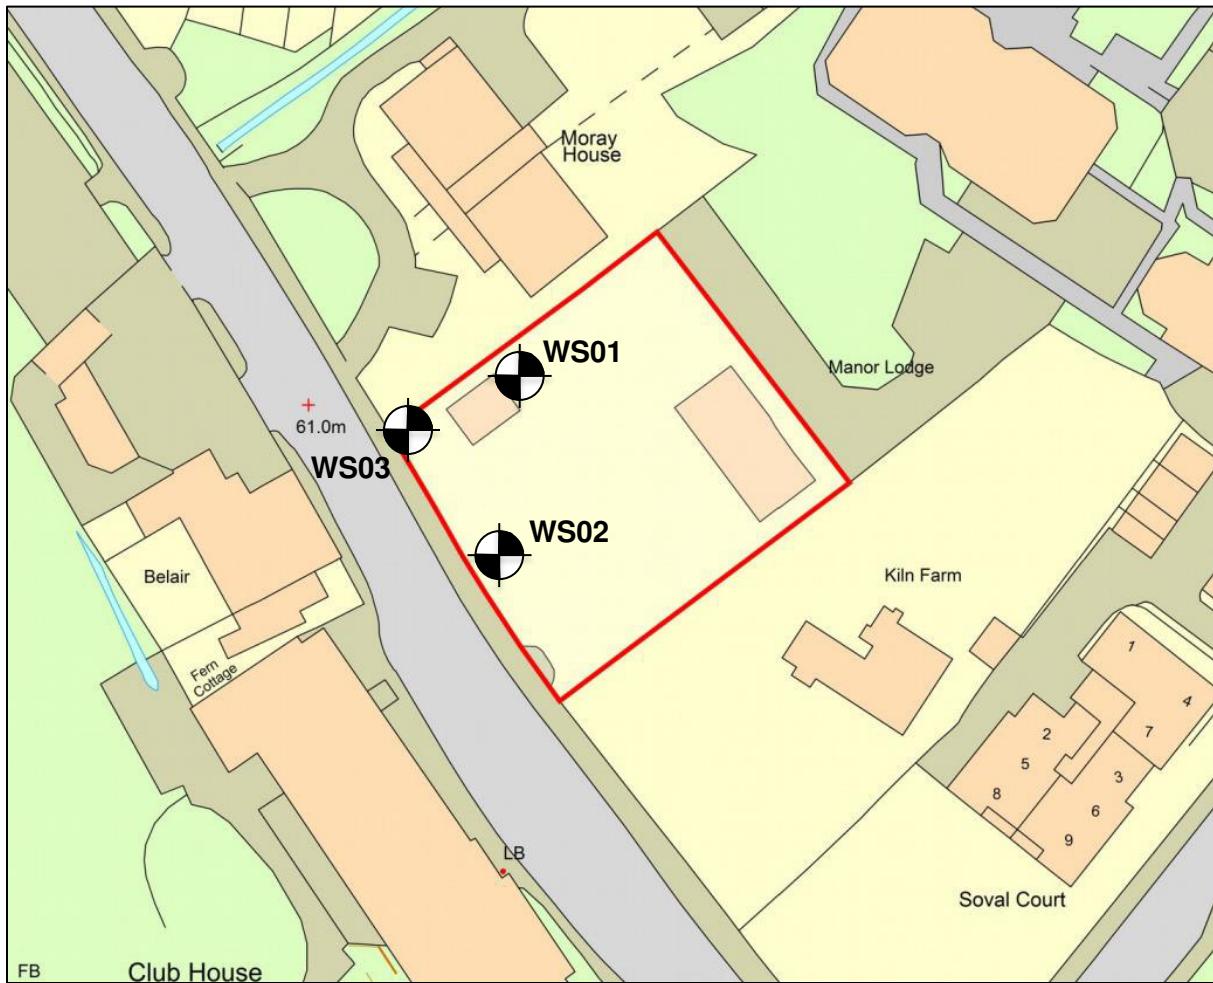
Proposed WS Borehole

Three window sample boreholes were advanced to a maximum depth of 5.00mbgl in the eastern part of the site to assess the potential presence of contamination. A total of nine shallow soil samples were retrieved and sent for analysis at a UKAS/MCERTS accredited laboratory.

An exploratory hole location plan and exploratory hole logs are included in **Appendix C**.
