**Arboricultural Method Statement & Tree Protection Plan – In
Accordance with BS 5837:2012**

Proj. No 10443	37 St Martins Approach, Ruislip, HA4 7QH		
Client:		Daniel Patel	
Date of Report:	04/09/2023	Revision:	Original

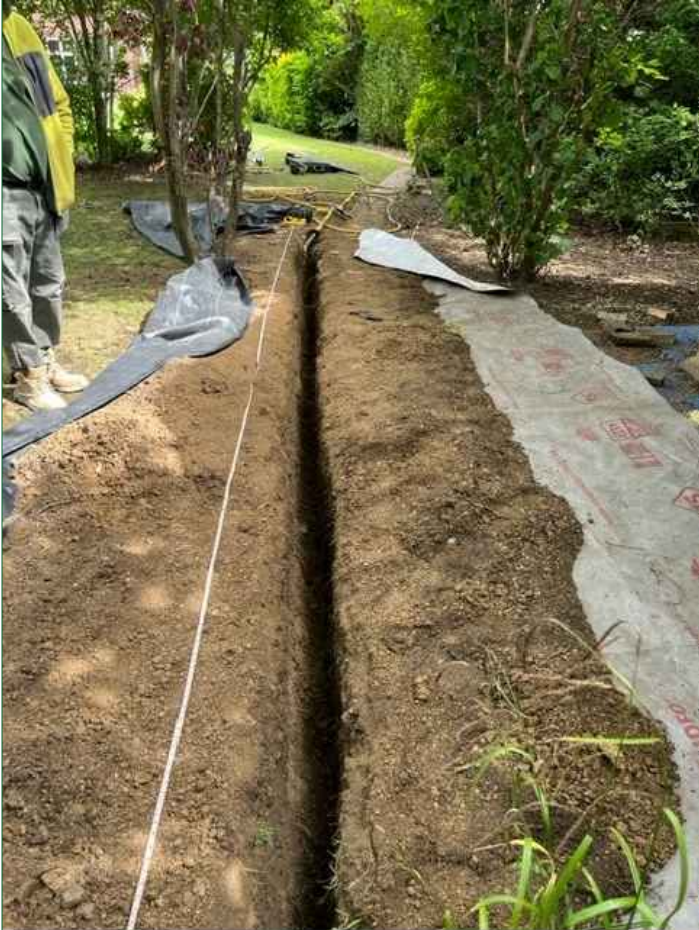
01 - Location of 8m trench excavated by air-spade to a depth of 0.7m, 0.3m beyond footprint of approved garden office.

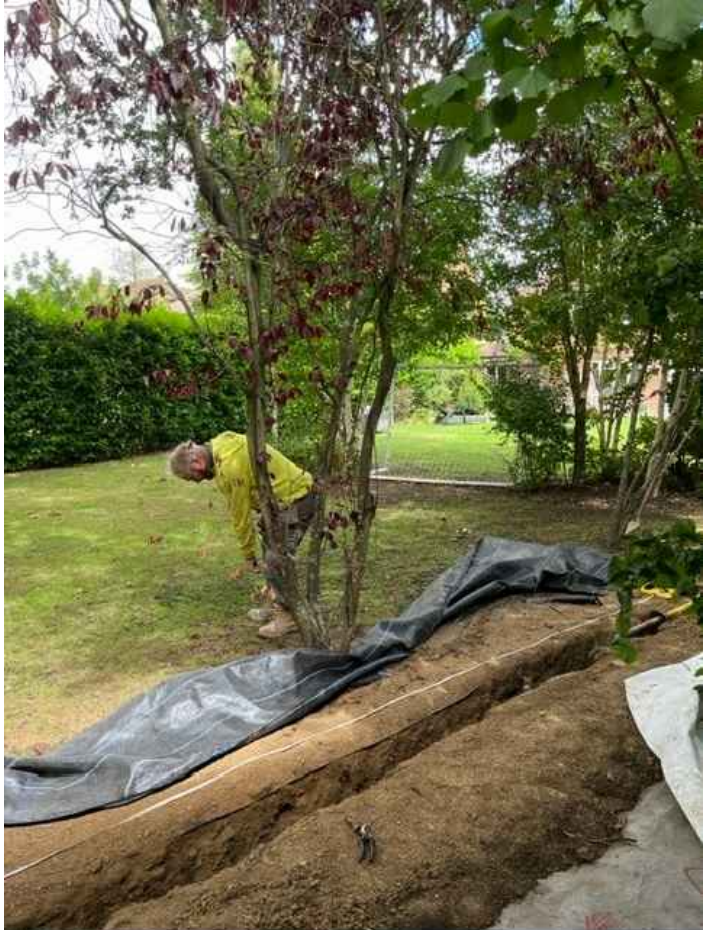
02 - Multi-stemmed Purple Plum to north of trench

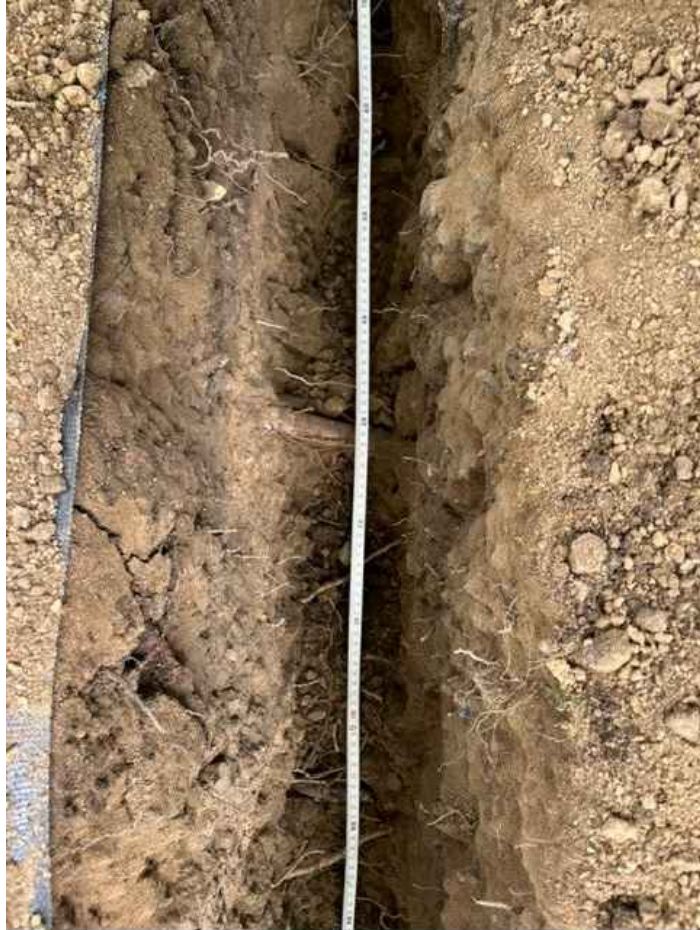
03 - 1x 3cm diameter Oak root located at 4.5m along trench from west aspect

2.8.2 Shown on the attached drawing no. 10443-D-ASI, which is included at Appendix H, are the findings of the secondary investigations undertaken on 1st August 2023. As can be seen, only one Oak root measuring 3cm in diameter was unearthed during excavation of the exploratory trench. Given only a single Oak root was exposed, it is considered this can be severed and traditional foundations installed without having an adverse impact on the longevity of T003.

2.8.3 The root will therefore be pruned back to the side wall of the trench by making a clean cut with suitable sharp tools such as bypass secateurs or pruning saw. A suitable root barrier will then be inserted to prevent both the chemical contamination to roots and the future risk of root damage to the structure.

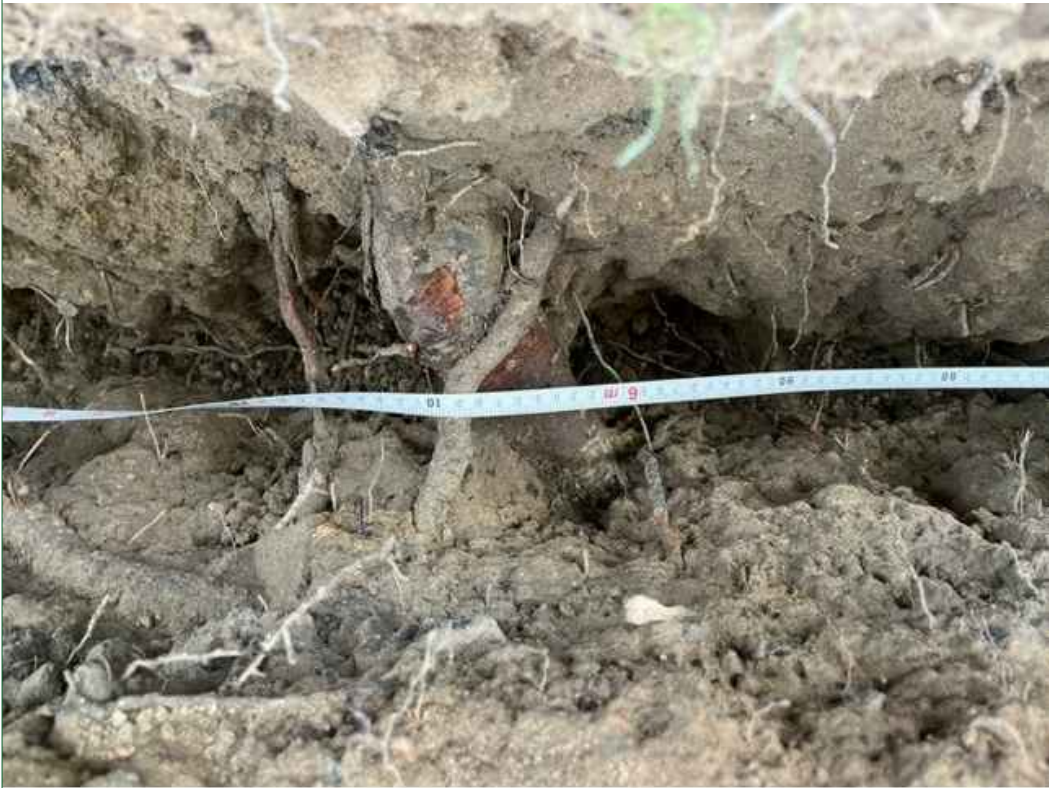
04 - 1x 6cm and 2x 2cm diameter Purple Plum roots located at 6m along trench from west aspect and directly south of Purple Plum in A001

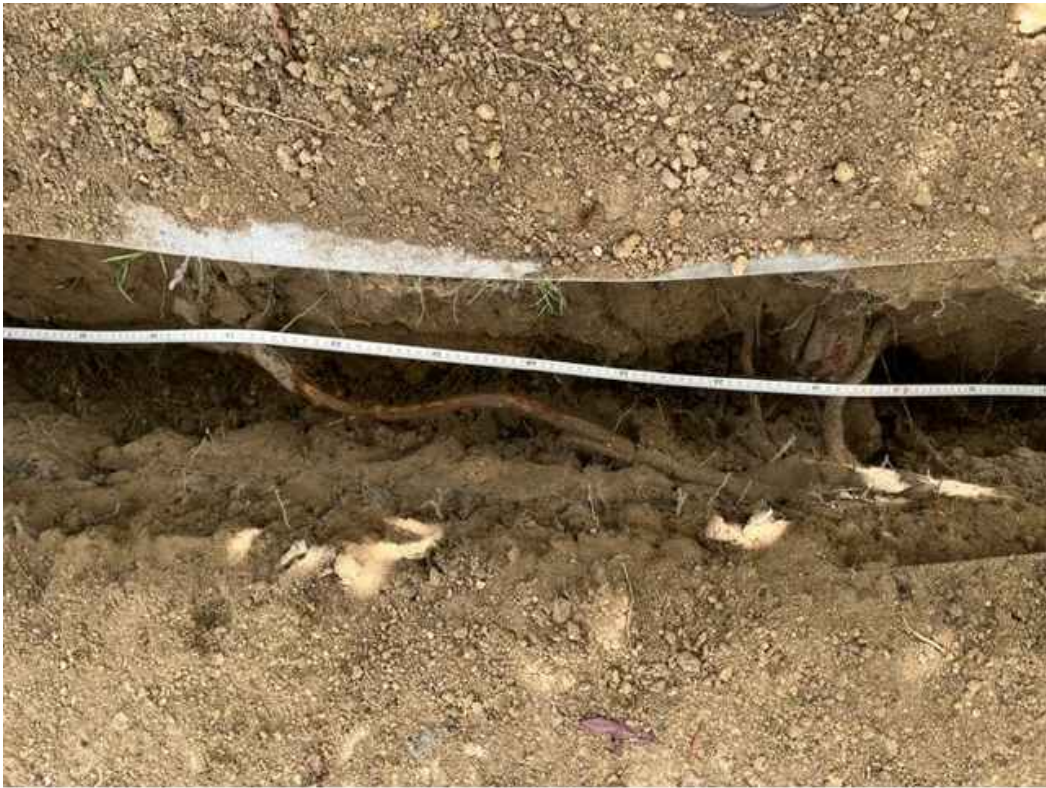
05 - Same roots as Photo 4
