## Preliminary Ecological Appraisal and Preliminary Roost Assessment

Unit 1, Caxton Trading Estate, Printing House, Hayes, UB3 1AP

This report is prepared to inform a planning application with the London Borough of Hillingdon. The proposal is described as: *Redevelopment of the existing B2/B8 unit at Unit 1, Caxton Estate, involving the subdivision of the building to create 6 no. smaller B2/B8 units and 1 no. larger B2/B8 unit, including a one-storey extension to the former two-storey office section. The proposal also includes the construction of an additional B2/B8 unit within the existing service yard, together with associated parking, servicing, and ancillary works.*

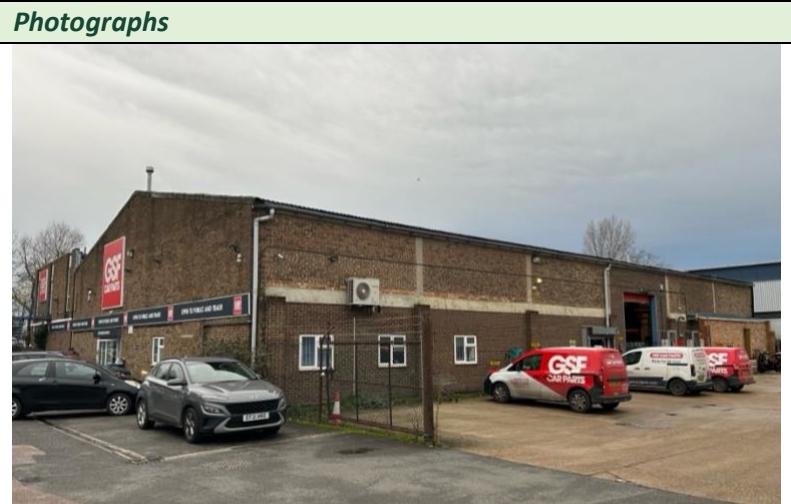
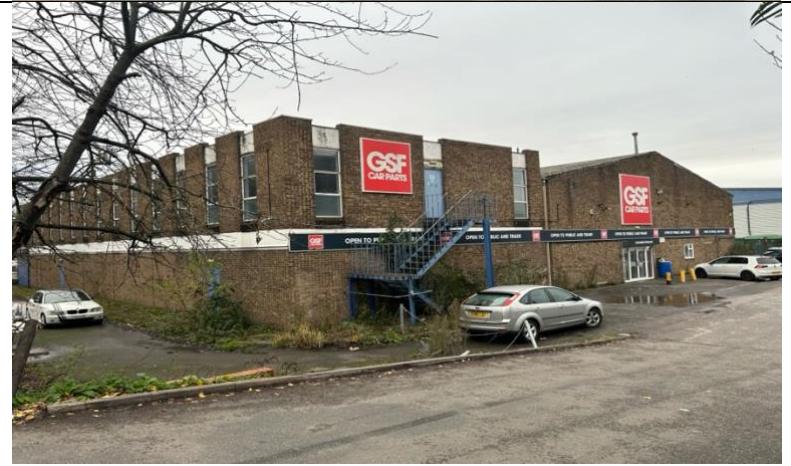
<p><b>B1 Building description</b></p> <p><b>Summary</b></p> <p>B1 a large commercial warehouse unit functioning as an active car parts store and workshop (GSF Car Parts).</p> <p>The eastern half of the building is a single storey with a pitched and gabled roof clad in metal corrugated roof sheets. The roof sheets are tightly fitted, offering no suitable roosting features for bats, although the asbestos verge capping sealing the roof to the north and south gables is lifted to an extent suitable for crevice-dwelling bats. There is timber fascia boarding along the eastern elevation, some sections of which are loosely fitted exposing gaps suitable for crevice-dwelling bats.</p> <p>The western half of B1 is the GSF car parts workshop on the ground floor but with an additional storey comprising disused office spaces and staff rooms. The roof is flat, and its construction material is unknown. No suitable roosting features were recorded on the western half of B1.</p> <p>There are no loft spaces/voids within B1.</p> <p><b>B1 has low habitat value for roosting bats</b> due to a low number of suitable roosting features on its exterior, specifically on the north and south gables and eastern elevation fascia boarding.</p>	<p><b>Photographs</b></p>

<p><b>B1 Suitability</b></p> <p><b>B1</b> has <b>low habitat value</b> for <b>roosting bats</b> due to a low number of suitable roosting features on its exterior (lifted verge capping on the north and south gables and eastern elevation fascia board gaps).</p> <p><b>Roosting habitat [Trees]</b></p> <p>There is a line of 14no. wild cherry trees on site. Although only T1 is proposed for removal, all 14no. trees underwent a ground level tree assessment (GLTA) for their suitability to support roosting bats:</p> <p><b>No suitable roosting features, such as knot holes, areas of decay, wounds, cracks or crevices suitable for bats to access and/or roost within were identified within any of the 14no. trees.</b></p> <p>T1 does in fact have a large split in the stem, although the split is too large and exposed for bats to roost within. The cavity is prone to environmental fluctuations such as rainfall, wind and temperature, creating unsuitable conditions for bats. As a result, <b>T1 has negligible habitat value for roosting bats</b> (PRF – NONE).</p>

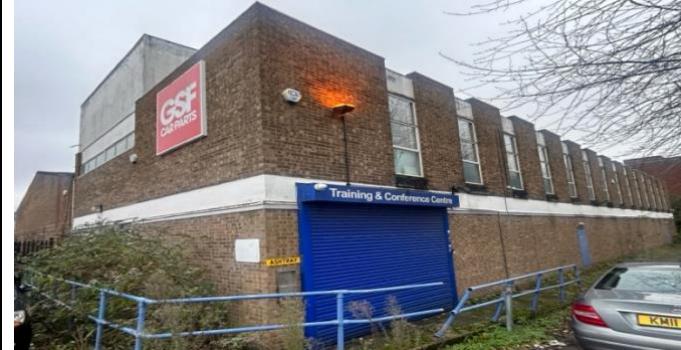
<b>Feature</b>	<b>Materials</b>	<b>Condition/description/suitability</b>	<b>Photograph(s)</b>
	Walls	Brick	<p><b>Condition/description</b> Good condition.</p> <p><b>Suitability/access/bat evidence</b> No holes, cracks or damaged areas suitable for crevice-dwelling bats to roost within, or for void-dwelling bats to enter.</p>

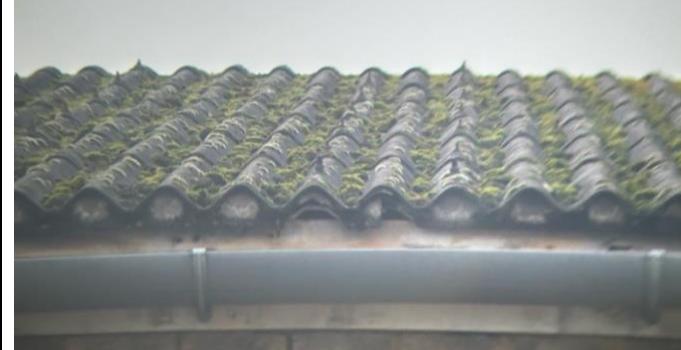
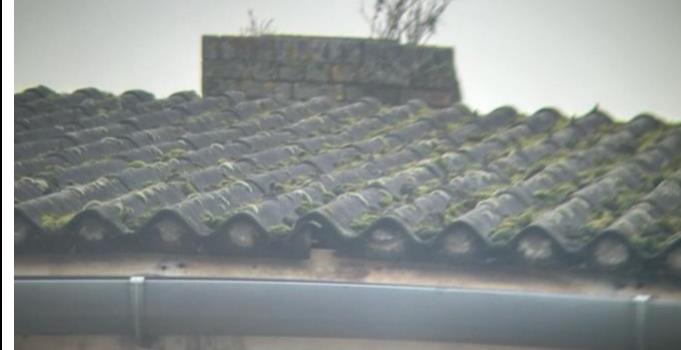
Roof	Corrugated metal sheets	<p><b>Condition/description</b> Roof on the eastern half of B1 is pitched, gabled and clad in corrugated metal sheets. Sheets are tightly sealed/well-fitted. Roof on western half of B1 is flat.</p> <p><b>Suitability/access/bat evidence</b> Roof sheets are flush and tightly sealed with no gaps or lifted areas suitable for crevice-dwelling bats to exploit and roost within.</p>

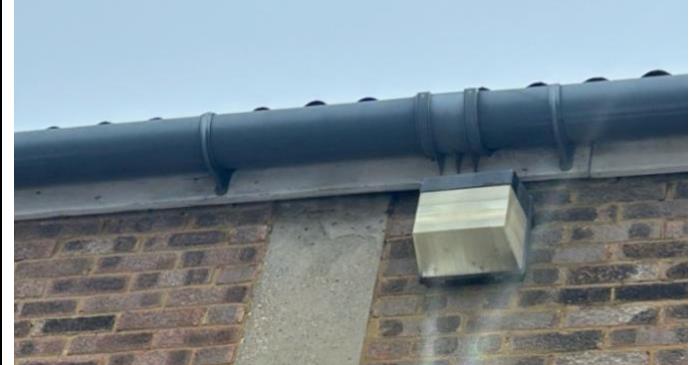
Fascia boards	Timber	<p><b>Condition/description</b></p> <p>Timber fascia boards cover the eastern elevation of B1 only. The boards are mostly flush and well fitted to the walls, but there are a few sections which are gappy (pictured, opposite).</p> <p><b>Suitability/access/bat evidence</b></p> <p>Gaps beneath the boards are suitable for crevice-dwelling bats.</p>

<p><b>No works to the property that may block or remove potential roosting features should be carried out until the required surveys have been completed. Undertaking such work beforehand could unlawfully affect bats if present and may compromise the validity of the surveys and hinder the planning application process.</b></p> <p><b>Roosting habitat [Trees]</b> No further surveys are required.</p> <p><b>Foraging and commuting habitat</b> No further surveys are required.</p> <p><b>Artificial lighting</b> A low impact lighting strategy will be adopted for the site during and post-development which outlines the areas of the site that will be retained as dark corridors (the western boundary shrub line with trees). Parameters can be found on the Bat Conservation Trust website: <a href="https://www.bats.org.uk/our-work/buildings-planning-and-development/lighting">https://www.bats.org.uk/our-work/buildings-planning-and-development/lighting</a></p> <p><b>Suggested biodiversity enhancements</b> A minimum of two Integrated bat boxes will be installed into the new extensions. They will be placed high up at eaves level, face south/southwest if possible, and be unlit by artificial light. The bat boxes will be a specification suitable for crevice dwelling species such as Vivara Pro Build-In Woodstone Bat Tube (integrated), Ibstock Enclosed Bat Box 'C' (integrated), or a similar alternative brand.</p>

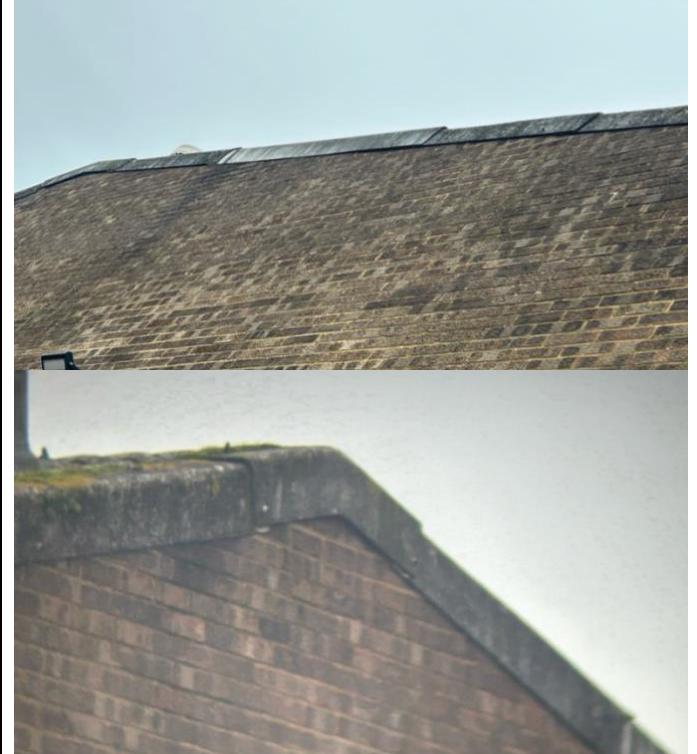
Verge capping	Asbestos	<p><b>Condition/description</b></p> <p>Asbestos verge capping sealing the roof to the north and south gables is almost entirely lifted.</p> <p><b>Suitability/access/bat evidence</b></p> <p>Gaps beneath the verge capping are suitable for crevice-dwelling bats.</p>

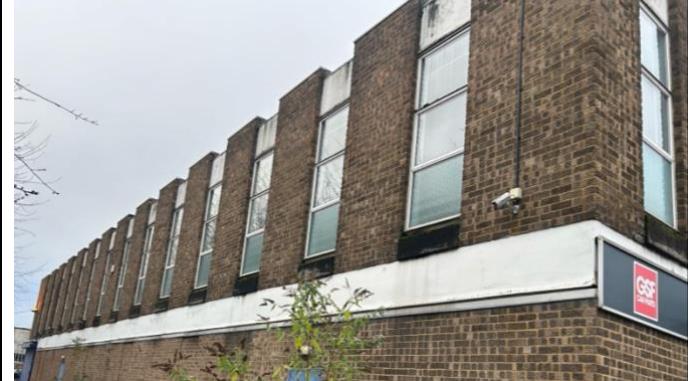
Window/door frames	uPVC	Tight fitting. No suitable roosting features for bats.

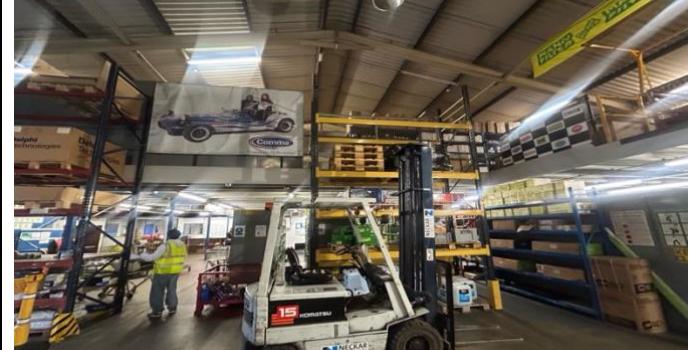
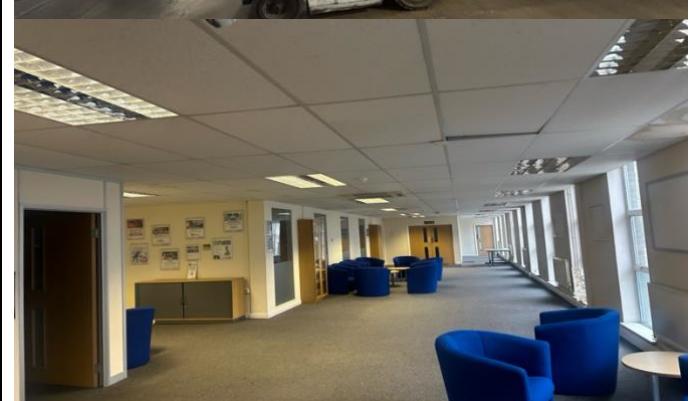
Internal voids		<p><b>Condition/description/suitability</b></p> <p>There are no loft spaces within B1.</p> <p>The eastern half of B1 is a single storey, so the entire space was visible from the workshop inside (pictured opposite). There is constant light, sound and human disturbance as well as a lack of suitable roosting features inside for bats.</p> <p>The western half of B1 contains the same ground floor car workshop, but with a second storey containing staff rooms/office space (pictured opposite). No suitable ingress points or roosting features were recorded inside.</p> <p>Further, no evidence of bats, such as bats themselves, droppings, feeding remains etc were found within B1.</p>

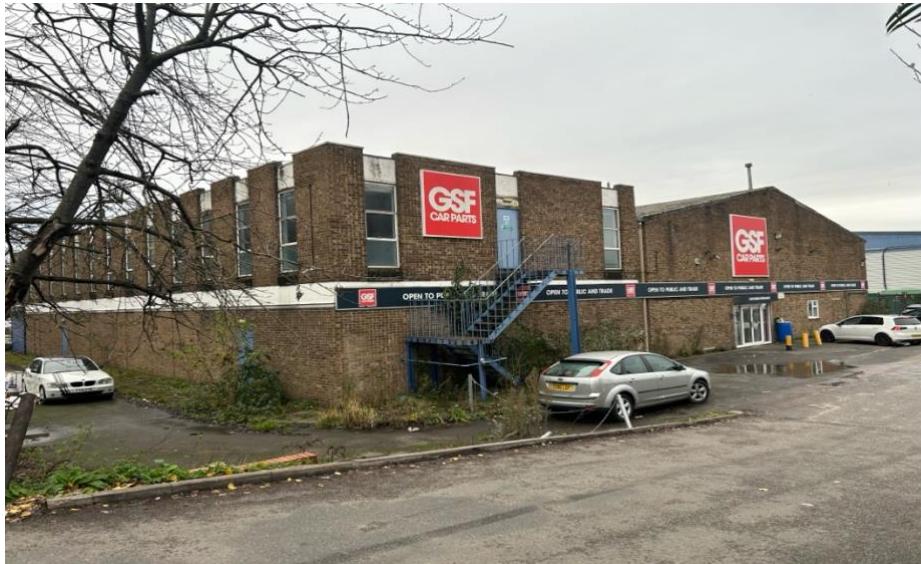
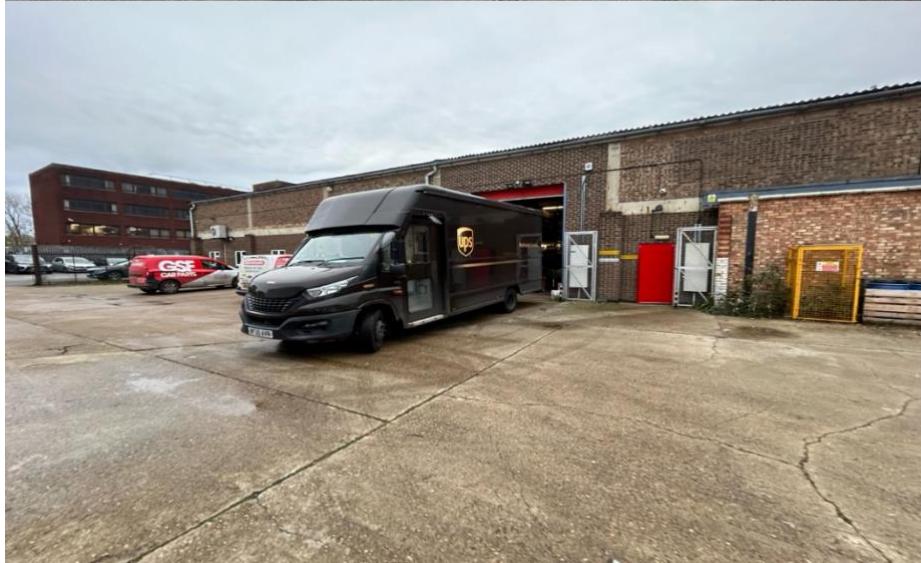
*Figure 1 (above) and figure 2 (below) showing the site entrance, B1 and loading area.*

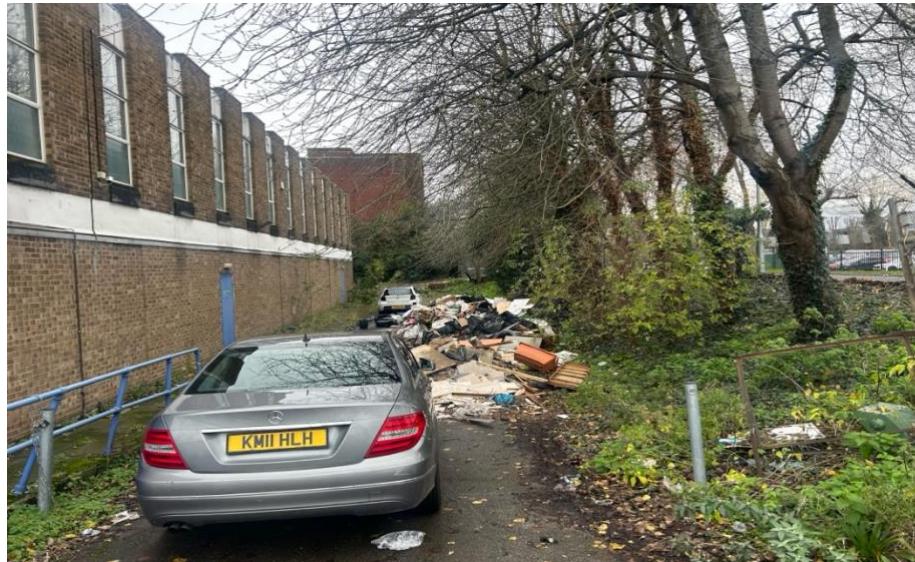
Figure 3 (opposite), figure 4 (bottom left) & figure 5 (bottom right) facing south/southwest at the strip of sparsely vegetated land (ruderals and shrubs) and line of mature cherry trees.

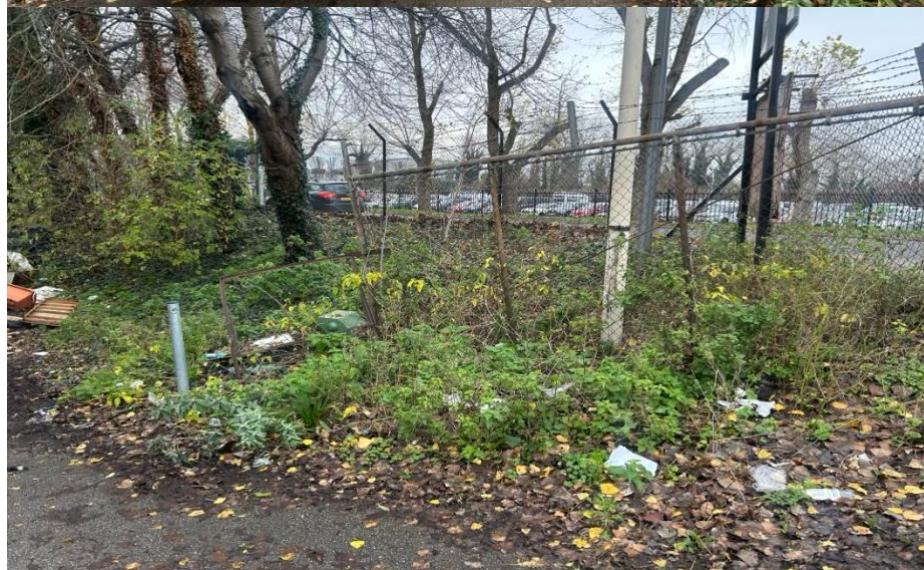
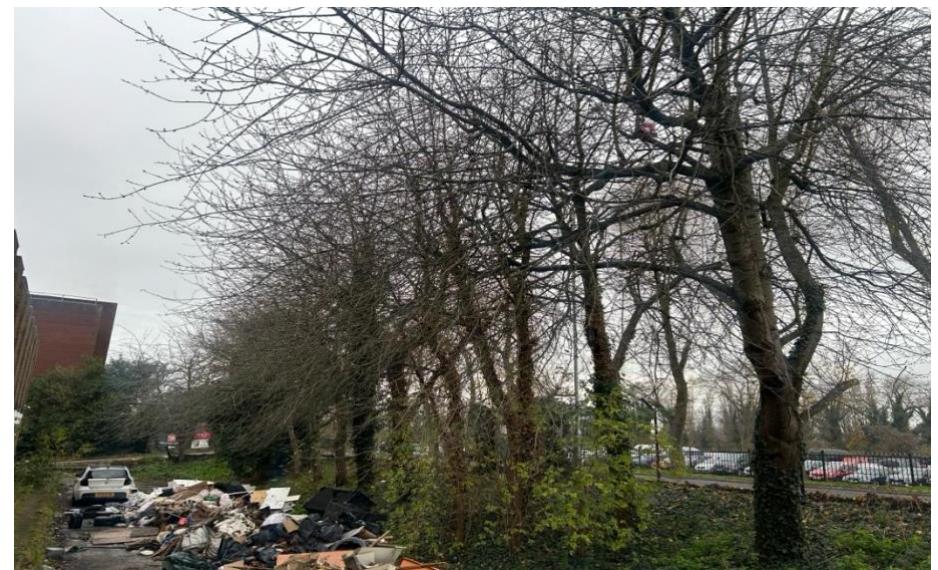
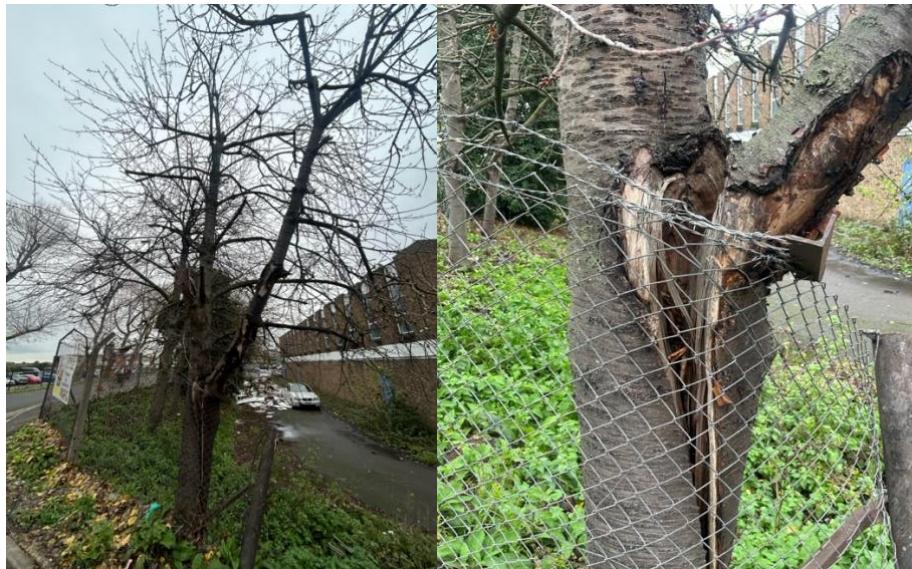
*Figures 6 and 7 (opposite) facing north at T1, proposed for removal*

<i>Recommendations</i>	<p><b>Buildings, trees and vegetation</b> The internal works to B1 and removal of tree T1 should be subjected to a close inspection to look for nesting bird activity, prior to the commencement of work. All active nests will need to be retained until the young have fledged.</p> <p>Precautions should be taken with machinery and noise levels when working close to any retained nests so as not to disturb any nearby nesting birds during construction works. At least a 3-5m buffer should be created between any machinery and active nests until the young have fledged.</p>
