# CHURCH GARDENS

## HAREFIELD

### HISTORIC IMPACT ASSESSMENT

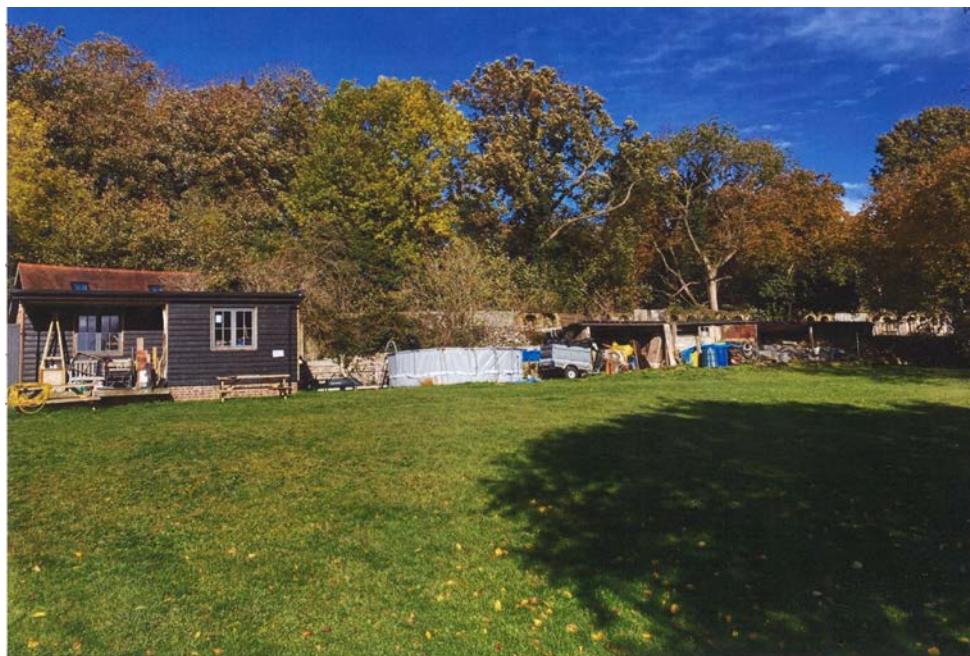
Figure 1 Existing view from the stream where the pond is proposed, north-east across the Orchard to the present buildings, with the arcade and terrace beyond.

2. The ornamental character has been visually degraded in the C20 by the insertion of a cluster of unsightly temporary structures which originated as service structures before the owners bought the site. The buildings and associated rubble have gradually been removed and replaced with more sensitive structures and open garden ground, but some elements survive (Figure 1).

scale (Figure 1 & 2). It will stand in the north-west corner of the garden below the west end of the main terrace which has been truncated by a recent building at its west end. This end of the terrace is detached from the arcade structure which does not stretch the whole length of the terrace.

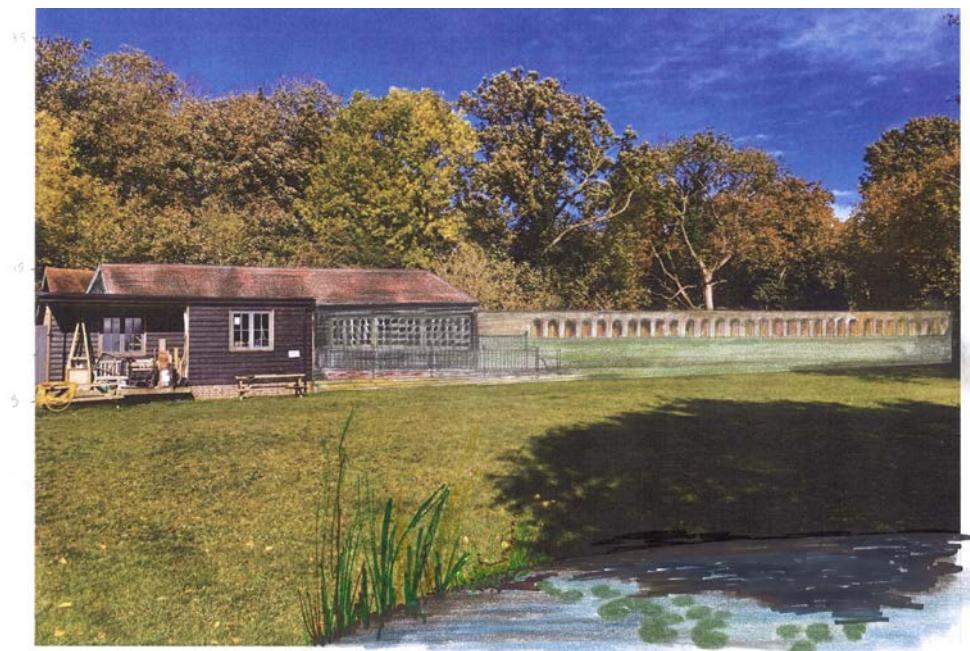
Figure 2 Visualisation of the existing view from the stream where the pond is proposed, north-east, past the proposed new building (left) and over the reinstated site of the present buildings once cleared, to the arcade and terrace.

3. This proposal continues the welcome removal of damaging elements of this cluster and reinstatement as open lawn with the additional benefit of revealing an obscured long view of the arcade which will also be repaired (Figure 2). However, the removal of these building elements is conditional on the incorporation of a basement level within the proposed building to provide essential replacement storage area.

5. The materials are sensitive to the existing rural environs and to the historic character. The building will be recessive in appearance, using traditional materials and forms.
6. The proposed site is likely to have been considerably disturbed, given the insertion of the existing structure and results of previous watching briefs in the vicinity. On the evidence of previous watching briefs in this area it seems that there is little potential.
7. The group of structures in which the new building stands is confined to this north-west corner of the walled garden and can absorb a replacement structure of similar scale as it is sensitively designed to respond to the present setting (Figure 2).

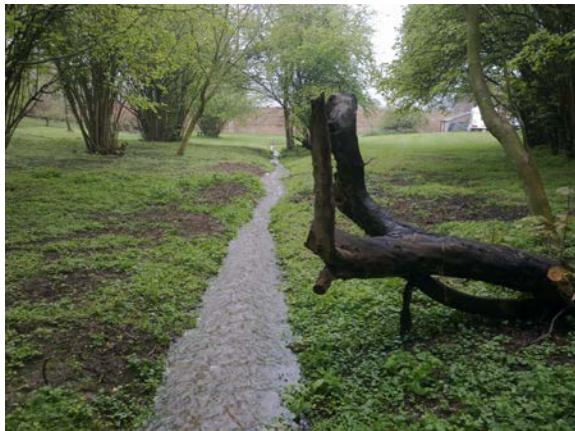
Figure 3 The west and central sections of the stream (left), view west.

5. The flanking man-made 'valley' ground modelling frames the route of the watercourse (Figures 3, 7, 8). It is integral to aligning the position of the stream along the central west-east axis of the garden.

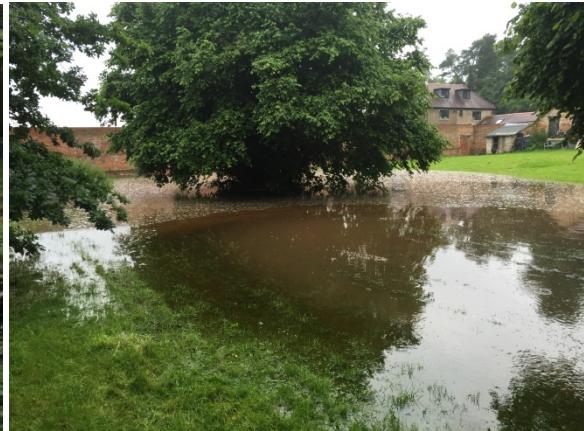
Figure 4 The west section of the stream where drainage is poor, forming an uncontrolled pond (right).

8. The ground form, especially evident during flooding (Figures 4 & 5), suggests there may have been a pond at the west end of the stream but there is no other evidence to support this.

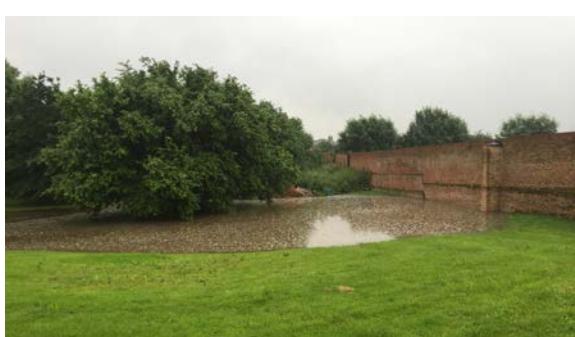
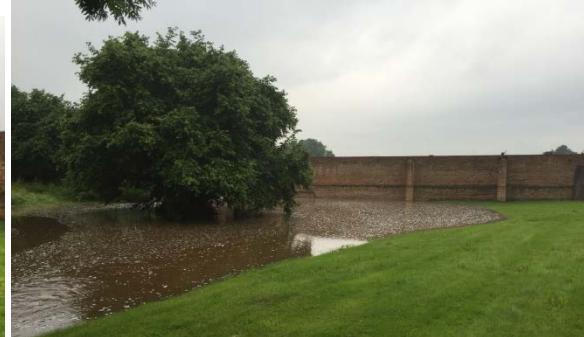
Figures 5 & 6 The west section of the stream where drainage is poor, forms an uncontrolled pond contained by the west garden wall, recently repaired.

7. An outflow sinks the water a few metres before it reaches the west wall below which it leaves the garden. When this outflow blocks an irregular oval pond forms, leading to uncontrolled ponding against the west wall (Figures 5 & 6). The wall is therefore vulnerable to catastrophic damage from continued episodes of ponding adjacent.

9. The frequency and intensity of extreme rainfall events is increasing with climate change. It has been damaging in the past, including a very serious flood in the orchard and kitchen garden and resultant destruction of a greenhouse. The effect of climate change will lead to increased periods of ponding which will soon damage the west wall if mitigation does not occur (Figures 5 & 6).

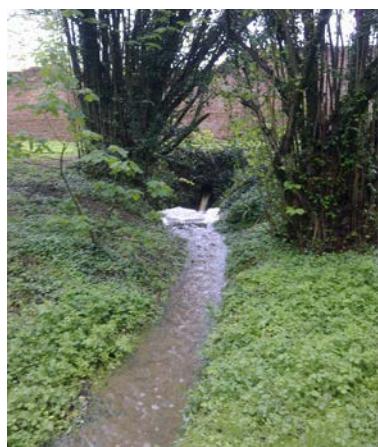
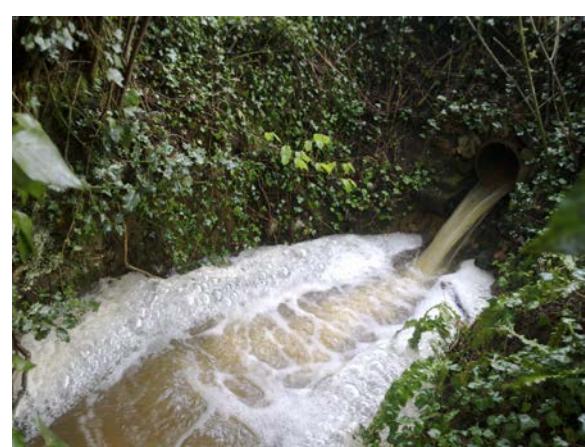
Figures 7 & 8 The east section of the stream where it is culverted below the east garden wall, through the east terrace and opens into the main garden.

6. A substantial culvert brings the stream centrally into the garden below the east wall and through the east arm of the terrace (Figures 7 & 8). Its form requires more investigation.
