# **Express Preliminary UXO Risk Assessment**

| <b>Project</b> | Hayes & Harlington |
| <b>Report Reference</b> | EP5858-00 |

## Detailed Unexploded Ordnance (UXO) Risk Assessment

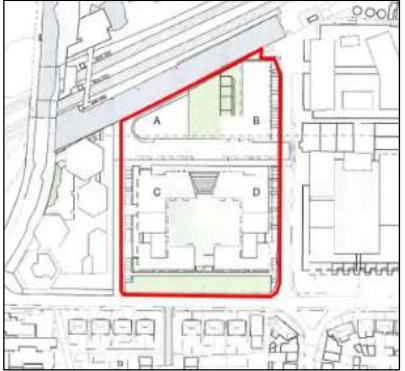
| Risk Assessment Considerations | |
|---|---|
| Site location and description/current use | <p>The site is located in the London Borough of Hillingdon, in the west of London.</p> <p>Nestles Avenue borders the south-west of the site and Viveash Close defines the eastern border. An area of hard-standing ground, adjacent to a railway, borders the site to the north whilst the west of the site is adjacent to a commercial structure at the junction of Station Road and Nestles avenue.</p> <p>Recent aerial photography shows the site to be occupied by four distinct, large, commercial structures. Associated areas of hard-standing ground are also within the site, especially in the northern and southern areas of the site.</p> <p>The site is approximately centred on the OS grid reference: <b>TQ 0975279308</b></p> |

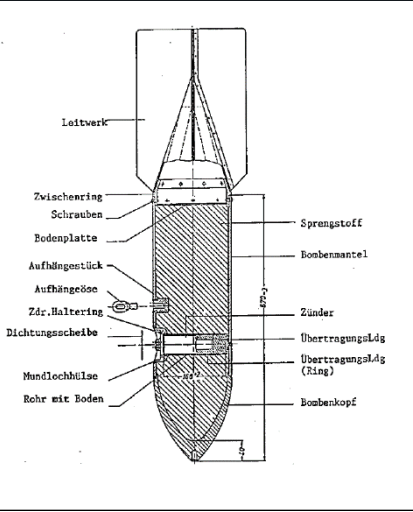
SC 250kg High Explosive Bomb

| Remarks | The smallest and most common conventional German bomb. Nearly 70% of bombs dropped on the UK were 50kg. |

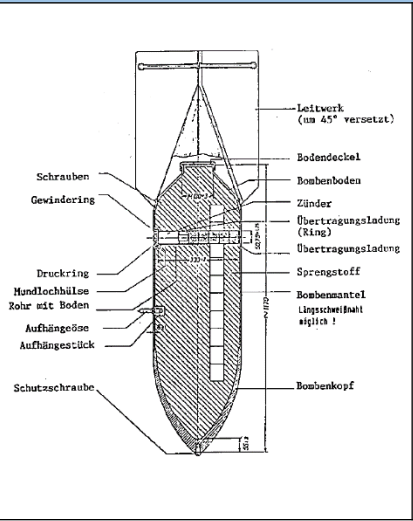
SC250 bomb being loaded onto German bomber

| Remarks | It could be carried by almost all German bomber aircraft, and was used to notable effect by the Junkers Ju-87 Stuka (Sturzkampfflugzeug or dive-bomber). |

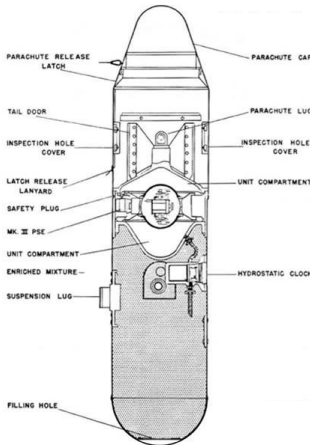
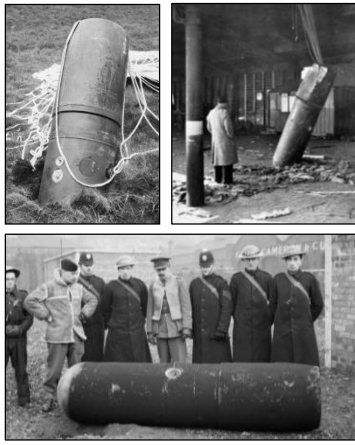
Parachute Mine (Luftmine B / LMB)

| Remarks | Deployed a parachute when dropped in order to control its descent. Had the potential to destroy a whole street of housing in a 100m radius. |

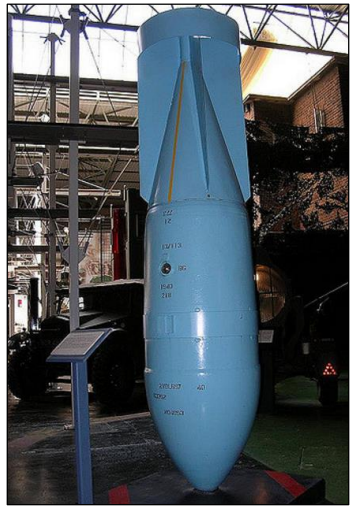
SC 1000kg

| Use | SC type bombs are General Purpose Bombs used primarily for general demolition work. Constructed of parallel walls with comparatively heavy noses. They are usually of three piece welded construction |

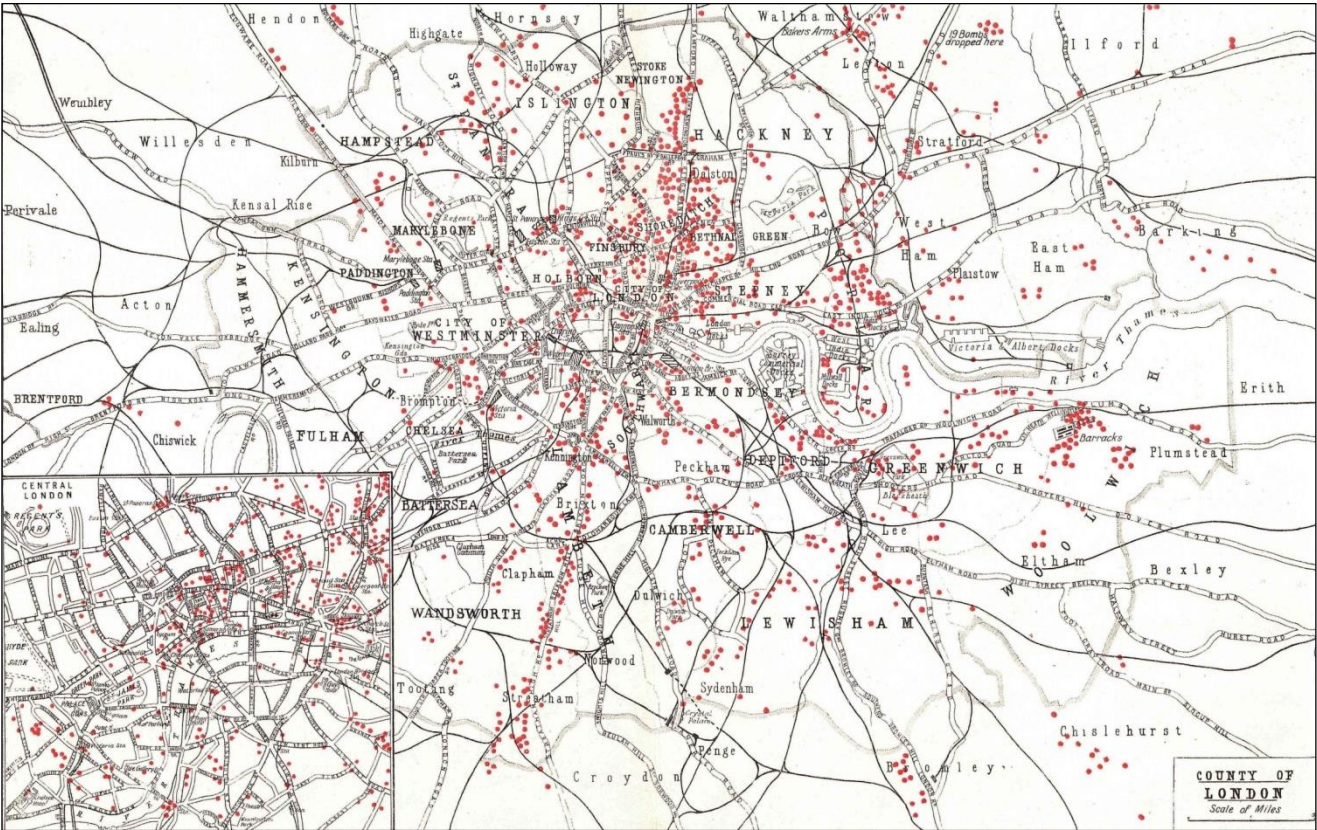
Examples of 50 and 100kg German WWI bombs

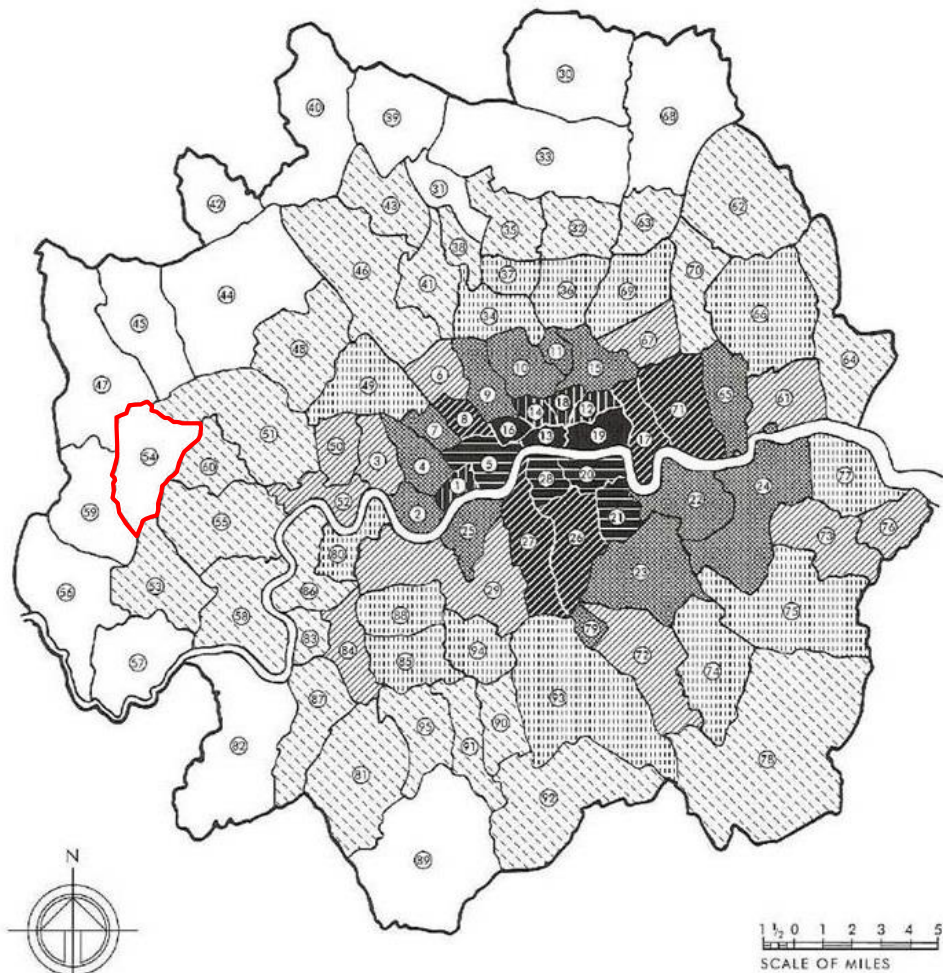
No. OF BOMBS PER 1,000 ACRES

During WWII the site was located within the Urban District of Hayes and Harlington which sustained a low-moderate bombing density, with an average of 40.1 items of ordnance recorded per 1,000 acres according to official Home Office statistics. Available bombing records do not indicate the presence of any strikes directly within the site, but do display strikes close to the site to the north and north-west. Evidence available at this preliminary stage appears to suggest the presence of bomb damage within the site, as a structure evident in pre-war OS mapping is notably absent in available low-resolution post-war aerial photography. It is possible that the absence of this structure was caused by bomb damage. Due to this possibility, it cannot be concluded that the site received a regular level of access throughout the war. It is therefore considered possible that an item of unexploded ordnance could fall unnoticed within the site.

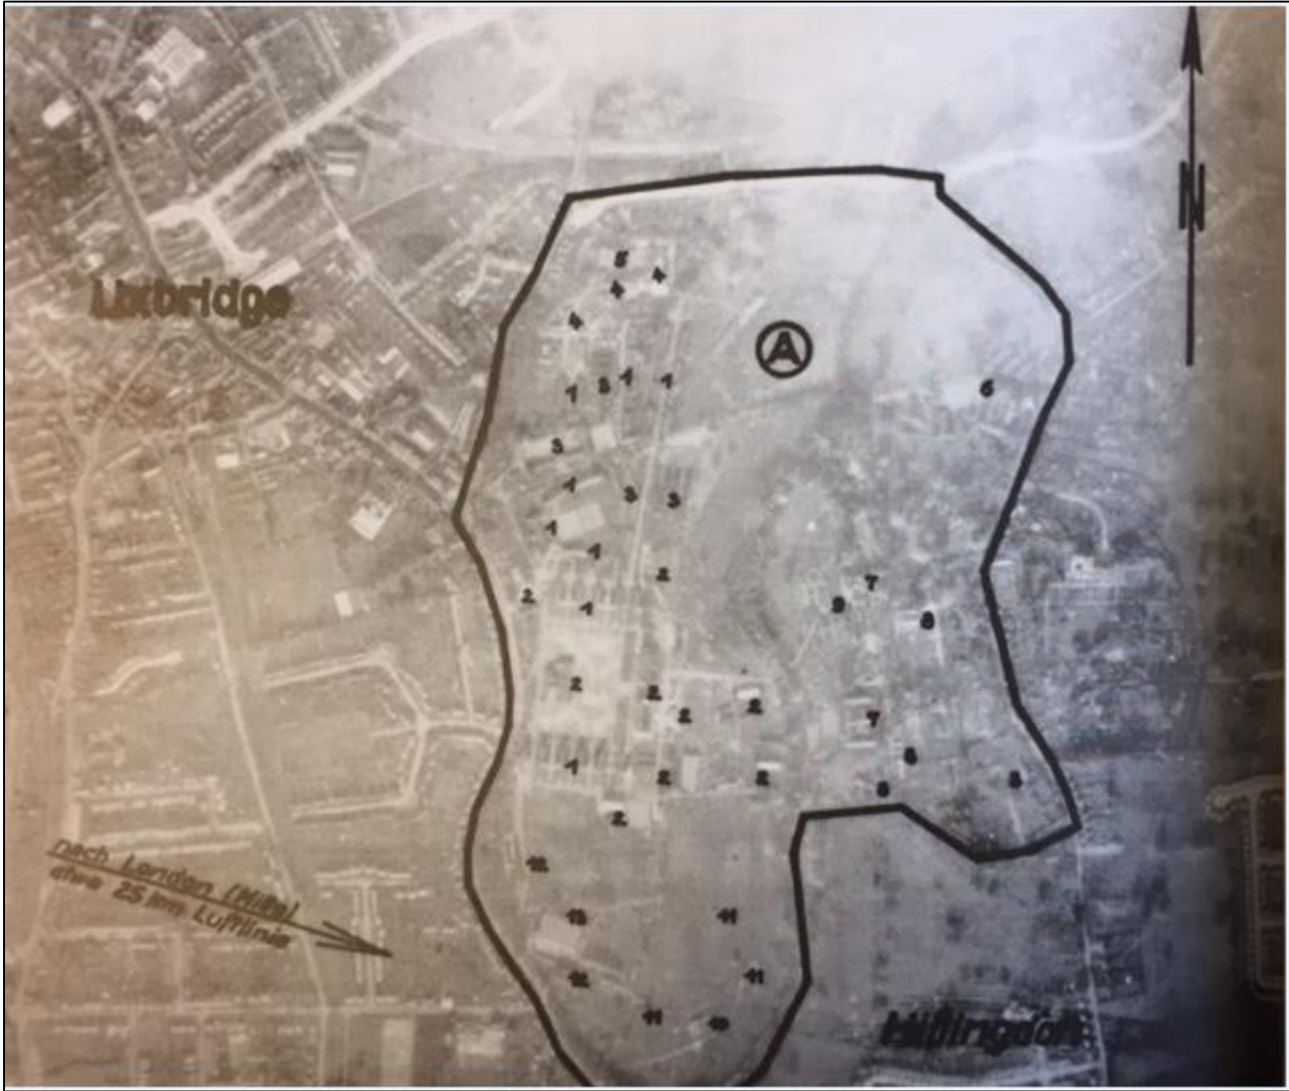
**Middlesex- Uxbridge RAF Depot**

The site located approximately 5.6km south-east of the Uxbridge RAF Depot

Bombing 1940, 1941 to 18<sup>th</sup> August 1943

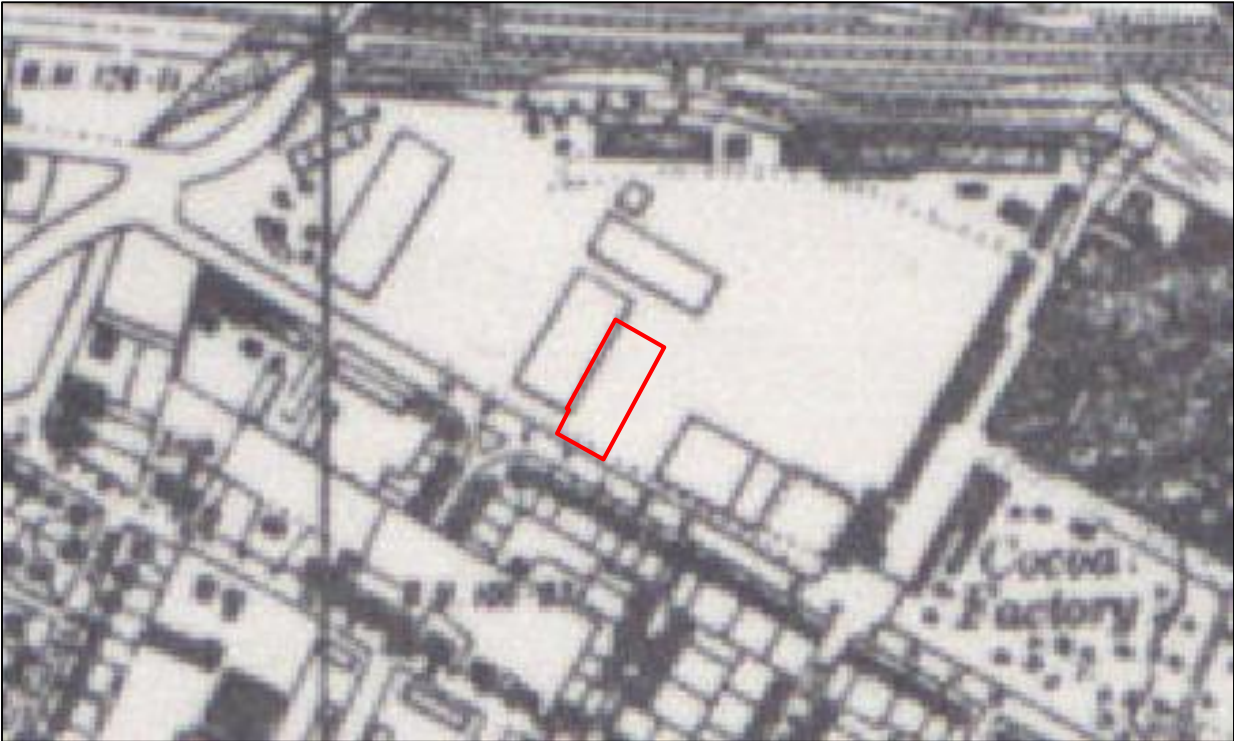
Night Bombing up to 7<sup>th</sup> October 1940

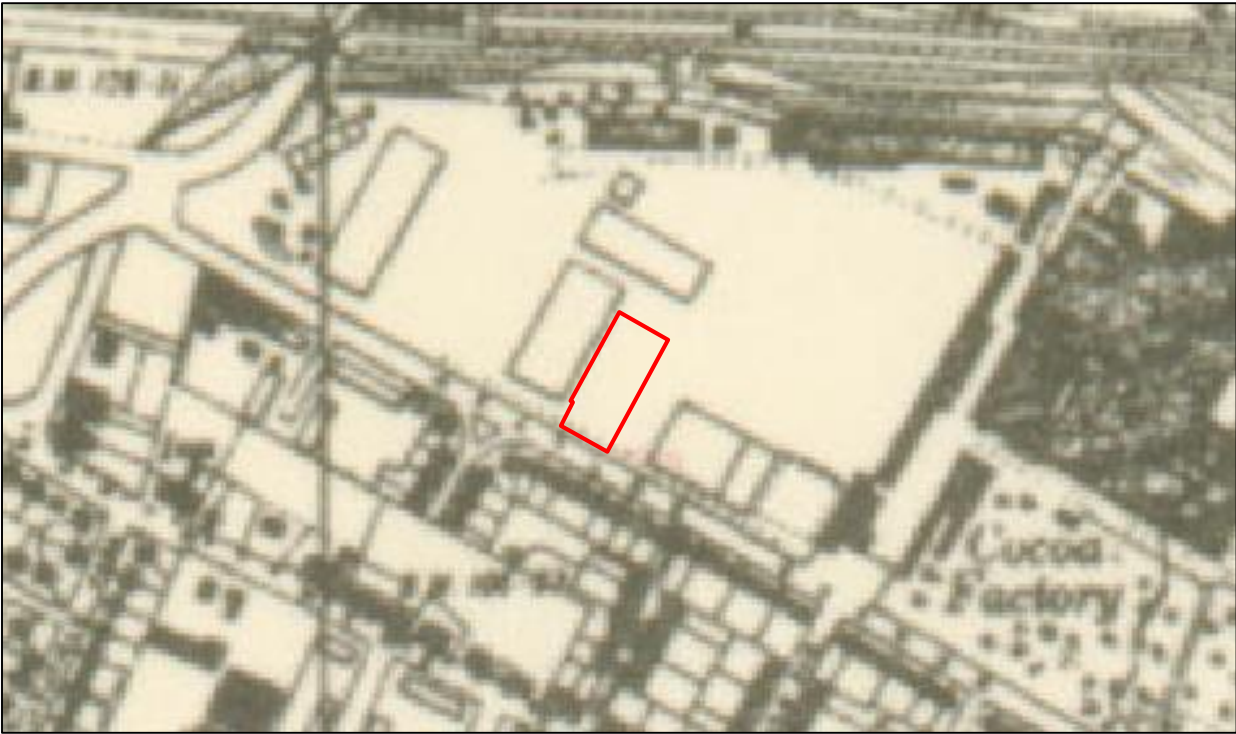
●● Recorded bomb strike

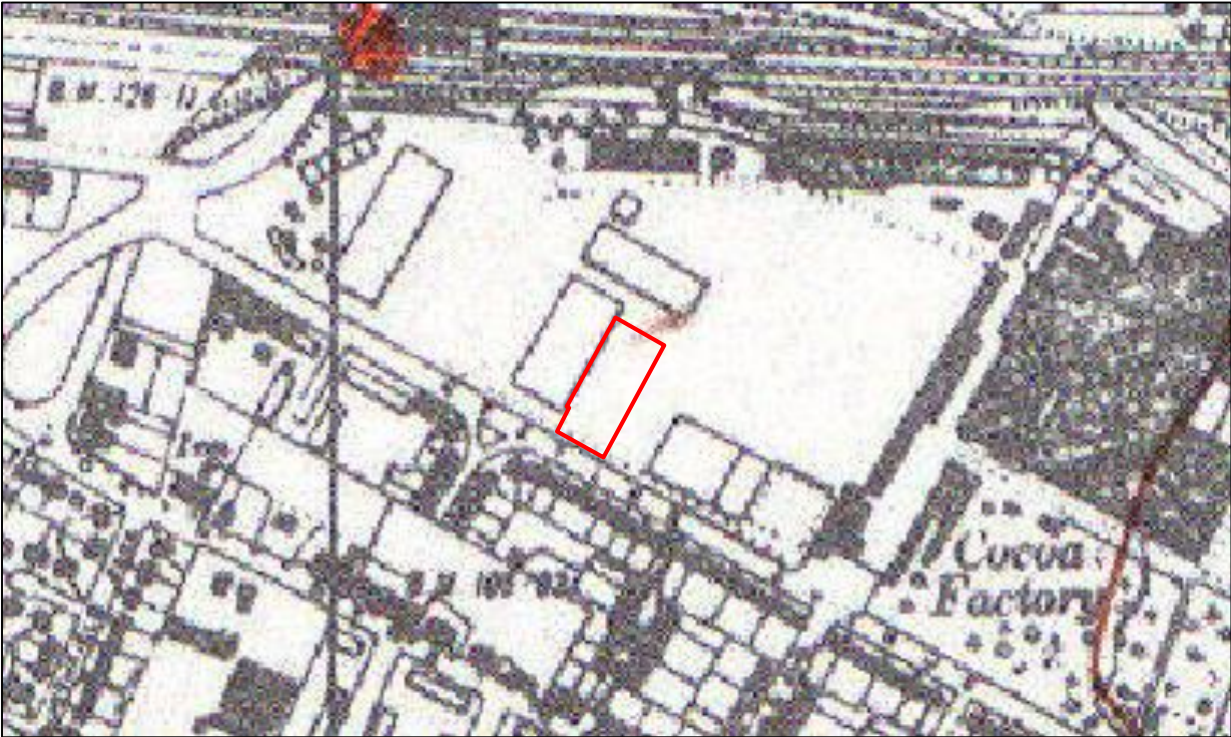
Night Bombing 7<sup>th</sup> October 1940 to June 1941

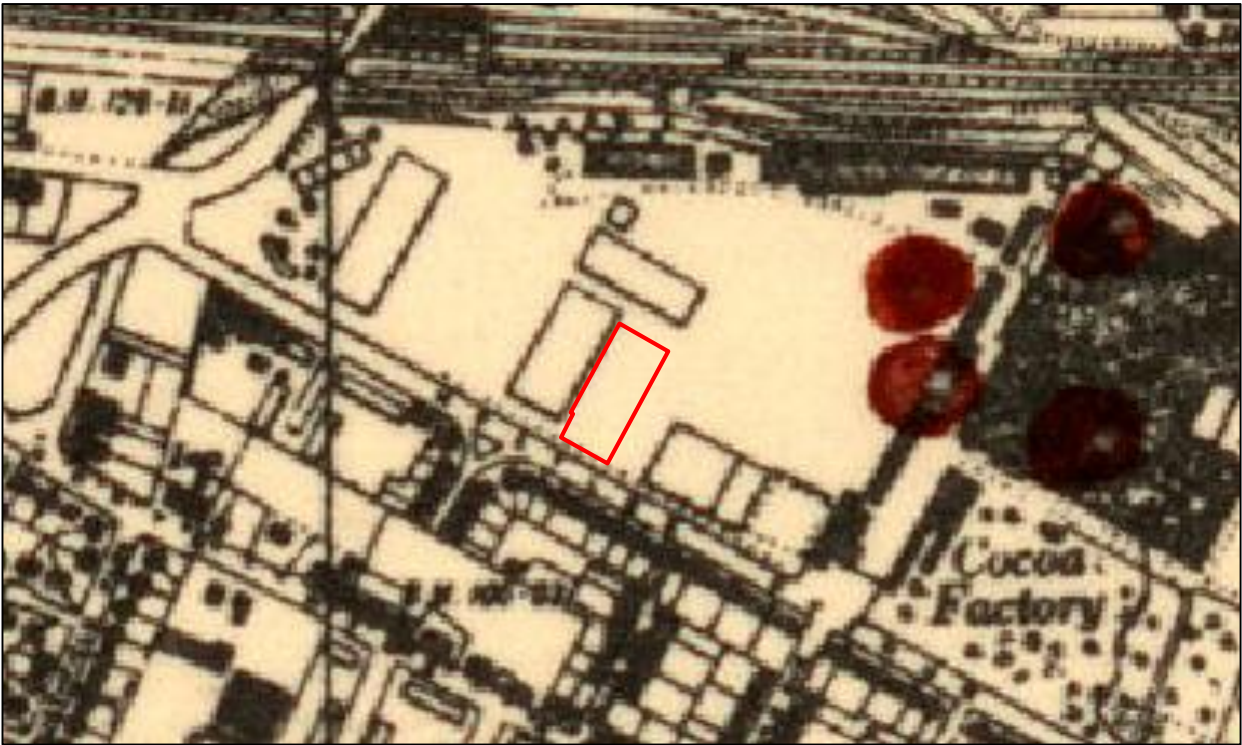
Bombing 11<sup>th</sup> 18<sup>th</sup> November 1940

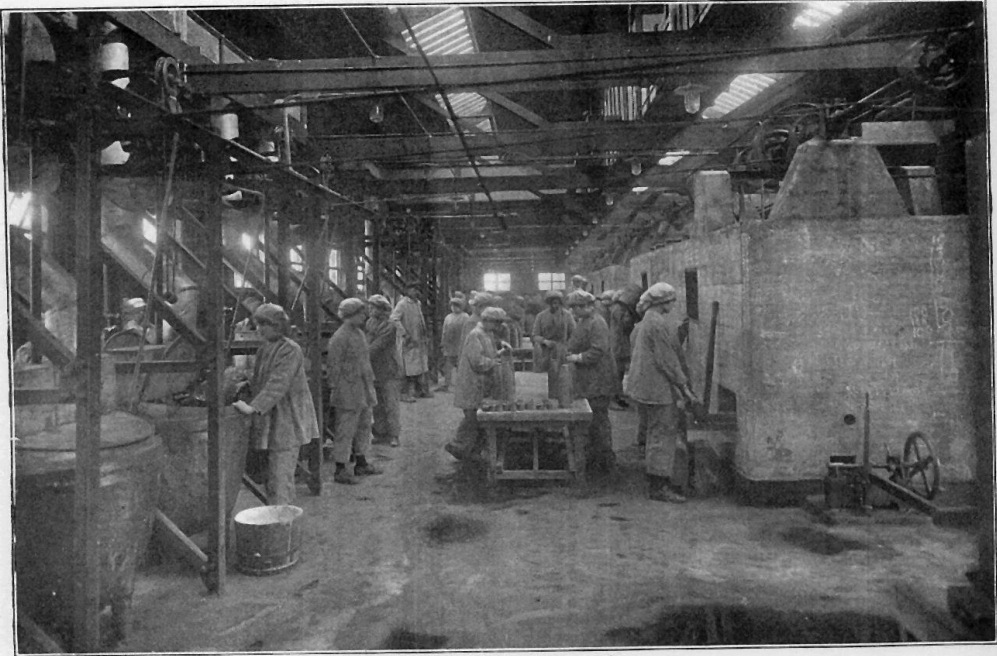
Mechanical Shell Filling, Amatol Section. Shells are filled by extruder machines inside the armoured concrete chambers on the right, so that in the event of an explosion no one would be injured.

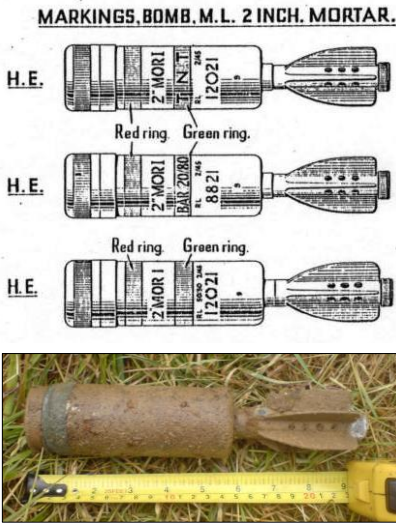
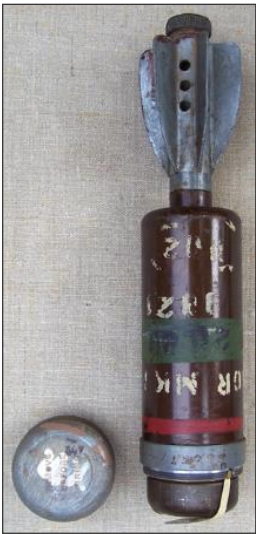
| Use | It had greater range and firepower over hand and rifle grenades, and was used to attack targets behind cover with high explosive rounds. |
| Identification | HE has a rounded edge to a flat back. Can either be a black body colour with red and yellow band or dark green with yellow band. Brass cap on top. Practice will have hole all the way through the top. |

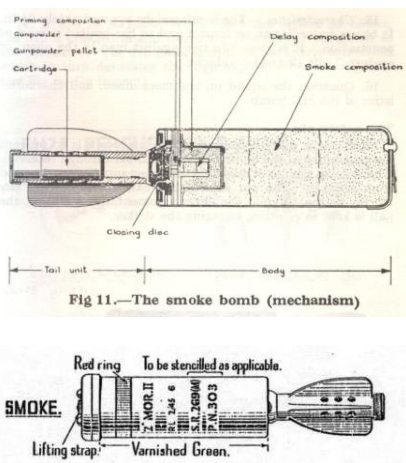
2 inch Mortar Smoke

| Fuze Type | An impact fuze which initiates a bursting charge. This ruptures the mortar bomb's body and disperses the phosphorus filler |
| Identification | Smoke mortars have a recess and emission holes. May still see light green body paint. Look for stained ground around munition. |
| Use | As a screening devices for unit movement or to impair enemy field of vision. |

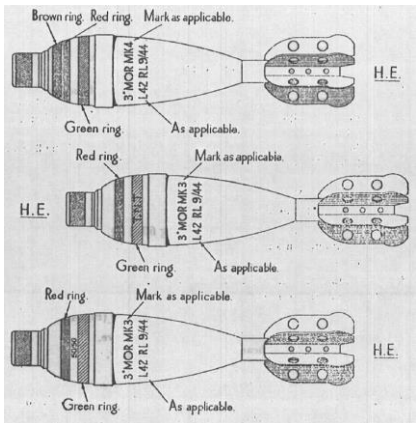
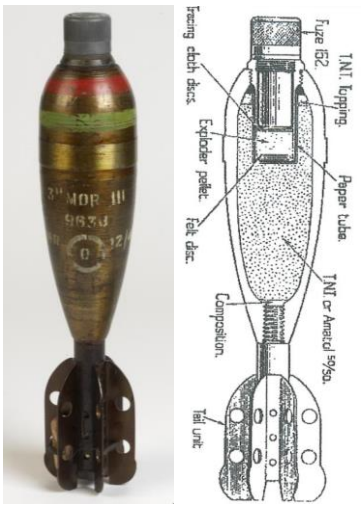
3 inch Mortar High Explosive

| Remarks | Fin-stabilised bomb fired by means of a charge consisting of a primary cartridge in the tail and four secondary cartridges |
| Identification | An old style mortar. No way of telling if HE or practice so treat as HE |

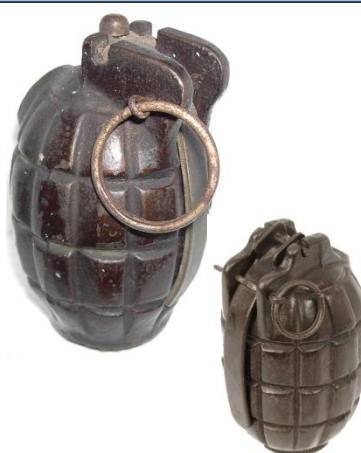
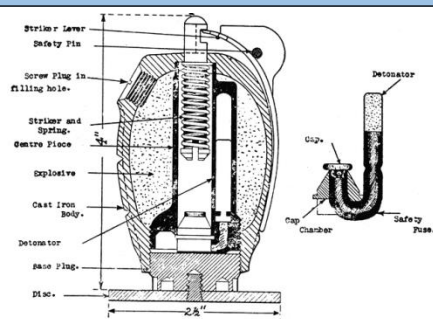
Left: baseplate and detonator removed

| Remarks | First introduced in 1915 its classic grooved, cast-iron 'pineapple' design was designed to provide uniform fragmentation. The detonator is inserted before use after removing the base plug. |

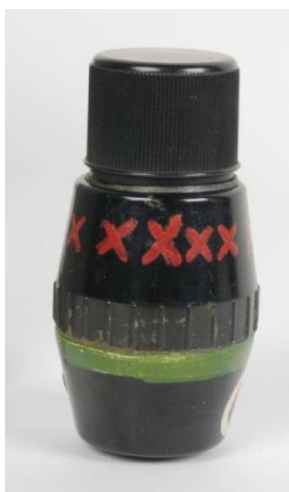
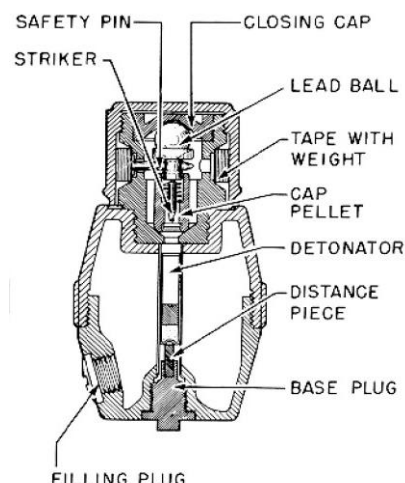
| Use | A blast grenade for use as an offensive weapon. Detonator was inserted before use. |
| Remarks | Introduced December 1940 and made from the plastic Bakelite as opposed to conventional metals. Detection is difficult due to this low metal content. |

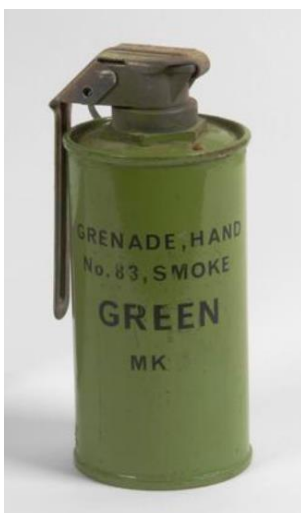
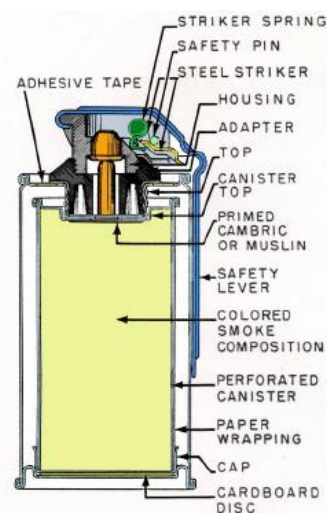
**No. 83 Smoke Grenade**

| Use | Use as a target or landing zone marking device and as a screening method for troop / unit movement. |
| Remarks | This basic design stayed relatively unchanged up to the 1980's. The letters CCC were often etched into the body of the grenade in the colour of the smoke. |

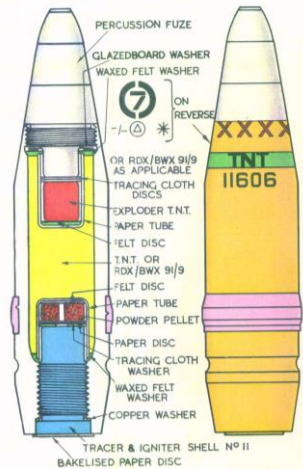
40mm Bofors Projectile

| Remarks | Light quick fire high explosive anti-aircraft projectile. Each projectile fitted with small tracer element. If no target hit, shell would explode when tracer burnt out. Designed to engage aircraft flying below 2,000ft |

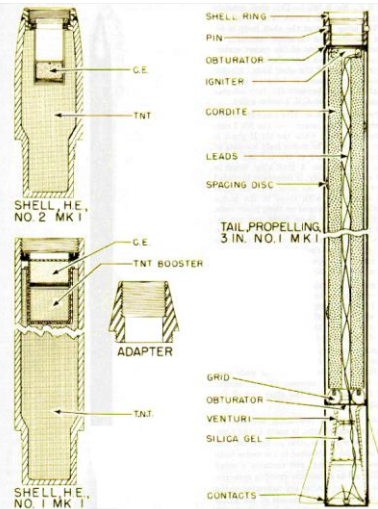
3in Unrotated Projectile (UP) Anti-Aircraft Rocket ("Z" Battery)

| Remarks | As a short range rocket-firing anti-aircraft weapon developed for the Royal Navy. It was used extensively by British ships during the early days of World War II. The UP was also used in ground-based single and 128-round launchers known as Z Batteries. Shell consists of a steel cylinder reduced in diameter at the base and threaded externally to screw into the shell ring of the rocket motor |
