9 Nestles Avenue, Hayes, UB3 4SA  
Arboricultural Impact Assessment  
Report for Healey Development Solutions  
(Hayes) Ltd

| <b>Job Number</b> | <b>ART2240</b> | | |

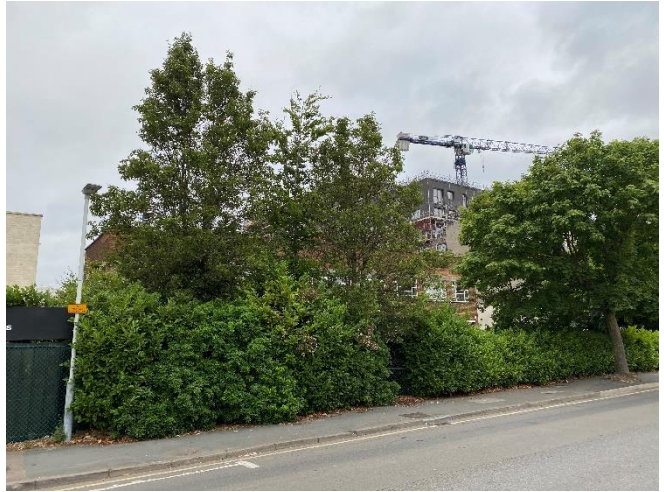
### Photograph 1

View looking north east towards the trees fronting Nestles Avenue

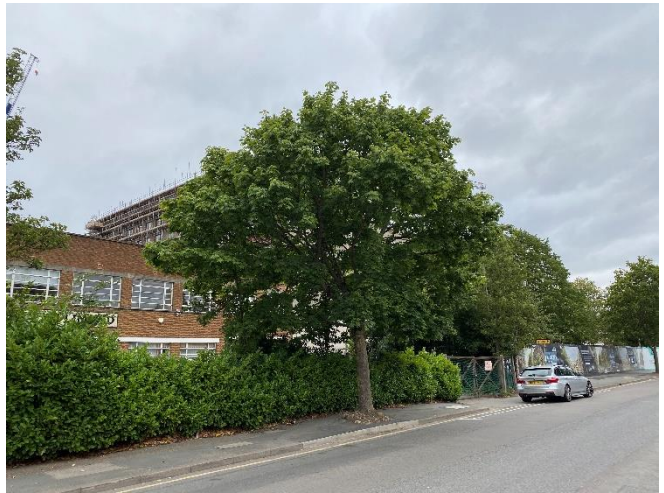
### Photograph 2

condition. Root activity was causing displacement of the adjacent footpath surfacing.

| No | Species | Ht. | S | St.<br>1.5<br>m | Canopy Spread | | | | Cr.<br>CI | Ls | SC | PC | Comments<br>/Observation | Preliminary<br>Management<br>Advice | LE | Cat<br>** | RPA<br>m <sup>2</sup> | RPA<br>r |
|---|---|---|---|---|---|---|---|---|---|---|---|---|---|---|---|---|---|---|
| T6 | Norway maple | 7.5 | 1 | 350 | 5 | 5 | 5 | 5 | 3 | M | Fair | Fair | Surface root activity lifting the adjacent public footpath. | None. | <40 | B1 | 55.4 | 4.2 |

View looking north west to tree T6

- 4.1 Tree T6 is located within the public highway and will require the written consent of the local authority prior to any arboricultural works being undertaken on this tree.
- 4.2 Tree T8 is located within the neighbouring ongoing development site and inside the curtilage of the Nestles Avenue Conservation Area. Reference to the approved arboricultural information submitted in support of the approved development indicated that the tree is highlighted for pollarding. This would negate the need for any additional works associated with the proposed development. That notwithstanding, and in the absence of clearly defined works to implement a full planning permission, the proposed access facilitation pruning would require the submission of Section 211 Notification to the Local Planning Authority six weeks prior to the proposed pruning taking place.

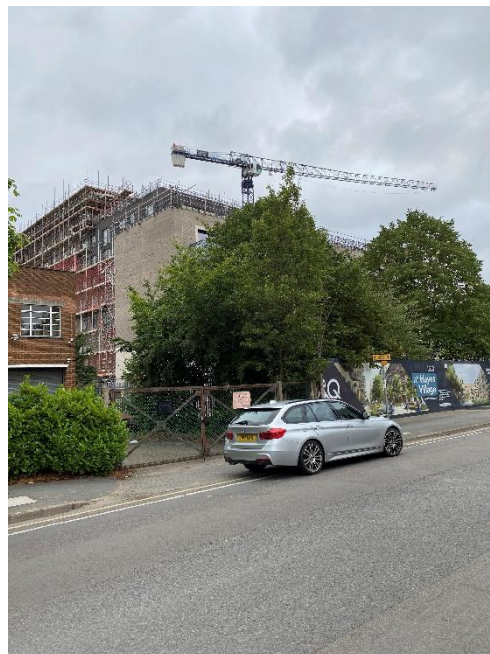
### Photograph 3

- Common lime T8, was situated off site, adjacent to the south east boundary and 15m south of the existing structure. The tree was mature, 12m in height, had a single stem and a maximum canopy radius of 5m in all directions. Access to the main stem was restricted however the tree appears in fair structural condition. Leaf colour, size and distribution indicated good vitality levels. The tree was situated inside the Nestles Conservation Area and within an ongoing development site. Reference to the submitted arboricultural details in relation to the adjacent development indicate that this tree has been recommended for pollarding.

View north west to tree T8 and G1

- 3.17 The level of incursion by the proposed new hardstanding inside the RPA of tree T8 and was calculated to be 29.9% as displayed in Table 4. The existing surface comprises asphalt, while it is likely that ground conditions beneath the existing hardstanding are unlikely to change as a result of the new surface, any excavations inside the RPA of T8 have the potential to cause significant damage to the structural and physiological condition of the tree. As such the drafting of specialist root protection measures as part of an Arboricultural Method Statement will be required to enable T8's satisfactory long-term retention.
