6 Firs Walk Northwood HA6 2BZ

Arboricultural Impact Assessment Arboricultural Method Statement (AMS)

(Ref. 101 914)
Date: 26/03/2024

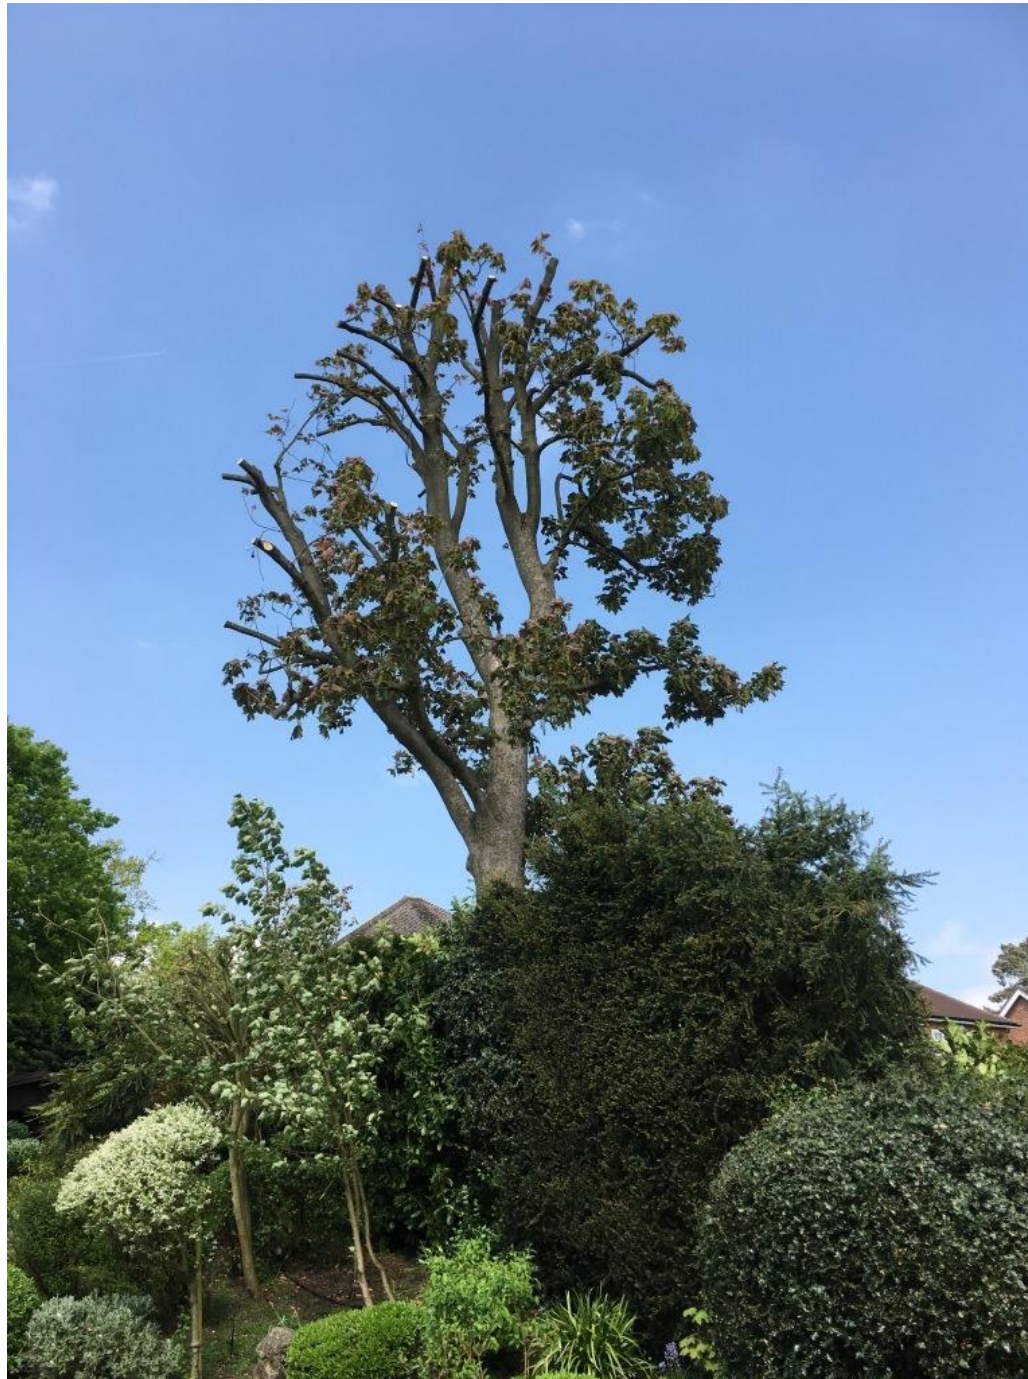
Photo to show heavily lopped & topped crown form of T7

When a tree has been lopped and/or topped by heavily ‘pruning’ back the primary scaffold limbs within the crown framework that is subsequently replaced by secondary epicormic re-growth, the former crown size will unlikely be replaced when compared to a maiden tree that not been lopped and/or topped. *In this way the former crown structure of the affected tree has been permanently disrupted.* See corresponding text below that relates to the RPA reduction of affected trees.
