### *CGL Remediation Scheme Addendum*

# **Western Access, Southall**

## *Remediation Scheme Addendum*

September, 2017

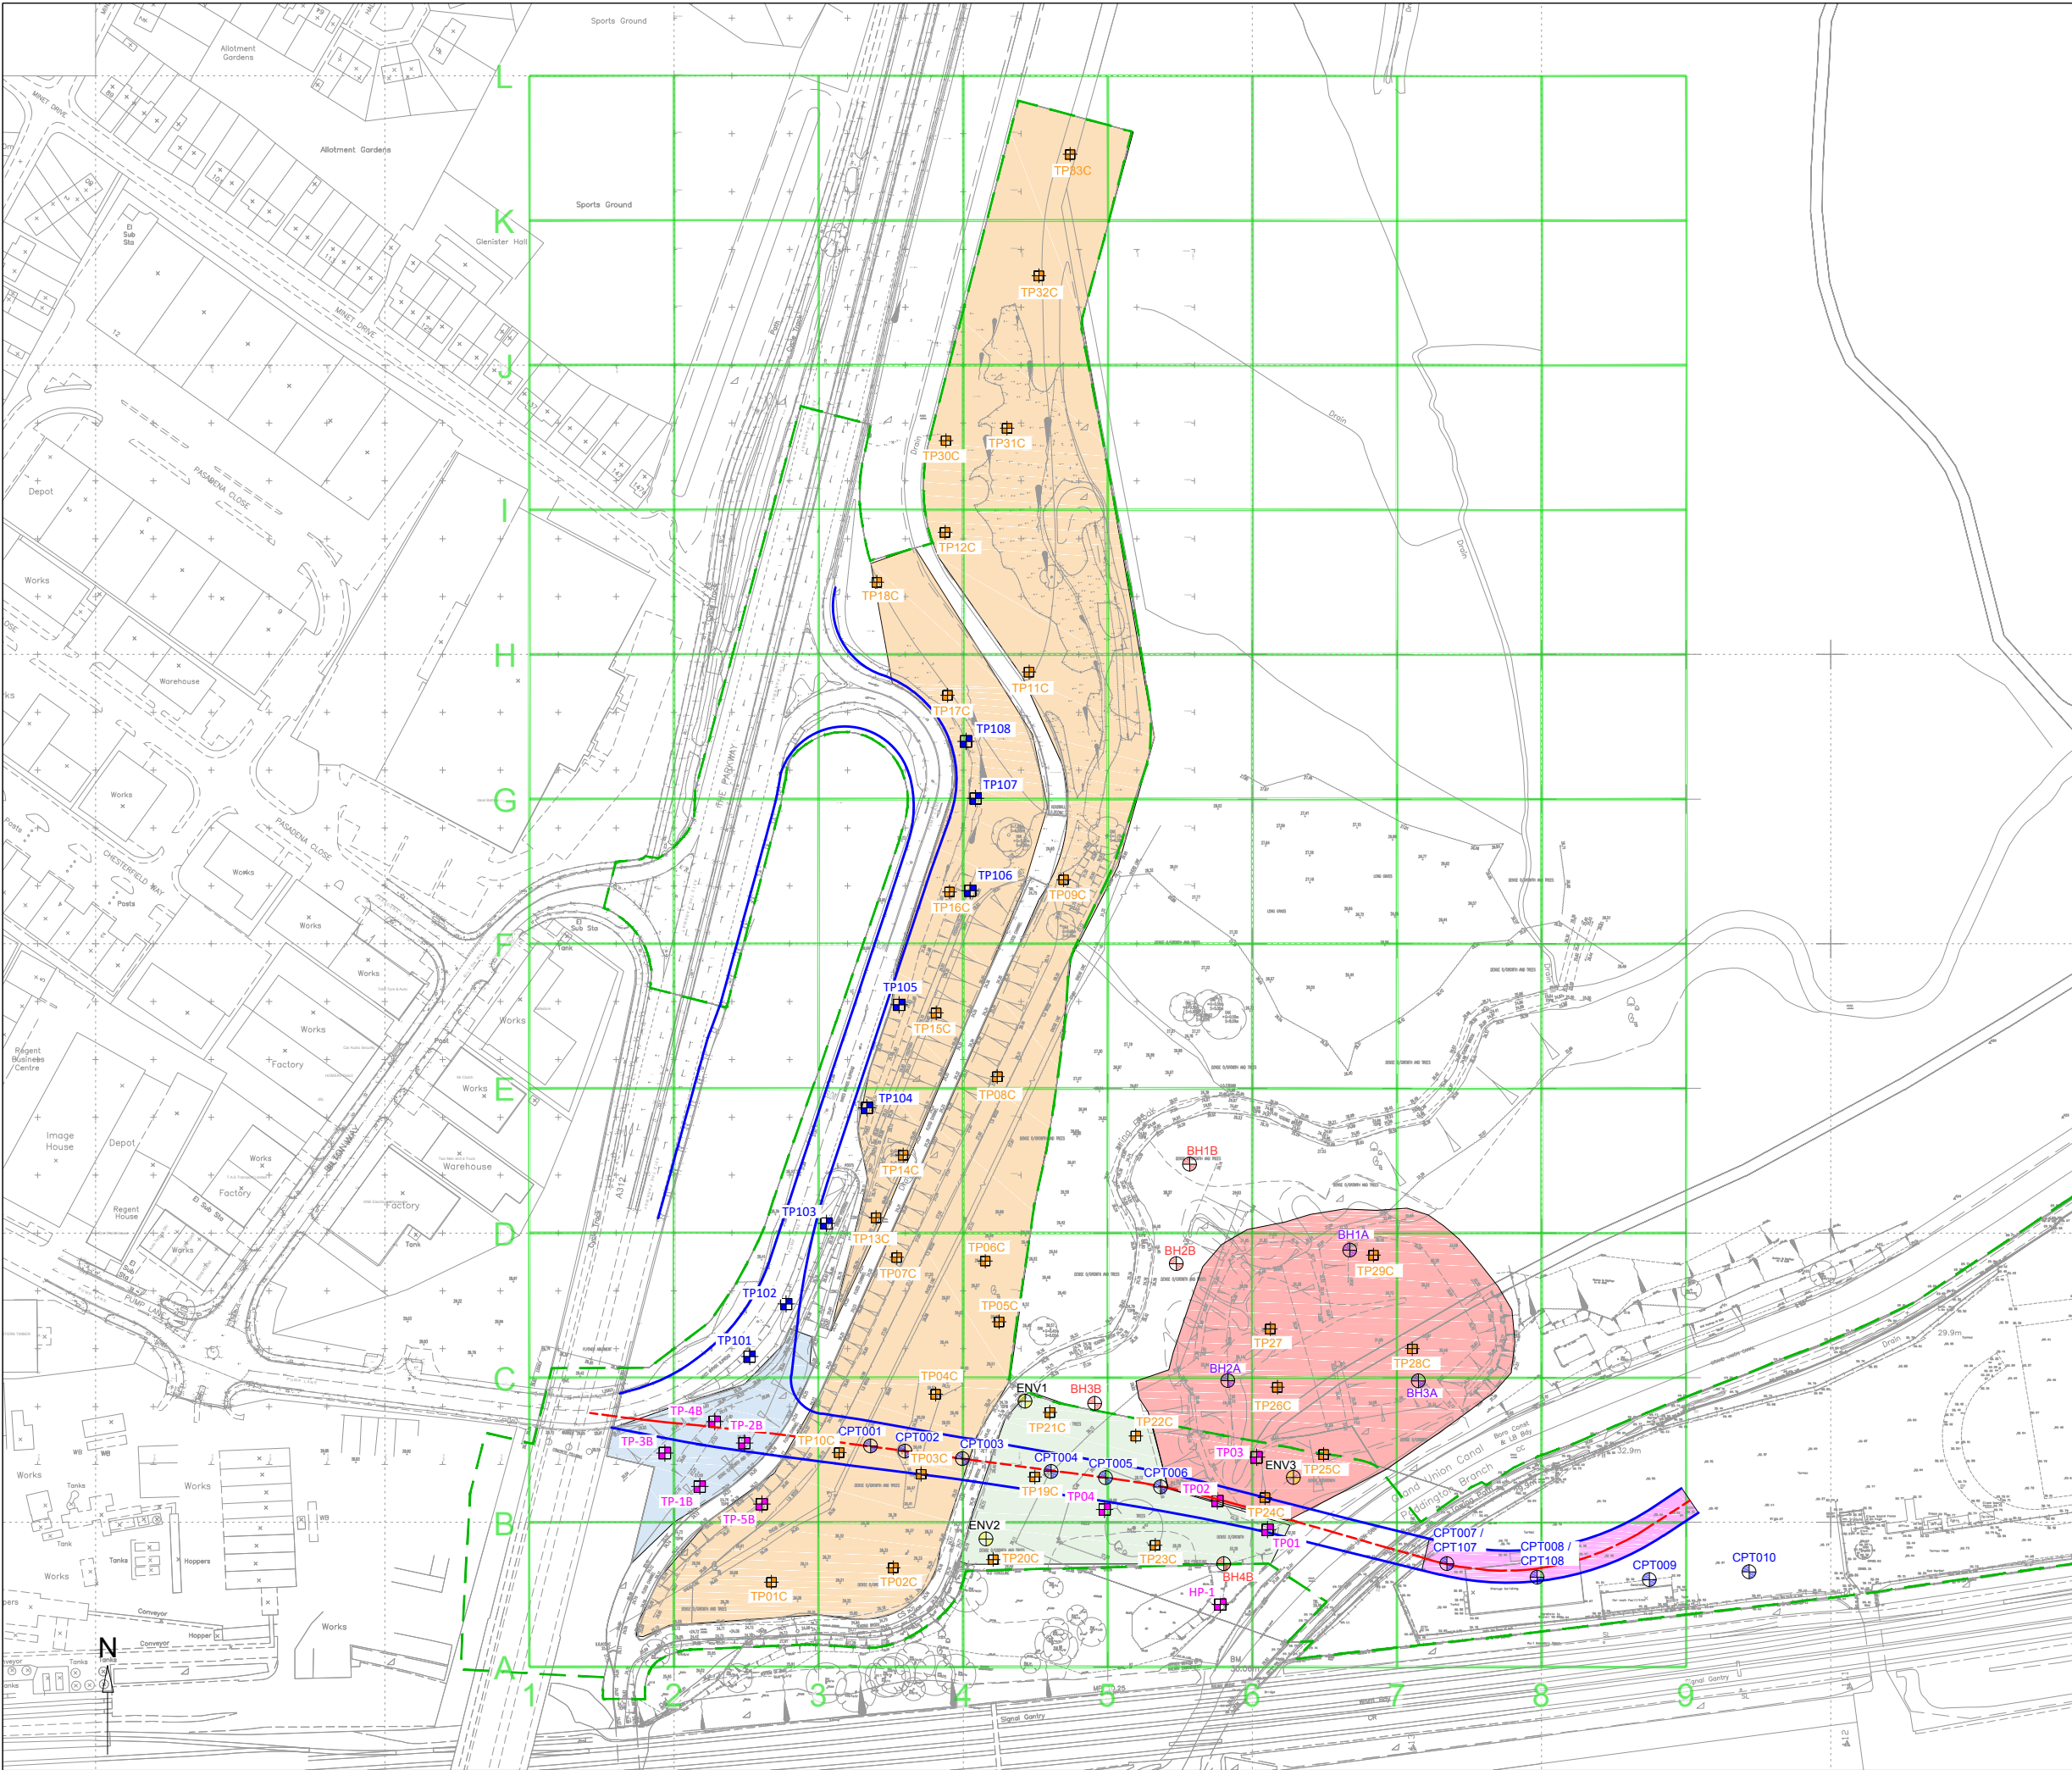
| | Title | Figure 2 |

| | Development Overview Plan | |

A site location plan is presented as Figure 1 and a development overview plan is presented as Figure 2.

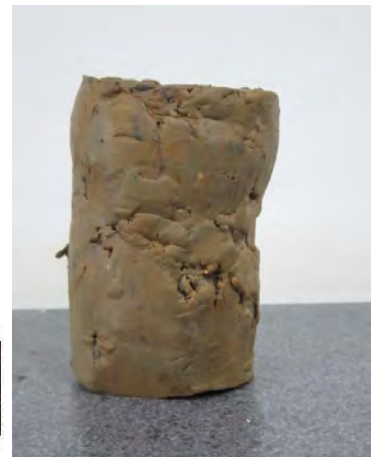
**Failure Sketch**  
(surface inclination)
