| Project | | Southall Western Access | |
| Drawing title | | Contamination Observation Plan | |

| <b>Clark Smith Partnership</b> | <b>Western Access – Remediation Scheme Addendum</b> | <b>CGN/03732I</b> |

**Western Access, Southall**  
*Earthworks Material Acceptability  
and Waste Characterisation (Pump  
Lane Bund)*

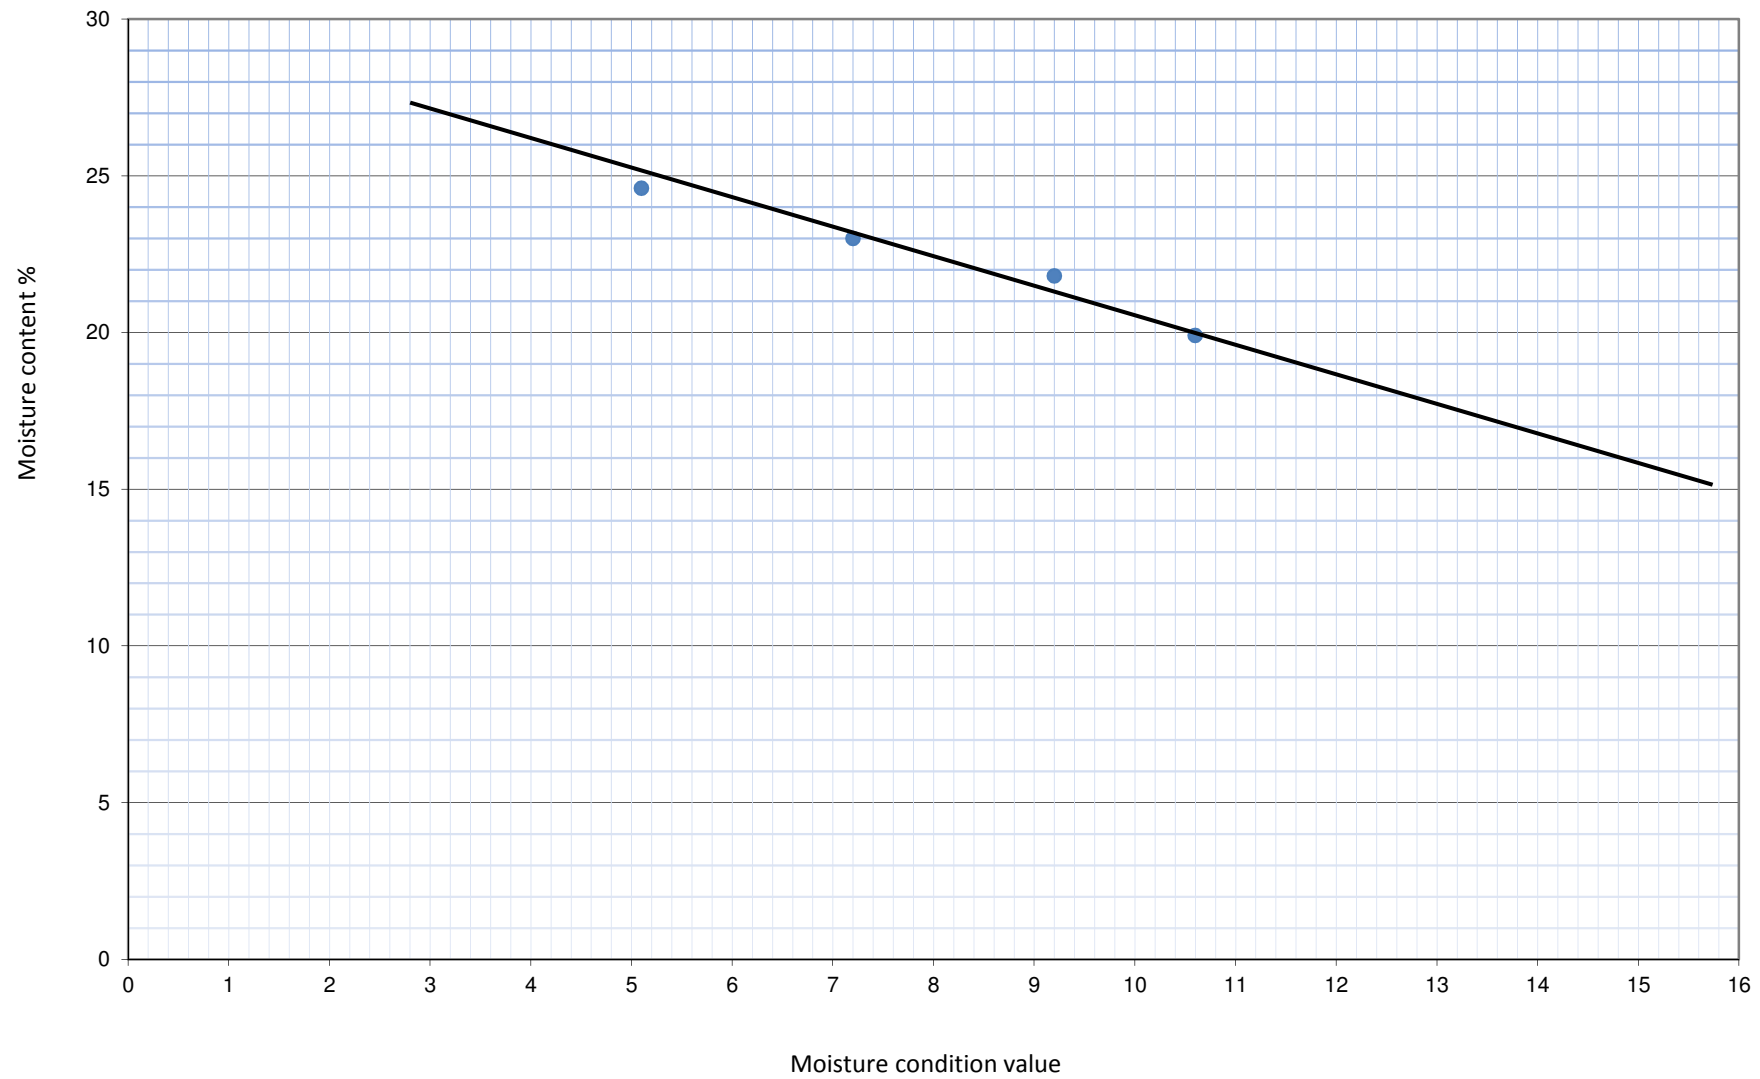
**Determination of moisture condition value in accordance with BS1377 Part 4 Clause 5**

Sample description: Made ground:  
brown sandy clay with occasional  
gravel and very occasional concrete
