# Phase 1 Desk Study

67 Pinkwell Lane - Hayes

**LUSTRE**  
CONSULTING

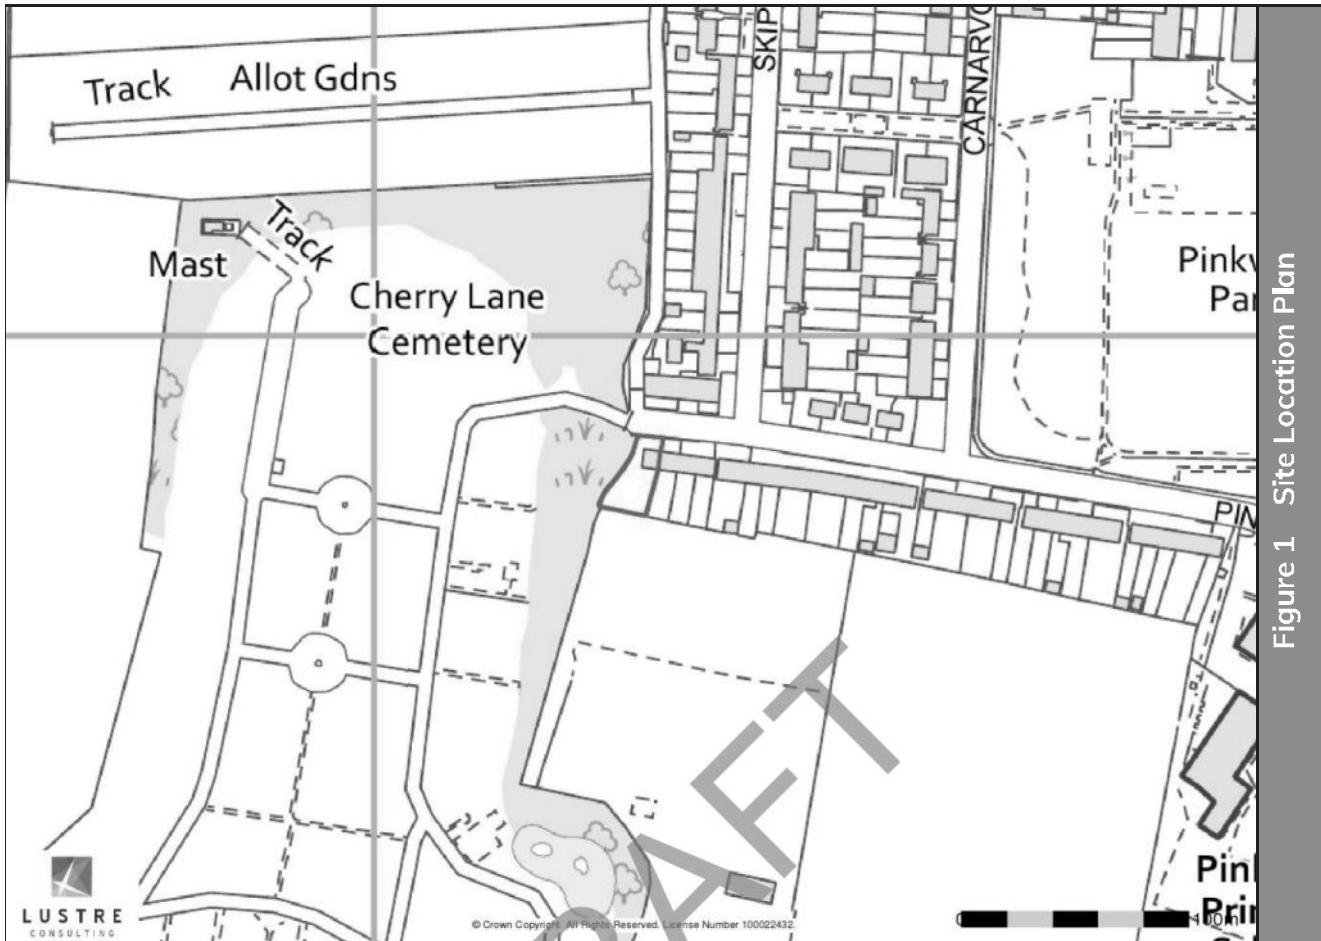
1.5 The site, quadrilateral in plan, currently comprises a single two-storey semi-detached house with a hardstanding driveway to the east and soft landscaped garden to the west. The site is located within an urban area. The site area is shown in Figure 1.

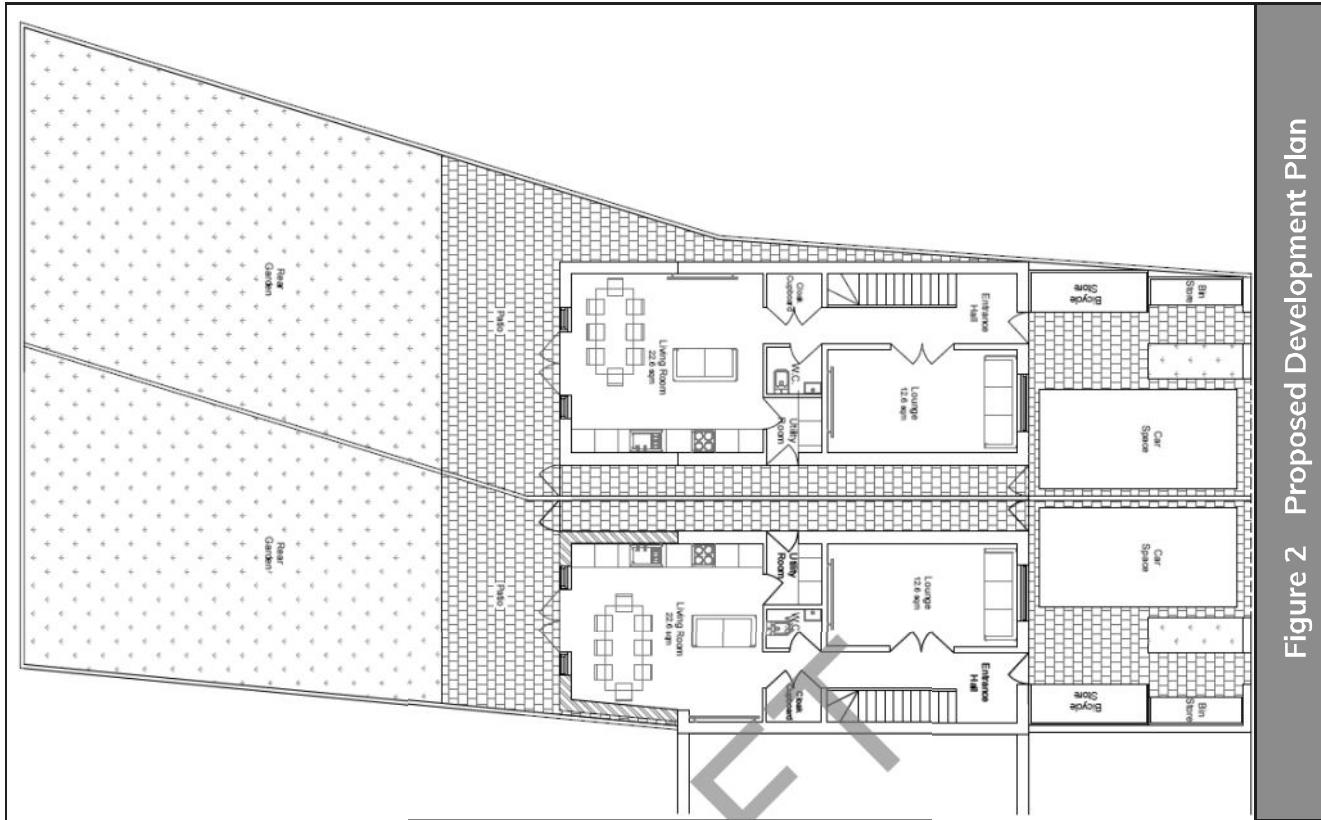
Figure 2 Proposed Development Plan

- 1.6 It is understood that the site has planning permission (ref: 54986/APP/2023/3718) for redevelopment to provide a residential scheme, as illustrated in Figure 2.

- 1.7 The proposed development involves the development of the site to produce two residential dwellings. Enabling works are understood to involve the full clearance of 67 Pinkwell Lane (excluding the demolition of the party wall adjoining 67 Pinkwell Lane with 68 Pinkwell Lane) to facilitate the construction of the two dwellings within the existing building and driveway/garage footprint. External parts of the site will comprise private gardens to the west with, hardstanding driveways to the east. There are no basements, undercroft car parking or other underground structures anticipated with below ground features limited to foundations and buried services. It is understood that site levels will remain relatively similar to that present.

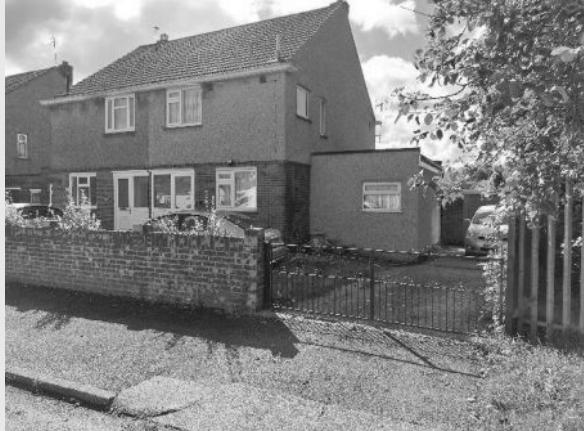
A View of the Site to the South from Pinkwell Lane

2.3 At the time of the site walkover the site comprised a vacant two storey semi-detached house with hardstanding driveway to the front and a soft landscaped private garden to the rear.

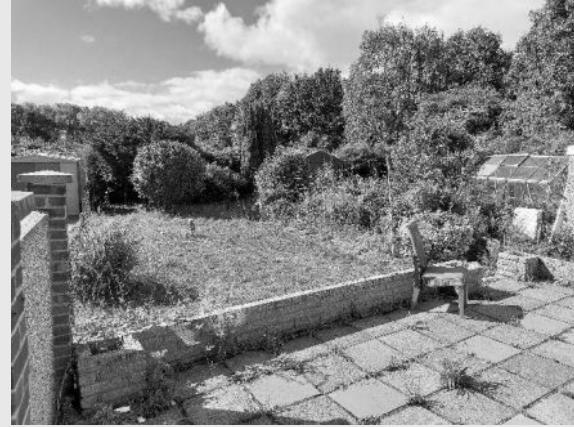
A View towards the Southwest of the Rear Garden

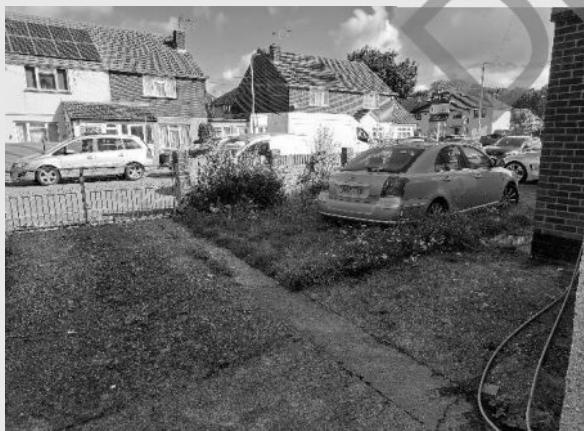
A View to the Northeast of the Front of the Site and out to Pinkwell Lane

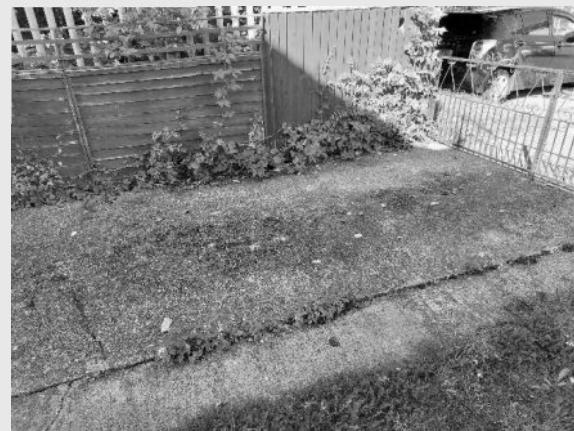
2.4 The driveway was concrete with minor staining noted to the area in front of the gate. A small area of grass was noted to the northeast corner of the driveway adjacent to Pinkwell Lane and the neighbouring 68 dwelling. Next to the house and at the back of the driveway was the garage which extended into the rear garden towards the south.

Minor Staining to the Concrete Driveway adjacent to the Access to Pinkwell Lane

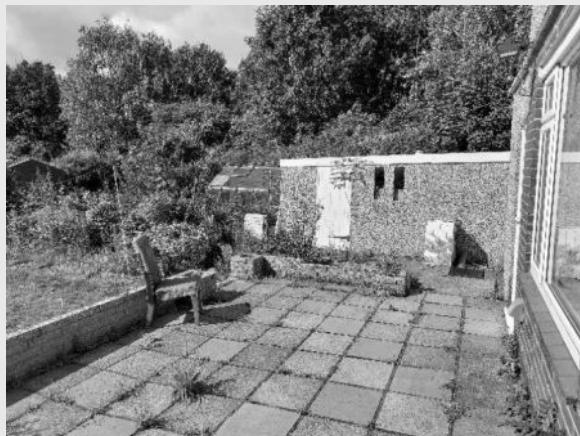
2.5 The rear garden was comprised of grass with ornamental trees and bushes through the centre. A shed was noted to the southern perimeter of the garden and an empty greenhouse to the rear of the garage. The shed was noted to contain a lawn mower. Adjacent to the back of the house was a patio which joined to the concrete path that led to the driveway.

**The Patio (foreground) and Garage (background) within the Rear Garden**

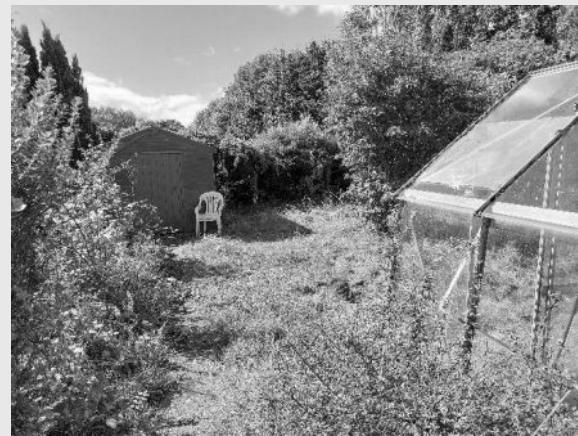
**The Shed (left) and SW Corner of the Rear Garden**
