St Helens Close, Cowley, UXBRIDGE, UB8 5SZ

## Express Preliminary UXO Risk Assessment

| <b>Project</b> | St Helens Close, Cowley |

## Appendix F Site Photographs

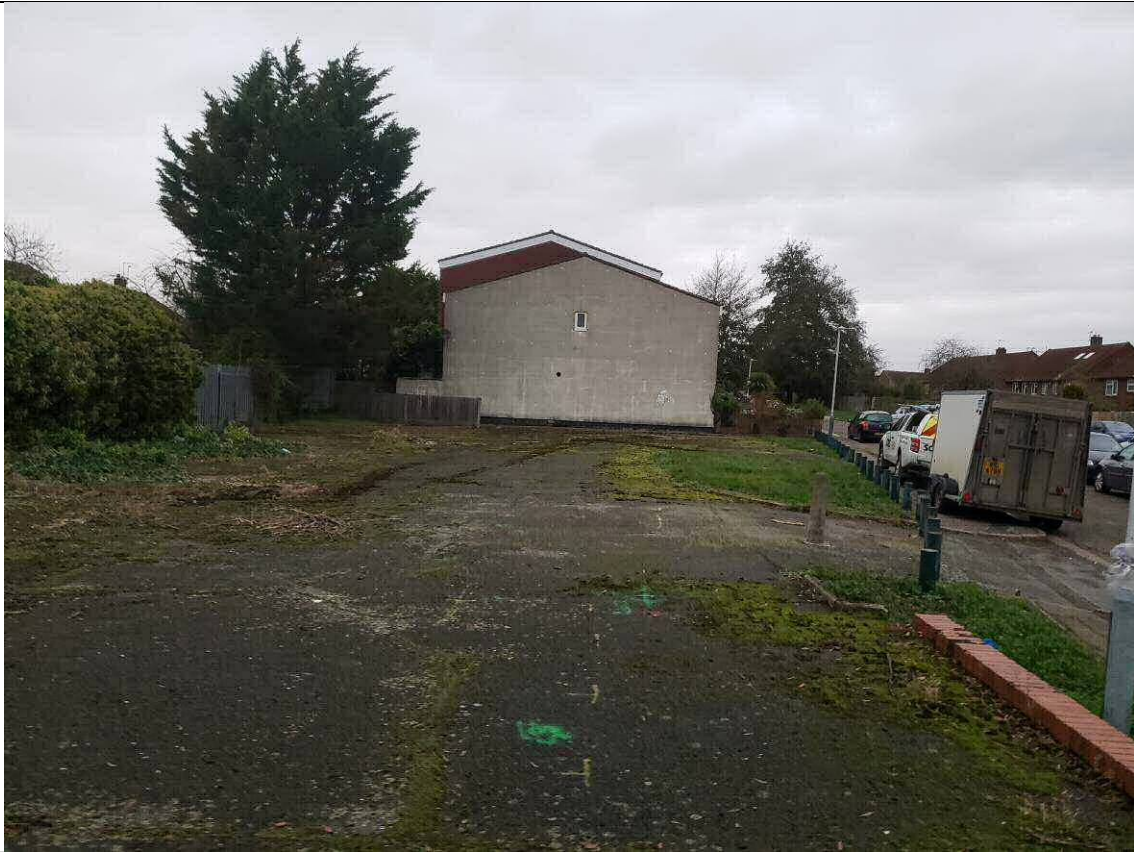
**Photo 1:** From the middle of the site looking north.

| Risk Assessment Considerations | |
|---|---|
| Site location and description/current use | <p>The site is located within the London Borough of Hillingdon.</p> <p>Recent aerial imagery indicates that the site is comprised of open, hardstanding ground, with no structures found on site.</p> <p>The site is bound by St Helens Close to the east, and residential housing with associated gardens to the north, south and west.</p> <p>The site is approximately centred on the OS grid reference: <b>TQ 05771 81524.</b></p> |

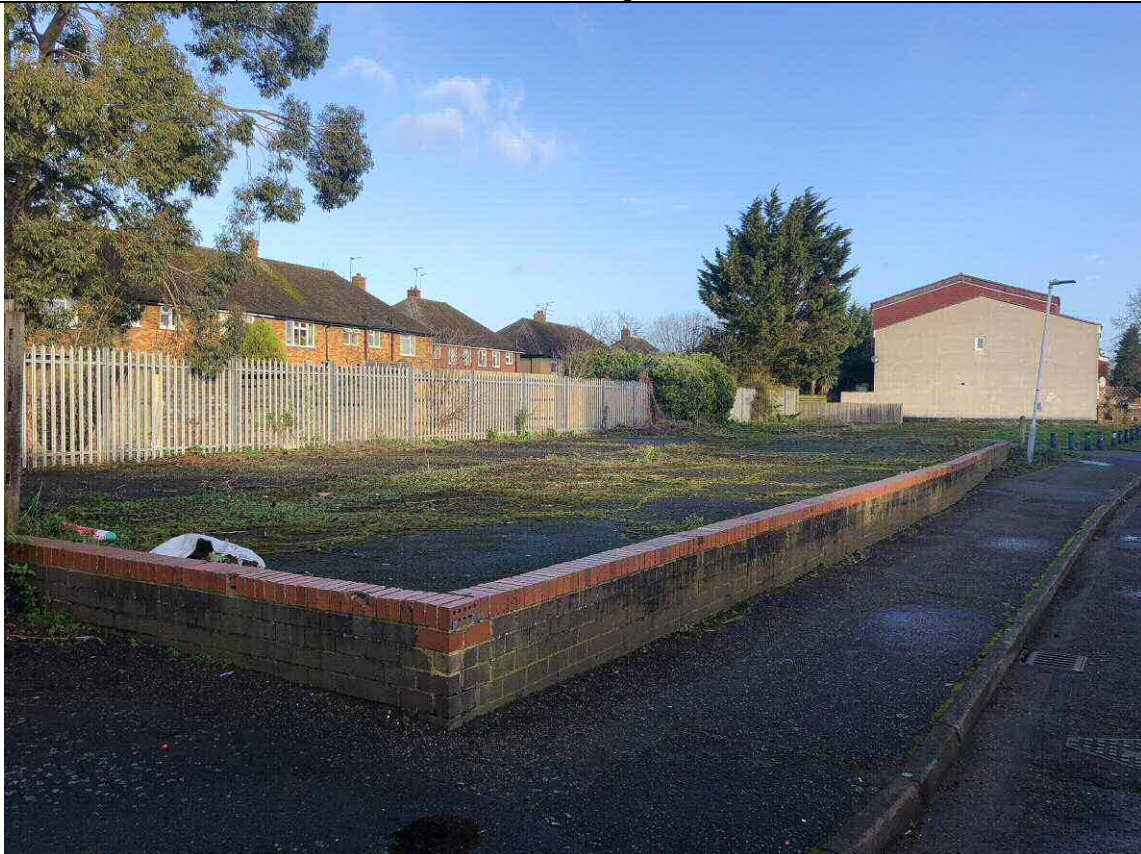
**Photo 2:** From just off site to the south looking north.
