**Hillingdon Young Person's Hub  
Falling Lane  
Yiewsley  
West Drayton  
Middlesex**

**Preliminary Ground Contamination  
Risk Assessment Report**

**Report No. R17-12386/ds**

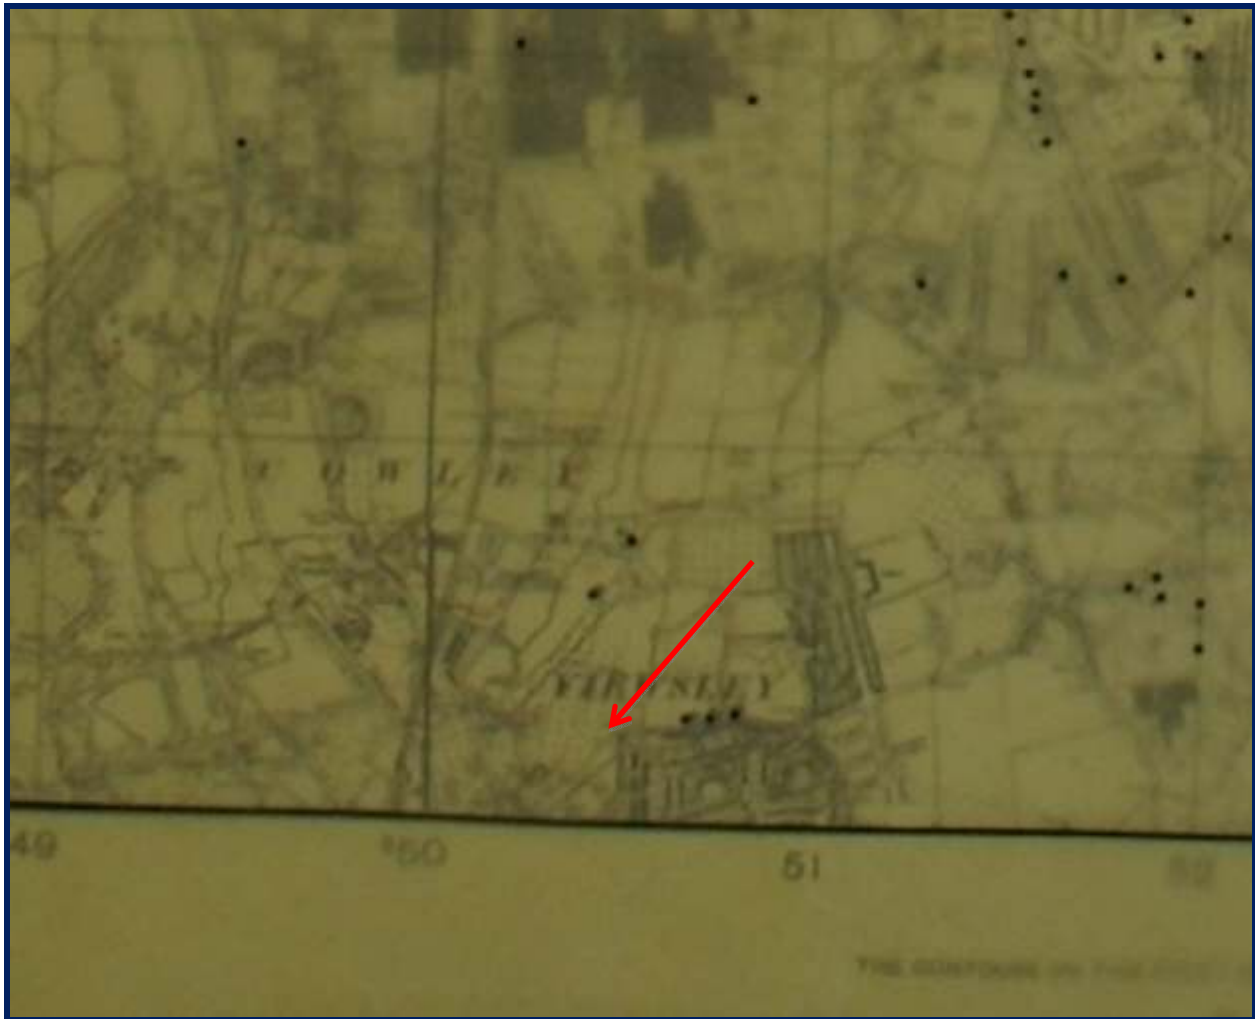
**MAP 2:** HO 193-13 Night bombing between 7<sup>th</sup> October and the 6<sup>th</sup> June.

**MAP SOURCE:** HO 193  
**MAP REVISION:** N/A  
**GRID REFERENCE:** 504 003

**NOTE:** The red arrow highlights the approx centre of the subject site.

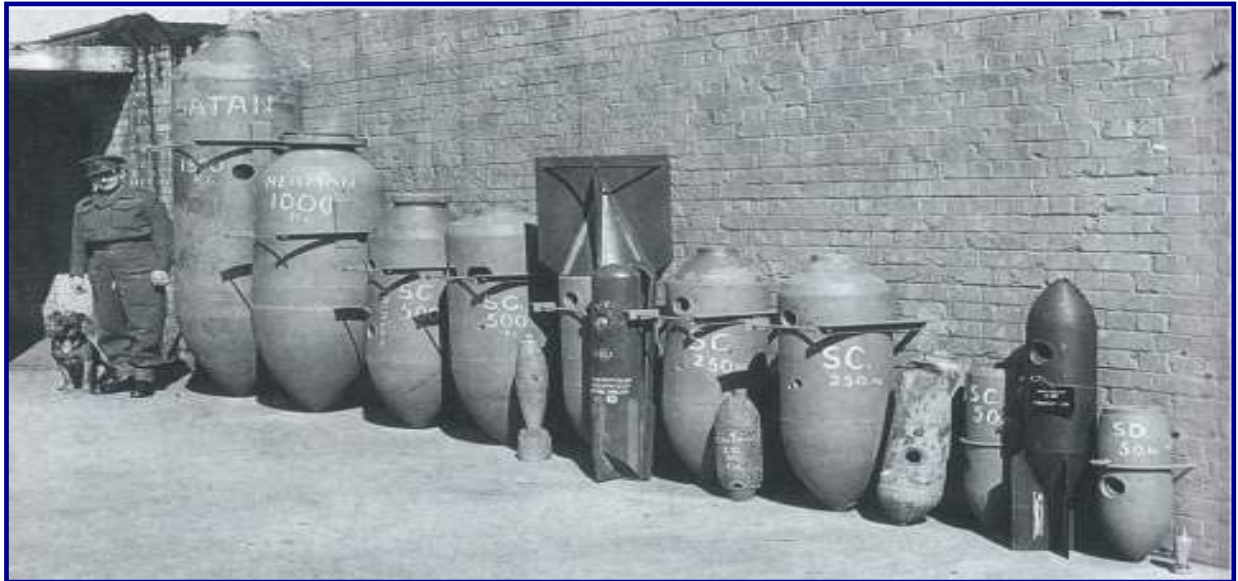
**FIGURE 3:** Range of HE bombs dropped on the United Kingdom.

*NOTE: The smaller sub-munitions (Bomblets) seen to the right, ranged in size between 1 and 3kg, were dropped in large numbers and were intended as incendiary bombs, anti-personnel bombs or as bombs filling both roles. The smaller bomblets were dropped in larger container bombs designed to hold between 360 and 620 of the bomblets. The containers were designed to burst open at a predetermined height above ground level, dispersing the bomblets over a wide area. Air raid damage was far greater by using both incendiary, and HE bombs on a single raid. The fires started by the incendiaries being rapidly spread by the blast waves from the HE bomb. This scenario was shown to devastating effect on the 14<sup>th</sup> February 1945 in the German city of Dresden. Where fires started and spread by the bombing increased to a point where the oxygen was being sucked into the flames at such a high speed that the fire became a "Fire Storm". At the time the city's population had increased due to a high number of refugees fleeing the Russian advance to the east, the exact civilian death toll from fire and suffocation will never be known, but is considered to be somewhere between 25,000 and 100,000.*

**High Explosive (HE) Bomb.** Some of the most common type of ordnance to be dropped on the United Kingdom, HE bombs are often the type encountered as UXBs. Relatively thick cased, they are still recovered in remarkably good condition. Ranging in size from 50 to 1700 kg, their typical release height (1,500m) allowed them to penetrate deep into the ground as a result of design or flaw. Towards the end of the bombing campaign, as steel became scarce the German Engineers produced a range of bombs that used steel reinforced concrete as the bomb body. Figure 6.3 shows the range of steel HE bombs dropped on the UK.

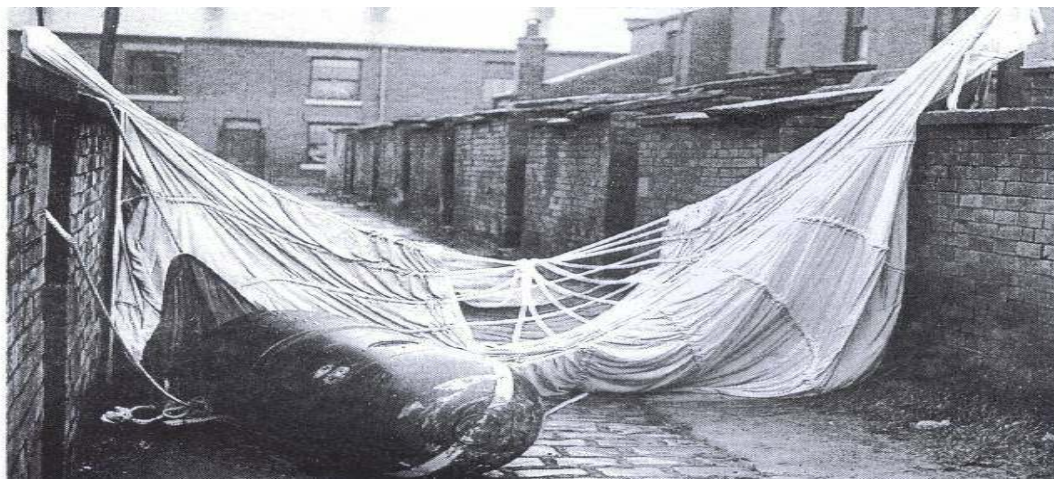
**FIGURE 5:** Common Airdropped Mines.

*Note; all mine fuzes were designed to arm after deployment from the ship, submarine or aircraft, some fuze designs incorporated anti-removal booby traps. Unexploded mines found today are the result of a failure within the arming mechanism or procedure whereby the mine never fully armed. Sudden shock or jarring of a weapon in this state has the potential to complete the arming sequence and could result in the mine detonating with lethal consequences.*

**Blast Bomb / Parachute Mine.** The parachute mine was extensively used on land and at sea and was fitted with specialist fuzes designed to trigger the weapon at a predetermined altitude, water depth or to switch on other magnetic influence mechanisms to trigger the weapon when a ship approached (Magnetic or Acoustic influence). While early versions were based on the standard 1000kg SD Bomb case others were specially designed and manufactured with an aluminium body, making them extremely difficult to detect using magnetometers. The thin cased versions would normally disintegrate on impact on land and are normally considered to pose little threat to work on land based projects, but the risk increases significantly on projects over water or in marshland. Thicker cased versions however will survive impact and pose a significant risk regardless of the local ground conditions. (See Figure 5)
