Project / Site name: Rifle Range St Andrews Park , Uxbridge

A
Report of Proceedings
On the
Munitions Contamination Survey
Of
Ground Investigation Locations
At
Old RAF Site, Hillingdon Road
Middlesex, UB10 0AE
For
Ian Farmer Associates (1998) Limited
FIL 1.5/1310-15 January 2015

This report was produced by Atkins Limited (Atkins) for VSM Estates (Uxbridge) Limited for the specific purpose of presenting the Remediation and Reclamation Strategy in order to discharge planning conditions 72 and 73 for the Phase 6 area which forms part of the St. Andrews Park Development.

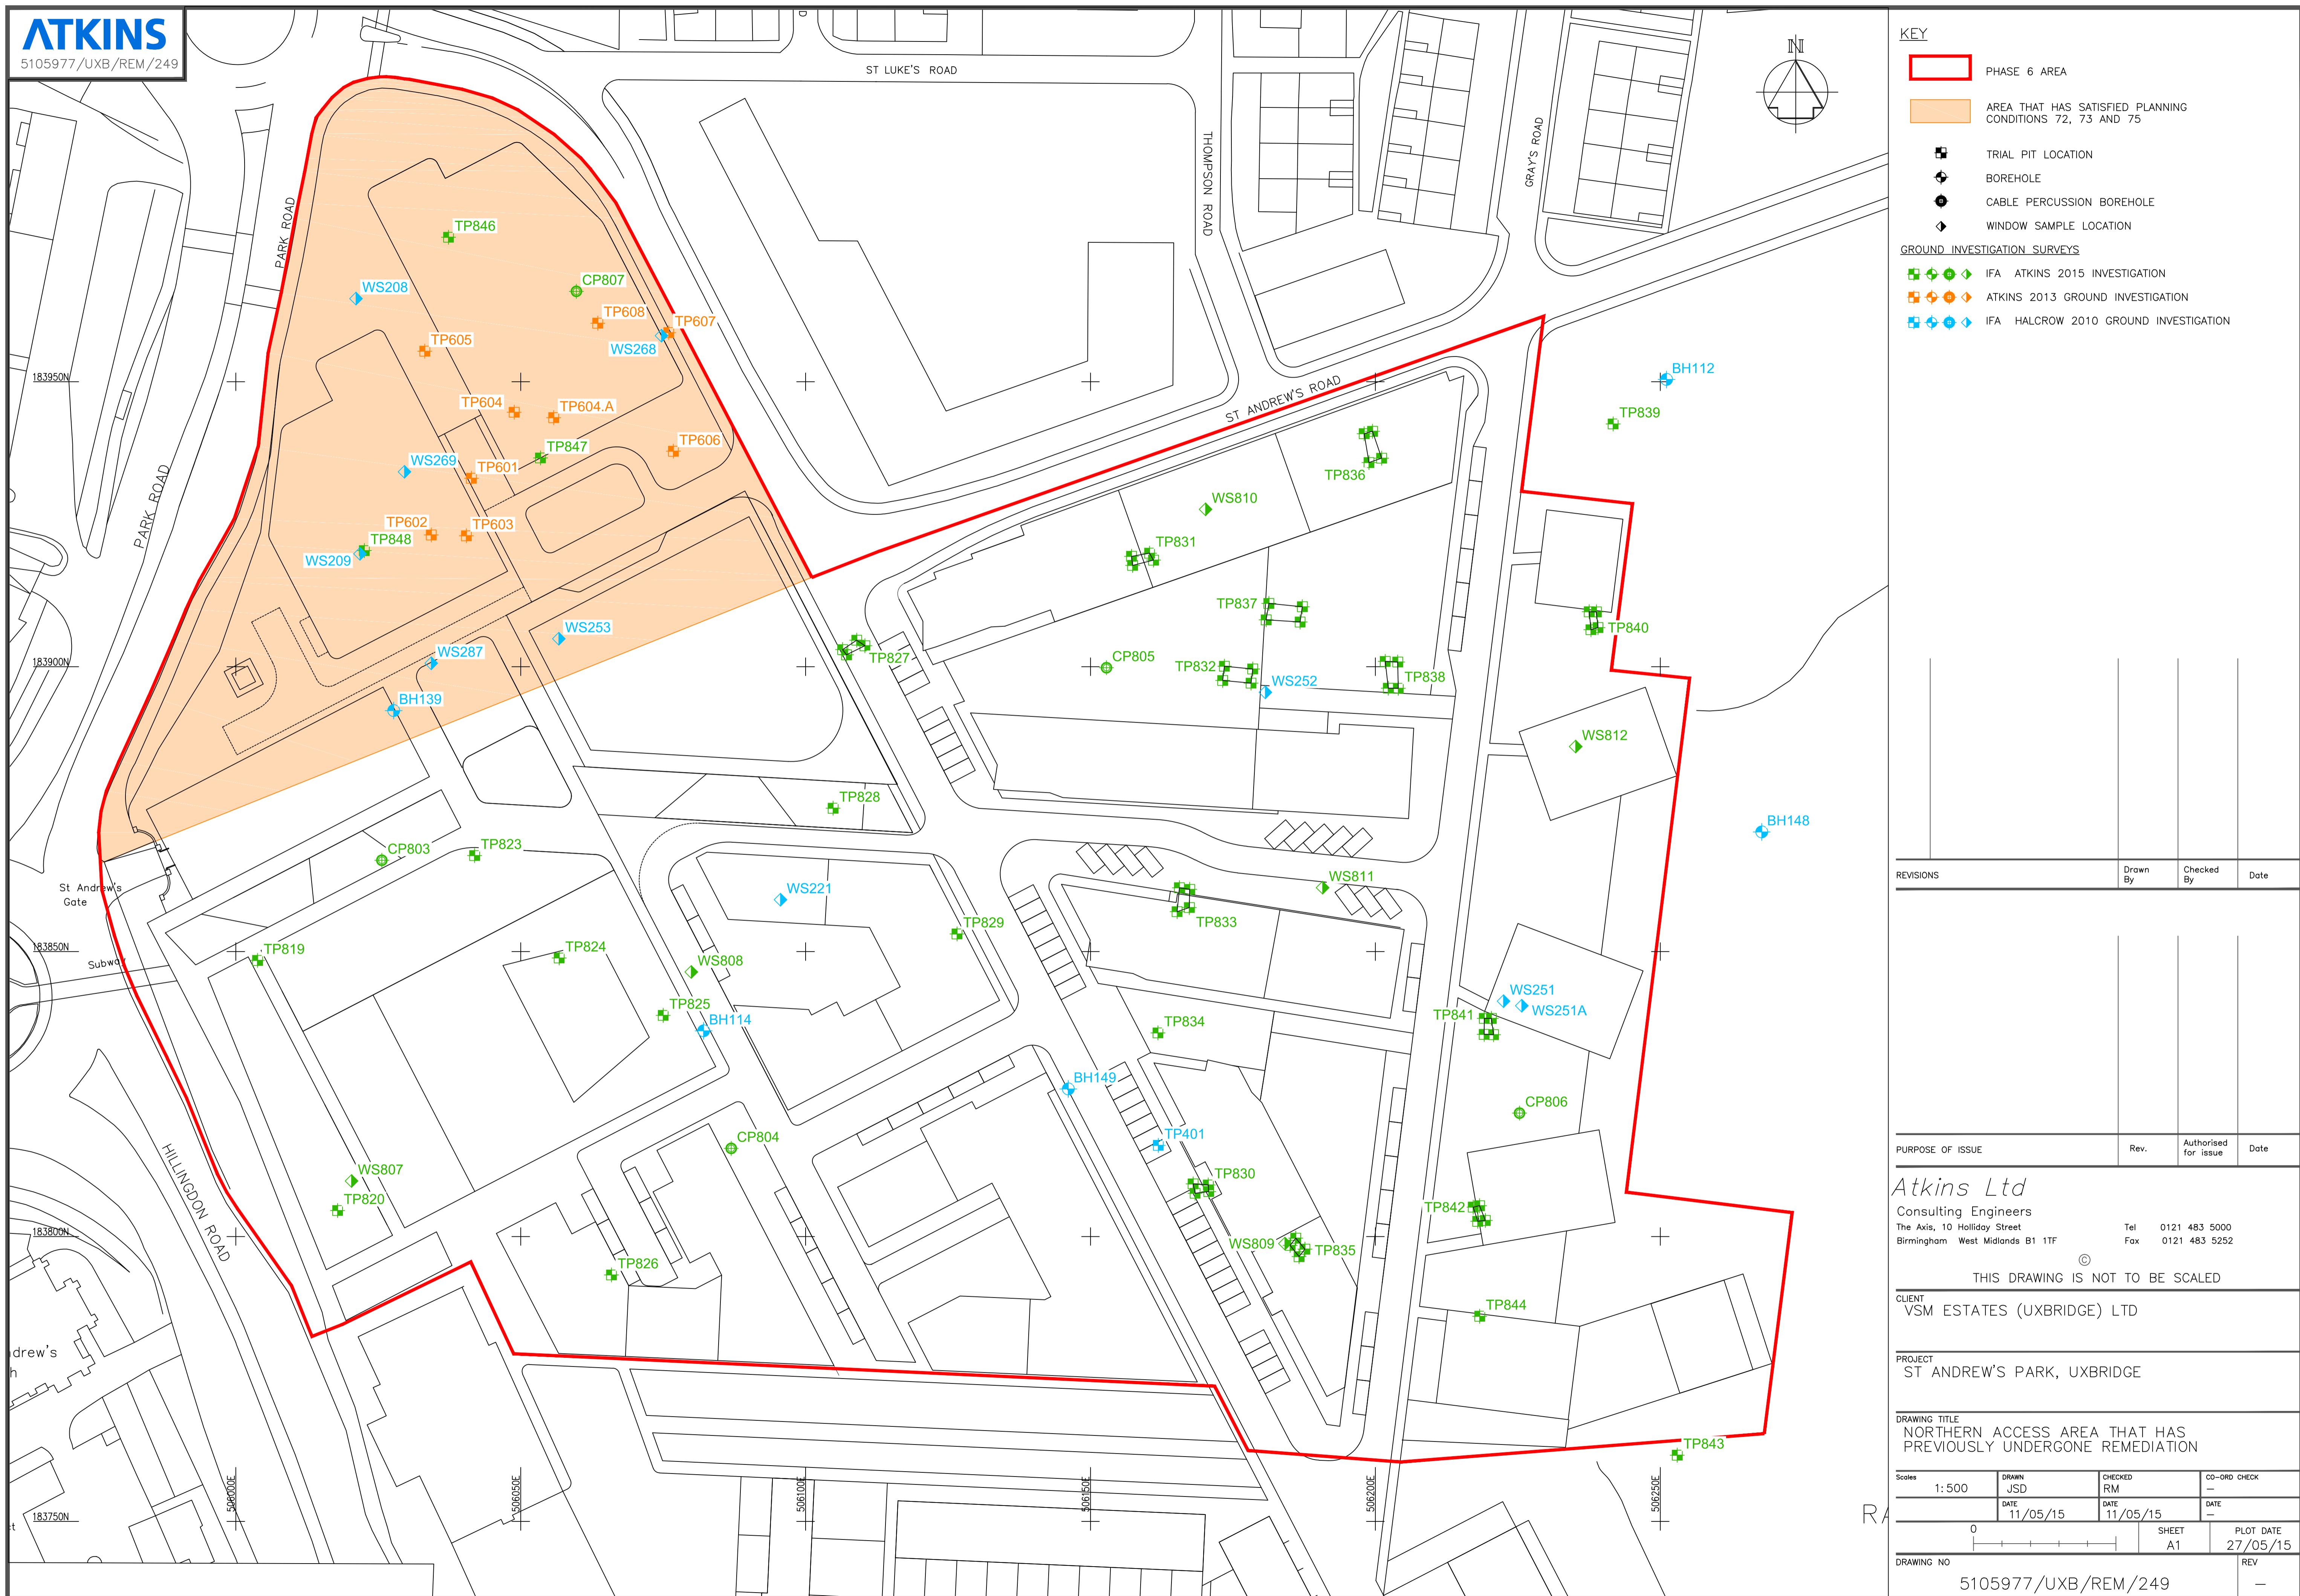
DRAWING TITLE			
NORTHERN ACCESS AREA THAT HAS PREVIOUSLY UNDERGONE REMEDIATION			
Scales	DRAWN	CHECKED	CO-ORD CHECK
1: 500	JSD	RM	—
	DATE	DATE	DATE
	11/05/15	11/05/15	—
0	—	—	—
	—	—	—
DRAWING NO	SHEET	PLOT DATE	REV
5105977/UXB/REM/249	A1	27/05/15	—

- PHASE 6 AREA
- AREA THAT HAS SATISFIED PLANNING CONDITIONS 72, 73 AND 75
- TRIAL PIT LOCATION
- BOREHOLE
- CABLE PERCUSSION BOREHOLE
- WINDOW SAMPLE LOCATION
- GROUND INVESTIGATION SURVEYS
- IFA ATKINS 2015 INVESTIGATION
- ATKINS 2013 GROUND INVESTIGATION
- IFA HALCROW 2010 GROUND INVESTIGATION

The western part of the 'Northern Access' phase falls within the north-western most corner of the site (formerly occupied by the Military Transport area), as illustrated on Drawing No. 5105977/UXB/REM/249 (Appendix A). The Northern Access phase was investigated, assessed and remediated between April and November 2013 (Ref. 28) to satisfy Planning Conditions 72, 73 and 75. Therefore, this report does not deal with human health or controlled water assessment of the north-western part of the site.
