BATTLE OF BRITAIN BUNKER

Wren Avenue, Uxbridge

Archaeological watching brief

April 2024

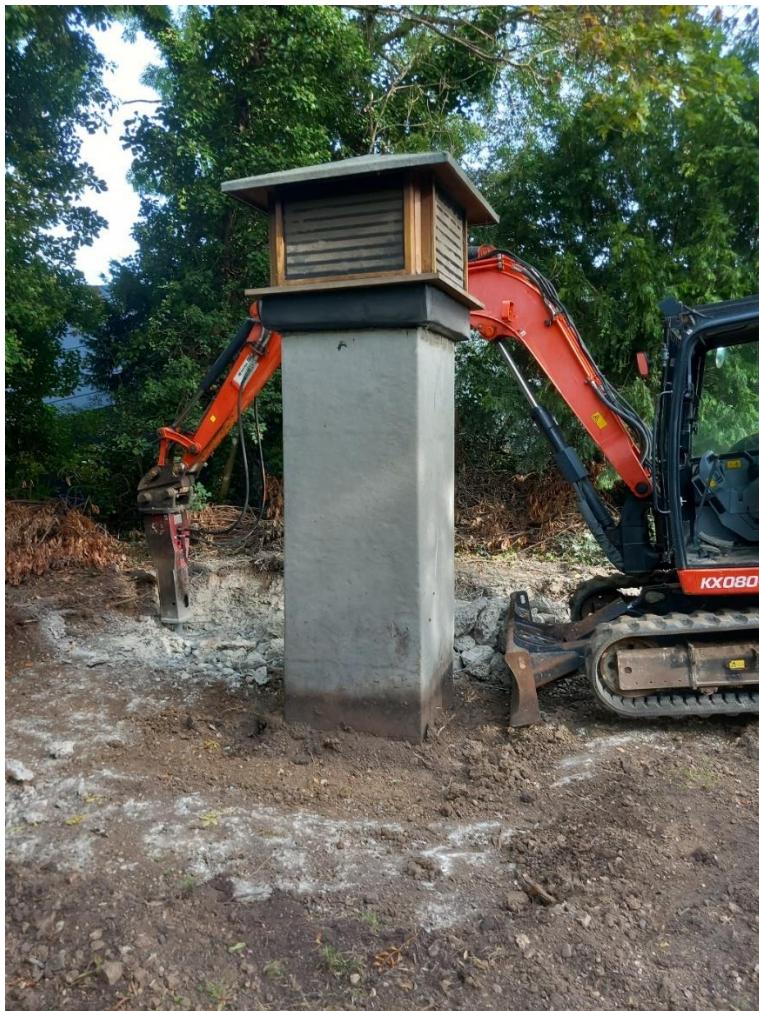
Image 1 the upper concrete burster slab being exposed near Vent X1 (looking NE)

4.2.2 As part of the remedial works to prevent water ingress, three of these vents (Y2, X1 and X2) were exposed down to the top of the engine room part of the bunker. The fourth vent, Y1, was not affected by the current work. The shored shafts around the vents allowed the construction of the bunker to be investigated. The stratigraphy was very similar, with two concrete burster slabs above the roof bunker plant rooms.

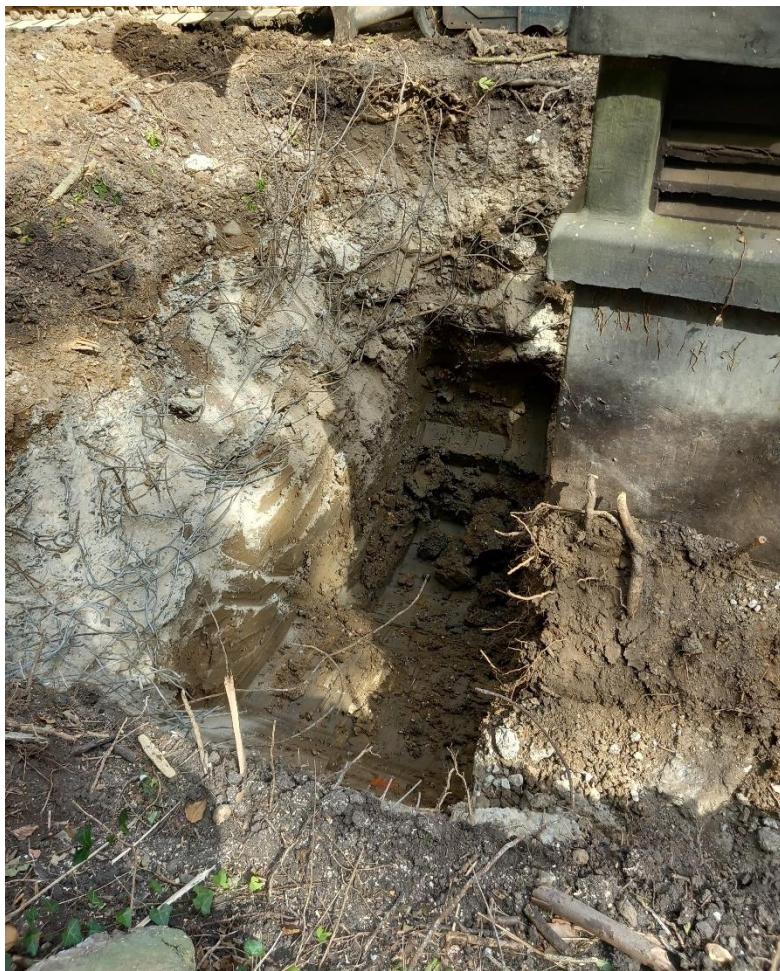
Image 2 mid-excavation section of Vent X2, showing upper concrete burster slab and clay layer below

VENT X2	Thickness	Levels
TOPSOIL	0.50m	43.26m OD
UPPER CONCRETE BURSTER SLAB	0.90m	
BROWN CLAY and GRAVEL	2.30m	
LOWER CONCRETE BURSTER SLAB	0.50m	
BROWN CLAY	0.90m	
TOP OF BUNKER		38.16m OD (5.10m below ground level)

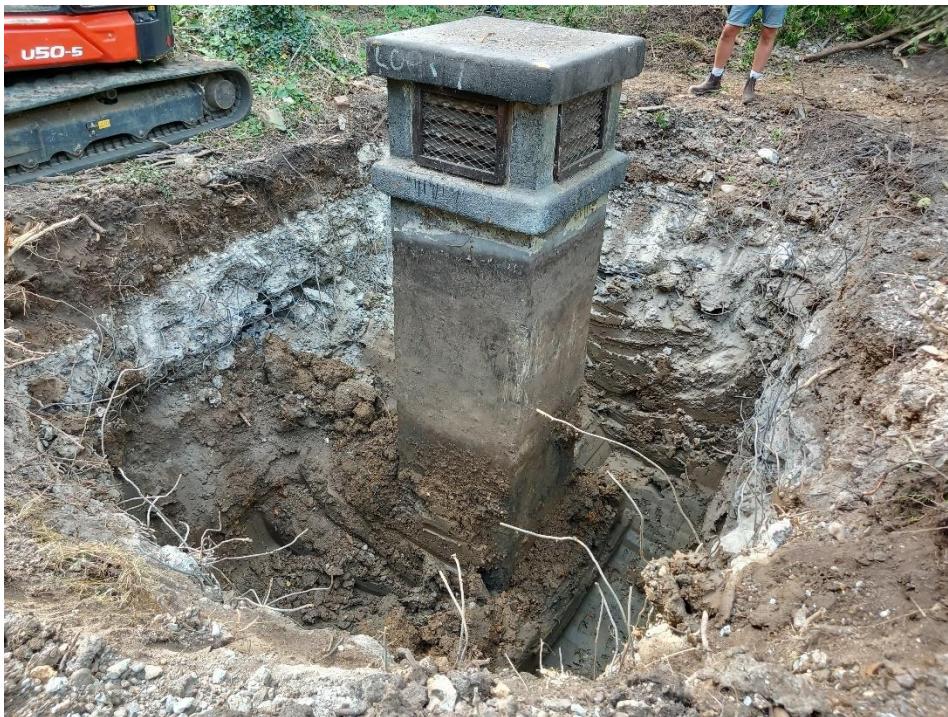
Image 3 mid-excavation view of Vent Y2, showing upper concrete burster slab and clay layer below

VENT Y2	Thickness	Levels
TOPSOIL	0.15m	38.76m OD
CLAY	0.50m	
UPPER CONCRETE BURSTER SLAB	1.0m	
BROWN CLAY	1.40m	
LOWER CONCRETE BURSTER SLAB	0.60m	
GRAVELLY CLAY	1.05m	
TOP OF BUNKER		33.96m OD (4.80m below ground level)

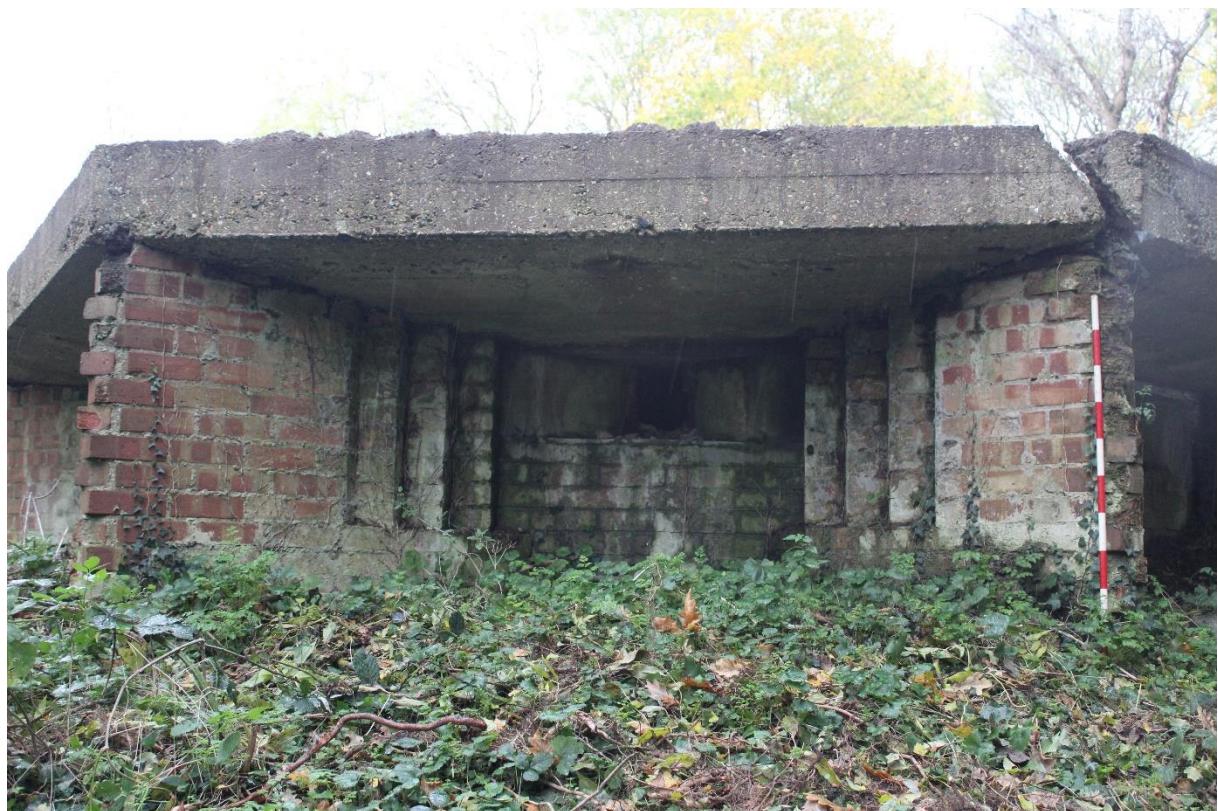
4.3.2 This pillbox was later modified with extra protection added to the outside faces that comprised brick 'spurs' supporting a concrete roof and giving it an odd star shape (Image 5). Many pillboxes were reinforced in early 1941 but this was usually with extra concrete on their roofs and thickened walls, here the modifications seem slightly odd.

Image 5 the pillbox showing the brick 'spurs'(looking N)

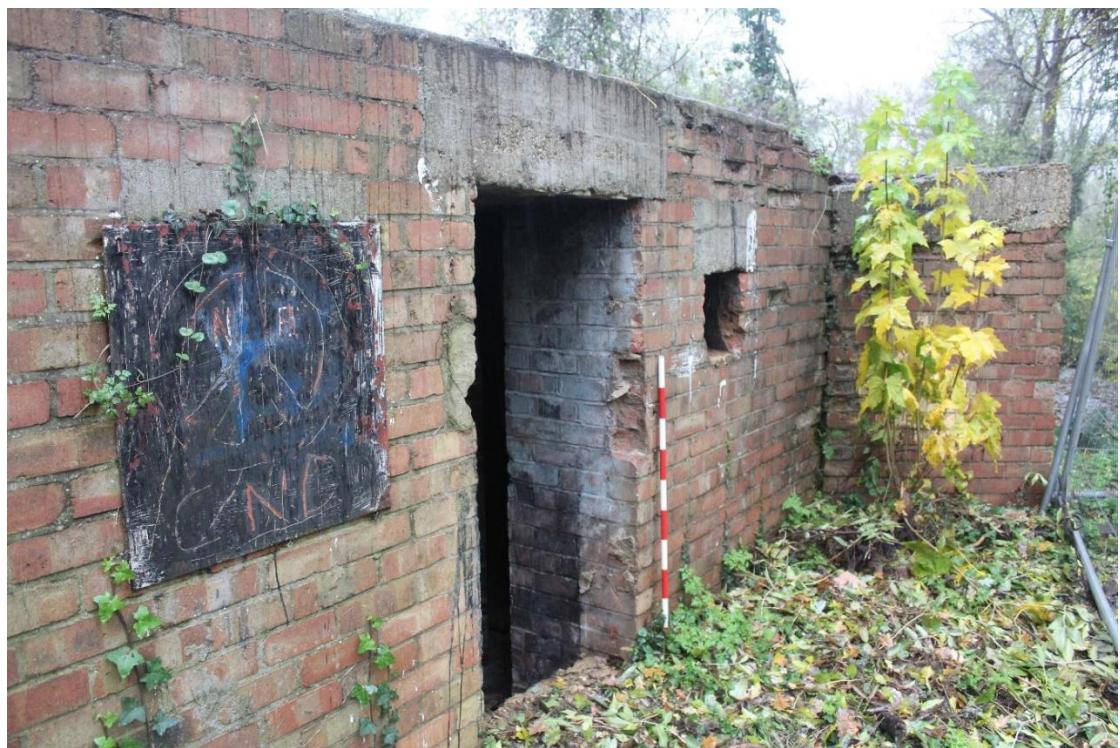
Image 6 the pillbox entrance with CND graffiti (looking NW)

4.4.1 There is a faded Campaign for Nuclear Disarmament (CND) symbol painted on a sheet of metal covering one of the gun ports of the pillbox (Image 6). It is unknown

when this was painted, but the amount fading suggests it has been there for decades. This symbol is often referred to as a peace symbol and was probably painted after RAF Uxbridge closed in the 1990's.

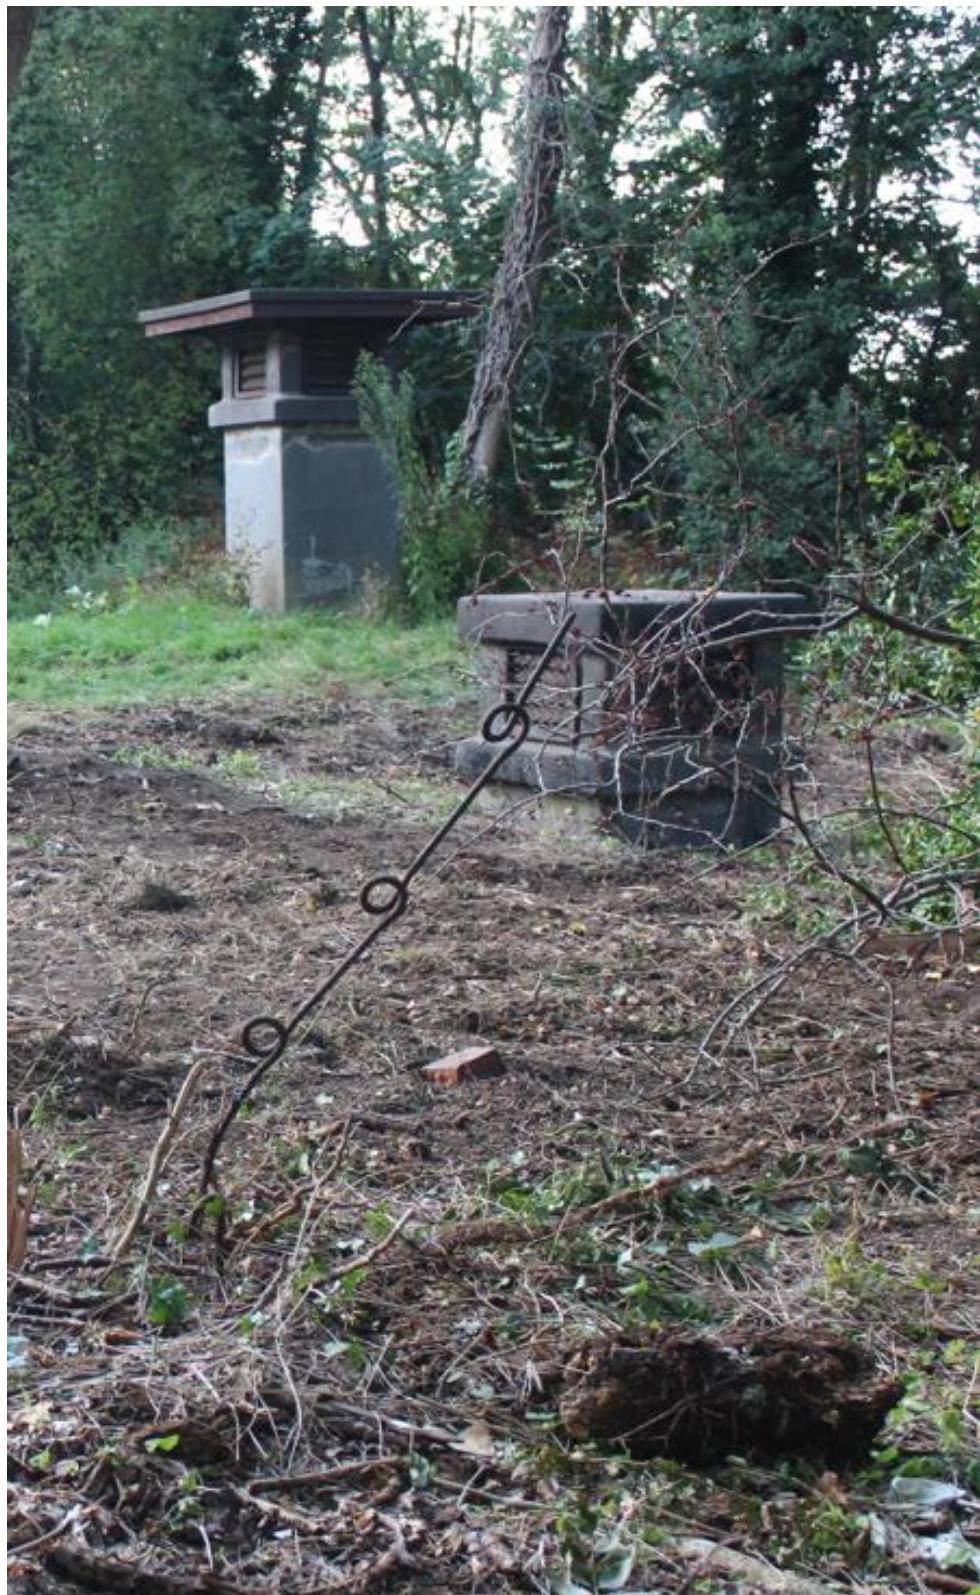
4.3.3 When initially recorded early in 2023 there were still traces of barbed wire and supporting stakes around this pillbox (Image 7). These were removed to allow access to the area around the nearby Vent Y2. The pillbox had been bricked up but has now been opened up, the vegetation cleared from its roof and some of the external brickwork repaired.

Image 7 one of the iron pickets used to hold barbed wire near the pillbox (looking SE)

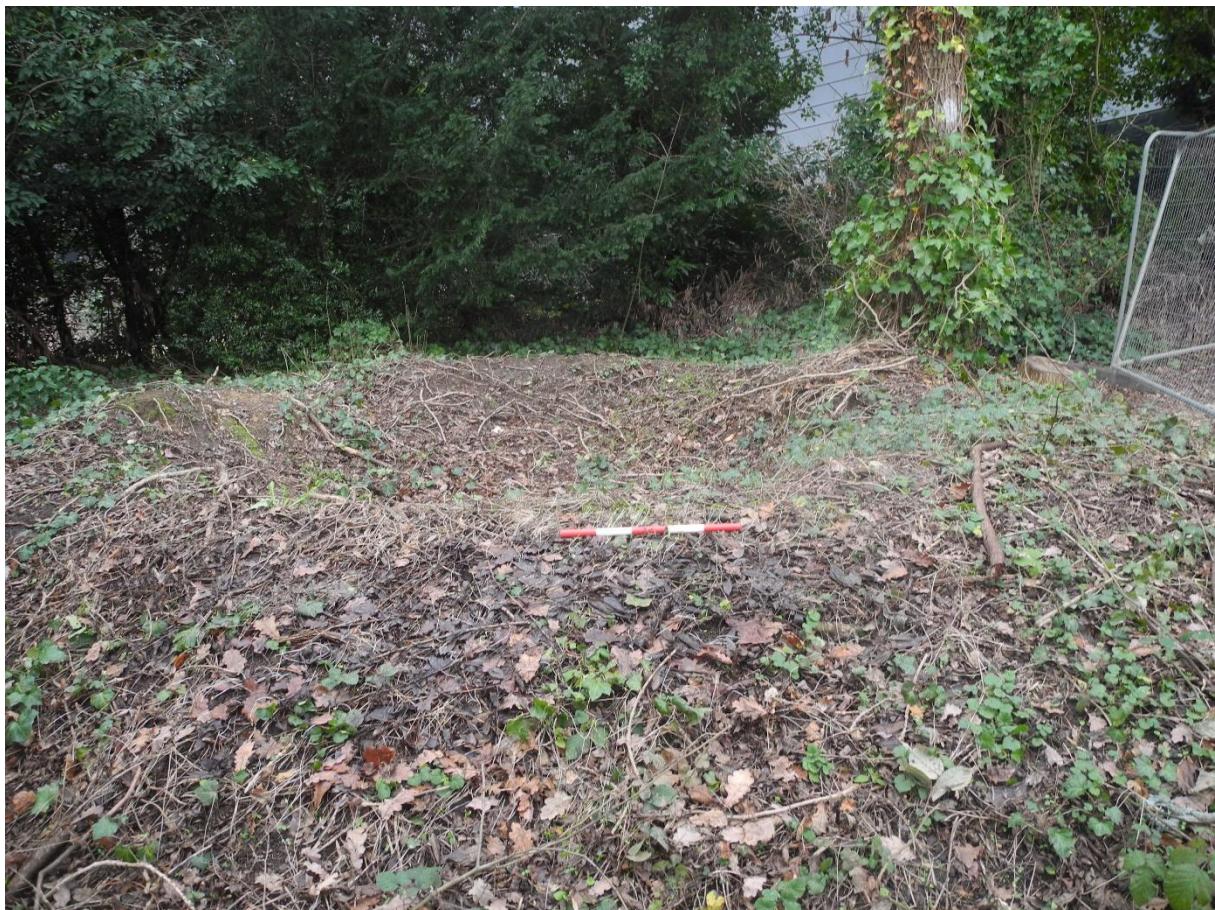
4.5.1 There are two small circular or semi-circular earth embanked features that must have been weapons positions added presumably to increase the defences around the bunker (Image 8). However, when they were constructed is unknown. A quick personal investigation of the one near vent X1 confirmed the banks were heavily eroded and there was c 0.40m of erosion deposits over the base. These features were not affected by the current works.

Image 8 the embanked feature near to Vent X1 (looking N)

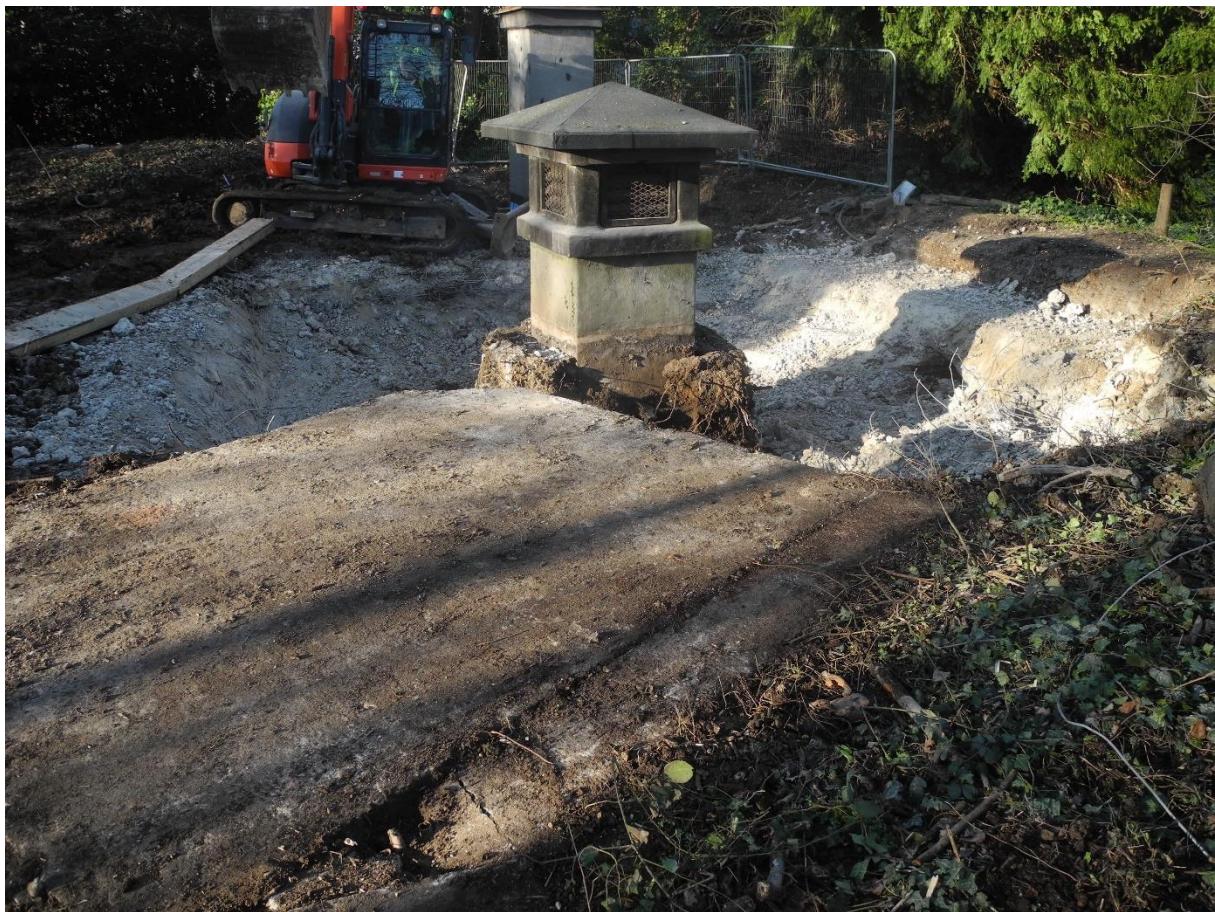
4.7.1 There was an isolated concrete slab at ground level that was located above the bunker (Image 9). This was 3.20m (N-S) x 2.30m (E-W) x 0.15m thick and laid flat with the top at 43.26m OD. A service duct covered by concrete slabs ends at this feature. This slab is clearly not part of the bunker but built over it as there was a layer of soil between it and the first concrete burster slab. This looks like it was the

base for a small storage tank or building requiring an electric connection to either lights or a pump. This slab was removed as it was affected by the current works and will be reinstated.

Image 9 the concrete slab near to Vent X2 (looking NW)

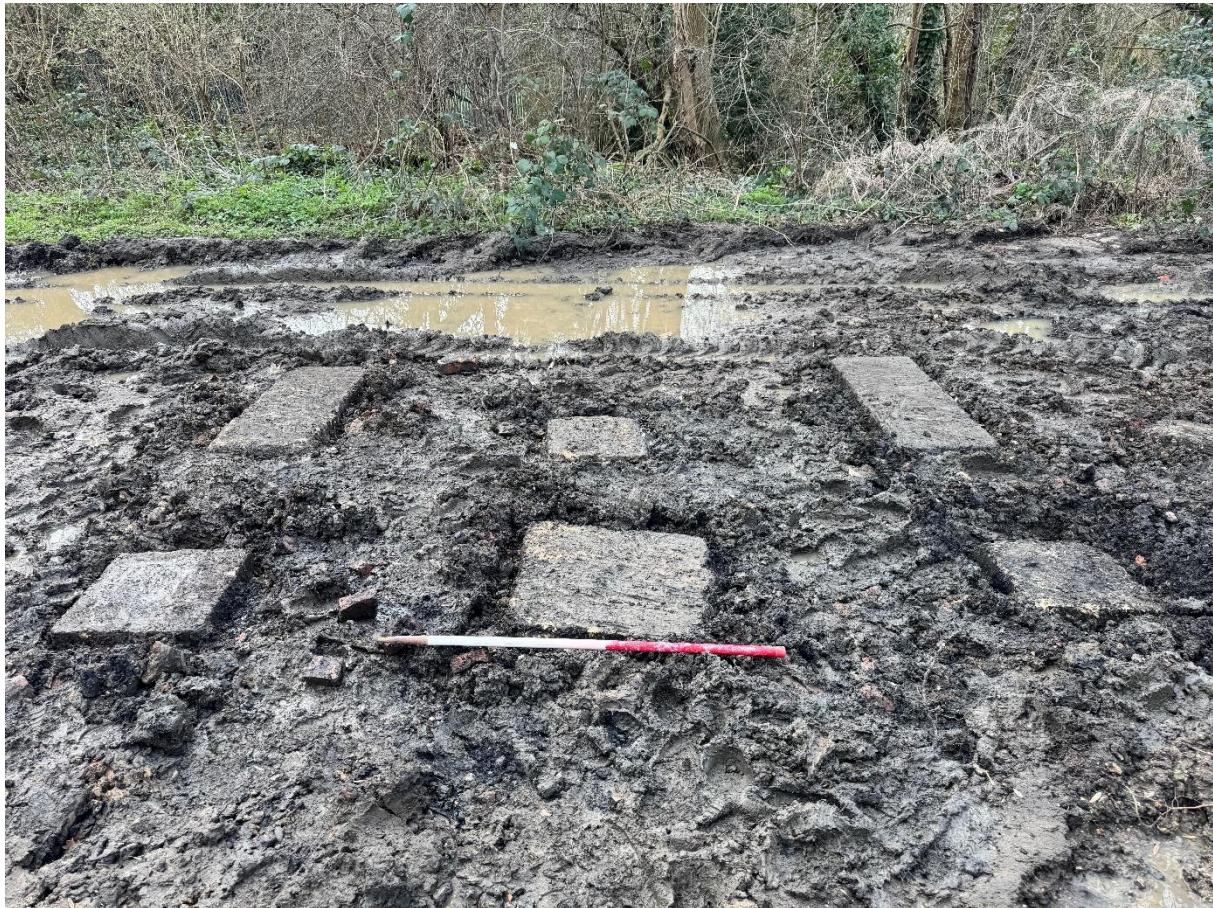
4.8.1 In one area a series of 10 brick and concrete foundation pads and 2 concrete pillars were recorded below disturbed topsoil, just south of the bunker mound (Image 10). These were laid flat (at heights varying from 41.32 to 41.56m OD) and appeared to form regular groups suggesting they are foundation pads to support buildings. These pads, located just beyond the outer edge of the bunker, are probably evidence of the wooden buildings that were known to cover this whole area of the site, but were removed when the bunker was constructed in 1938. These buildings were constructed after 1917 when Uxbridge was the Royal Flying Corps Central School of Aerial Gunnery and could be seen on Air Ministry drawings of 1918 and 1925. Between these dates the layout changed slightly but the pads probably relate to the two east-west aligned buildings see on the 1925 drawing (see front cover and Fig 6 MOLA 2022a).

Image 10 some of the concrete foundations (looking W)

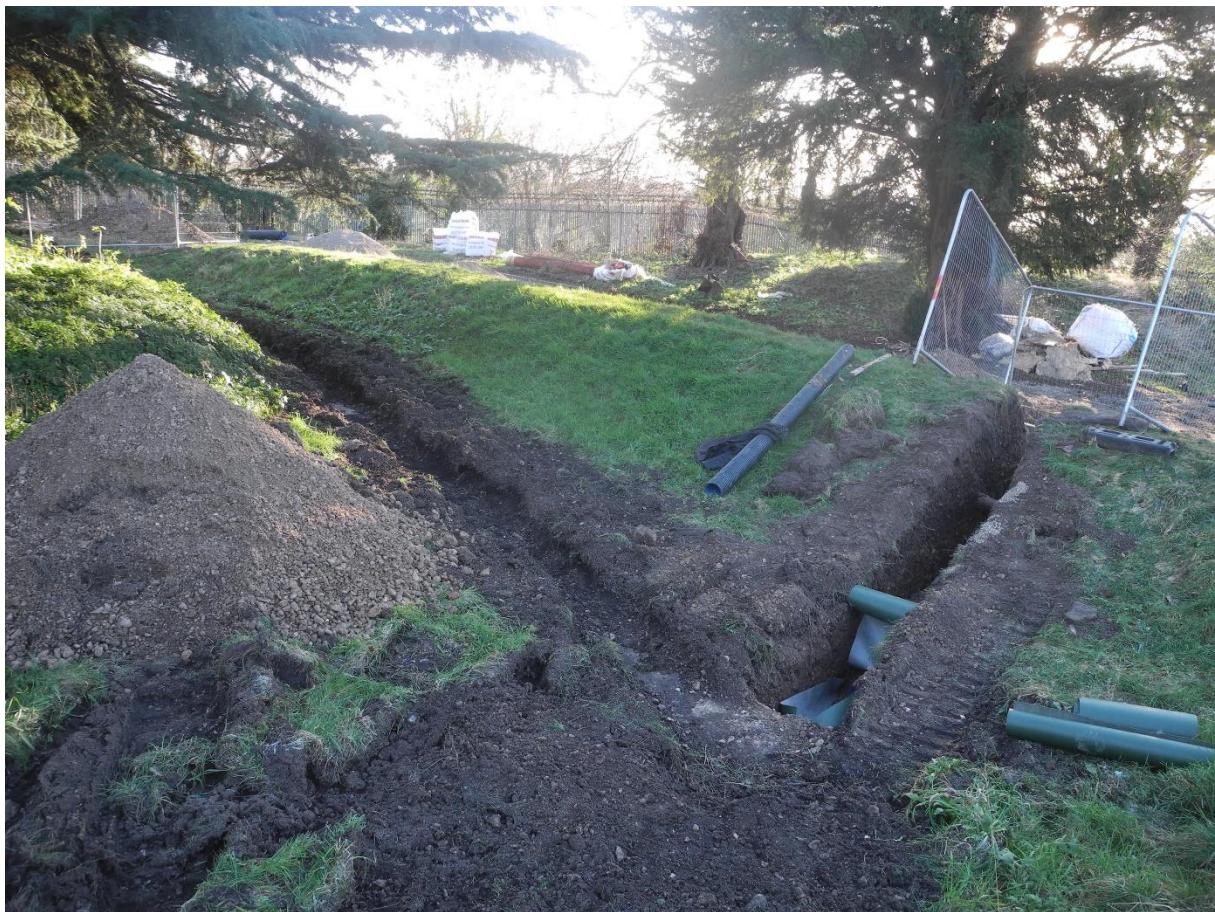
4.9.2 Several other new land drains were observed but no archaeological features were noted (Image 11). None reached natural as they were dug through either backfill associated with the bunker or in areas of existing landscaping (such as 'the pond') and only redeposited clay or topsoil was seen.

Image 11 new drainage in the area of the pond (looking SW)

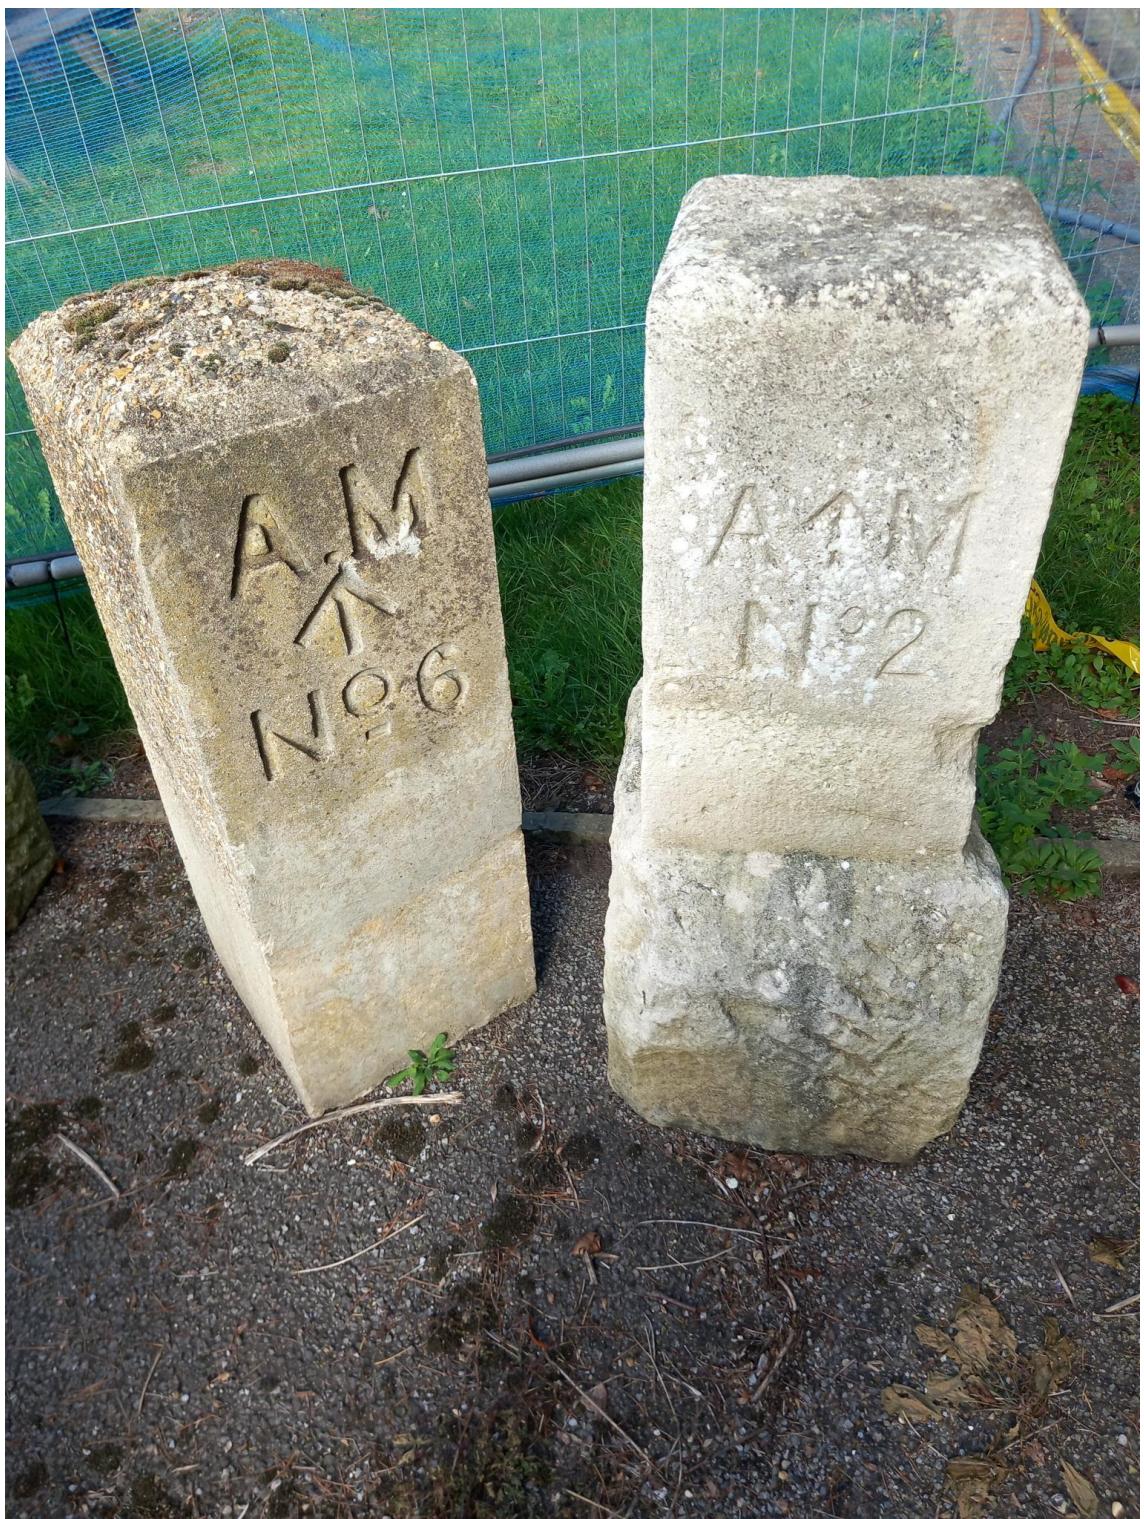
- 4.10.1 There were two inscribed concrete bollards, along with a third unmarked one, that had been moved and saved in the contractor's compound (Image 12). These date from before April 1964 as the letters A M refer to the Air Ministry, which disappeared when the Ministry of Defence was formed at that date. The numerals presumably reference numbers and are probably boundary markers showing the limits of Air Ministry land at RAF Uxbridge. The two different styles may suggest they were made at different times.
- 4.10.2 The contractors were not aware of exactly where they originated but they must have been found ex-situ within the works area. They do not appear on the topographic plan and were not noted during the initial site visit by MOLA on 07/02/23.

Image 12 inscribed boundary markers on 09/10/24

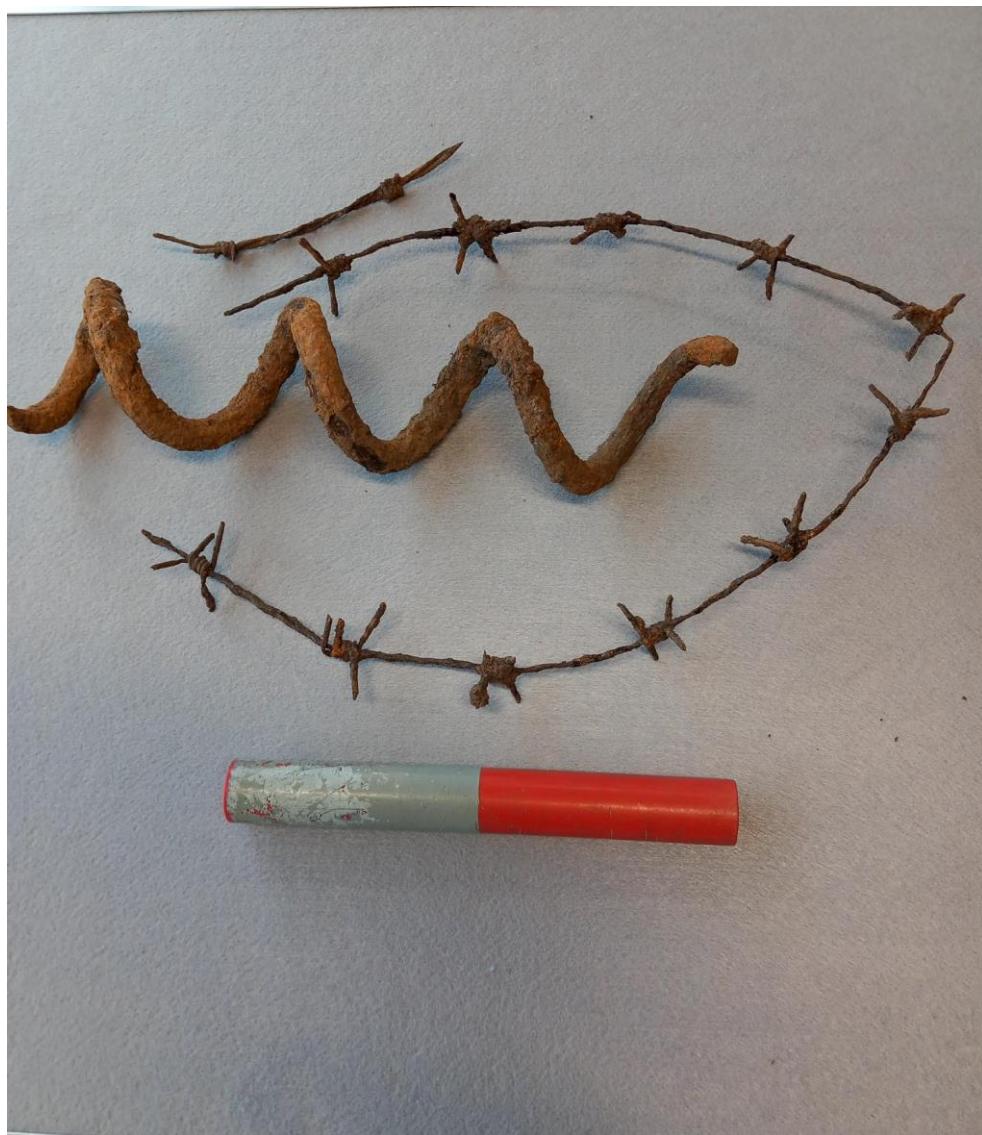
4.11.1 A small number of finds were recovered from unstratified topsoil or made ground above the bunker. Other than sections of barbed wire (Image 13), the iron pickets to hold it in place, and one cartridge case (Image 14), there was little amongst the metal scraps, tin cans and fragments of 20th century bricks that could confidently be attributed to the lifetime of the bunker. Nothing was retained for archiving but the finds were kept for the client (or for display in the visitor centre).

Image 13 screw from an iron picket and barbed wire

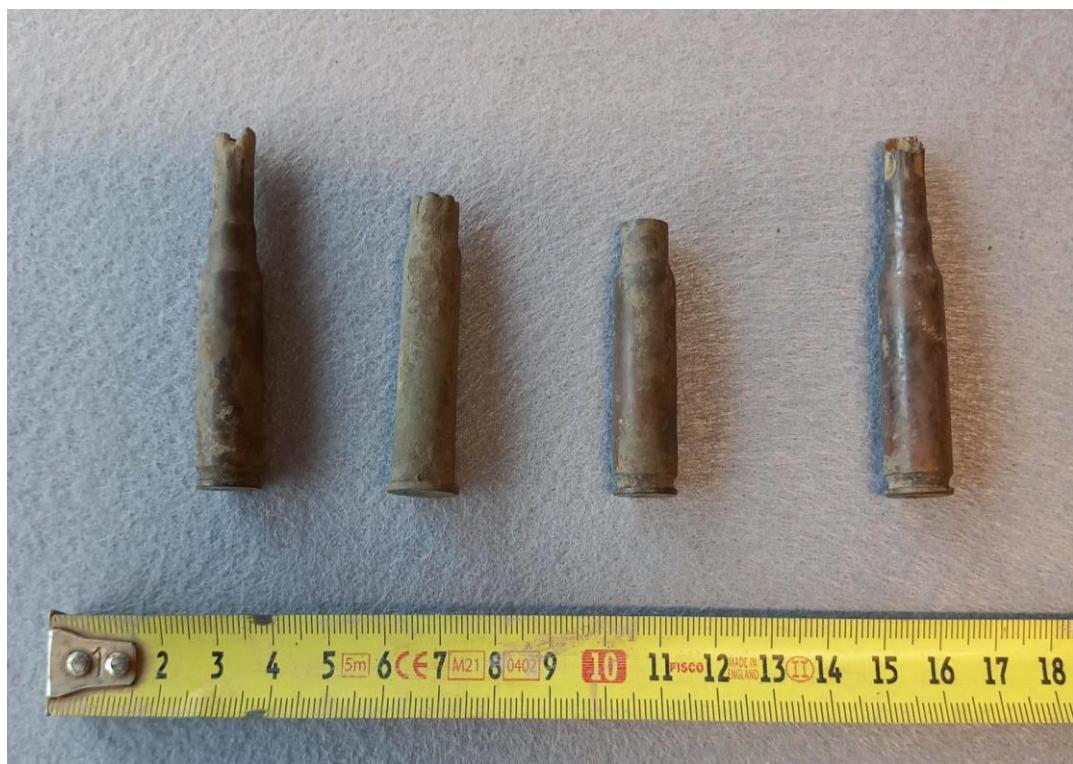
4.11.3 The .303 cartridge case is dated 1942 so probably relates to the wartime usage of the area, maybe when the pillbox or the weapons positions were occupied. The other three cartridge cases are clearly post-war as they range in date of manufacture from 1962 to 1986 and two were blanks for training purposes. This indicates the area was occasionally used for training exercises.

Image 14 Cartridge cases, (L to R) 7.62mm blank, 7.62mm ball, .303, 7.62mm blank

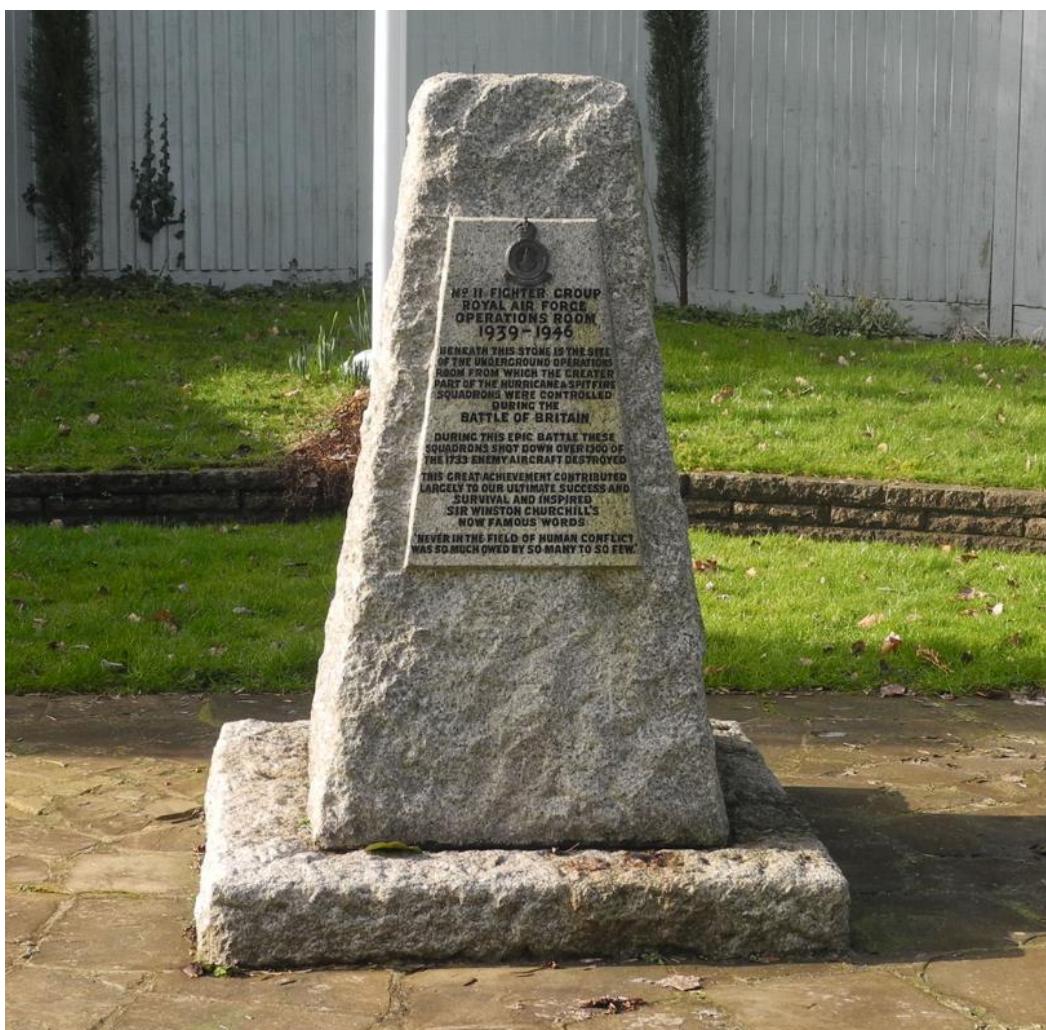
Image 15 the current Operations Room monument (2024)

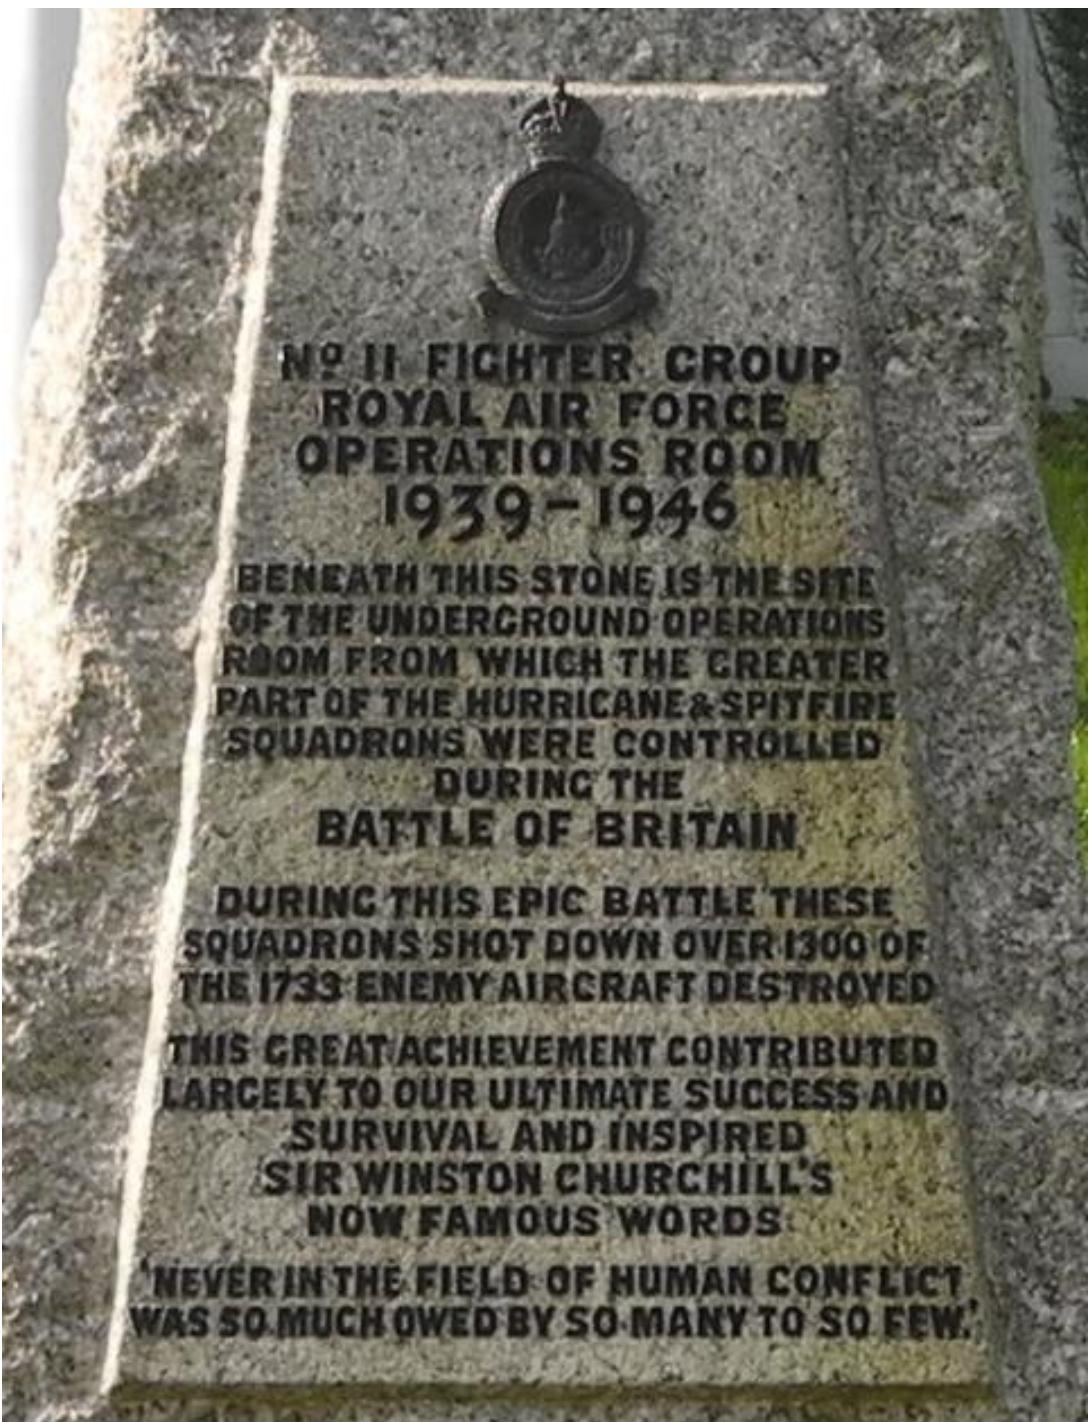
Image 16 detail of the text on the monument showing this may have been moved from another location

An aerial photo taken in 1945 shows the area over the bunker was laid out as a garden with bedded areas separated by several paths leading to a small square central feature such as a plinth. This must be an attempt at camouflage to disguise the top of the bunker. The garden was difficult to see by the time of an aerial photograph in 1953, and by 1961 there was no trace of it. In a previous report (MOLA, 2023a) it was suggested the central plinth was for a sundial or small statue. At the present time (2024), placed some distance from the bunker there is a granite monument with an inscription suggesting it had been originally located over the bunker (Image 15 & Image 16). This could possibly be the central feature of the garden with the inscription added at a later stage, but further research would be necessary to support this theory.
