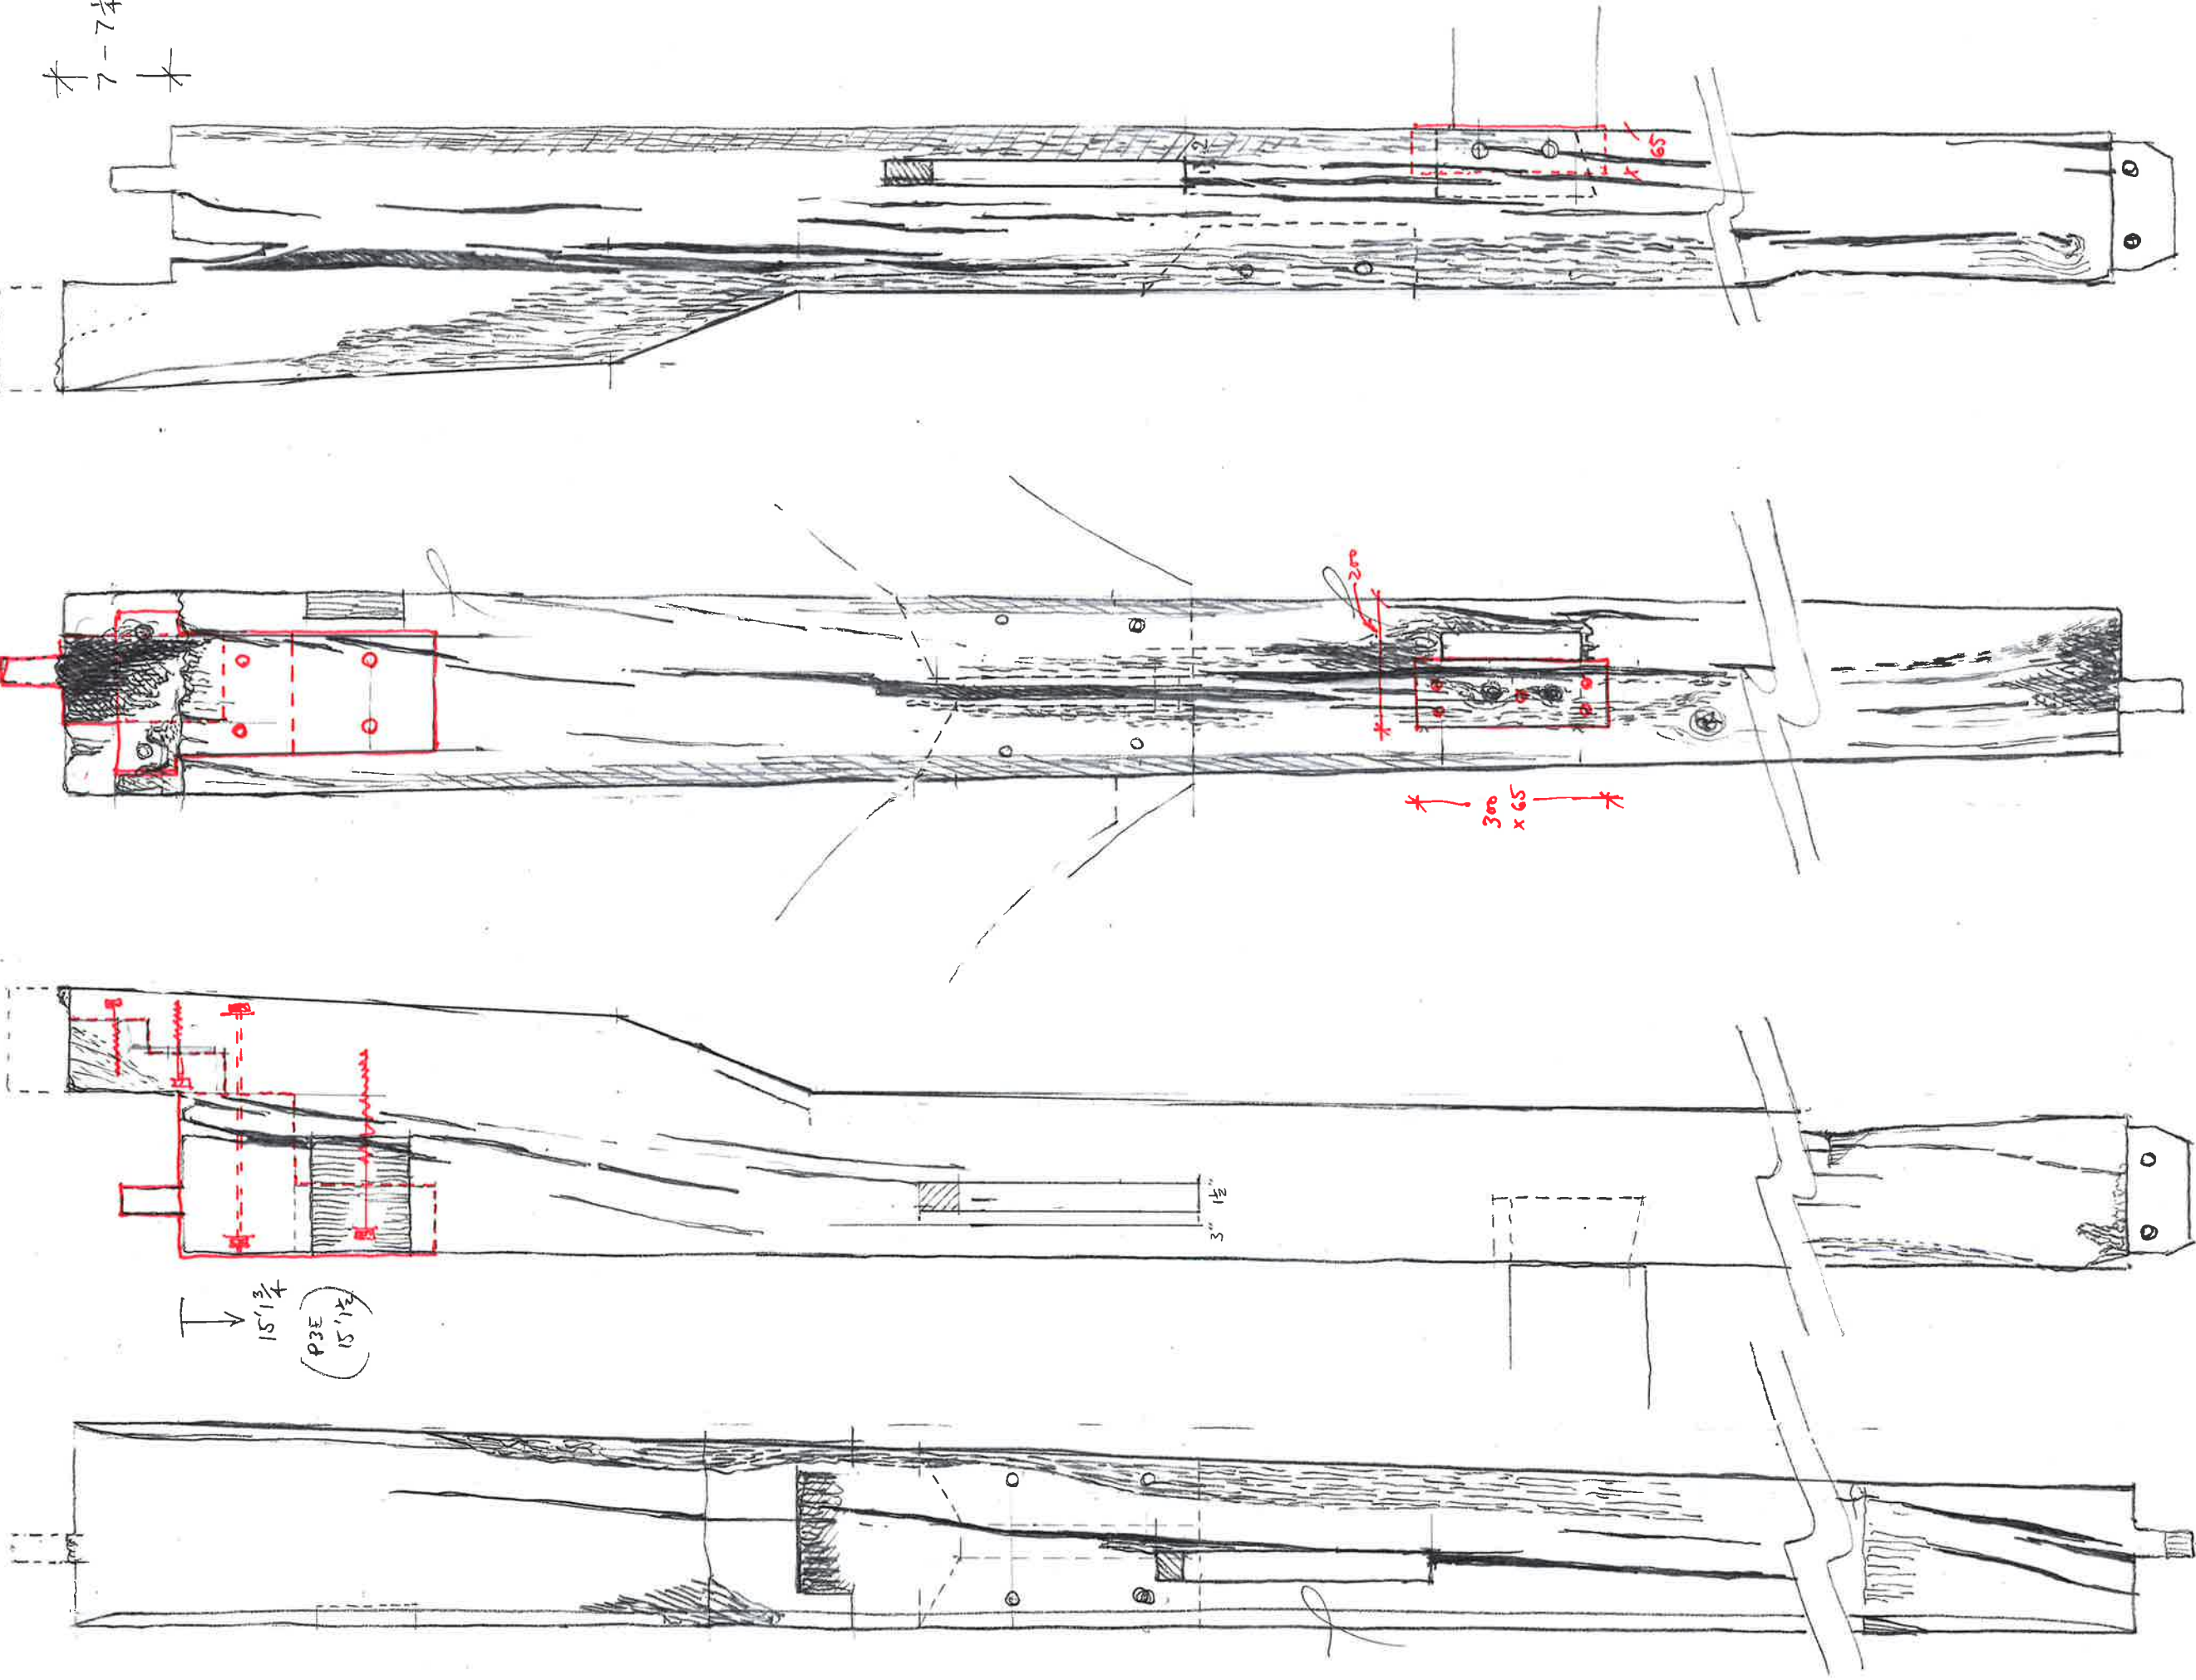
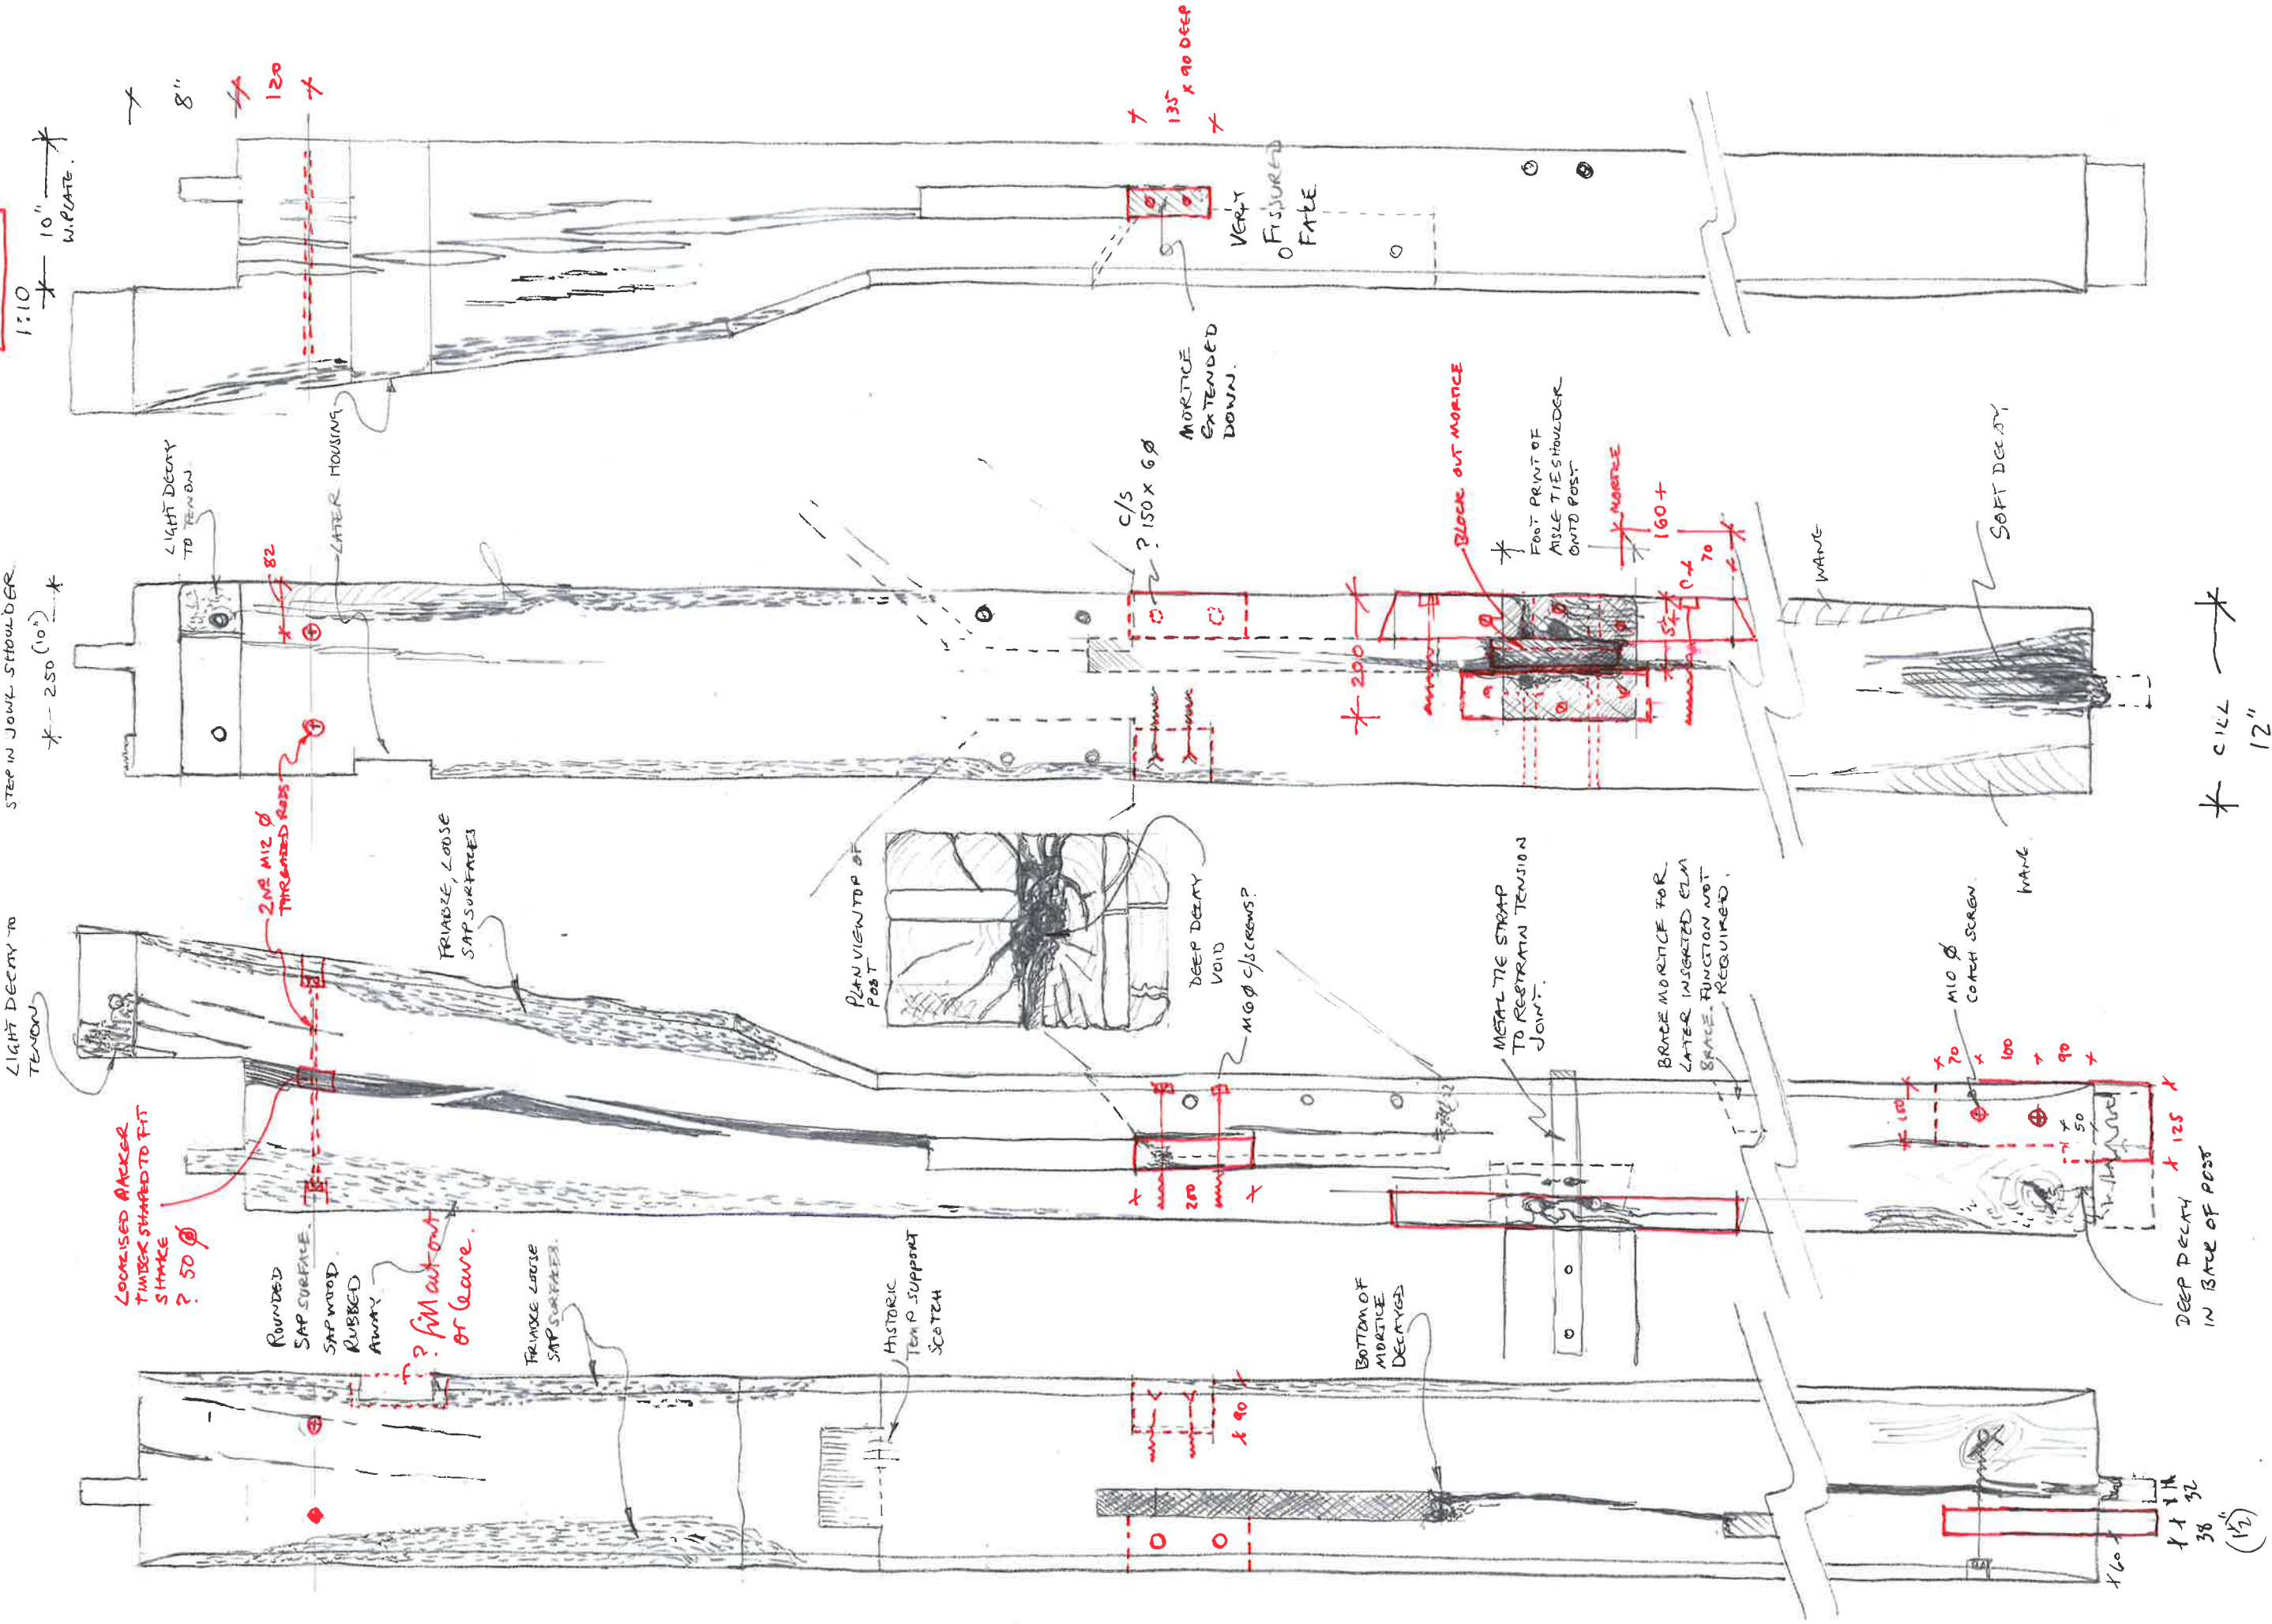
P3E

TABLE TENON VERY WEAK  
WEATHERED, THIN AND  
DAMAGED

DEEP DECAY IN END  
GRAIN

END GRAIN BEARING  
SURFACE IS VERY POOR.  
DEEPLY FISURED / GROOVED  
& LOOSE  
LOSS OF  $\frac{3}{4}$

WALL PLATE TENON  
DECAYED & WEAK
