REMEDIAL STRATEGY AND METHOD STATEMENT  
GLOBAL ACADEMY UTC  
HAYES  
PURPLEXED LLP  
RSMS-MER00566-15-93  
MARCH 2015

### 1.4 **IDENTIFIED GROUND CONDITIONS**

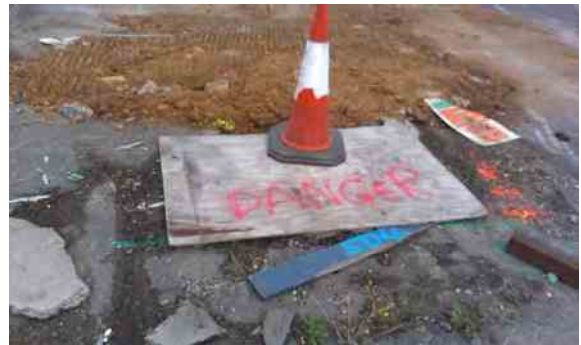
Typical trial pit reinstatement condition

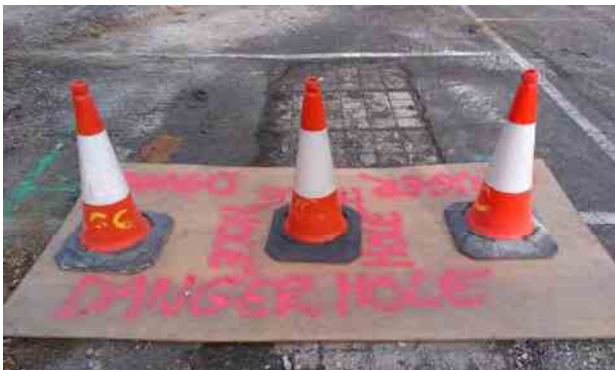
Warning and covers placed over access holes where original covers not be replaced

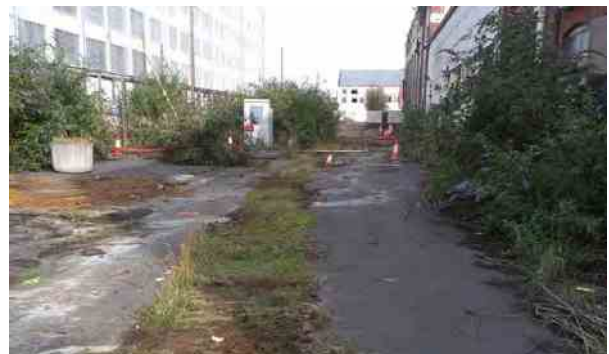
Warning and covers placed over access holes where original covers not be replaced
