# Geotechnical Ground Investigation Report

59 Elm Avenue  
Ruislip  
HA4 8PE

GT-2022-000020

STM Environmental Consultants Ltd

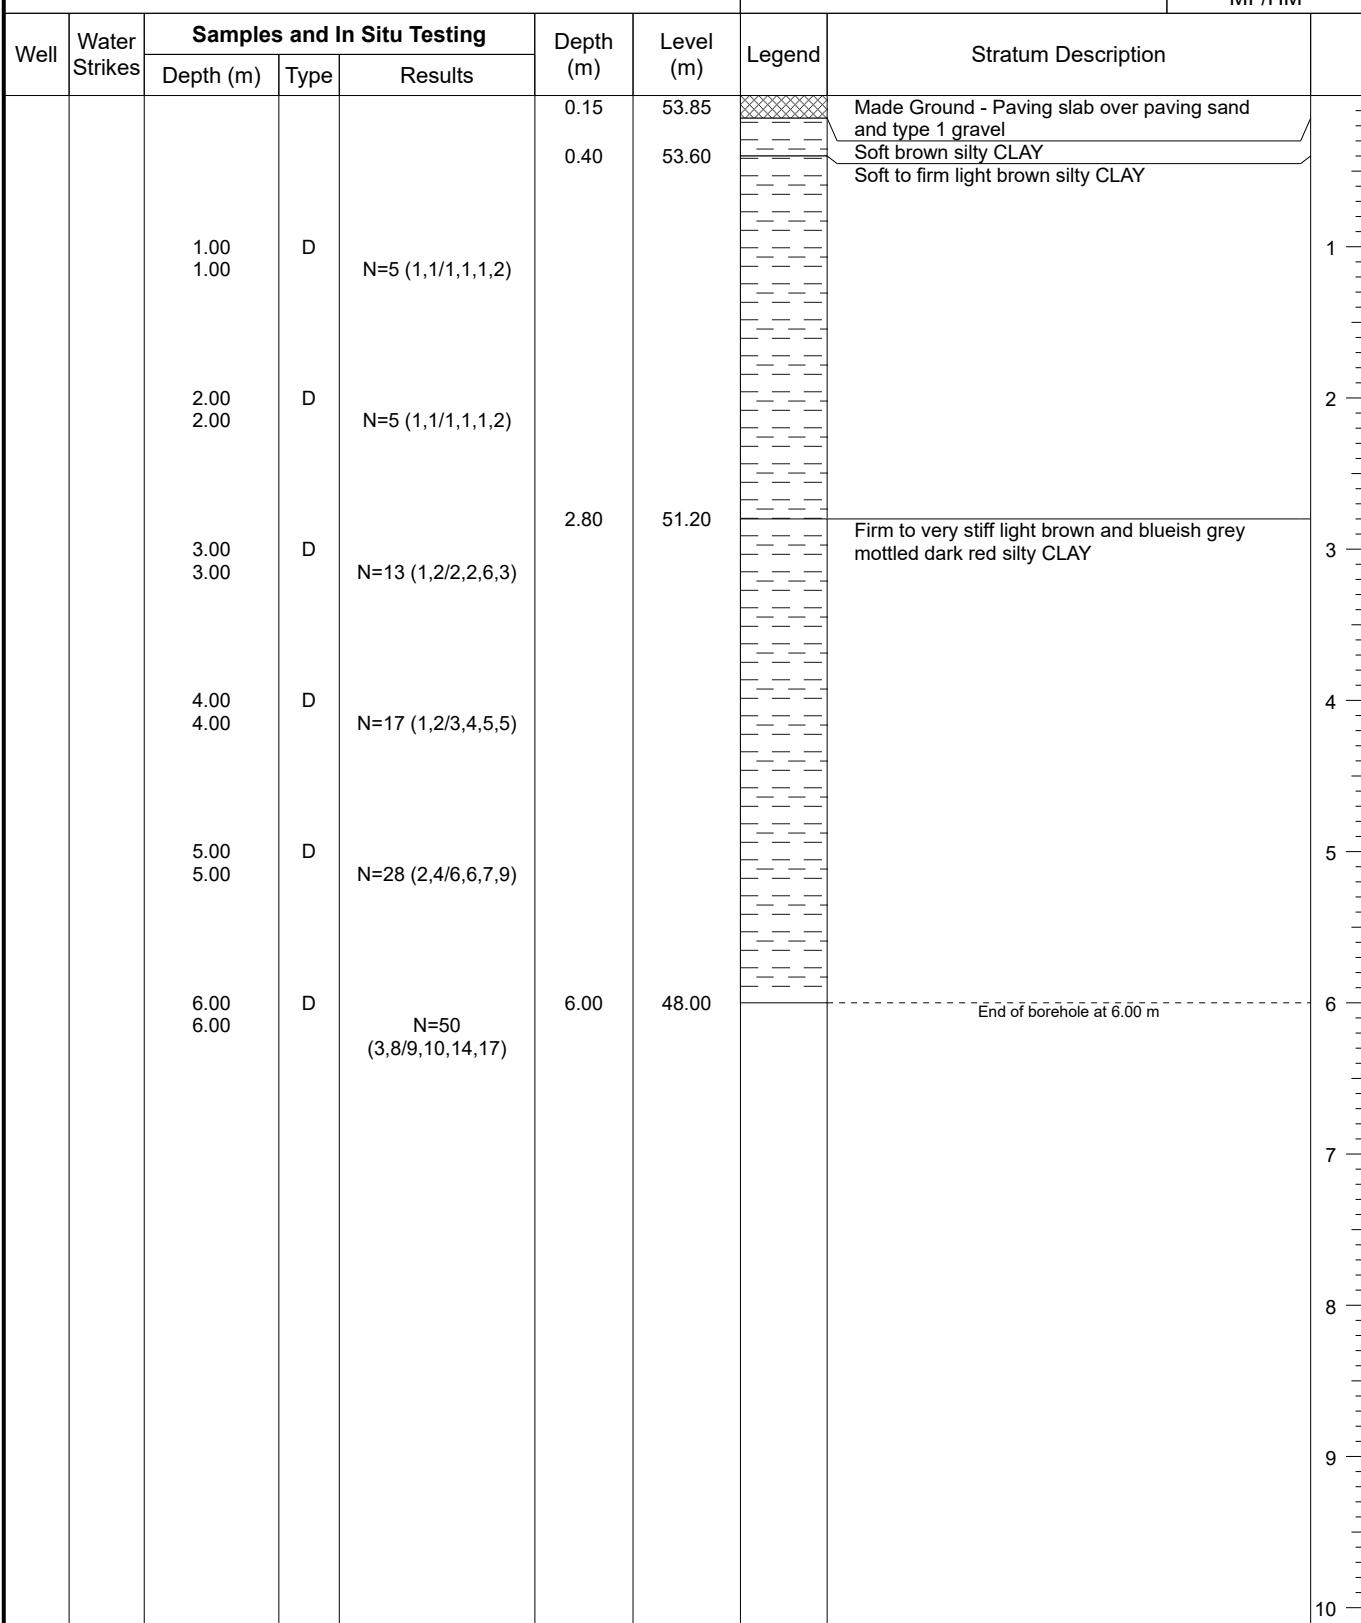
# Borehole Log

Borehole advanced to a maximum depth of 6mbgl. No water encountered. Elevation levels and borehole location grid references are approximated based on satellite imagery (not measured).

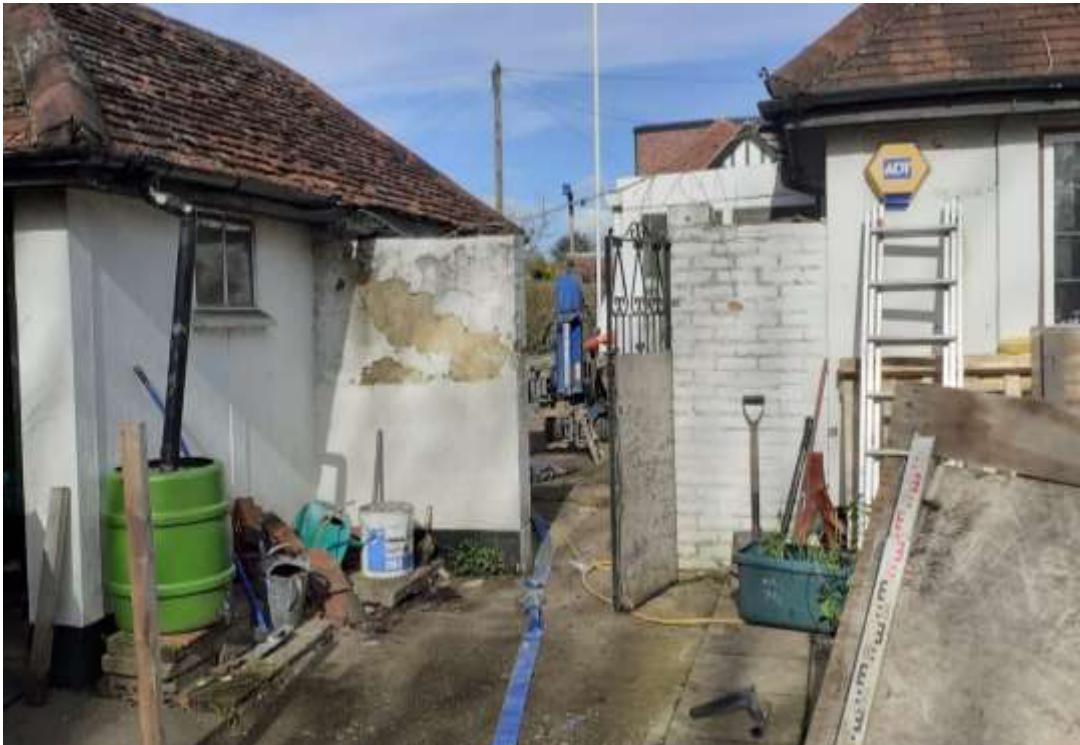
Photograph of windowless sampler rig in operation at location BH01

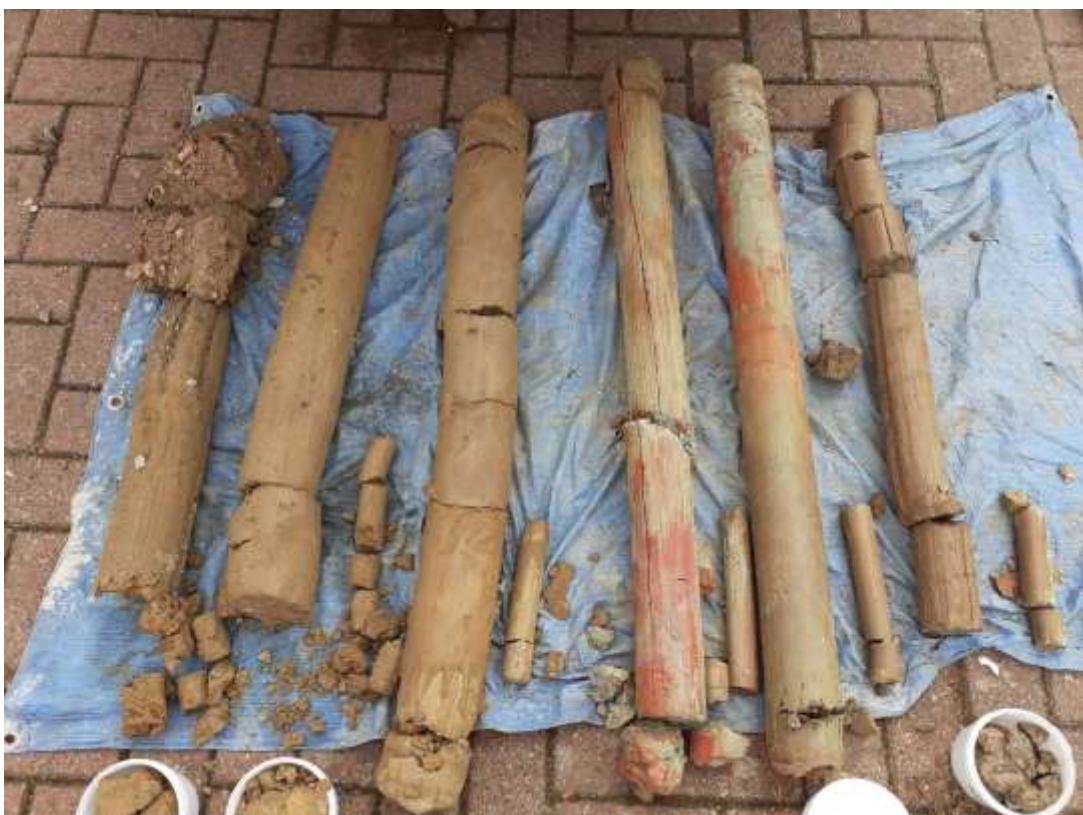
6m of core extracted from location BH01
