**Report prepared at**  
Land at Sullivan Crescent  
Harefield  
UB9 6NL

**Report reference**  
23-248.01

**Report date**  
October 2023

Report Quality Management			
<b>Project Name</b>	Land at Sullivan Crescent, Harefield, UB9 6NL		
<b>Project Title</b>	Preliminary Risk Assessment and Site Investigation		
<b>Client</b>	Bugler Developments Limited		
<b>Project Number</b>	23-248.01		
<b>Version</b>	1		<b>Date</b>
<b>Prepared by</b>	Vanessa Bell MSc (Hons)	Geo-Environmental Consultant	17/10/2023
<b>Prepared by</b>	Orlando Blackwell BEng (Hons) MSc (Eng)	Principal Engineer	18/10/2023
<b>Approved by</b>	James Burkitt BEng (Hons) CEnv MRICS	Managing Director	23/10/2023

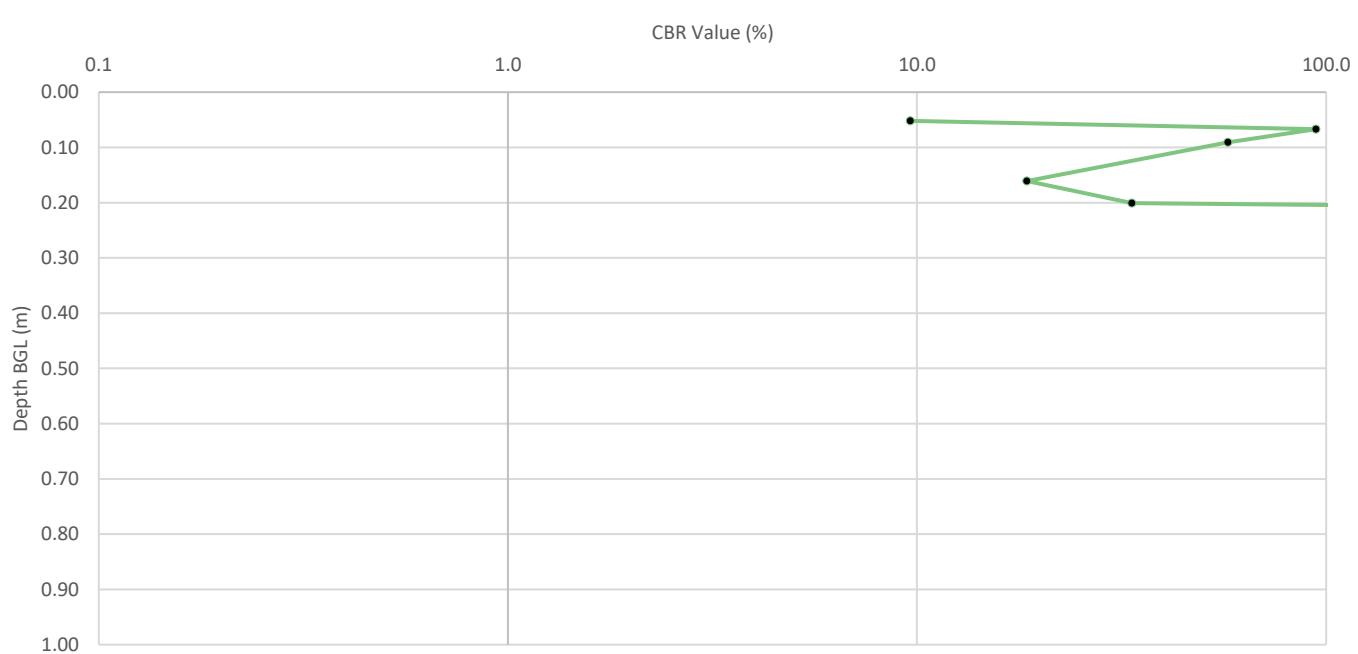
Project: <b>Land at Sullivan Crescent, Harefield, UB9 6NL</b>	Project No: <b>23-248.01</b>	DCP Location: <b>DCP1A</b>
Client: <b>Bugler Developments Limited</b>	Operator: <b>DN</b>	Date: <b>20/09/2023</b>
Surface Conditions & Observations: <b>Concrete hardstanding removed</b>	Zero Error (mm): <b>39</b>	Approx AOD (m):
