SOIL INFILTRATION TESTING

Client	Bugler Developments Limited	
Project Type	Soil Infiltration Testing	
Site	Land at Sullivan Crescent, Harefield, UB9 6NL

Project	Version	Date
23-248.02	1	24 October 2023

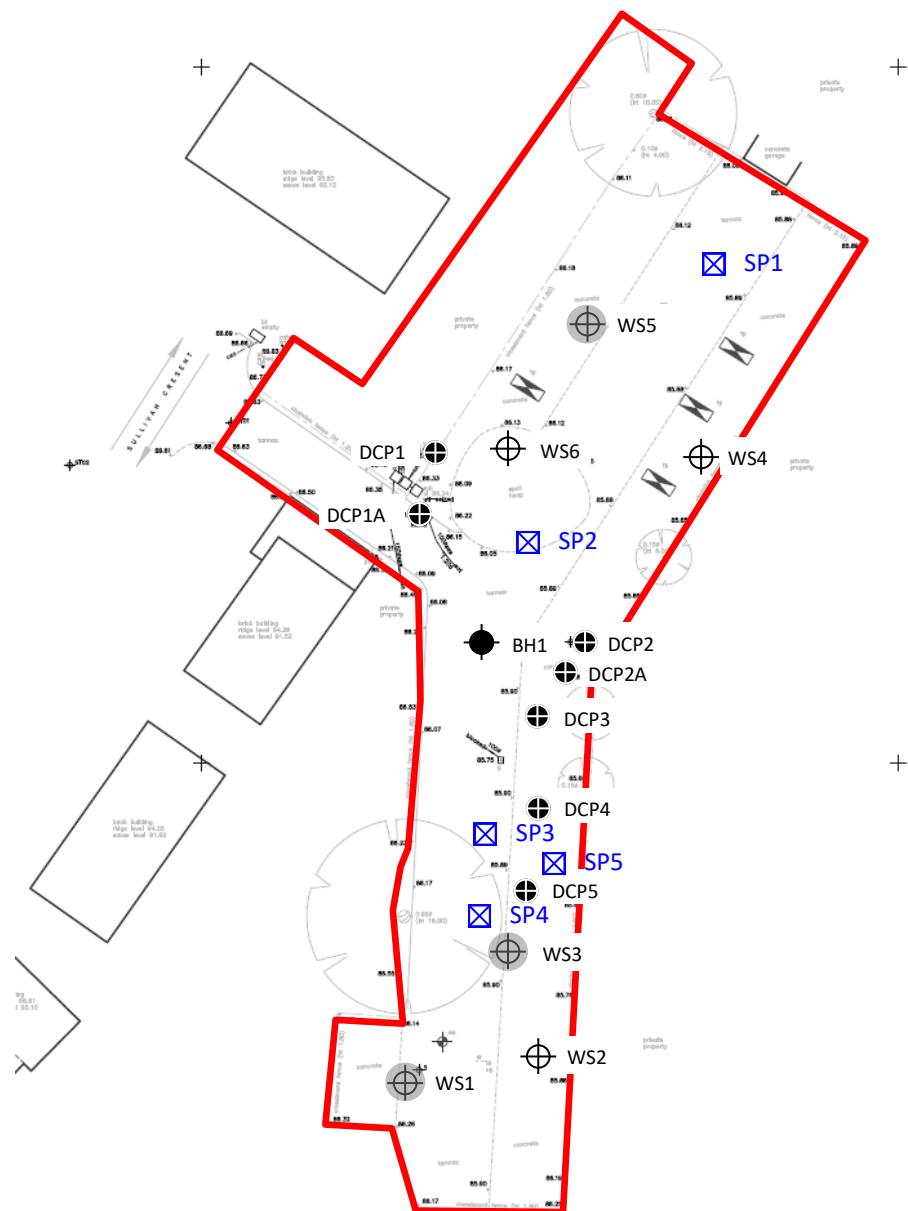
Figure 1

APPENDIX I**Figure 1 – Infiltration Test Location Plan**

SP1 + SP3 + SP5
Conventional soakaways

SP2 + SP4
Permeable paving

The locations of trial pits are illustrated in **Figure 1**, which is included as **Appendix I**.

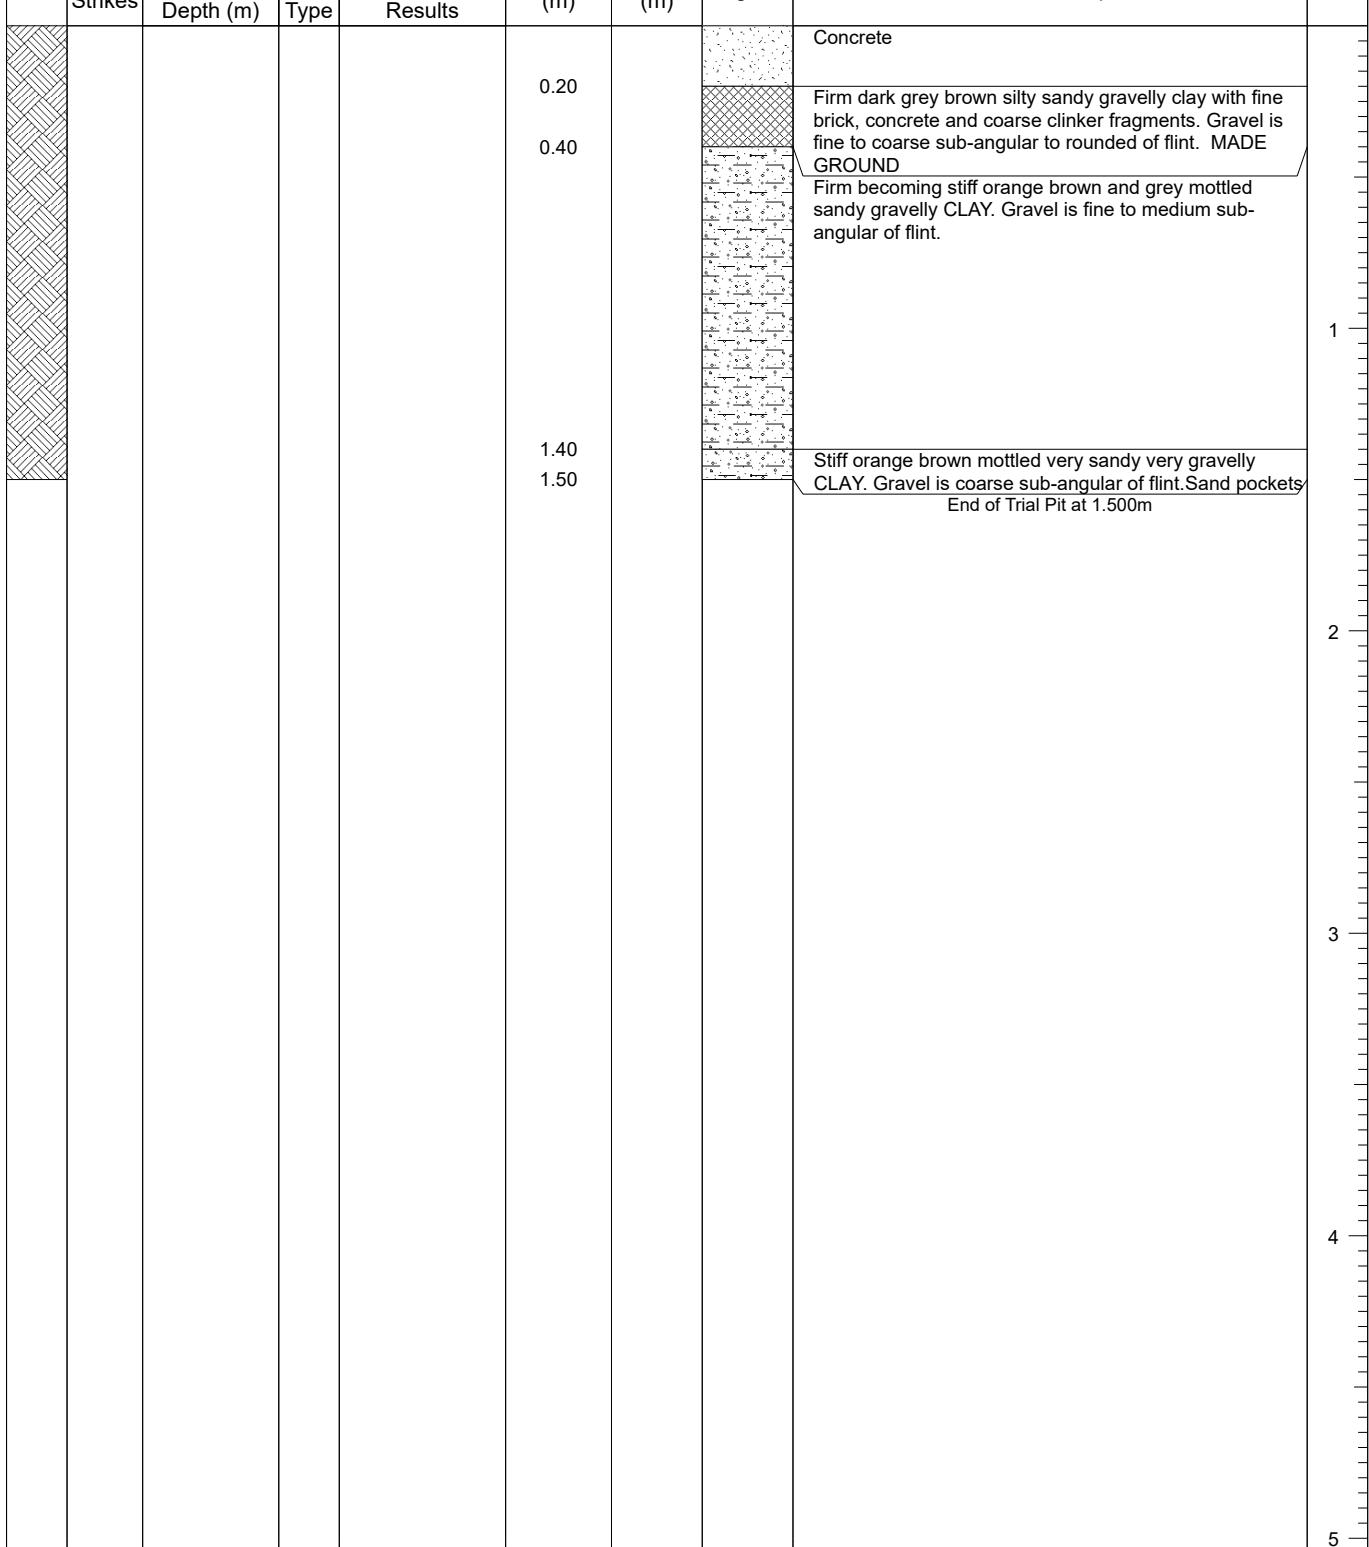
Location Number SP3		Location Type TP		Level		Logged By ac	Scale 1:25	Page Number Sheet 1 of 1
Well	Water Strikes	Sample and In Situ Testing			Depth (m)	Level (m)	Legend	Stratum Description
		Depth (m)	Type	Results

Groundwater not encountered. Soakage test carried out.

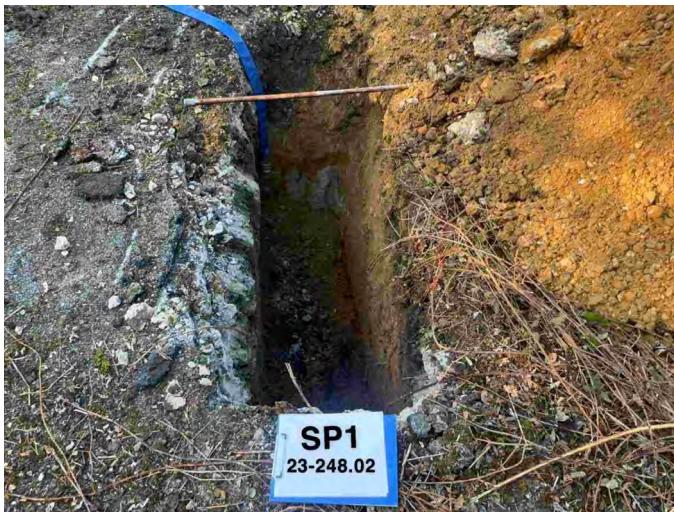
SP1

Well	Water Strikes	Sample and In Situ Testing			Depth (m)	Level (m)	Legend	Stratum Description	1
		Depth (m)	Type	Results					
					0.20			Concrete	
					0.40			Firm dark grey brown silty sandy gravelly clay with fine brick, concrete and coarse clinker fragments. Gravel is fine to coarse sub-angular to rounded of flint. MADE GROUND	
					1.40			Firm becoming stiff orange brown and grey mottled sandy gravelly CLAY. Gravel is fine to medium sub-angular of flint.	
								End of Trial Pit at 1.400m	
									2
									3
									4
									5

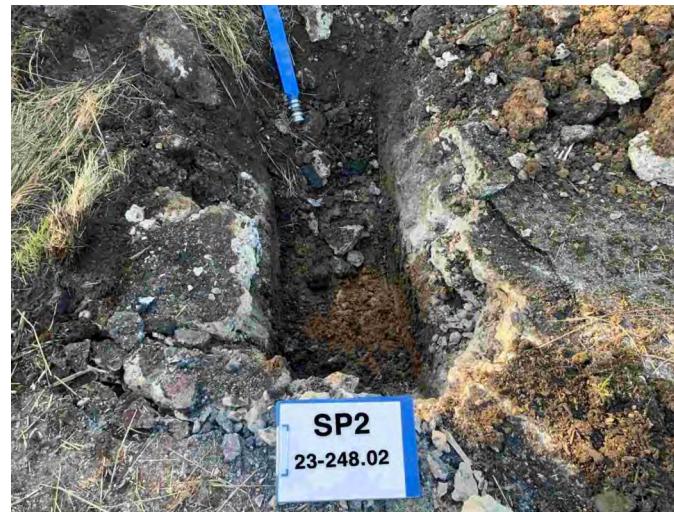
SP2

Firm becoming stiff orange brown and grey mottled sandy gravelly CLAY. Gravel is fine to medium sub-angular of flint.	
								End of Trial Pit at 0.700m	2
									3
									4
									5

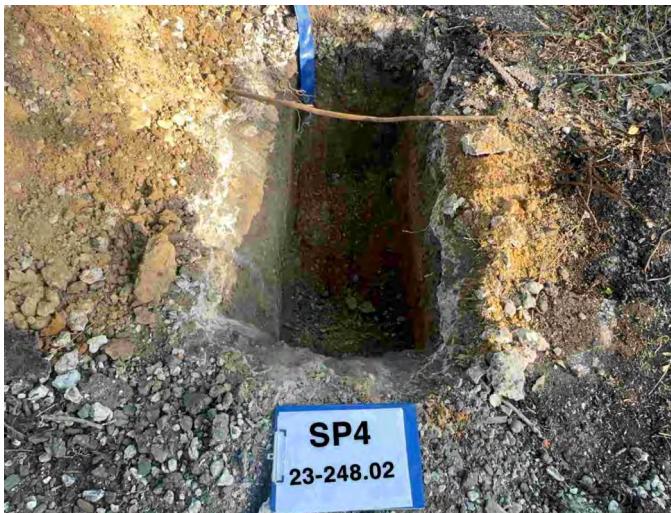
SP4

Well	Water Strikes	Sample and In Situ Testing			Depth (m)	Level (m)	Legend	Stratum Description	1
		Depth (m)	Type	Results					
					0.15			Concrete	
					0.40			Firm dark grey brown silty sandy gravelly clay with fine brick, concrete and coarse clinker fragments. Gravel is fine to coarse sub-angular to rounded of flint. MADE GROUND	
					0.80			Orange brown and grey mottled very clayey gravelly SAND Gravel is fine to medium sub-angular of flint.	
								End of Trial Pit at 0.800m	2
									3
									4
									5

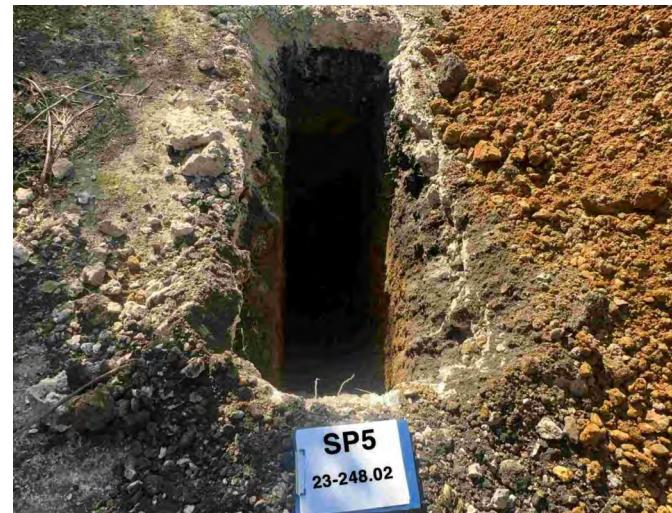
SP5

Well	Water Strikes	Sample and In Situ Testing			Depth (m)	Level (m)	Legend	Stratum Description	1
		Depth (m)	Type	Results					
					0.15			Concrete	
					0.50			Firm dark grey brown silty sandy gravelly clay with fine brick, concrete and coarse clinker fragments. Gravel is fine to coarse sub-angular to rounded of flint. MADE GROUND	
					1.90			Firm becoming stiff orange brown and grey mottled sandy gravelly CLAY. Gravel is fine to medium sub-angular of flint.	
					2.50			Light brown slightly clayey silty gravelly fine SAND. Gravel is fine to coarse sub-angular of flint.	2
								End of Trial Pit at 2.500m	3
									4
									5

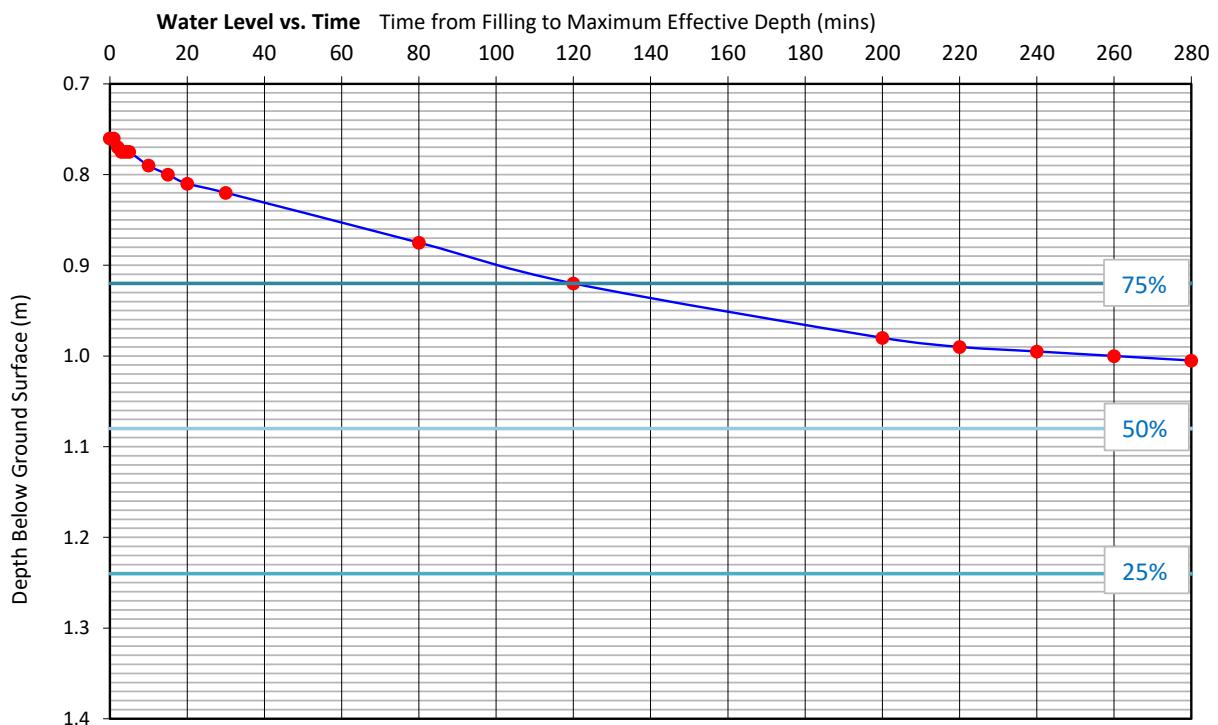
Test Pit SP1 - T1

Pit Dimensions: 1.8m(l) x 0.7m(w) x 1.4m(d)
Start Water Level: 0.76m

Actual Storage Volume: 1.76 m³
Effective Depth: 0.64 m

Time (mins)	Depth BGL (m)
0	0.760
1	0.760
2	0.770
3	0.775
4	0.775
5	0.775
10	0.790
15	0.800
20	0.810
30	0.820
80	0.875
120	0.920
200	0.980
220	0.990
240	0.995
260	1.000
280	1.005

Soil infiltration rate, f : 0.4032/(2.86 x 0)
 f : #DIV/0! ms⁻¹

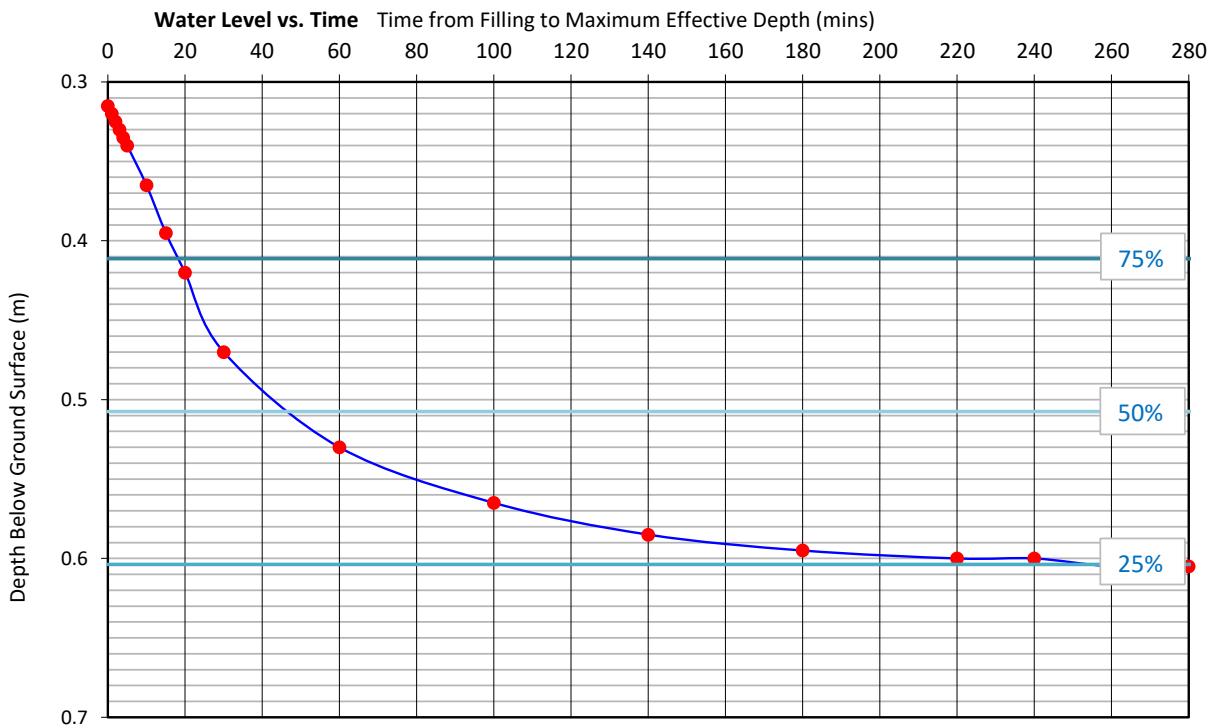
Test Pit SP2 - T1

Pit Dimensions: 1.9m(l) x 0.75m(w) x 0.7m(d)
Start Water Level: 0.315m

Actual Storage Volume: 1.00 m³
Effective Depth: 0.39 m

Time (mins)	Depth BGL (m)
0	0.315
1	0.320
2	0.325
3	0.330
4	0.335
5	0.340
10	0.365
15	0.395
20	0.420
30	0.470
60	0.530
100	0.565
140	0.585
180	0.595
220	0.600
240	0.600
260	0.605
280	0.605

Soil infiltration rate, f : 0.2743125/(2.44525 x 14220)
 f : 7.89E-06 ms⁻¹

Permeable paving may be feasible locally, as noted in the shallow test undertaken in SP2-1, however the infiltration rate was noted to be relatively poor, and insufficient time was available to undertake repeat tests.

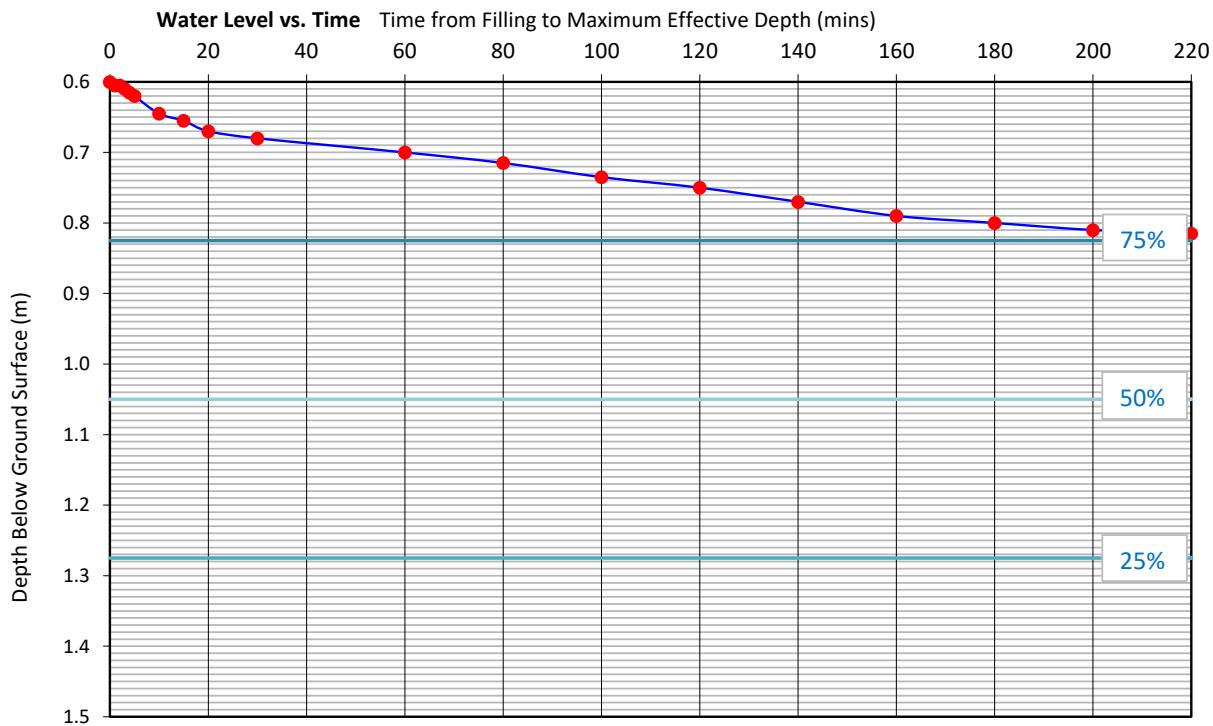
Test Pit SP3 - T1

Pit Dimensions: 1.8m(l) x 0.7m(w) x 1.5m(d)
Start Water Level: 0.6m

Actual Storage Volume: 1.89 m³
Effective Depth: 0.90 m

Time (mins)	Depth BGL (m)
0	0.600
1	0.605
2	0.605
3	0.610
4	0.615
5	0.620
10	0.645
15	0.655
20	0.670
30	0.680
60	0.700
80	0.715
100	0.735
120	0.750
140	0.770
160	0.790
180	0.800
200	0.810
220	0.815

Soil infiltration rate, f : 0.567/(3.51 x 0)
 f : #DIV/0! ms⁻¹

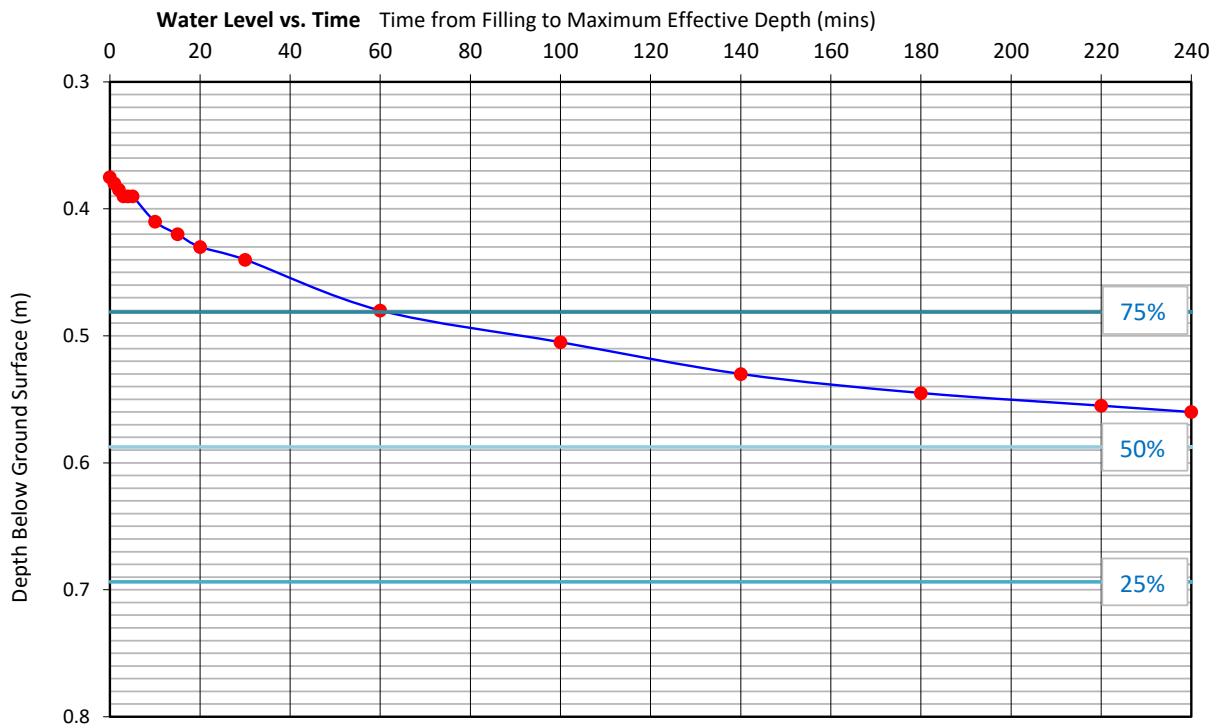
Test Pit SP4 - T1

Pit Dimensions: 1.6m(l) x 0.75m(w) x 0.8m(d)
Start Water Level: 0.375m

Actual Storage Volume: 0.96 m³
Effective Depth: 0.43 m

Time (mins)	Depth BGL (m)
0	0.375
1	0.380
2	0.385
3	0.390
4	0.390
5	0.390
10	0.410
15	0.420
20	0.430
30	0.440
60	0.480
100	0.505
140	0.530
180	0.545
220	0.555
240	0.560

Soil infiltration rate, f : 0.255/(2.19875 x 0)
 f : #DIV/0! ms⁻¹

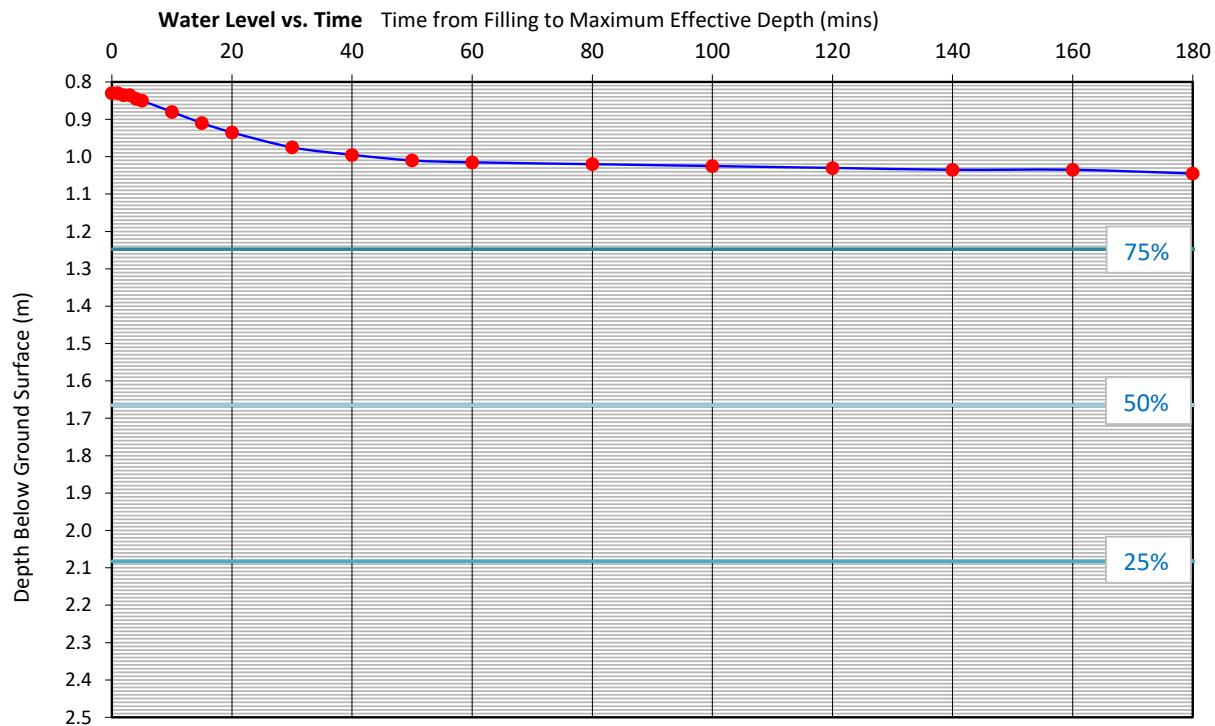
Test Pit SP5 - T1

Pit Dimensions: 2m(l) x 0.8m(w) x 2.5m(d)
Start Water Level: 0.83m

Actual Storage Volume: 4.00 m³
Effective Depth: 1.67 m

Time (mins)	Depth BGL (m)
0	0.830
1	0.830
2	0.835
3	0.835
4	0.845
5	0.850
10	0.880
15	0.910
20	0.935
30	0.975
40	0.995
50	1.010
60	1.015
80	1.020
100	1.025
120	1.030
140	1.035
160	1.035
180	1.045

Soil infiltration rate, f : 1.336/(6.276 x 0)
 f : #DIV/0! ms⁻¹
