## **DETAILED UXO RISK ASSESSMENT**

# STAGE 2 DETAILED UXO RISK ASSESSMENT

<b>Client:</b>	JNP Group		
<b>Project Ref:</b>	JNPG133R		
<b>Site Name:</b>	83-89 Manor Way, Ruislip		
<b>Report Ref:</b>	DRA-26-1994-JNPG133R-83-89ManorWay,Ruislip		
<b>Revision:</b>	0		
<b>Status:</b>	Final		
<b>Date:</b>	10 <sup>th</sup> March 2026		
<b>Author:</b>	Ewen Reader	Project Researcher	ewen.reader@brimstoneuxo.com
<b>Reviewed By:</b>	Will Slack	Senior Project Researcher	will.slack@brimstoneuxo.com
<b>Authorised By:</b>	Aaron Florence	Managing Director

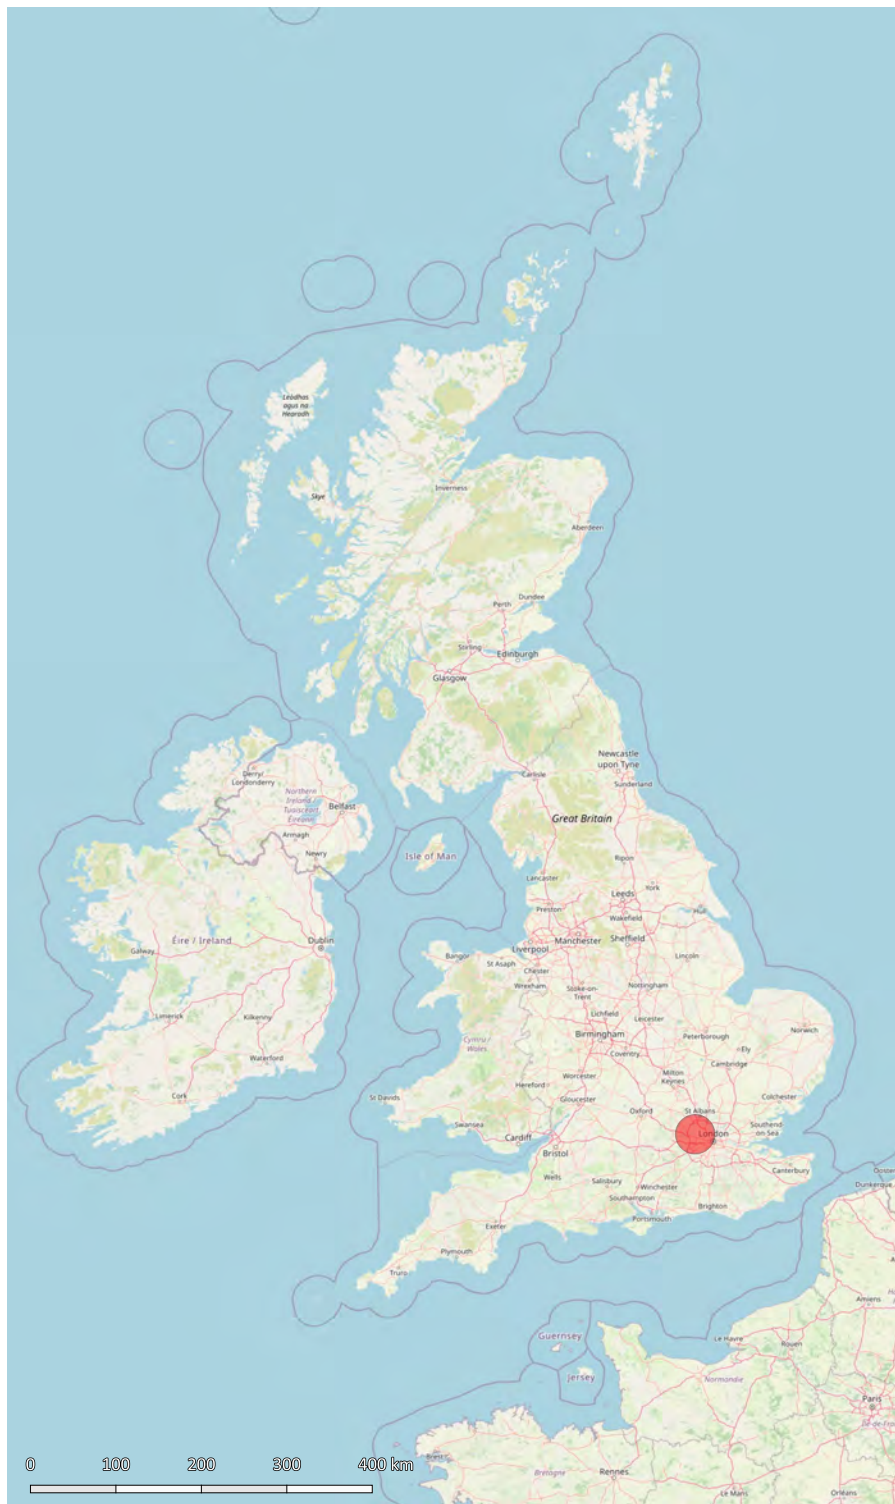
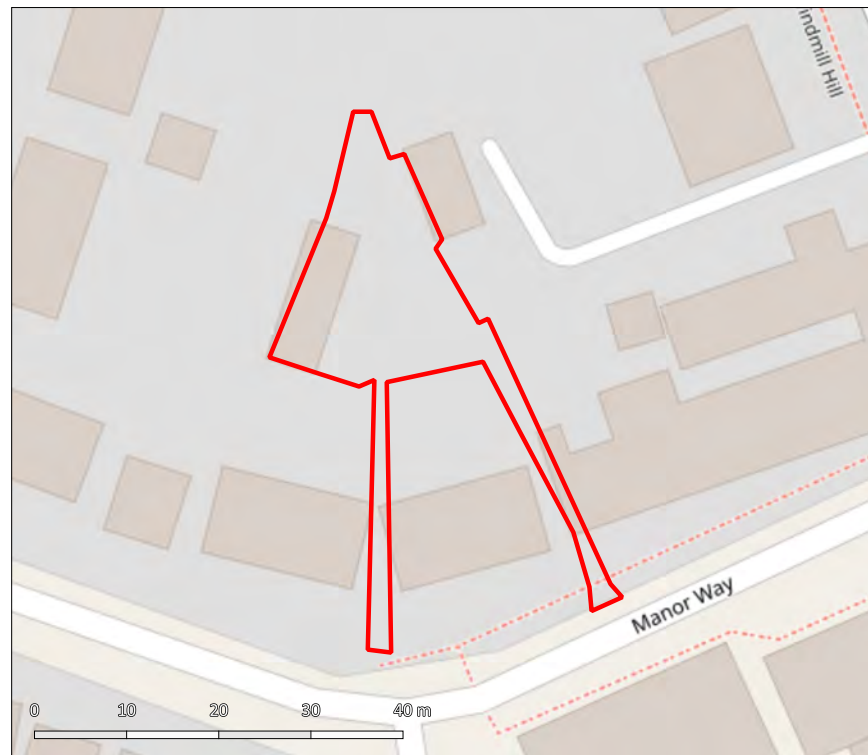
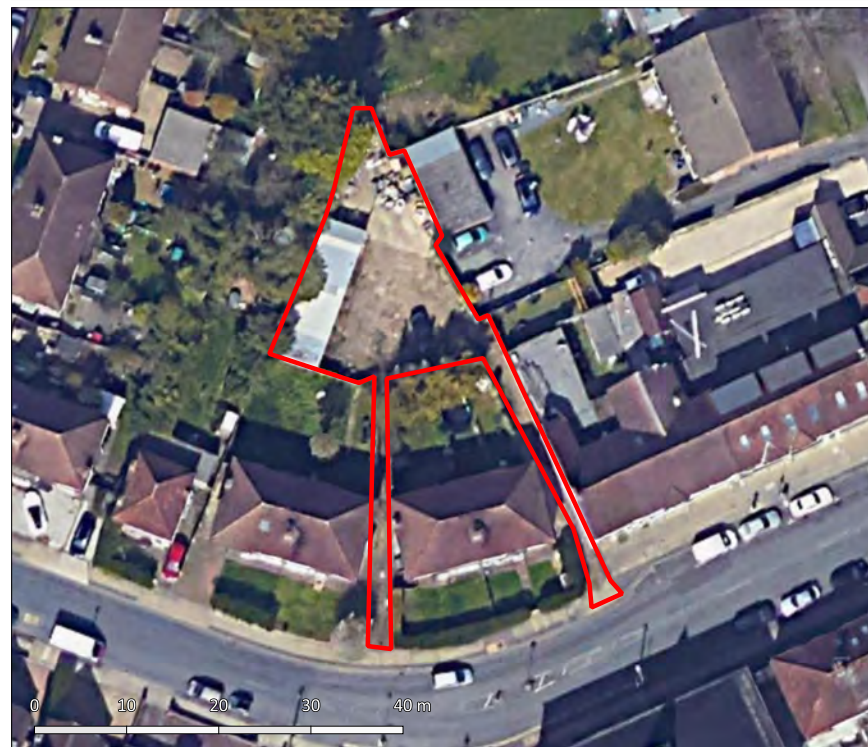
**FIGURE: 1**

**Site Location**

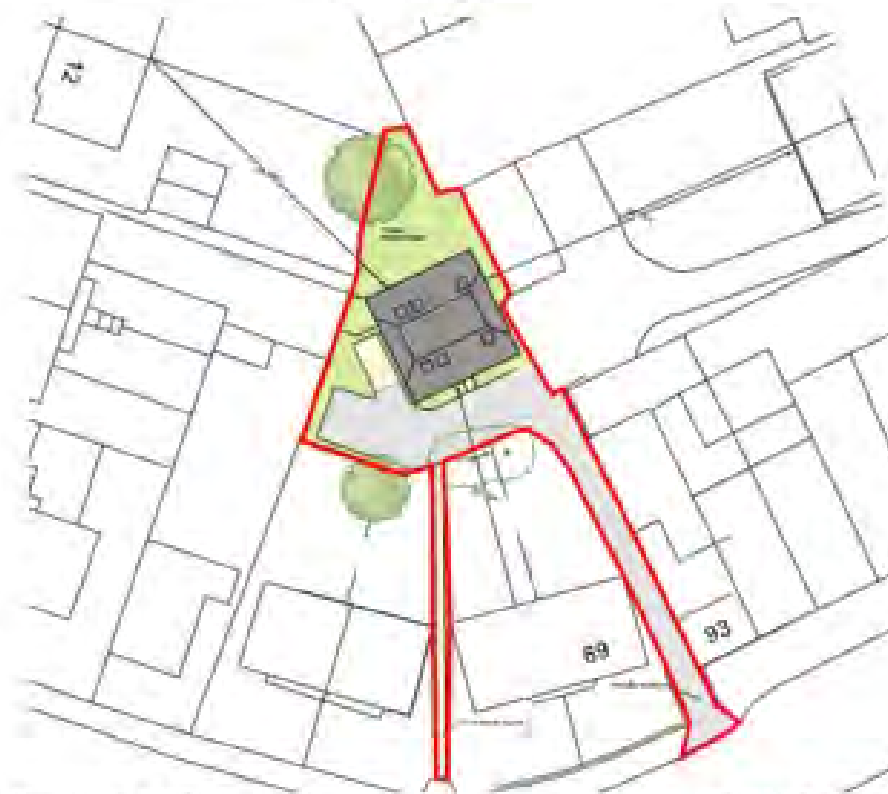
Proposed Site Layout

Client provided information states development works will comprise the construction of a three-storey building for five flats with hardstanding for a road/parking and shared green space. Associated depths of intrusions were not provided, and it is assumed that piling may be required.

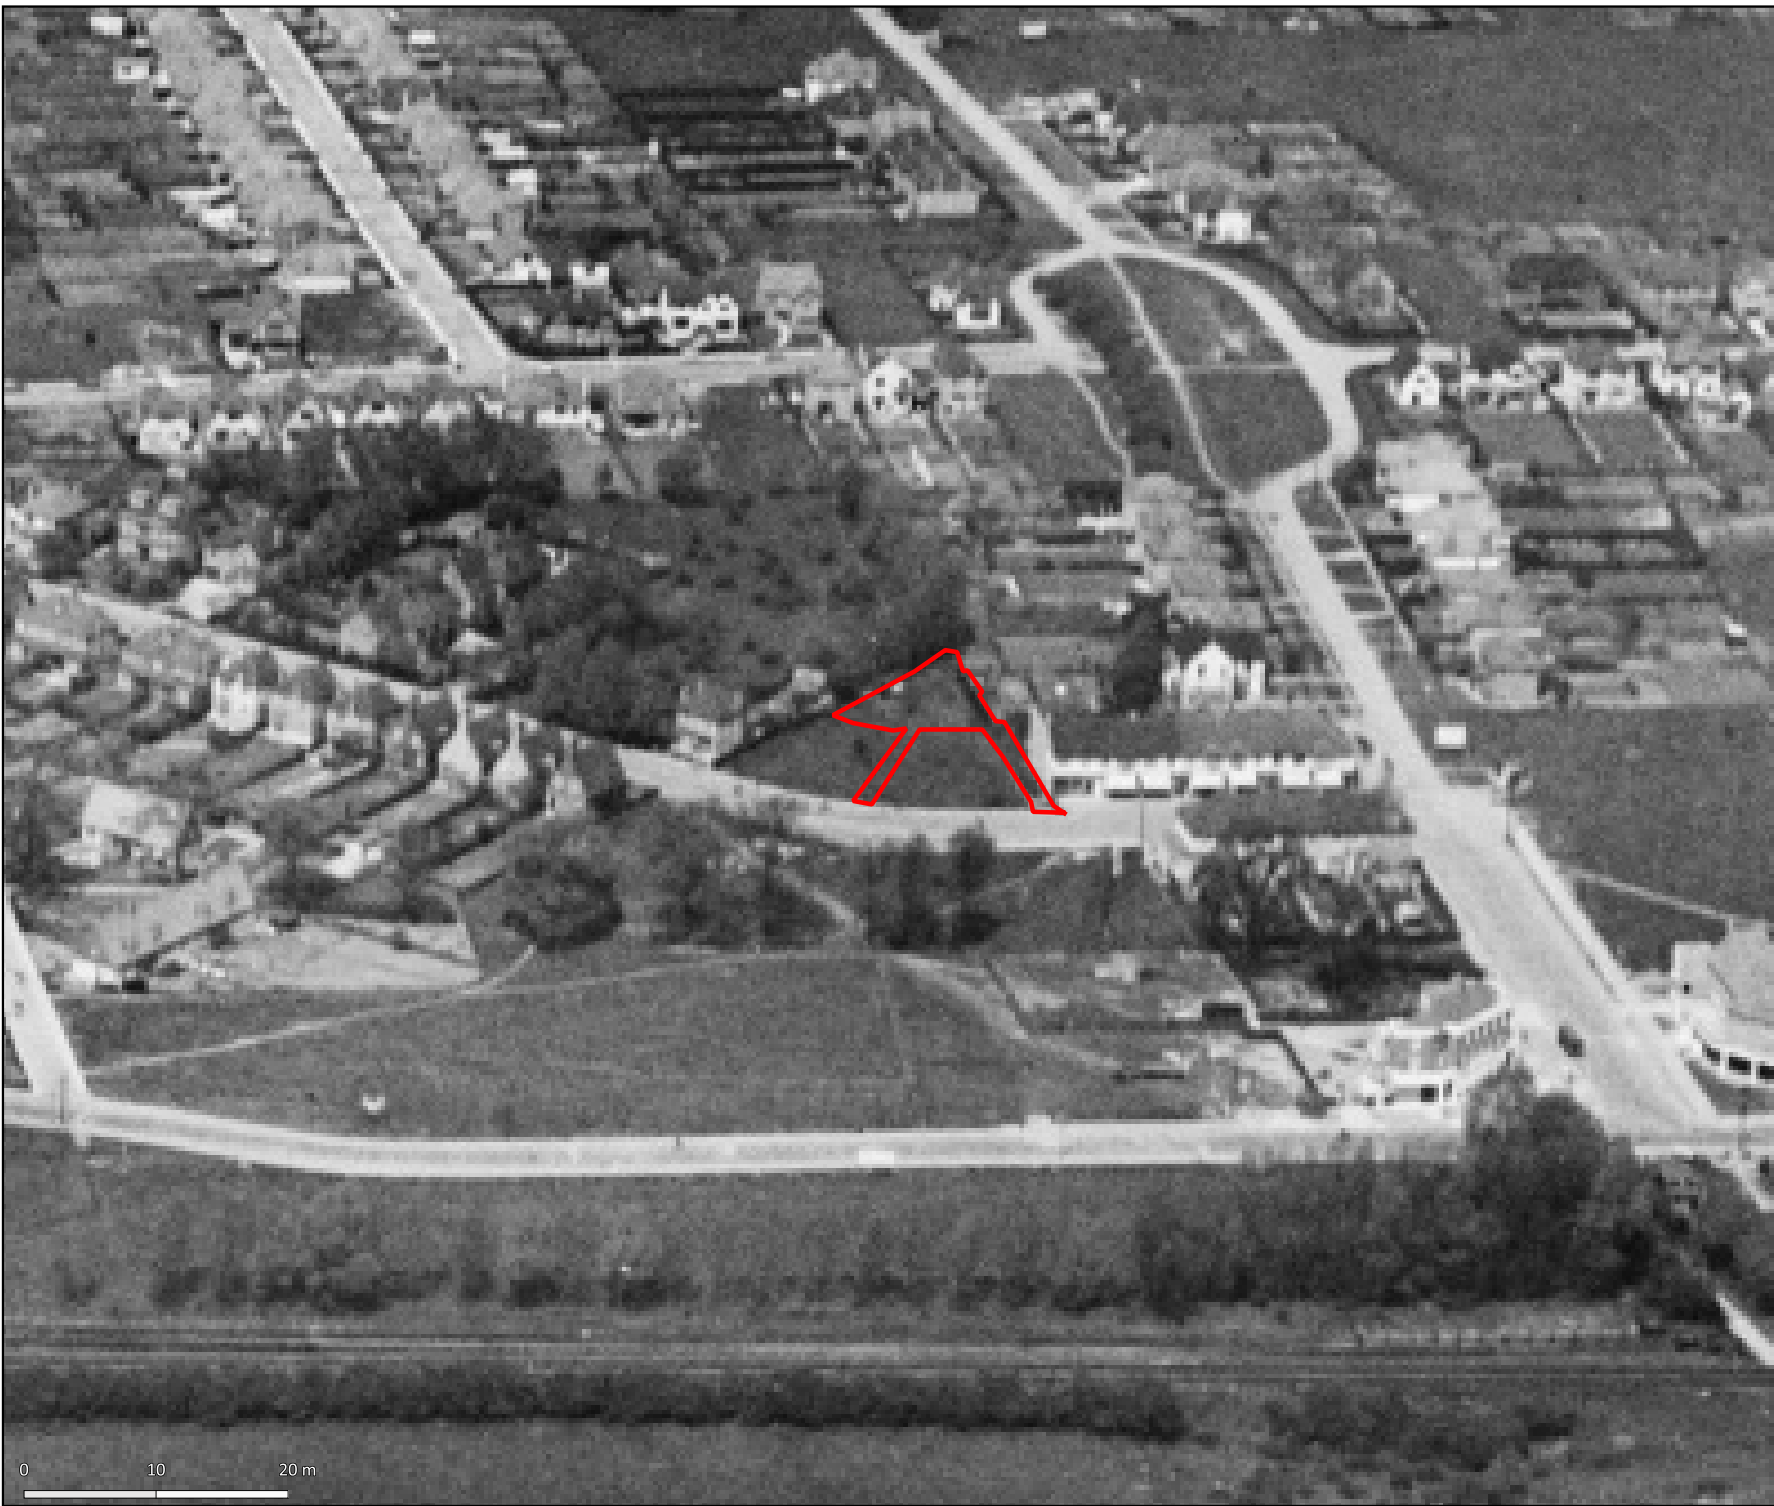
**FIGURE: 4.1**

Period	Photo Date	Review
Pre-WWII	May 1934	<b>FIGURE 4.1:</b> This oblique image, taken approximately five years before the start of WWII, displays the entirety of the Site and its immediate surrounds. The Site corroborates pre-WWII OS mapping, as it consists of entirely undeveloped ground. Furthermore, multiple residential structures and their associated gardens are adjacent to the east / west of the Site, and Manor Way is visible immediately south.

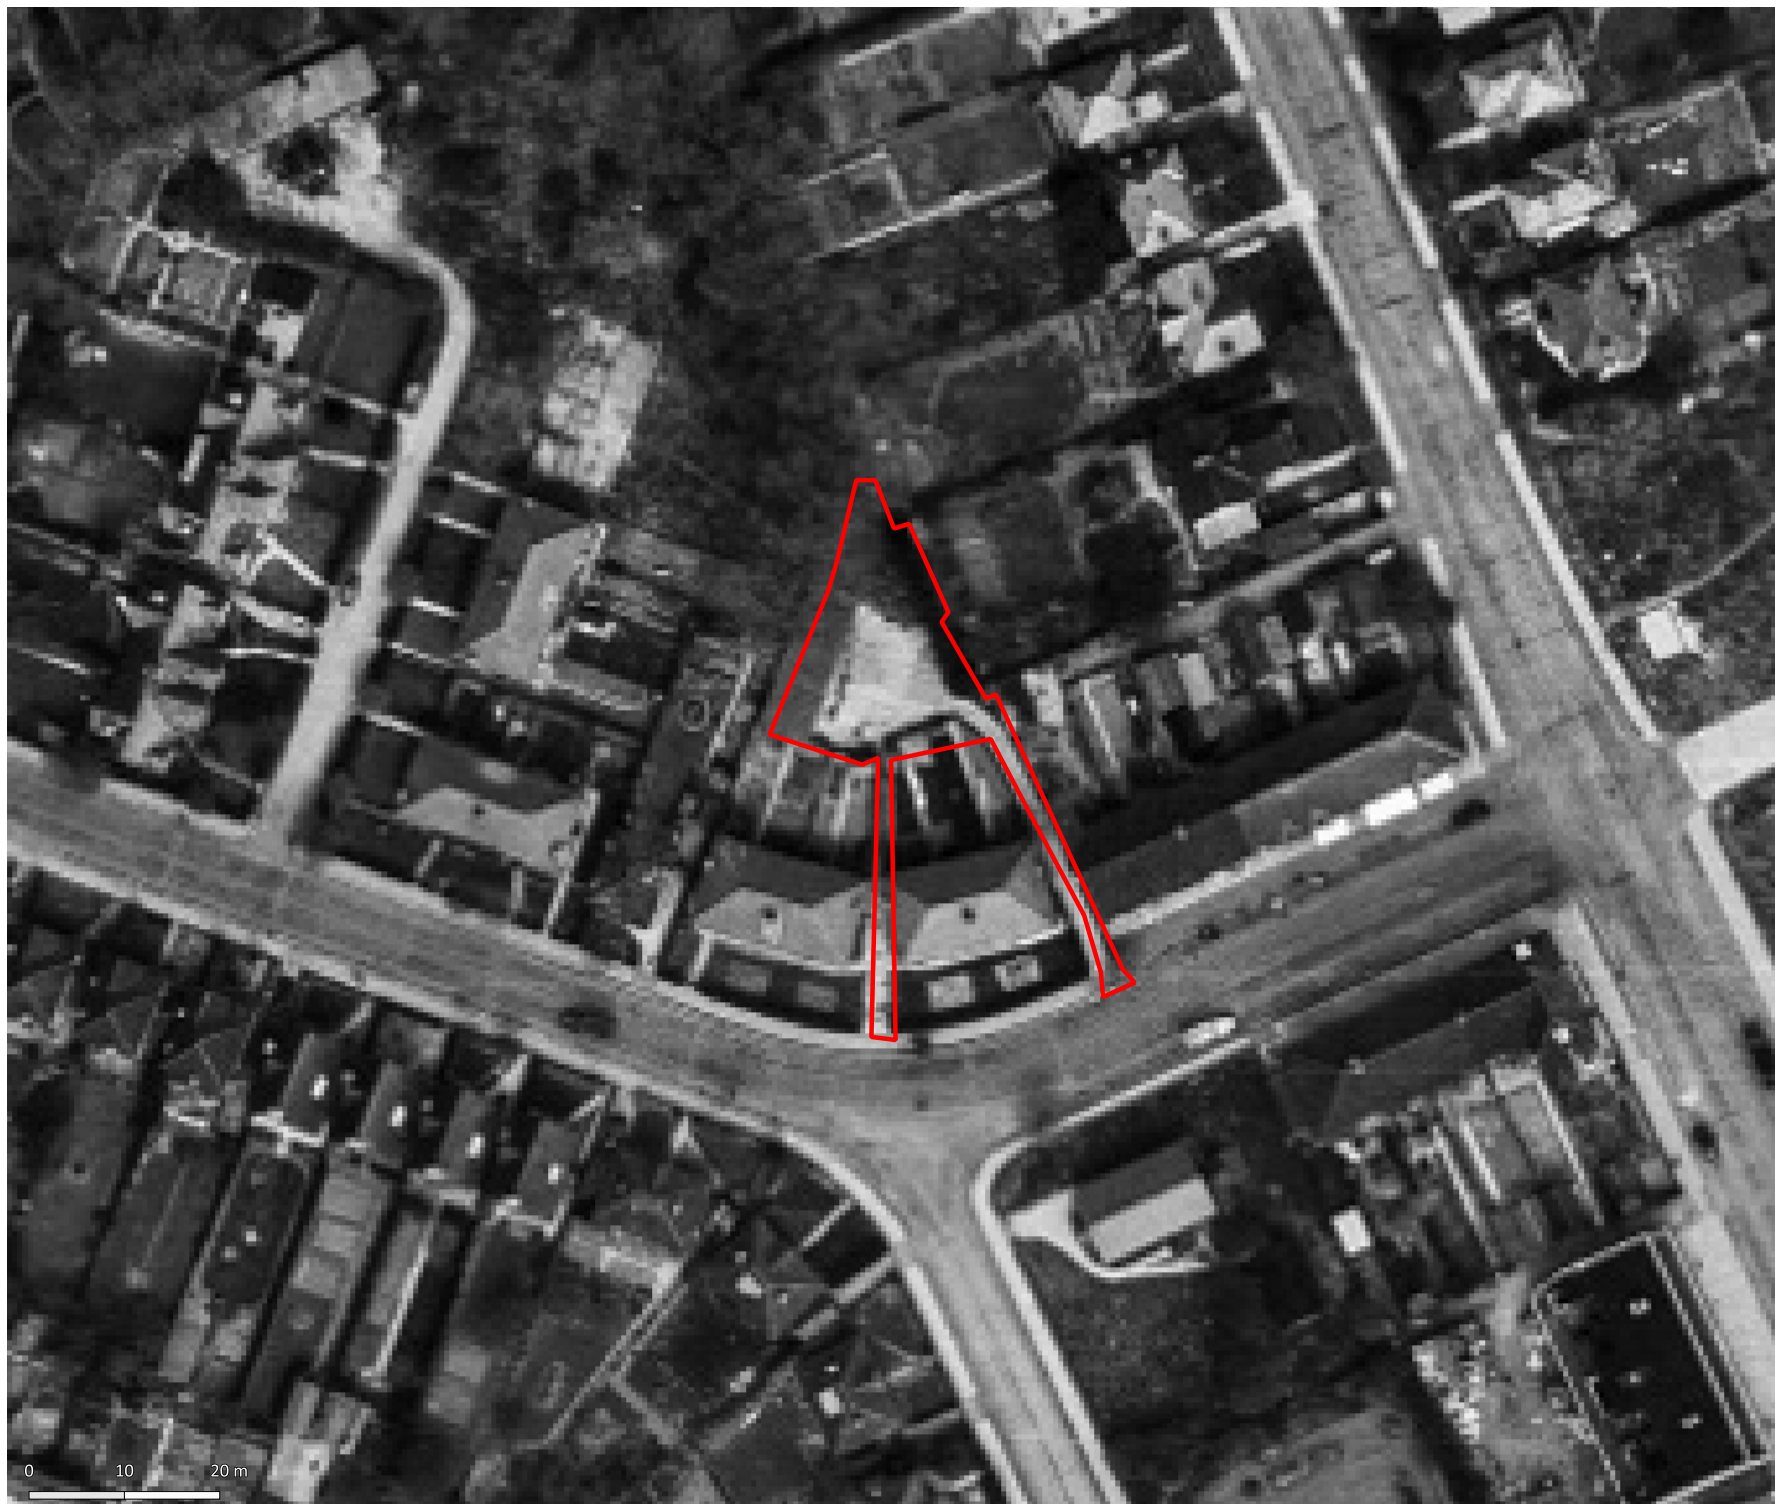
FIGURE: 4.2

<b>Post-WWII</b>	<b>29<sup>th</sup> April 1947</b>	<p><b>FIGURE 4.2:</b> This vertical view photograph, taken approximately two years after the end of WWII, displays the entirety of the Site and its immediate surrounds.</p> <p>Note, the majority of the Site is now occupied by hardstanding, it is possible albeit unconfirmed that this redevelopment occurred prior / during WWII.</p> <p>No immediately obvious evidence of bomb related damage on Site or in the immediate surrounds such as cratering / ground disturbances or structural clearance.</p>
------------------	---------------------------------------	--

No immediately obvious evidence of bomb damage, such as cratering or ground disturbances are visible on Site within post-WWII aerial photography. Furthermore, all structures adjacent to the Site do not appear to evidence any signs of significant bomb damage i.e. tiling repairs / structural clearance. It is possible that they sustained general blast damage which is not visible in available photography.

Due to the limitations of available aerial photography, it has not been possible to accurately determine the exact nature of the ground cover during WWII. However, had the hardstanding across the majority of the Site within post-WWII aerial photography been present during WWII, any such UXB strike to would have caused incontrovertible evidence of its incidence as it passed into the ground beneath. The same can be said for the majority of neighbouring structures and road to the south, where (assuming no cratering) a HE UXB entry hole would have been persistent and easily recognisable.

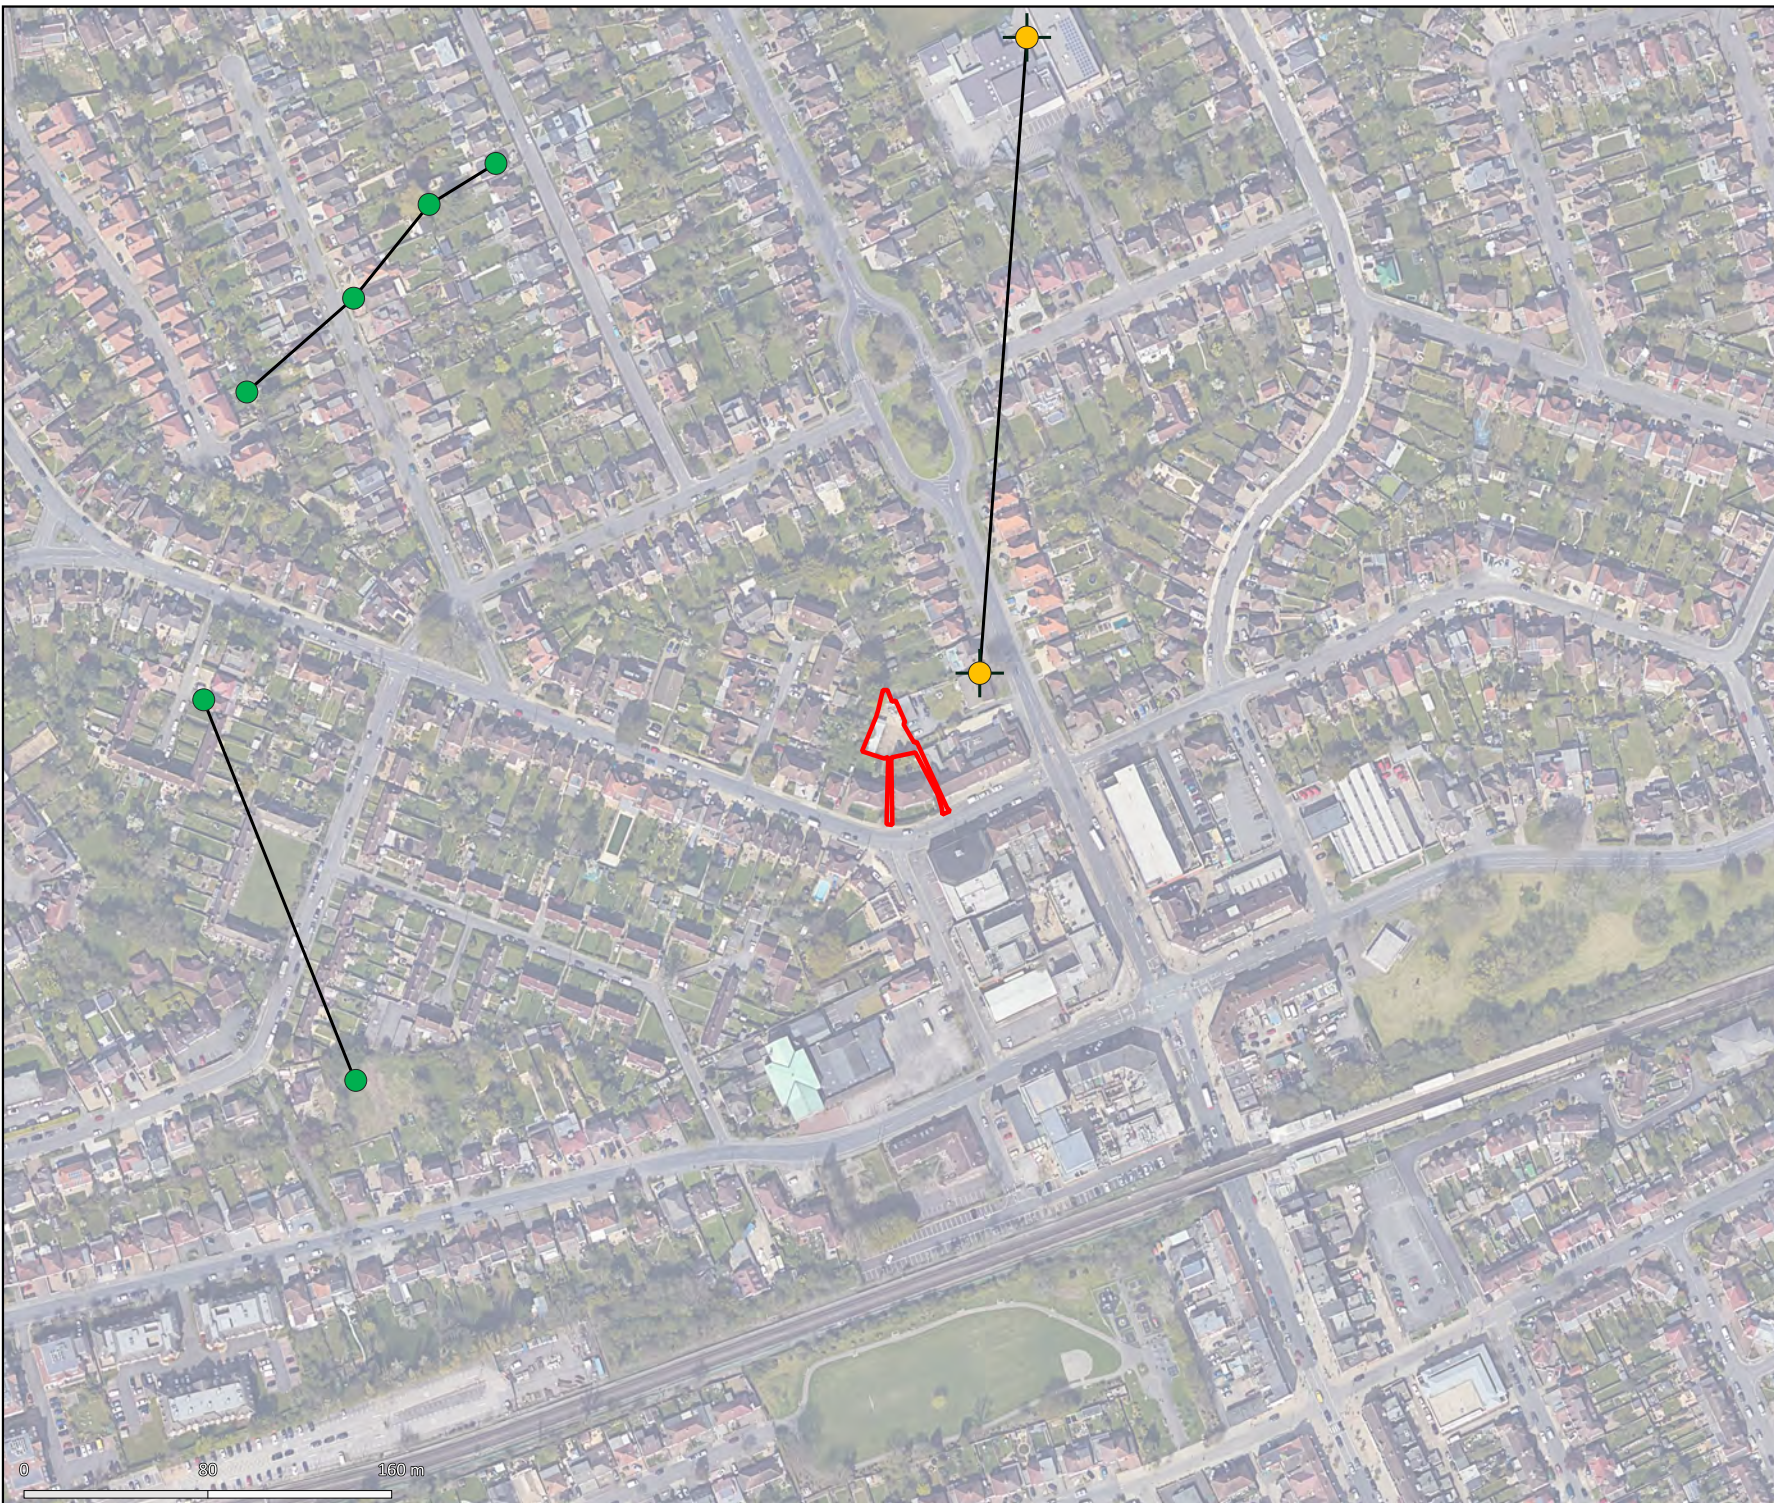
FIGURE: 5.2

- Approximately nine x 'iron' bombs and two unexploded oil bombs (UXOB) are plotted within a 300m radius of the Site. The closest of these, an UXOB, is located approximately 40m east of the Site. The weekly maps, presented at **FIGURE 5.2**, identify two bomb sticks within the same radius; neither of which intersect the Site, although one potentially straddles the south-eastern border of the Site.
- No day-time air raids affected the study area.
- No 1kg / 2kg IB showers are plotted within 300m of the Site. Note, no weekly plot maps are available for the 7<sup>th</sup> September to 7<sup>th</sup> October 1940 period and therefore it is not known whether IB showers affected the Site during this month.

**Weekly Bomb Census Mapping Overlay**

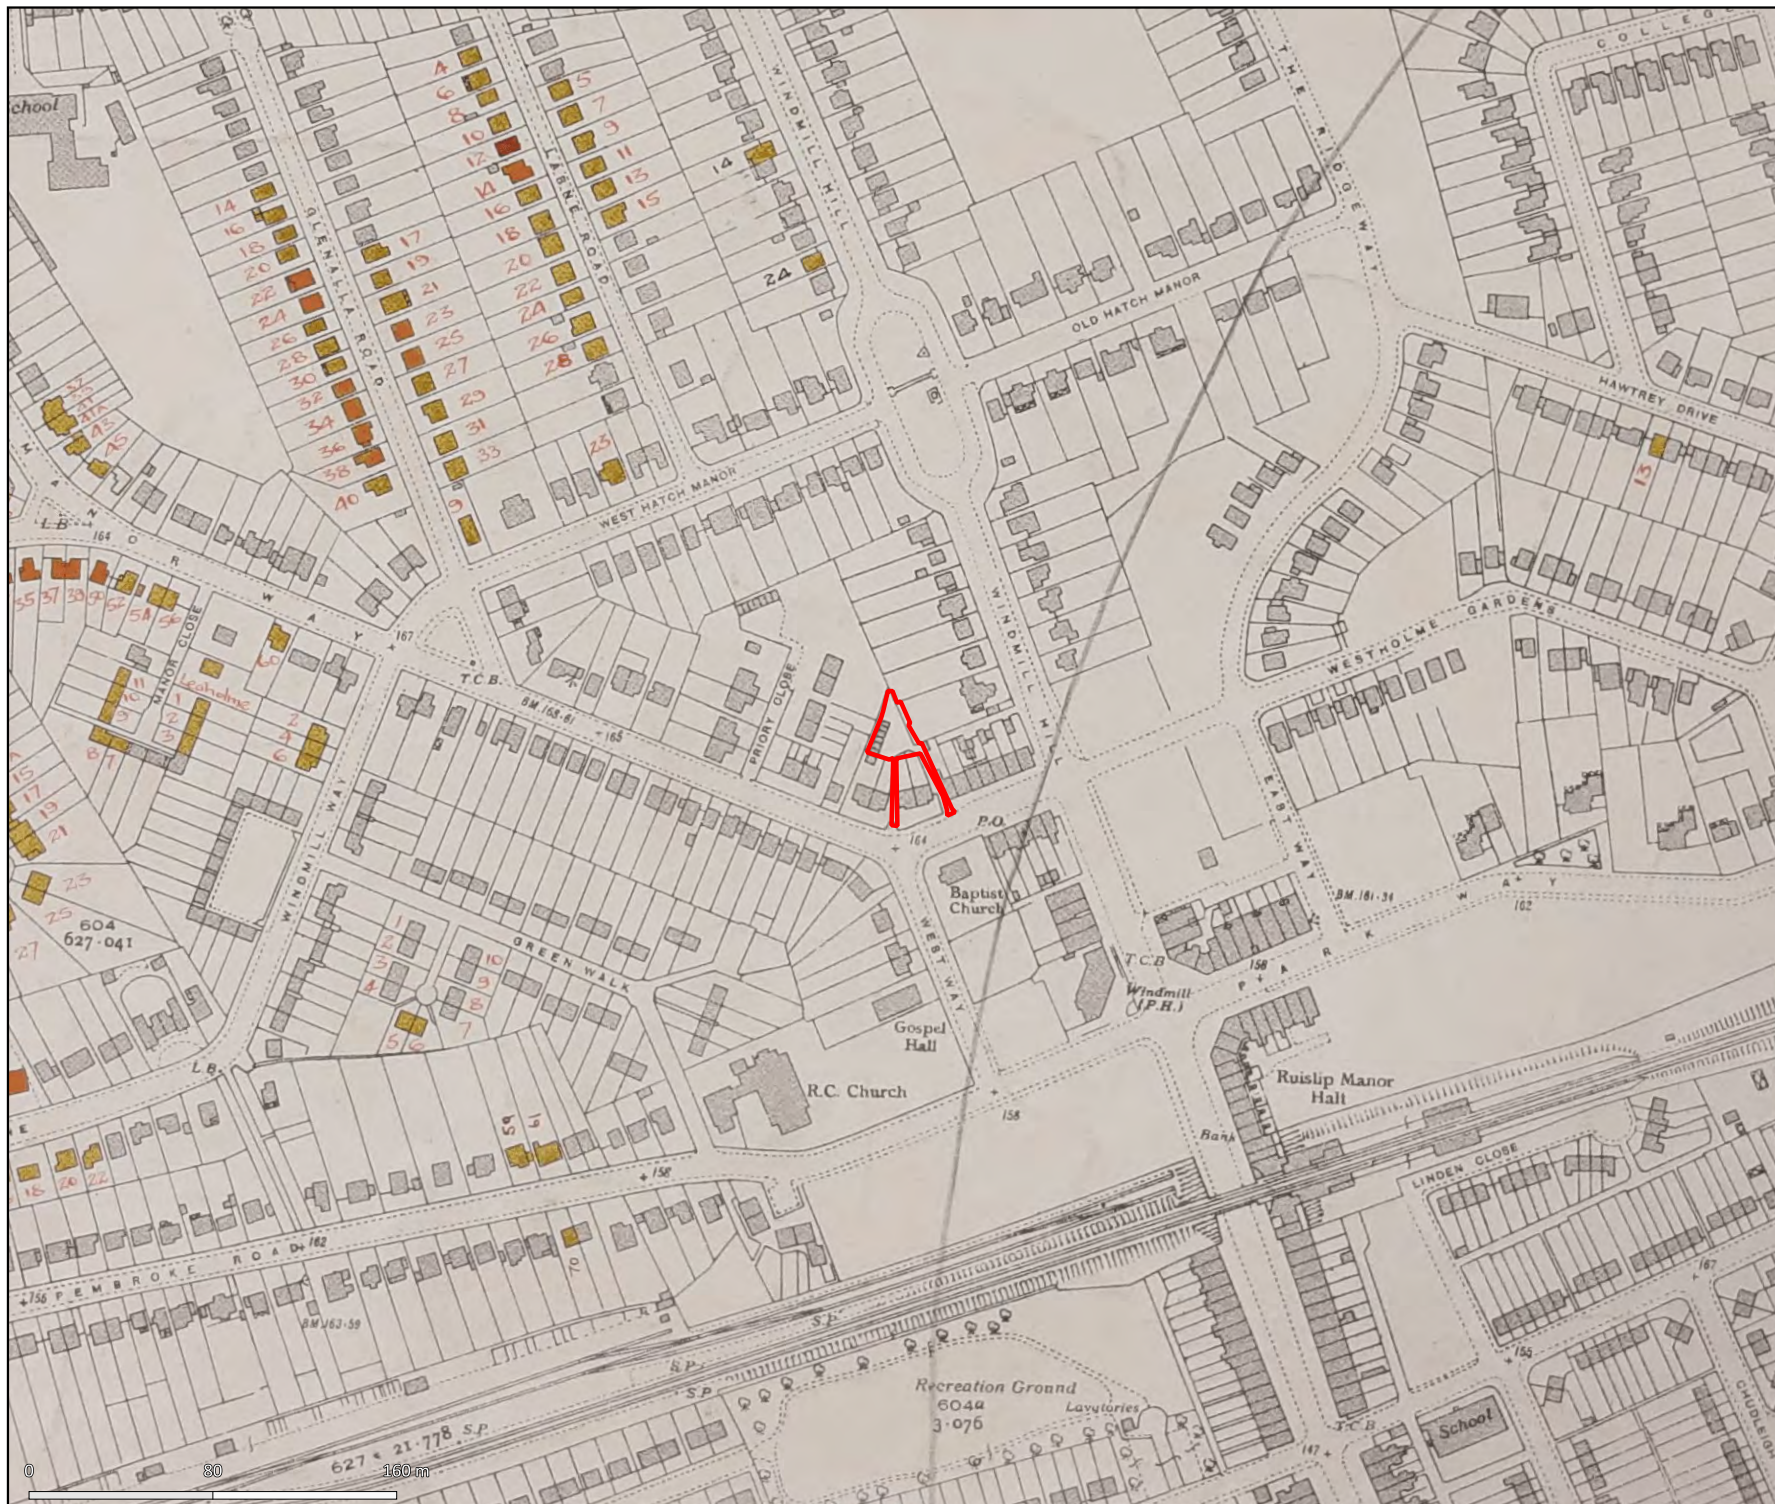
FIGURE: 7

Brimstone has reviewed an original war damage map covering the study area. The map was produced by the Engineer and Surveyors Department of the Middlesex County Council and was updated throughout the bombing campaign. The severity of damage is divided into three categories: Category 3 – indicates damage with uncertainty on whether repairs are possible, or demolition may be necessary. Category 2 – some repairs possible, could become Category 1, and Category 1 – total damage. Note, minor damage to structures was not recorded within this source. A section of the map covering the study area is displayed at **FIGURE 7**.

- No structures adjacent to the Site are recorded to have sustained a category of damage.
- The closest structure recorded as sustaining damage was situated approximately 150m north-west of the Site (Category 3 damage).
- As this source only records damage to structures and the Site itself comprised undeveloped ground, any potential significant damage occurring on Site would not be recorded in this source.

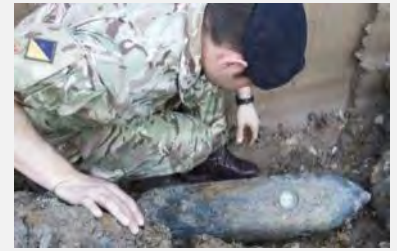
**SC 50**

**Bomb Weight:** 40-54kg (110-119lb)  
**Explosive Weight:** 25kg (55lb)  
**Filling:** TNT, Amatol or Trialen  
**Charge/Weight Ratio:** 46%  
**Fuse Type:** Electrical impact fuse or mechanical delayed action fuse  
**Body Dimensions:** 1,100mm length x 200mm diameter  
**Appearance:** Bomb body and tail painted grey/green with a yellow stripe on the tail unit. Steel construction.  
**Variants:** 8 x variants. Additional fittings: Kopfring nose for limited penetration and Stabbo nose for dive-bombing.

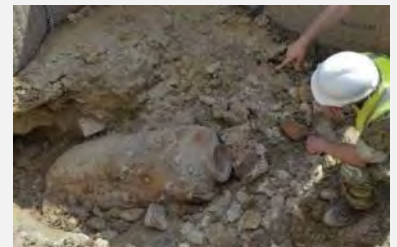
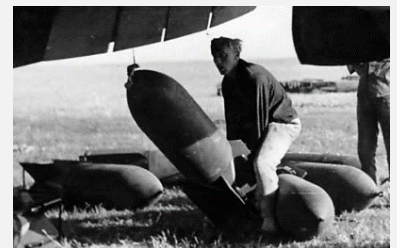
**SC 250**

**Bomb Weight:** 245-256kg (540-564lb)  
**Explosive Weight:** 125-130kg (276-287lb)  
**Filling:** TNT, Amatol and Trialen mix  
**Charge/Weight Ratio:** 44%  
**Fuse Type:** 1 or 2 electrical impact fuse(s) or mechanical delayed action fuse(s)  
**Body Dimensions:** 1,173mm length x 368mm diameter  
**Appearance:** Bomb body and tail painted grey/green with a yellow stripe on the tail unit. Steel construction.  
**Variants:** 8 x variants. Kopfring nose for limited penetration. Stabbo nose for dive-bombing.

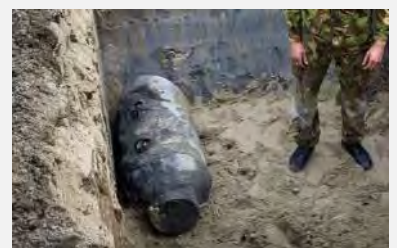
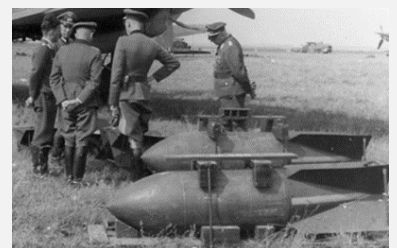
**SC 500**

**Bomb Weight:** 480-520kg (1,058-1,146lb)  
**Explosive Weight:** 220kg (485lb)  
**Filling:** TNT, Amatol and Trialen mix  
**Charge/Weight Ratio:** 44%  
**Fuse Type:** 2 electrical impact fuses or mechanical delayed action fuses  
**Body Dimensions:** 1,423mm length x 470mm diameter  
**Appearance:** Bomb body and tail painted grey/green or buff with a yellow stripe on the tail unit. Steel construction.  
**Variants:** 3 x variants. Kopfring nose for limited penetration.

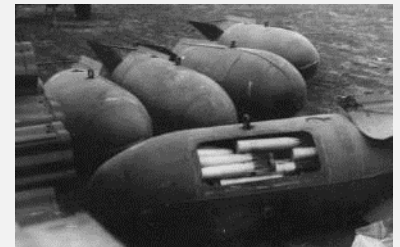
### B-1E Sub-Munition

**Bomb Weight:** 1-1.3kg (2.2-2.87lb)  
**Incendiary Weight:** 680g (1.4lb)  
**Filling:** Thermitite  
**Fuse Type:** Simple impact fuse  
**Body Dimensions:** 247mm length x 50mm diameter  
**Appearance:** Grey body and dark green painted tail unit. Magnesium alloy case.  
**Operation:** Small percussion charge ignites Thermitite (>1,000°C burn).  
**Variants:** Most common variant: B 2EZ (2kg) included a small HE charge  
**Remarks:** Drop containers varied in size. The smallest cluster bomb held 36 x B-1Es and the largest 620 x B-1Es.

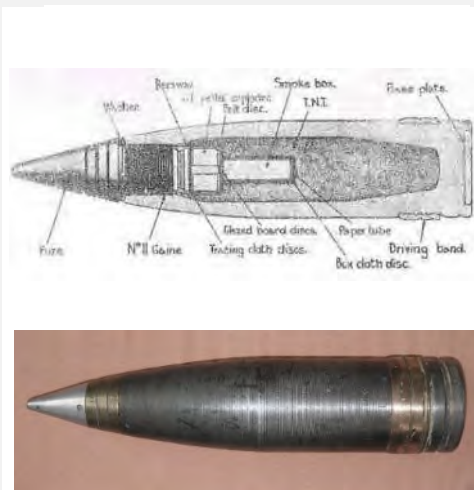
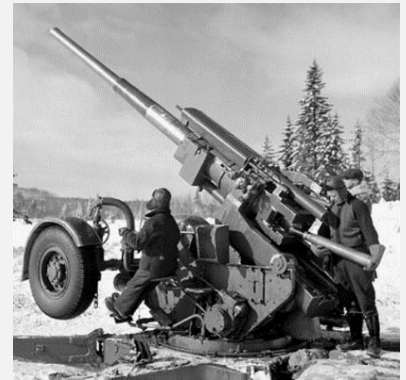
### HAA Battery - 3.7" QF Shell

- Shell Weight:** 12.7kg
- Shell Dimensions:** 94mm x 438mm
- Fill Weight:** 1.1kg
- Fill Type:** TNT
- Fuse Type:** Mechanical Time Delay fuse
- Appearance:** Grey body, copper driving bands, brass neck
- Rate of Fire:** 10 - 20 rpm
- Ceiling:** 9,000 - 18,000m
- Variants:** HE or shrapnel shells.  
Note, the 4.5" gun was also used in an HAA role throughout the UK.

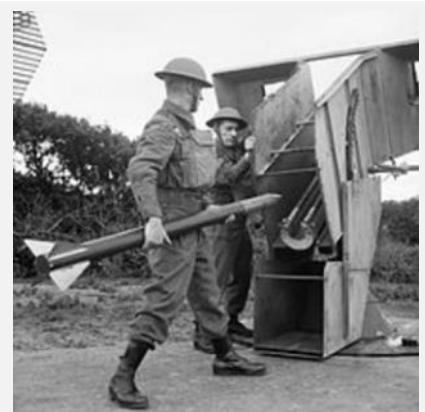
### Z Battery - 3" U.P Rocket

- Rocket Weight:** 24.5kg
- Warhead Weight:** 1.94kg
- Filling:** TNT warhead. Black Powder solid fuel rocket motor.
- Fuse Type:** Mechanical Time Delay fuse
- Rocket Dimensions:** 1,930mm x 76mm
- Ceiling:** 6,770m
- Operation:** Fired from single, tandem and (later) 36 x rail launchers (Z Batteries). Limited use throughout the UK.
