**ACS Hillingdon – General Repairs to  
External Elements & Internal Upgrades,  
Phase 1.2b  
Design & Access Statement**

**ACS Hillingdon, Vine Lane, Hillingdon, Uxbridge,  
UB10 0BE**

**Job No: 20447  
Issue Date: 15 October 2024  
Revision No: 01**

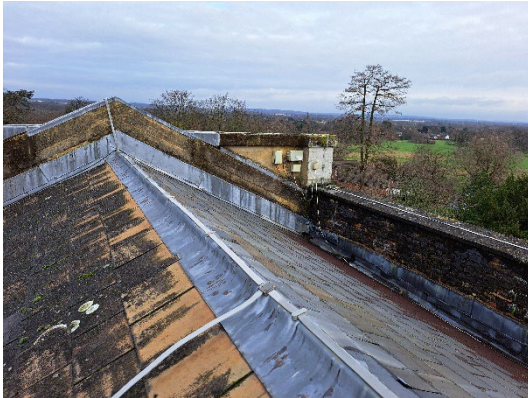
Image 1: Existing roof coverings to be replaced

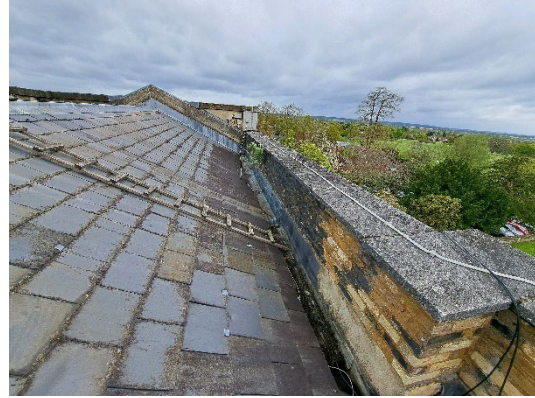
Image 2: Existing roof coverings to be replaced

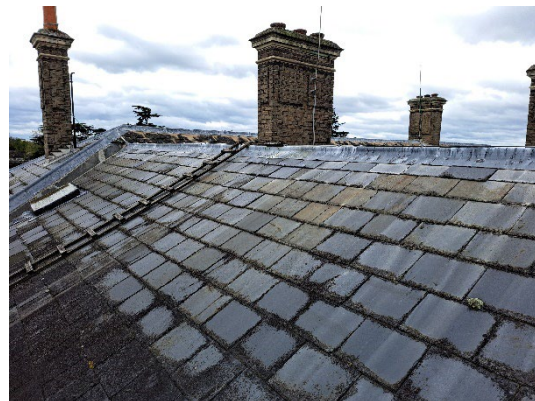
Image 4: Existing roof coverings to be replaced

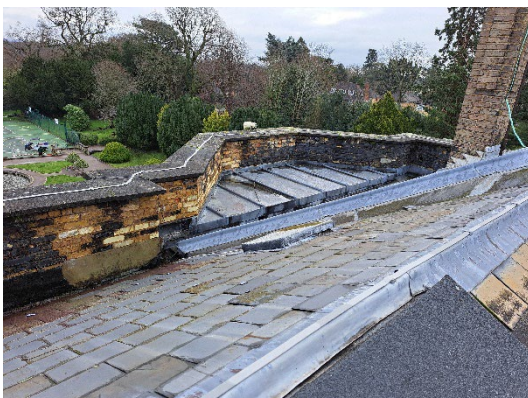
Image 5: Existing roof coverings to be replaced and parapet wall to be dismantled

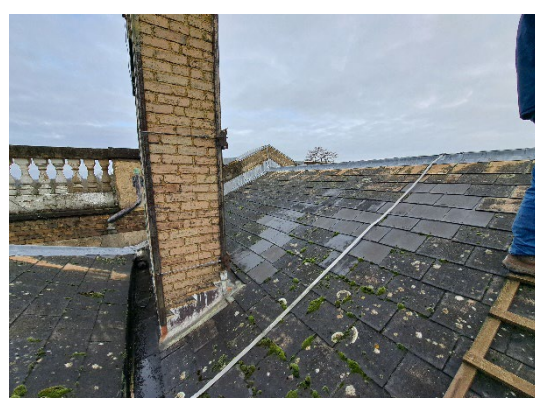
Image 6: Existing roof coverings to be replaced and chimney to be repaired

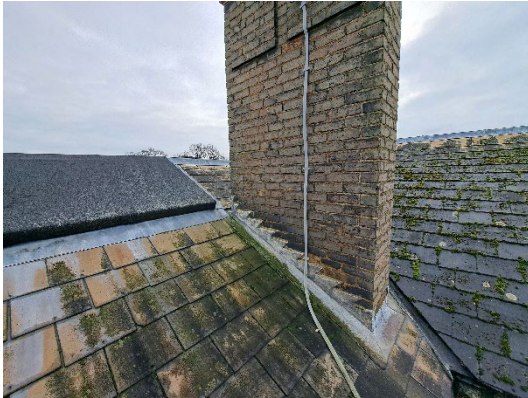
Image 7: Existing roof coverings to be replaced and chimney to be repaired

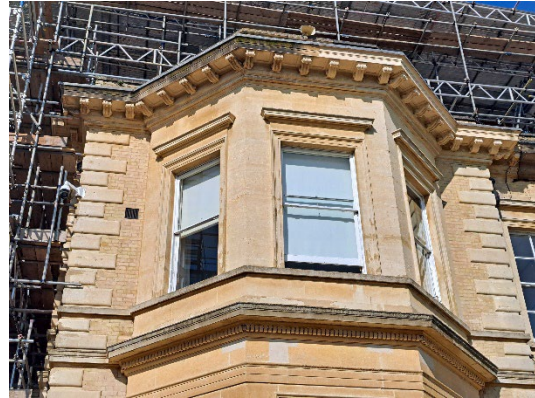
Image 8: Existing cornice to be replaced, windows to be repaired and glass to be replaced

Another aim of the proposal seeks to rectify previous recent historic repairs that have been done using cheaper and unsuitable materials, such as a render finish used for the cornice, and replacing them with the more traditional alternative, such as stone to match all other areas of the cornice. This cornice has become unstable and as such, parts of it are breaking away which is a health and safety issue.

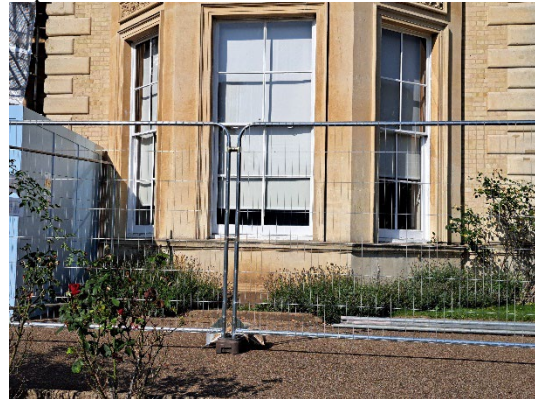
Image 10: Existing windows to be repaired and glass to be replaced

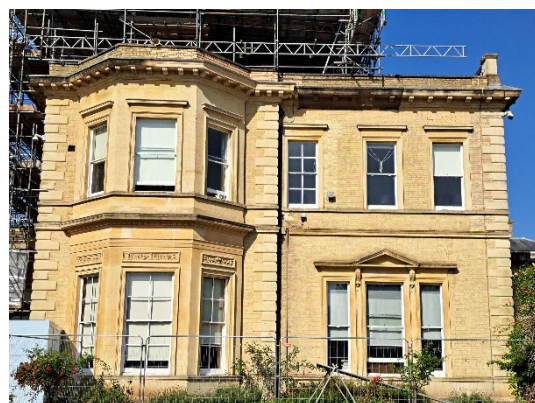
Image 12: Existing windows to be repaired and glass to be replaced

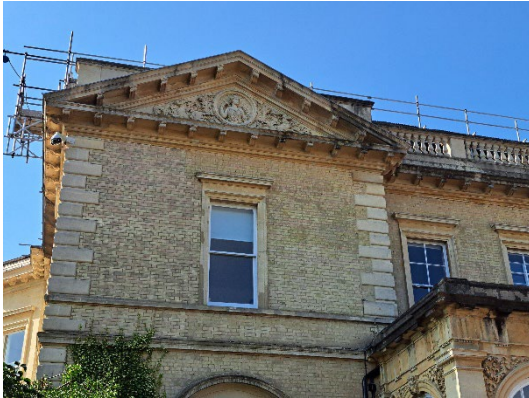
Image 13: Existing windows to be repaired and glass to be replaced; cornice to be replaced but original tympanum will be retained and conserved

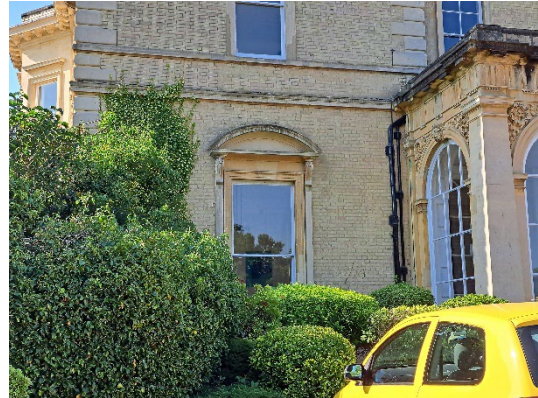
Image 14: Existing windows to be repaired and glass to be replaced
