BASEMENT IMPACT ASSESSMENT REPORT

28 NICHOLAS WAY
NORTHWOOD
HA6 2TT

Report Title: Basement Impact Assessment for 28 Nicholas Way, Northwood HA6 2TT

Job No: P35048J2804/JWT

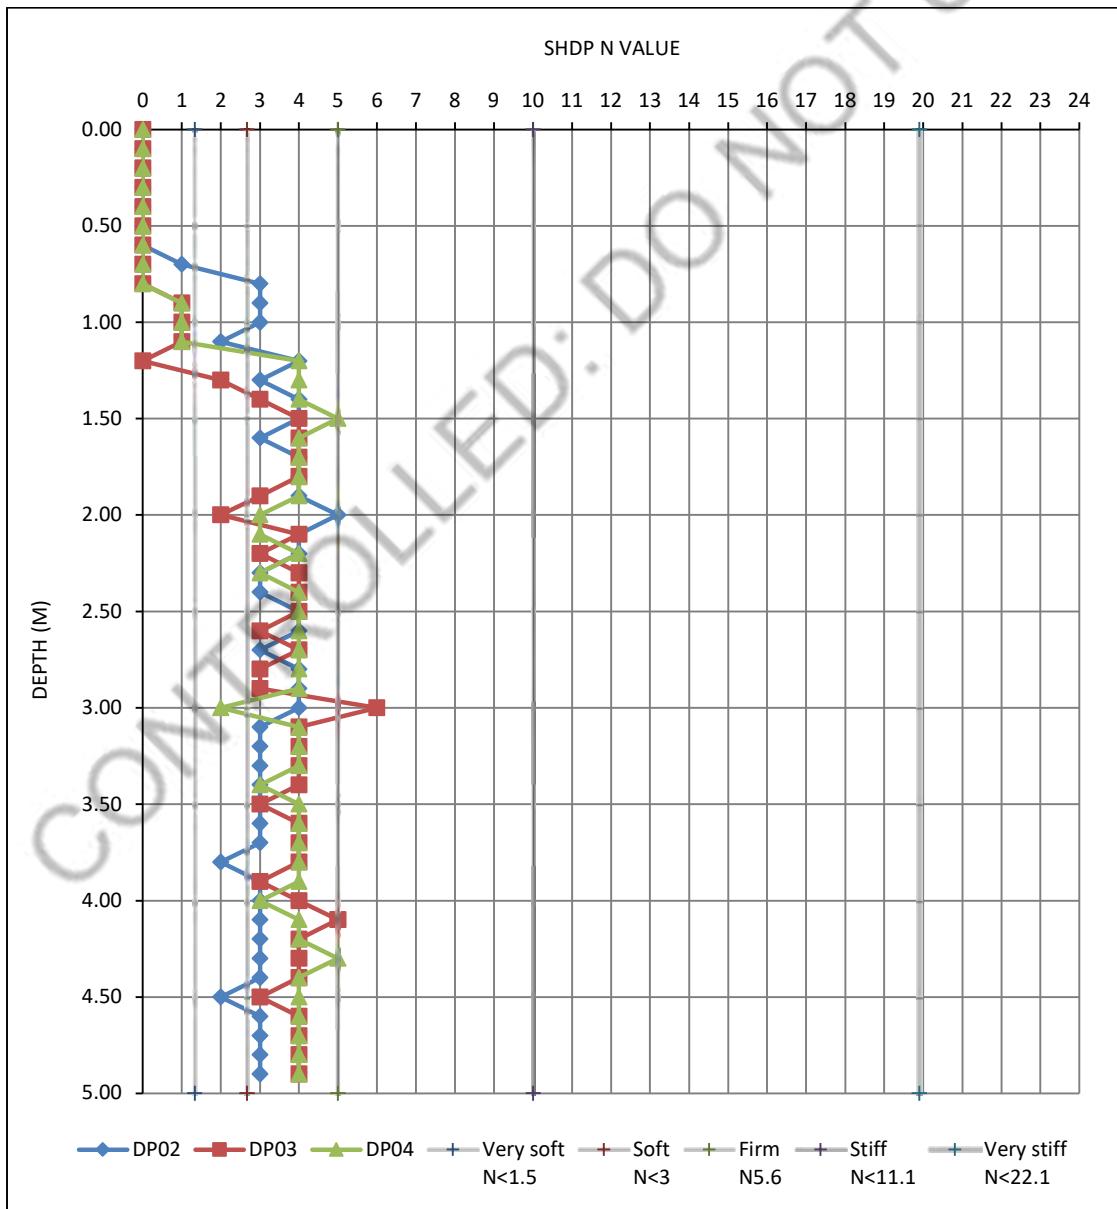
6.2 Super Heavy Dynamic Probing (SHDP)

The results in the London Clay Formation typically ranged between N=0 and N=2 to a depth of 1.00m, before increasing to values of between N=3 and N=5 to depth.

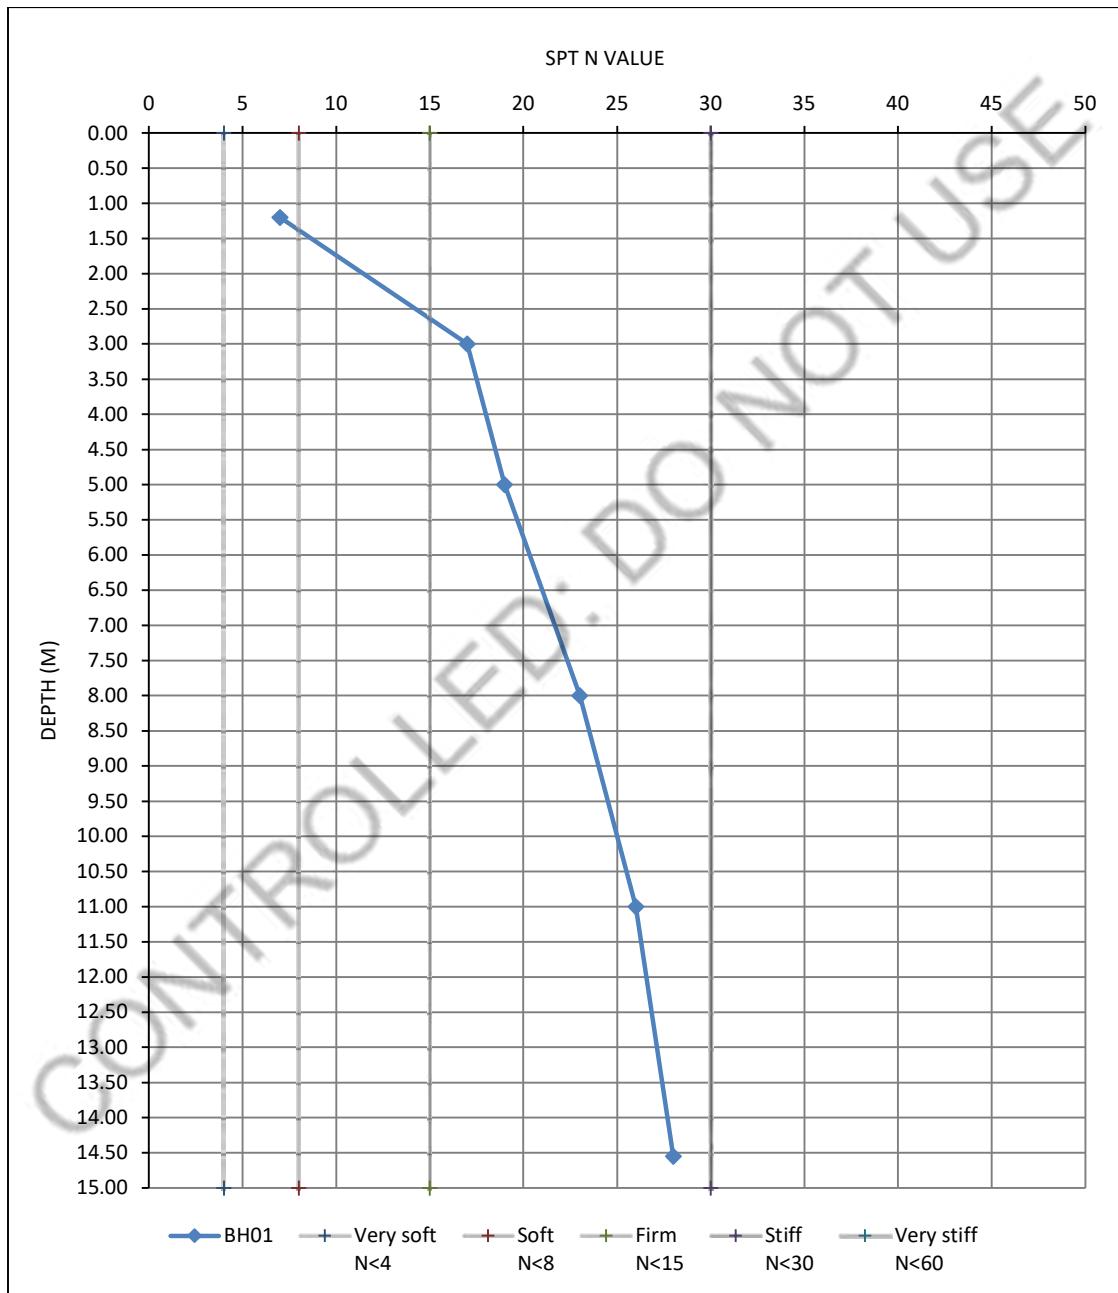
6.3 Standard Penetration Test (SPT)

The results in the London Clay Formation showed an overall consistent trend of increasing results with depth. At ~1.20m, a value of N=7 was recorded, increasing to N=28 at 14.50m depth.

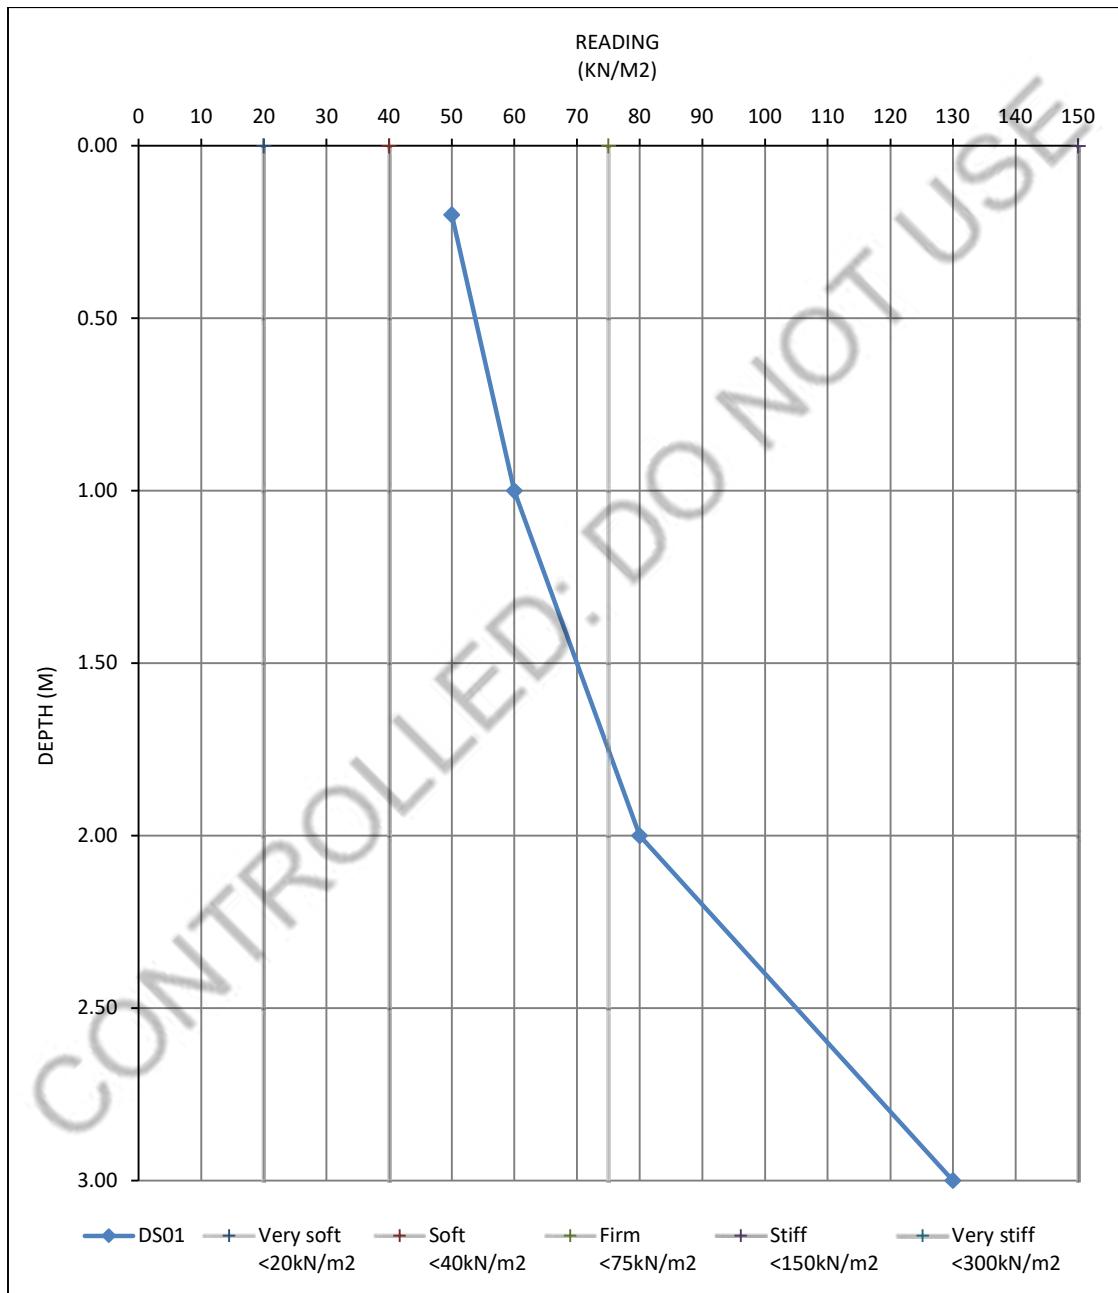
6.4 Shear Vanes (SV)

Materials suitable for shear vane tests were only encountered in DS01, the results showed a general increase in shear strength with depth, ranging from 50 kN/m² at 0.20m, up to 130 kN/m² at 3.00m.

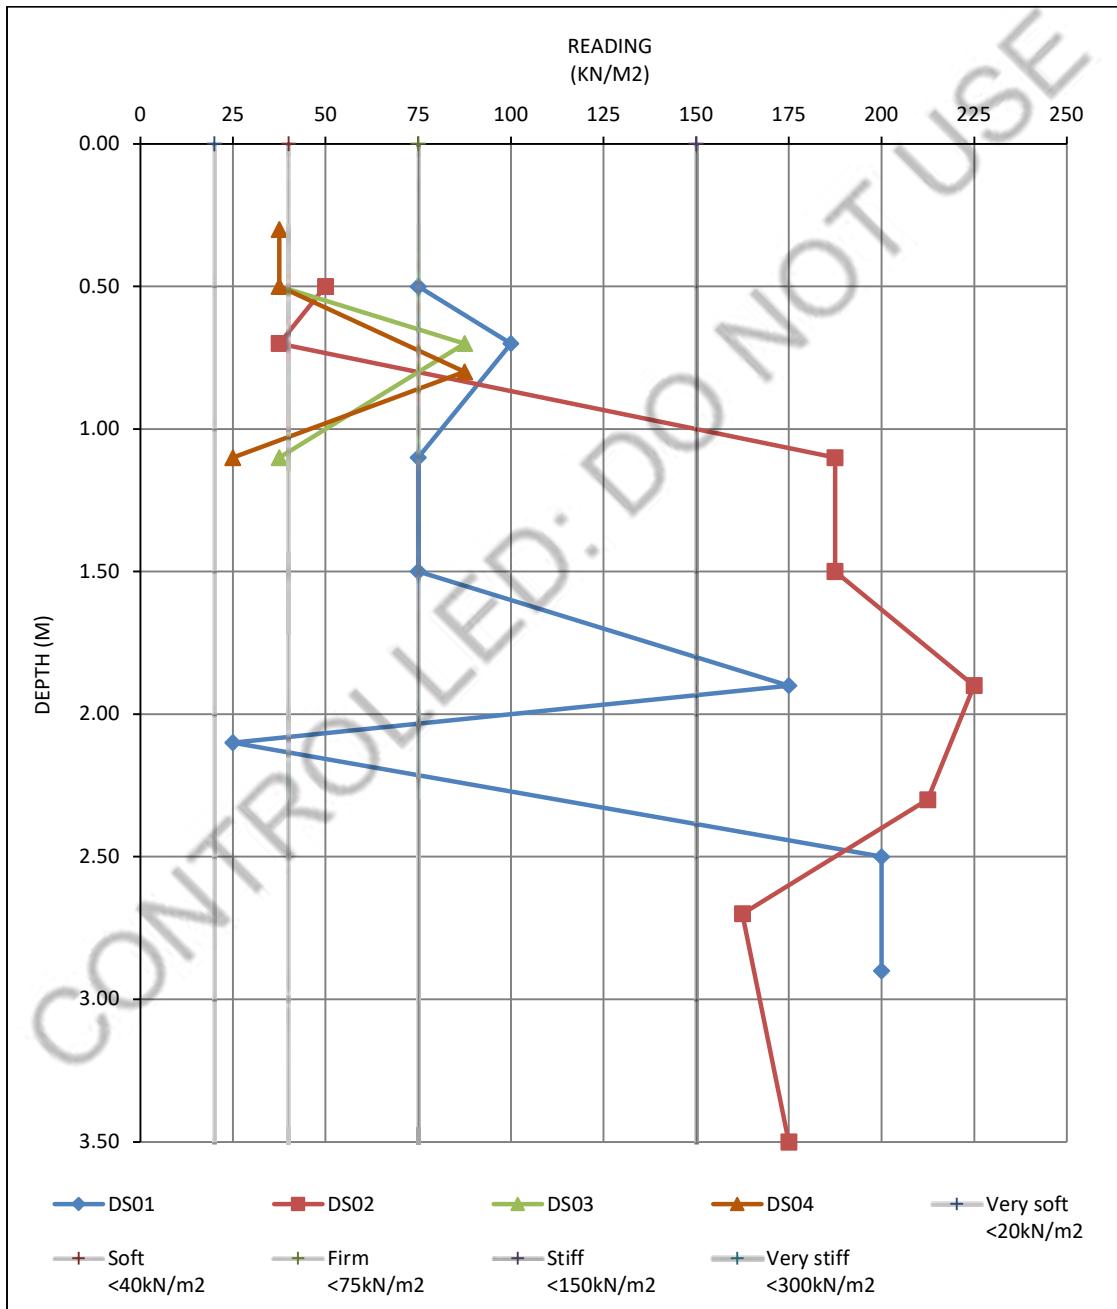
6.5 Hand Penetrometers (HP)

The results in the London Clay Formation were highly variable due to notable changes in the strata across the site. They typically ranged between 25 kN/m² and 100 kN/m² from 0.30-1.10m depth. Beyond this depth results in DS01 and DS02 became variable, ranging between 25 kN/m² and 225 kN/m² a depth of ~2.00mbgl.

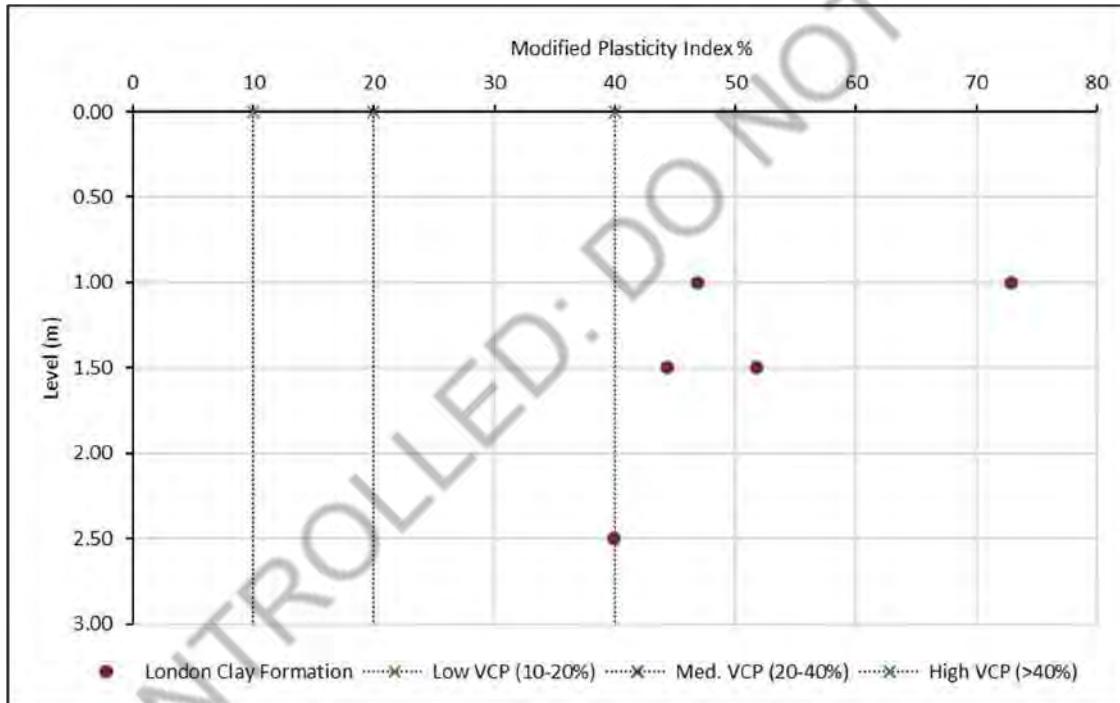
A modified plasticity index (PI') was calculated following the NHBC methodology, to account for any non-shrinkable percentage not passing the 425 μ m sieve:

Strata	No. of tests	Modified Plasticity Index %		
		Minimum	Maximum	Average
London Clay Formation	5	39.9	72.9	51.2

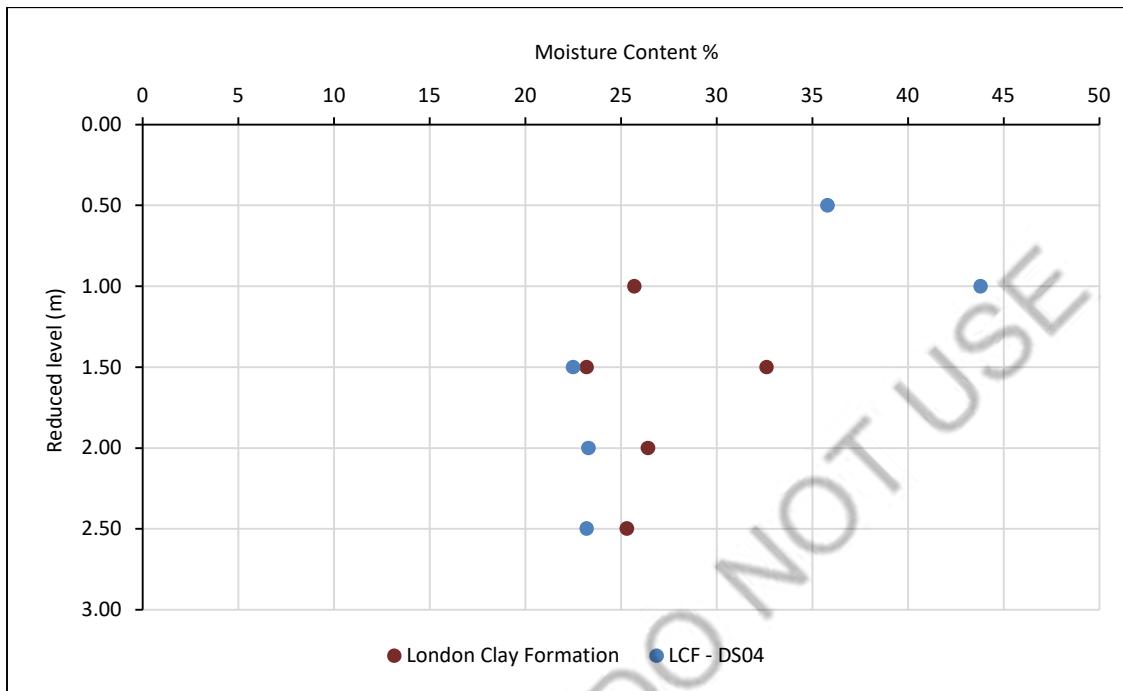
8.3 Water Content

Water content determinations (formerly known as *moisture content*) were undertaken in combination with various classification tests, and the results are summarised below.

Strata	No. of tests	Moisture content %		
		Minimum	Maximum	Average
London Clay Formation	10	22.5	43.8	28.2

DS04 is plotted separately from the other moisture content results as numerous tall mature trees were noted around this position. This is to show a profile of moisture contents with depth in an attempt to identify any evidence of desiccation, if present

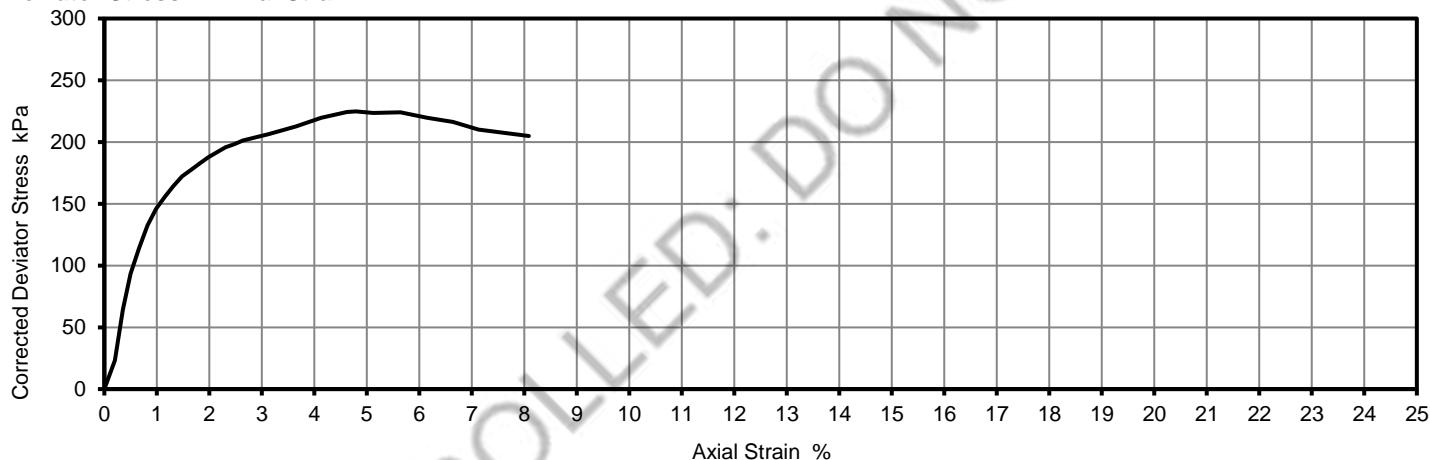
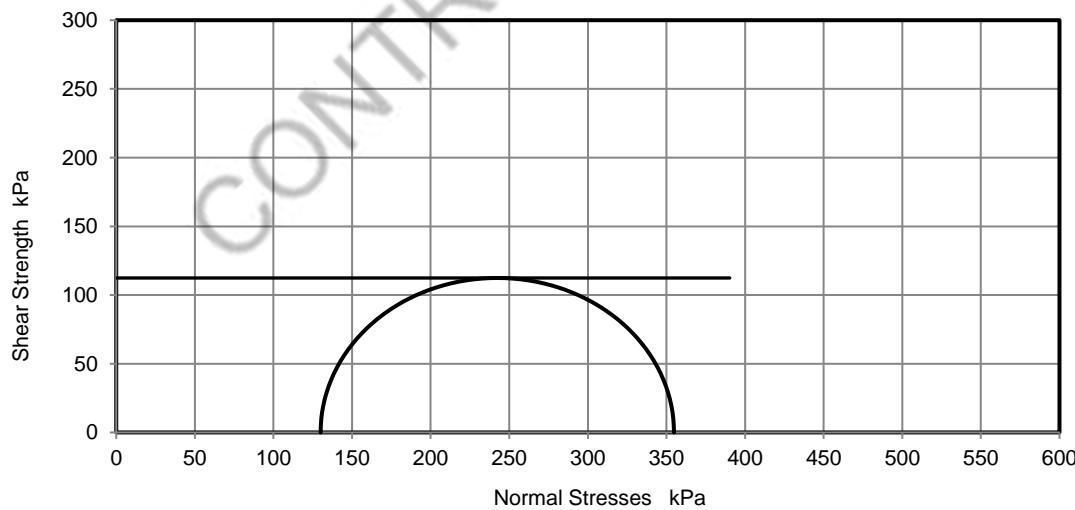
Rate of Strain	2.00 %/min
Cell Pressure	130 kPa
Axial Strain at failure	4.8 %
Deviator Stress, ($\sigma_1 - \sigma_3$) _f	225 kPa
Undrained Shear Strength, cu	112 kPa
Mode of Failure	Brittle
Membrane thickness	0.24 mm

Deviator Stress v Axial Strain

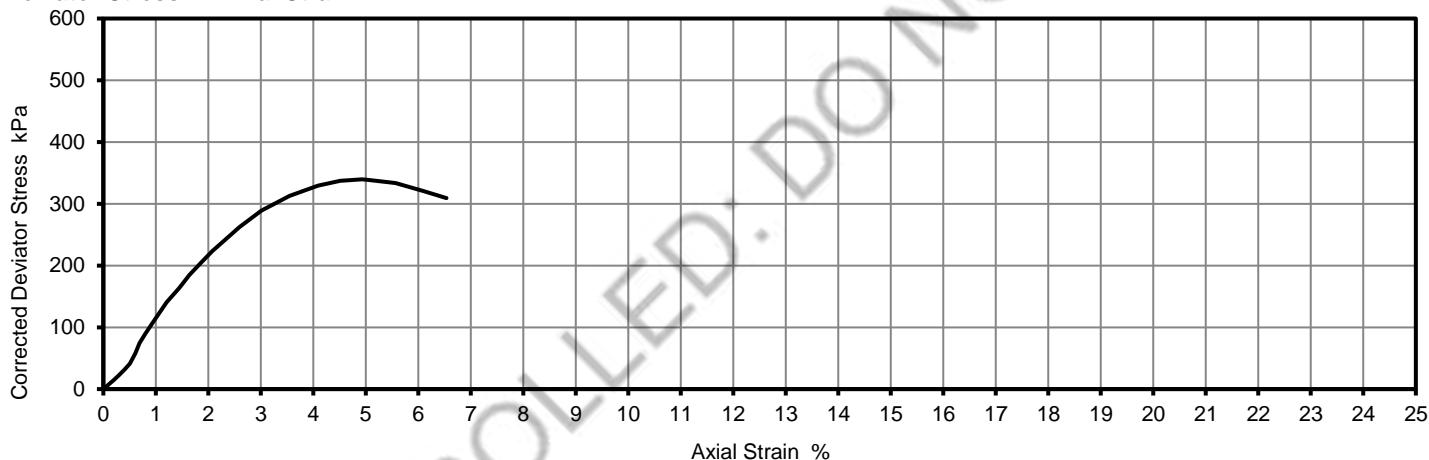
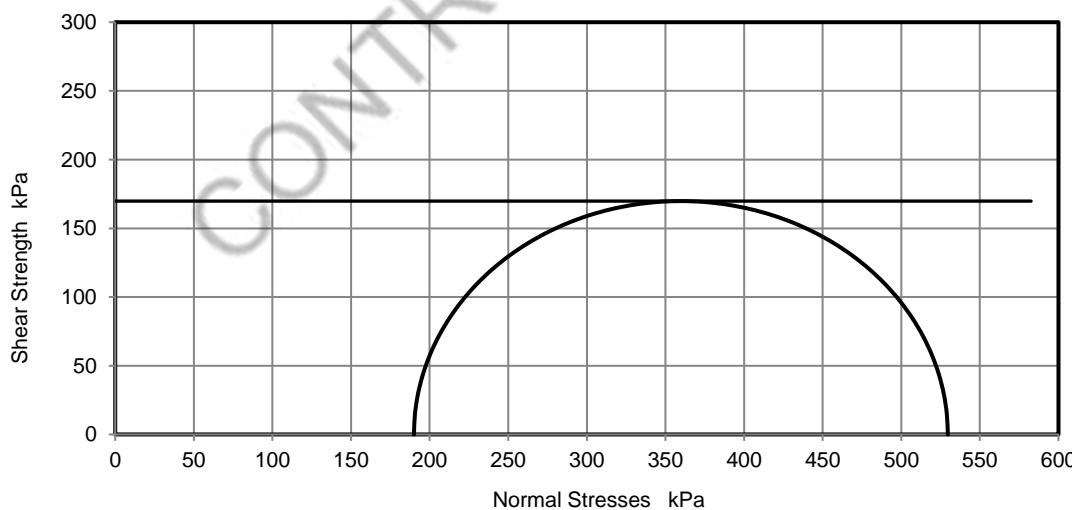
Test Number	1	Rate of Strain	2.00	%/min
Length	139.85 mm	Cell Pressure	190 kPa	
Diameter	68.83 mm	Axial Strain at failure	4.9 %	
Bulk Density	1.93 Mg/m ³	Deviator Stress, ($\sigma_1 - \sigma_3$) _f	340 kPa	
Moisture Content	26 %	Undrained Shear Strength, cu	170 kPa	$\frac{1}{2}(\sigma_1 - \sigma_3)$ _f
Dry Density	1.54 Mg/m ³	Mode of Failure	Compound	
Membrane Correction	0.45 kPa	Membrane thickness	0.23 mm

Deviator Stress v Axial Strain
