### Arboricultural Impact Assessment & Method Statement (to BS:5837 2012)

Land Adjacent to Whiteheath Junior School, Whiteheath Avenue  
Ruislip, HA4 7PR

Ref: TH 1981/C

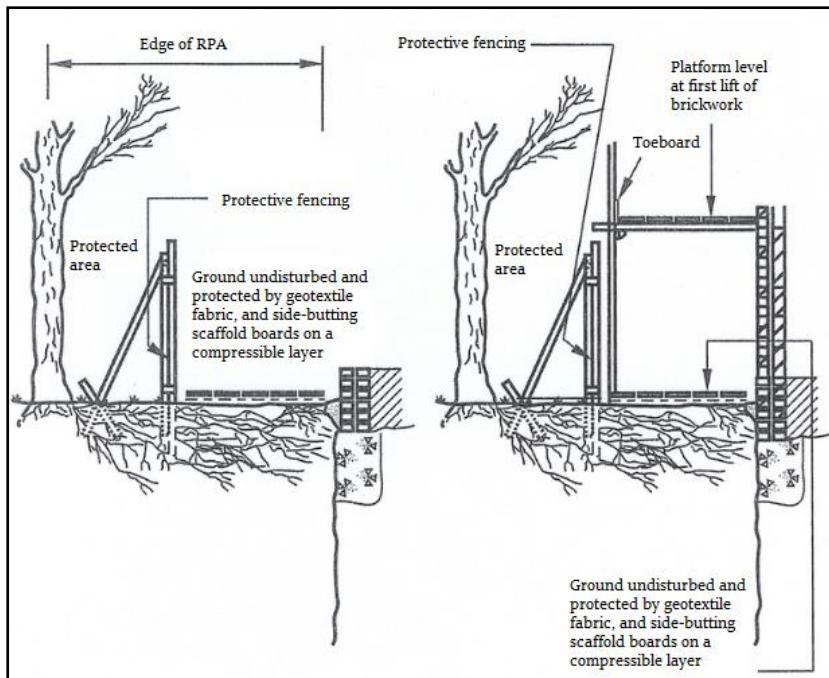
**Figure 1:** An example of ground protection on work areas within a RPA (BS 5837:2005).

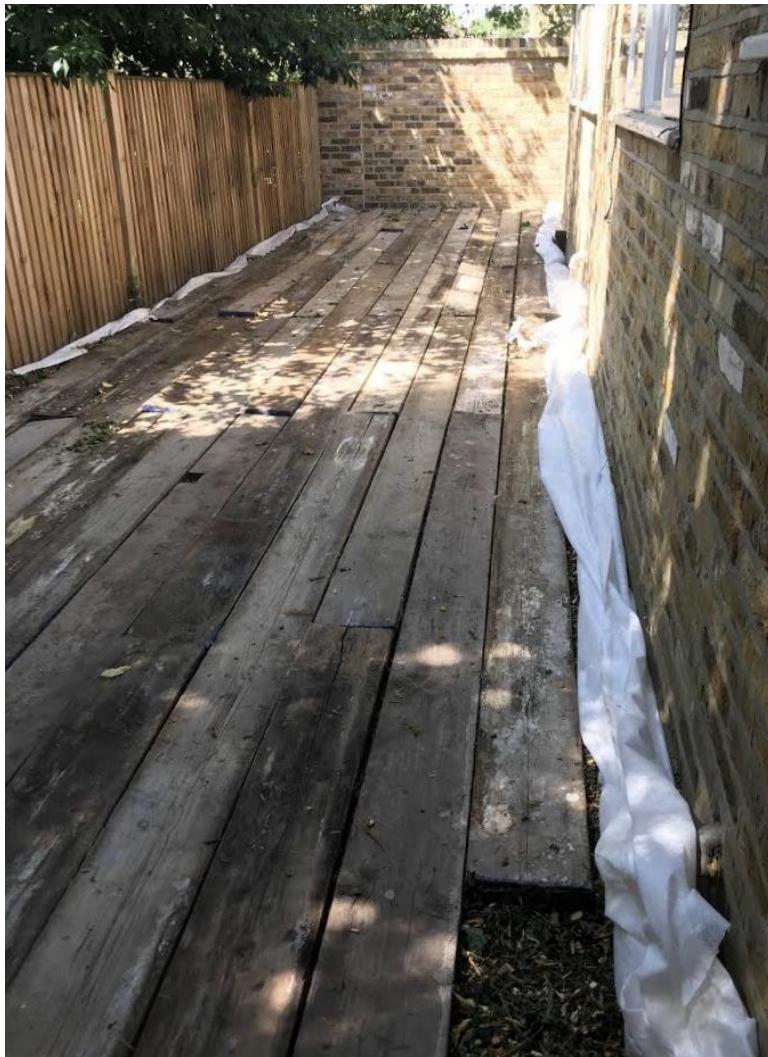
**Figure 2:** A worked example of the ground protection described at (a) on the previous page

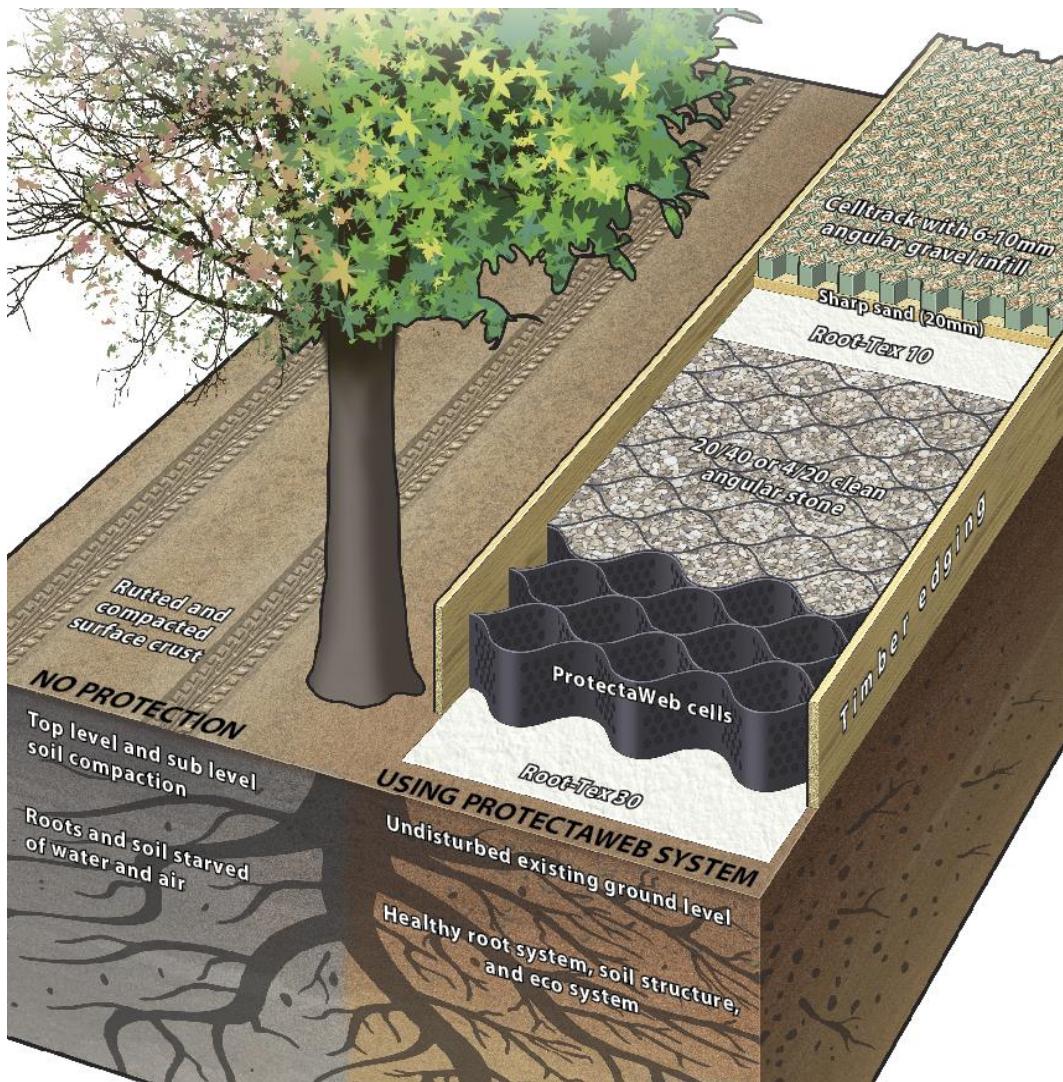
**Figure 4:** A good example of the principles of a no-dig surface.

The no-dig construction principles are outlined below and the areas to which they apply are shown on the TPP (shaded with orange honeycomb). A useful example diagram (by Protectoweb) is shown below (Figure 4).

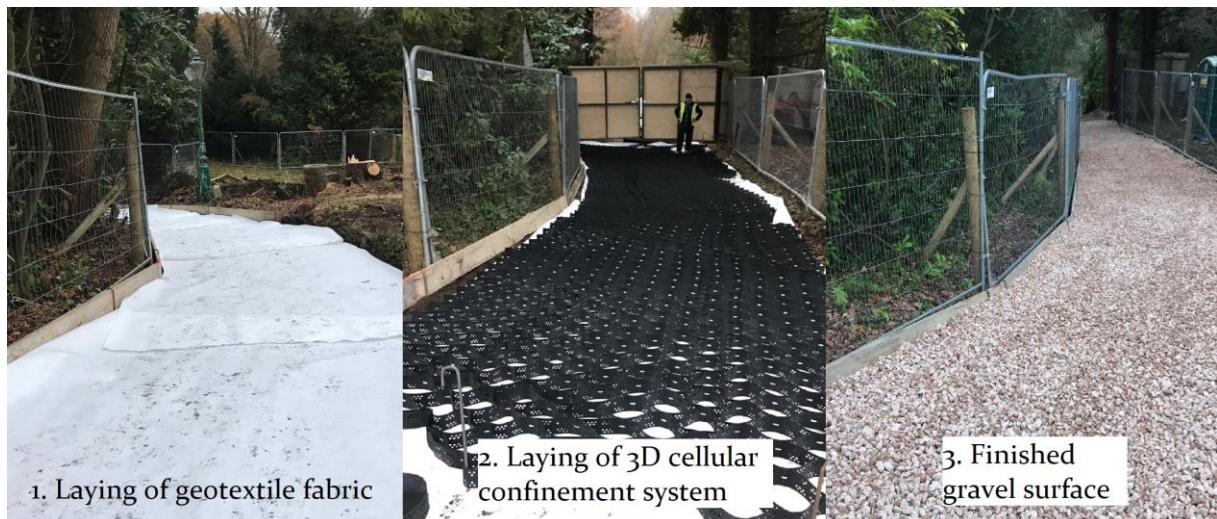
**Photo 3:** Three stages of a 'no-dig' driveway under construction.

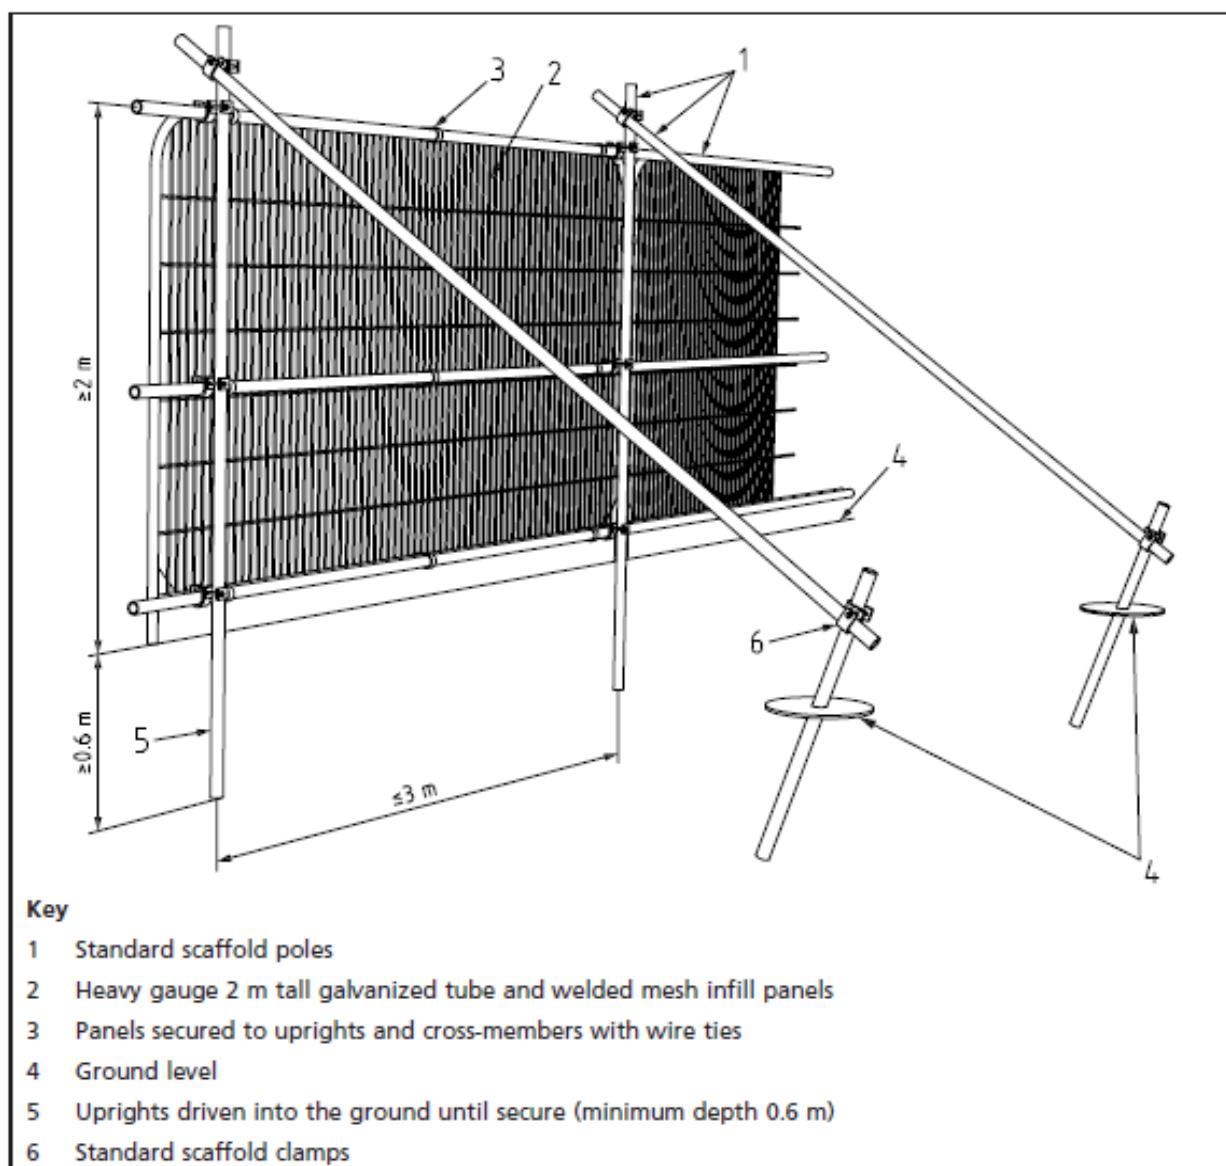
**Figure 2:** Default specification for protective barrier (BS 5837:2012)

The framework support (shown in Figure 2 and photo 1) is the usual method of support for 'Heras' fencing. Some variations are possible if site conditions are appropriate; i.e. support by wooden posts (75mm x 75mm x 2.75m) dug or concreted into the ground (dry mix concrete contained within a plastic bag), or if there is no pressure for access, a lighter form of netting on stakes.

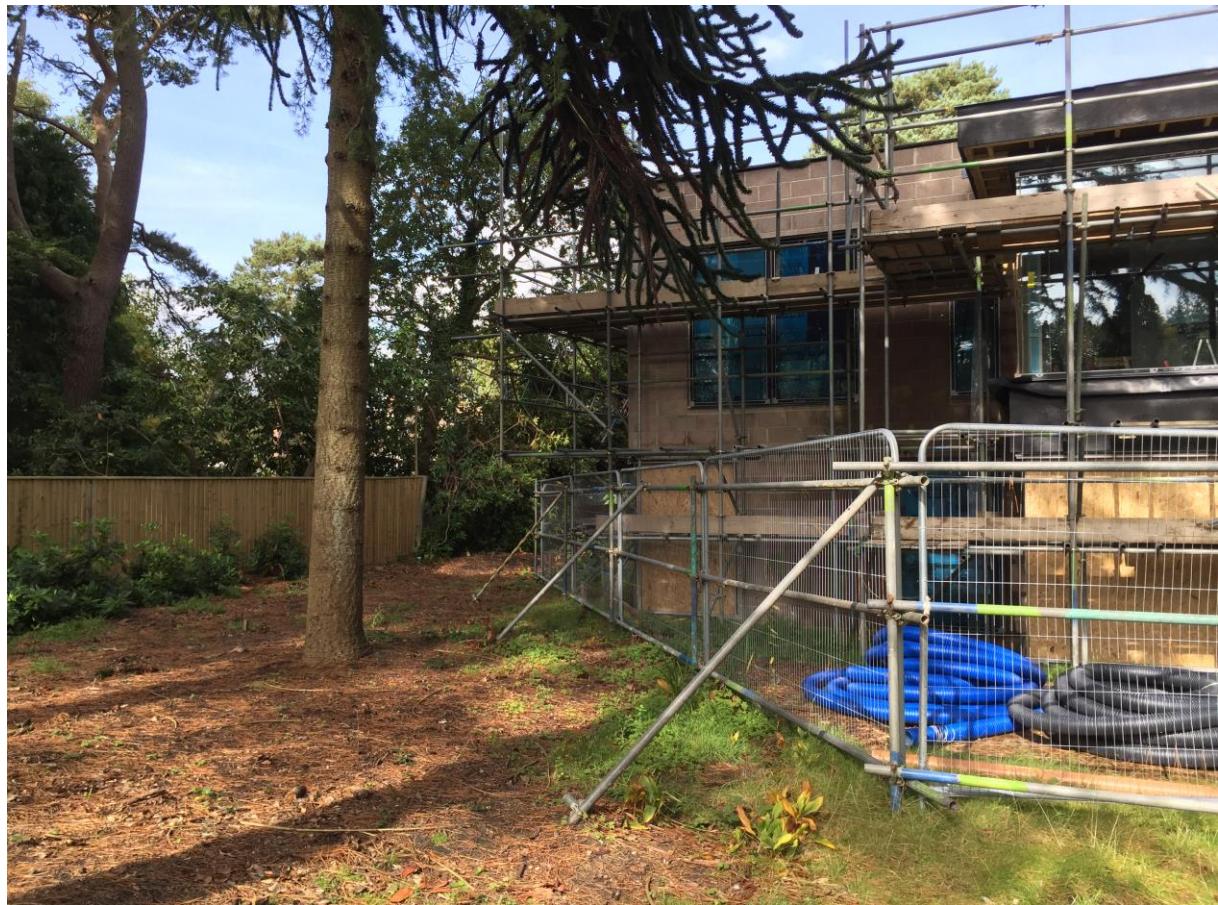
**Photo 1:** A worked example of the default specification for protective barrier (BS 837:2012)

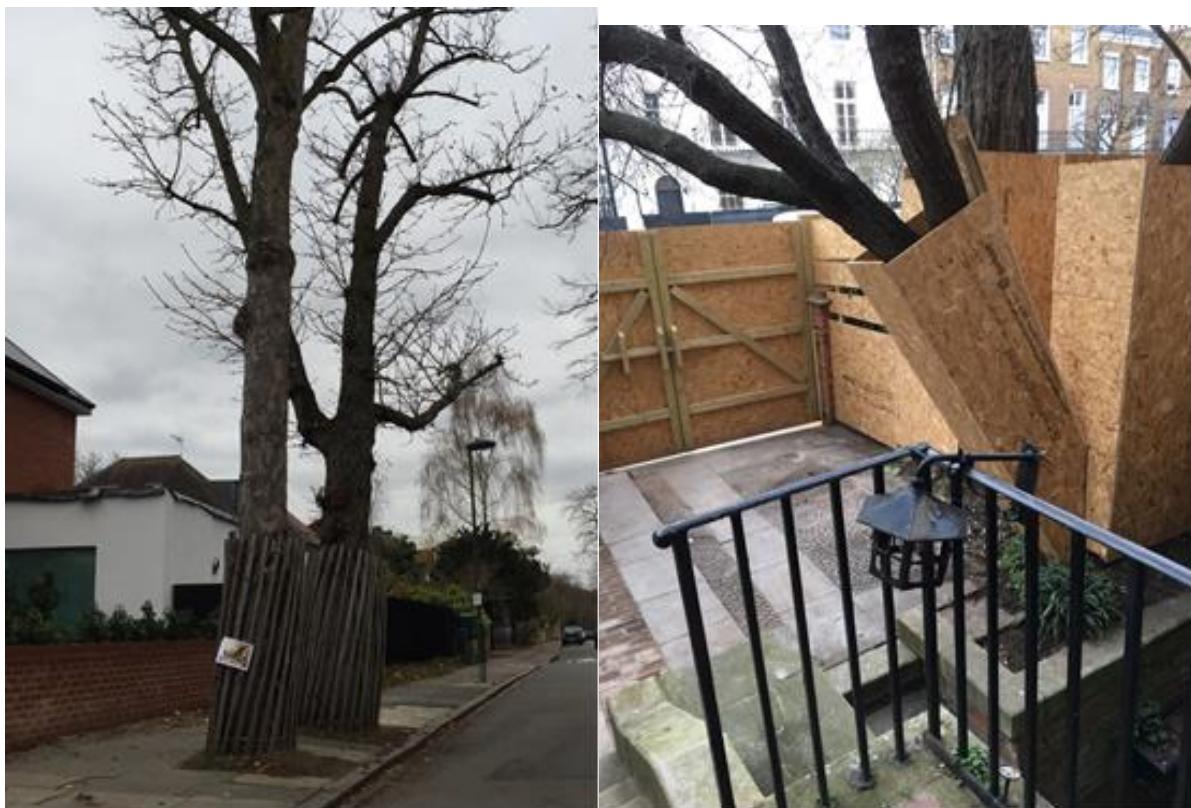
**Photo 2:** Trees protected by hessian & chestnut pale fencing / limbs protected by wooden boxing

Where specified in the AMS, the tree(s) stem/s shall be boxed off with wooden ply boards or wrapped in hessian and chestnut pale fencing. This will help avoid any direct damage to tree stems from passing machinery (see photo 2).

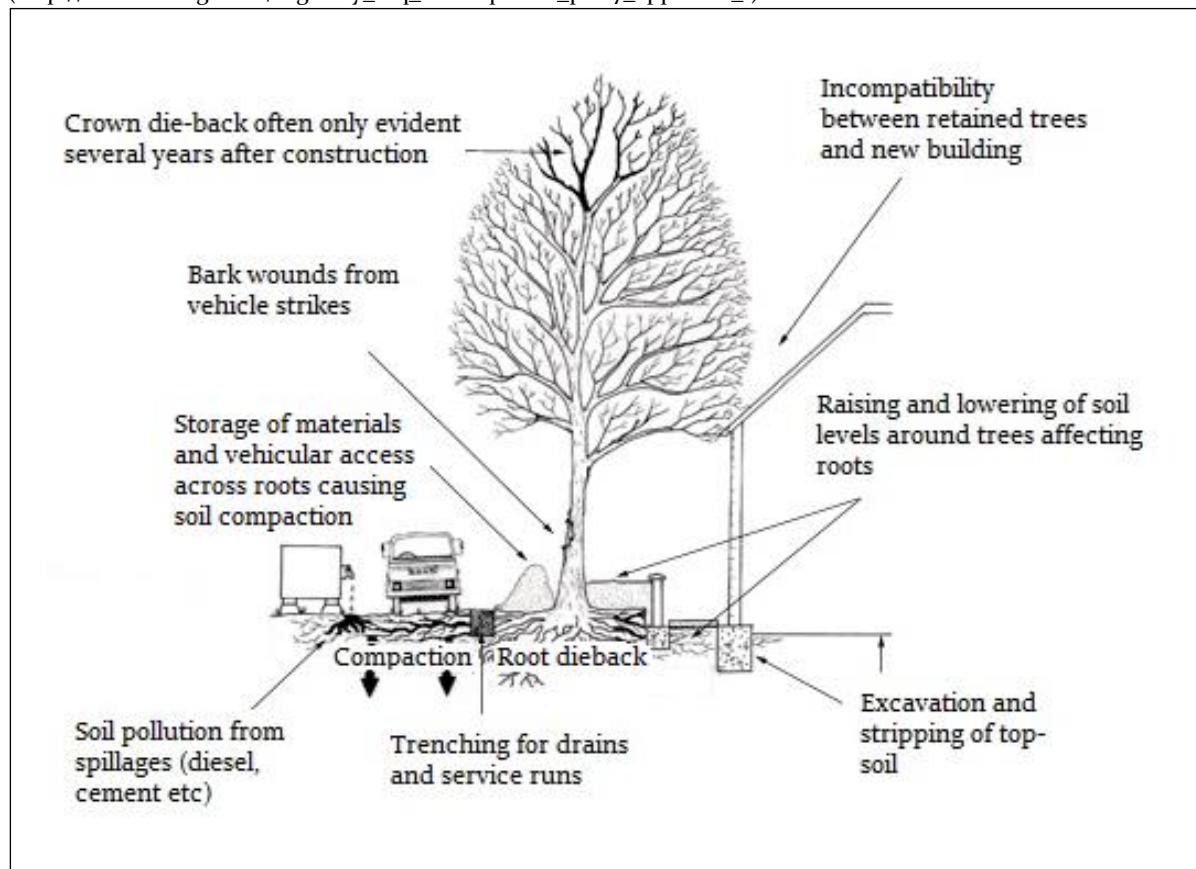
**Figure 4:** Common problems for trees on development sites  
([http://www.leics.gov.uk/highway\\_req\\_development\\_part7\\_appendix\\_f](http://www.leics.gov.uk/highway_req_development_part7_appendix_f))

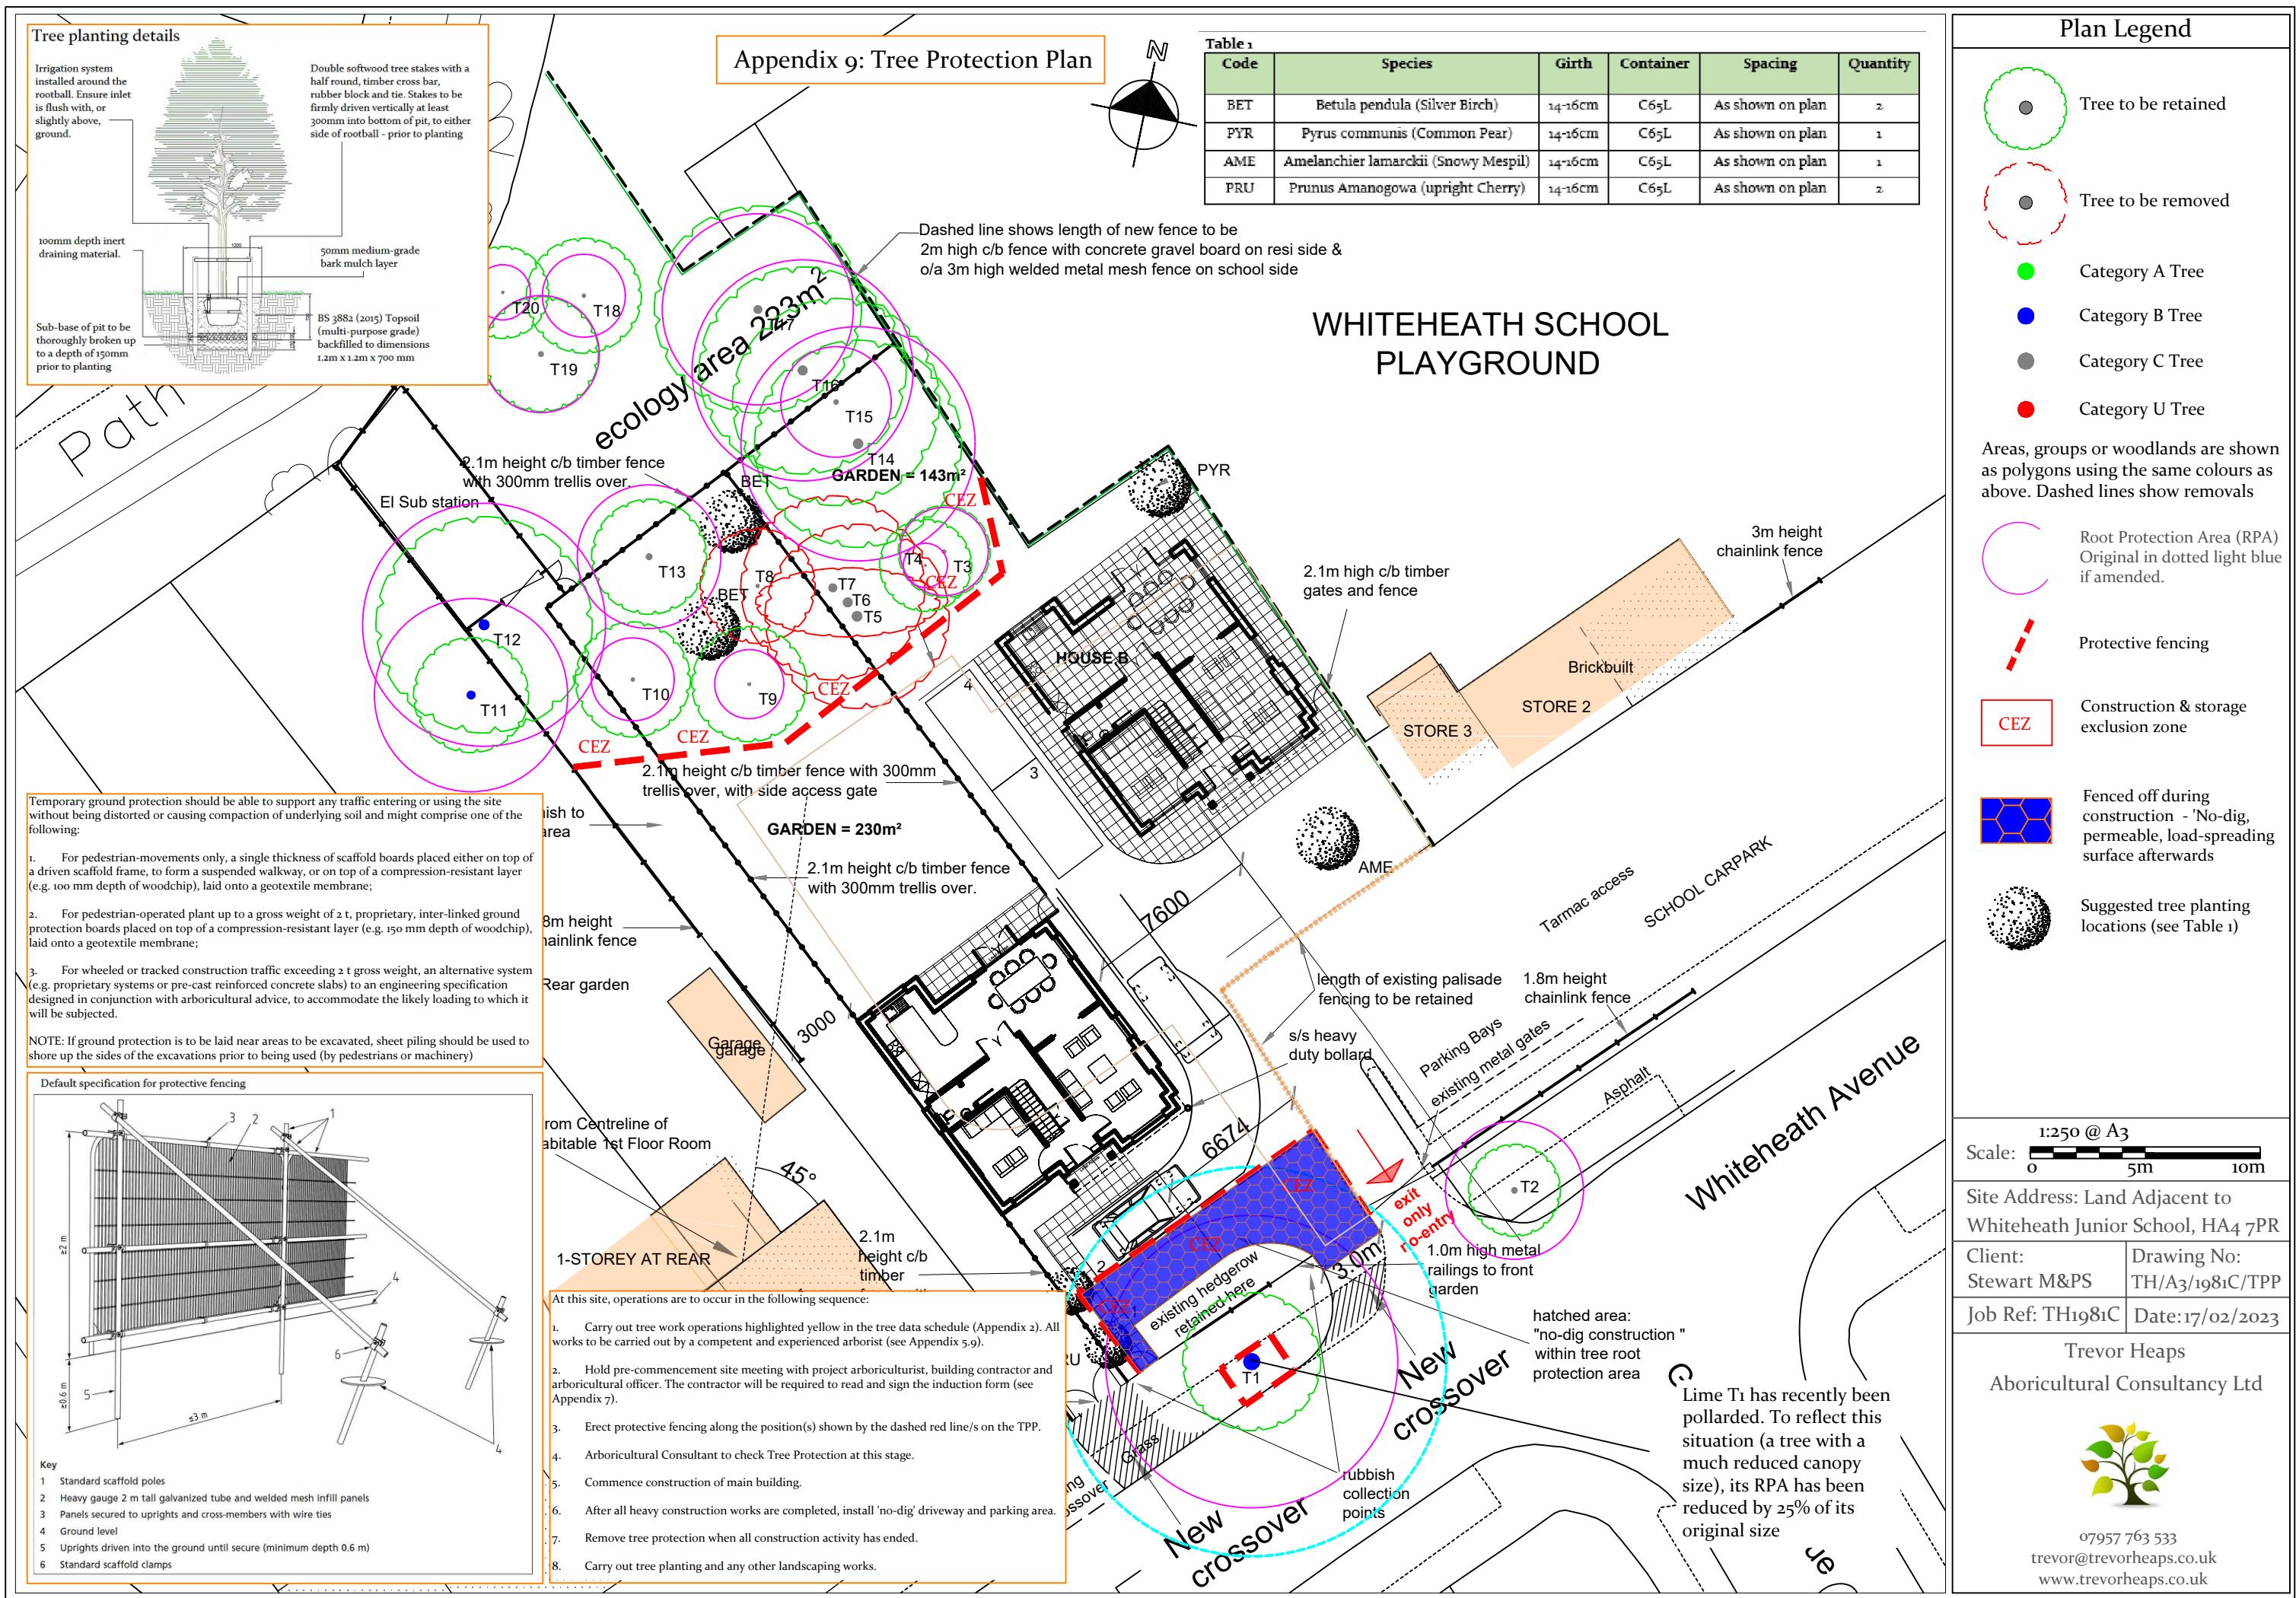
9.3.2 Subsequently, the RPA of Lime T1 has been reduced by 25%. The amended RPA is shown as solid magenta circles. The original RPA is shown on the TPP as a dotted blue circle.
